## C1981022, Elk Creek Mine, February Inspection Report (Aerial)

<b>Permit Number:</b> C-1981-022 <b>Mine Name:</b> Elk Creek Mine <b>Operator:</b> Oxbow Mining, LLC <b>Operator Address:</b> Mr Doug Smith 3737 Hwy 133 P. O. Box 535 Somerset, CO 81434	<b>County:</b> Delta, Gunnison <b>Operation Type:</b> Underground <b>Permit Status:</b> Active <b>Ownership:</b> Private
	<b>Operator Representative Present:</b>  None
<b>Operator Representative Signature: (Field Issuance Only)</b>

<b>Inspection Start Date:</b> February 13, 2024 <b>Inspection Start Time:</b> 12:00 <b>Inspection End Date:</b> <b>Inspection End Time:</b>		<b>Inspection Type:</b> Aerial Inspection <b>Inspection Reason:</b> Normal I&E Program <b>Weather:</b> Clear	
<b>Joint Inspection Agency:</b>  None		<b>Joint Inspection Contacts:</b>	
<b>Post Inspection Agency:</b>  None		<b>Post Inspection Contacts:</b>	
<b>Inspector(s):</b>  Leigh Simmons  Brock Bowles	<b>Inspector's Signature:</b>

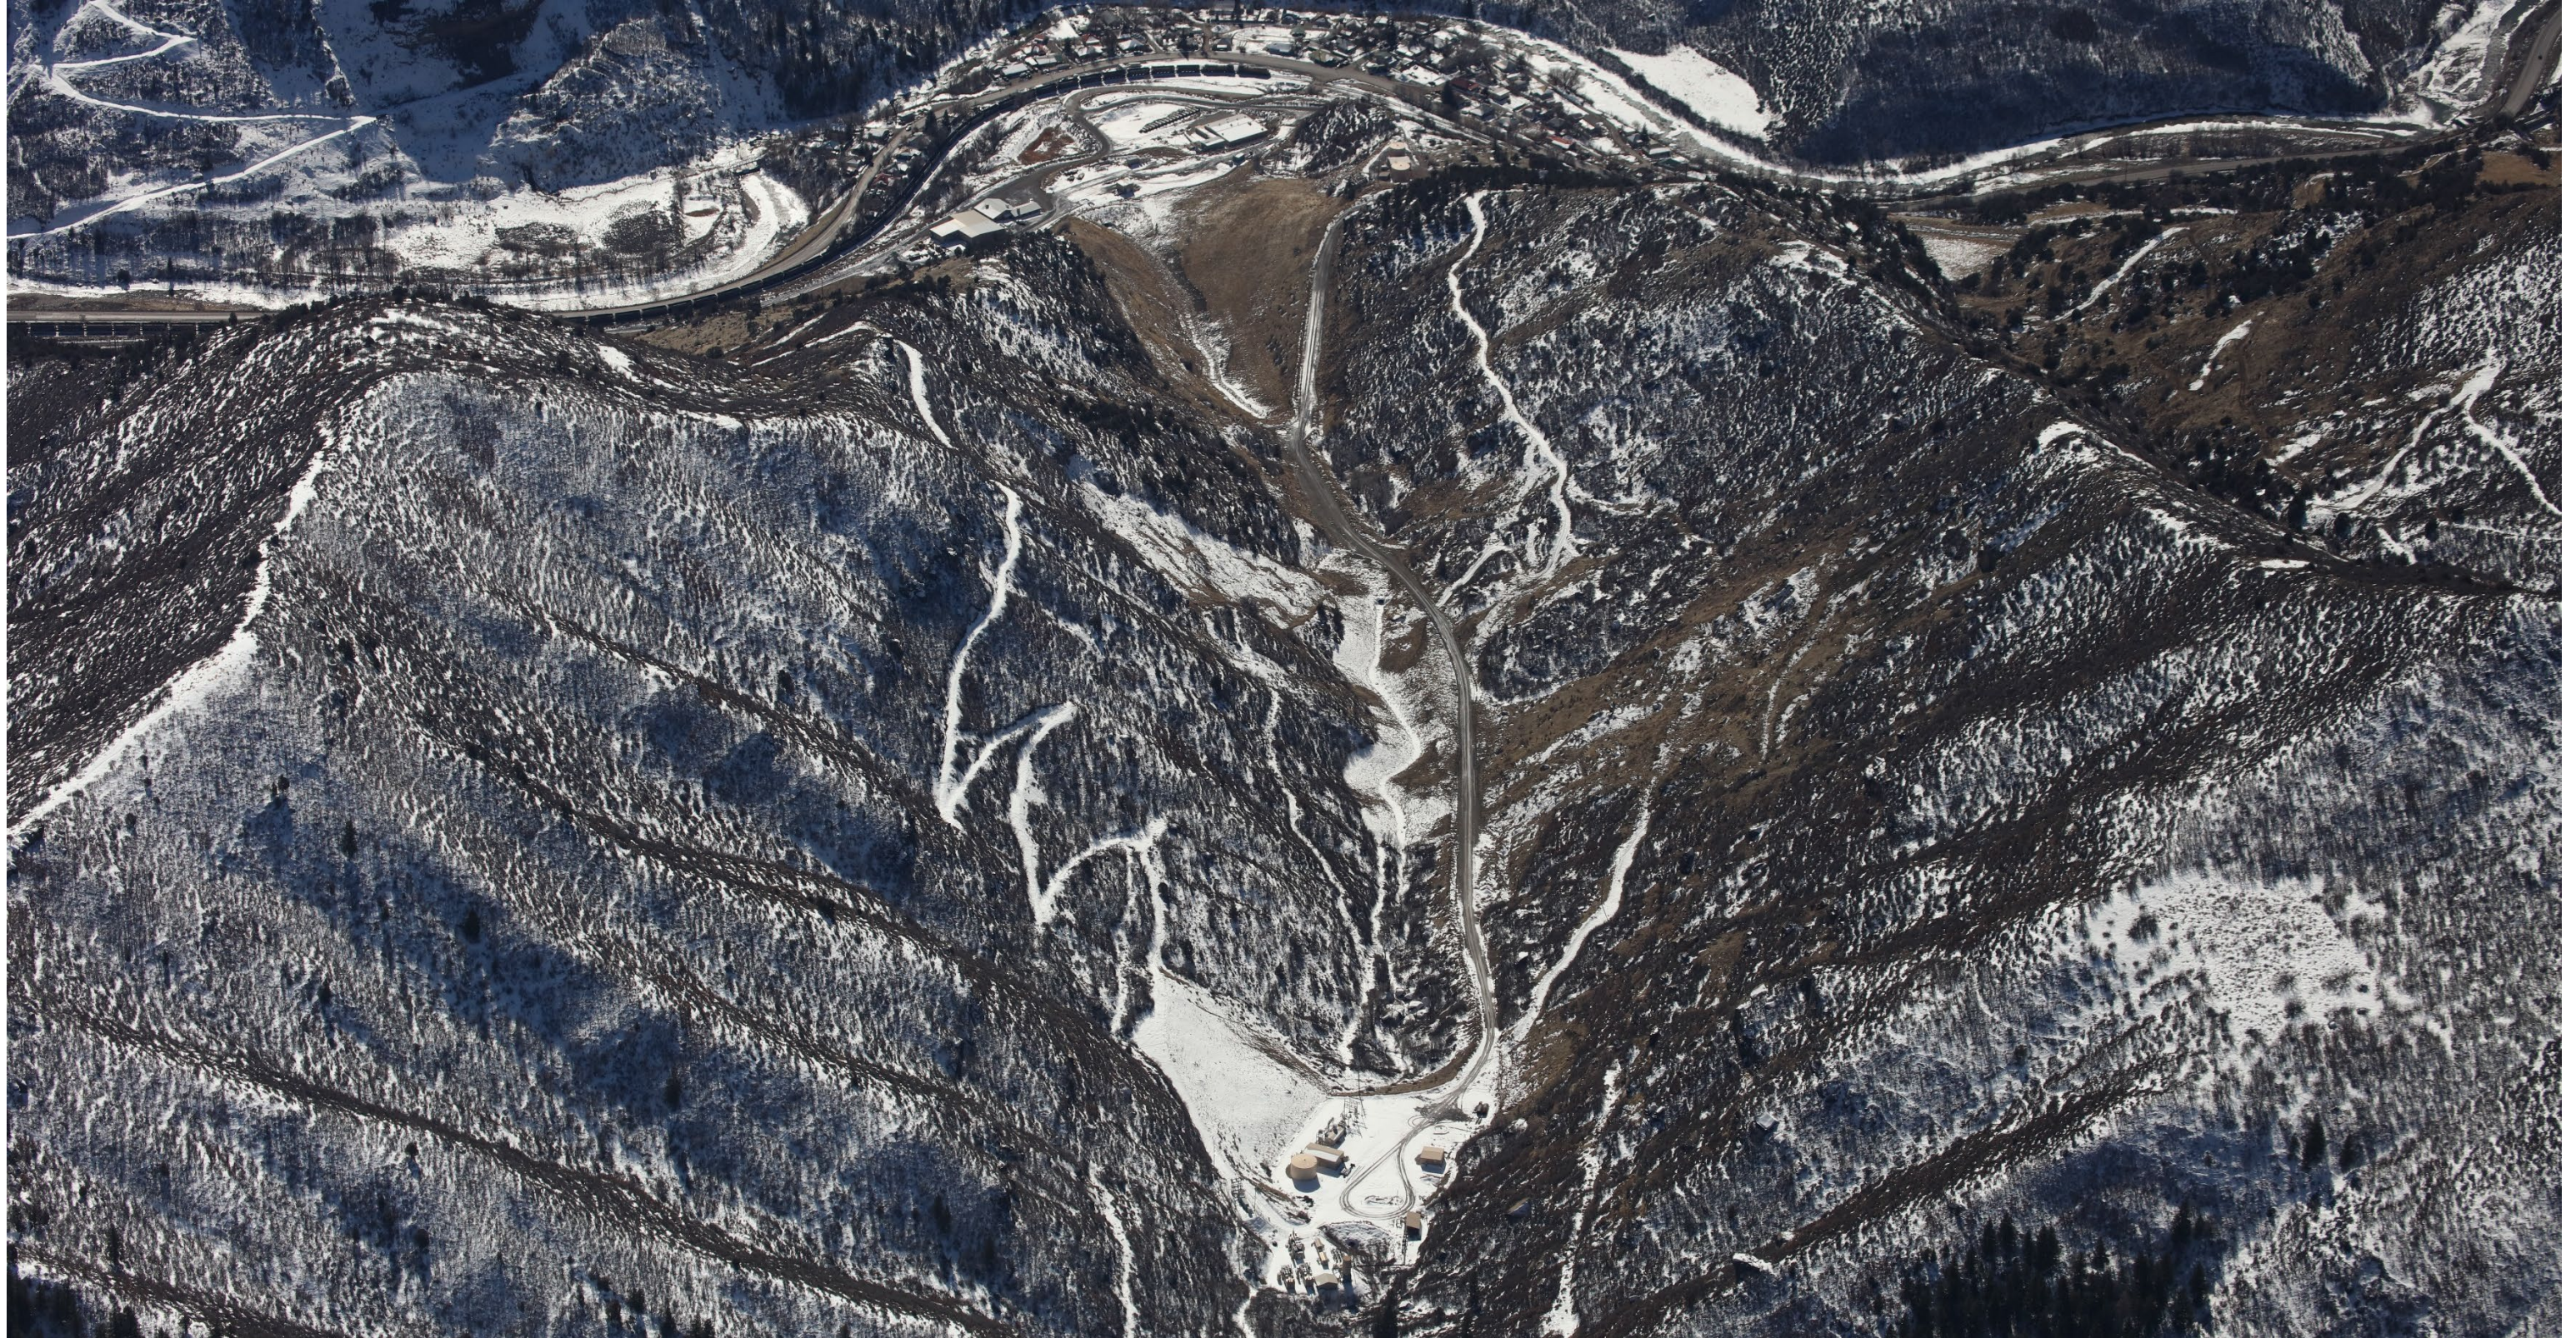
*Figure 13: Overview of Elk Creek facilities from north*
