## Inspection Report, Foidel Creek Mine, C-1982-056

**PERMIT INFORMATION**

| <b>Inspection Start Date:</b> February 6, 2024<br><b>Inspection Start Time:</b> 10:15<br><b>Inspection End Date:</b> February 6, 2024<br><b>Inspection End Time:</b> 12:15 | | <b>Inspection Type:</b> Coal Partial Inspection<br><b>Inspection Reason:</b> Normal I&E Program<br><b>Weather:</b> Clear | |

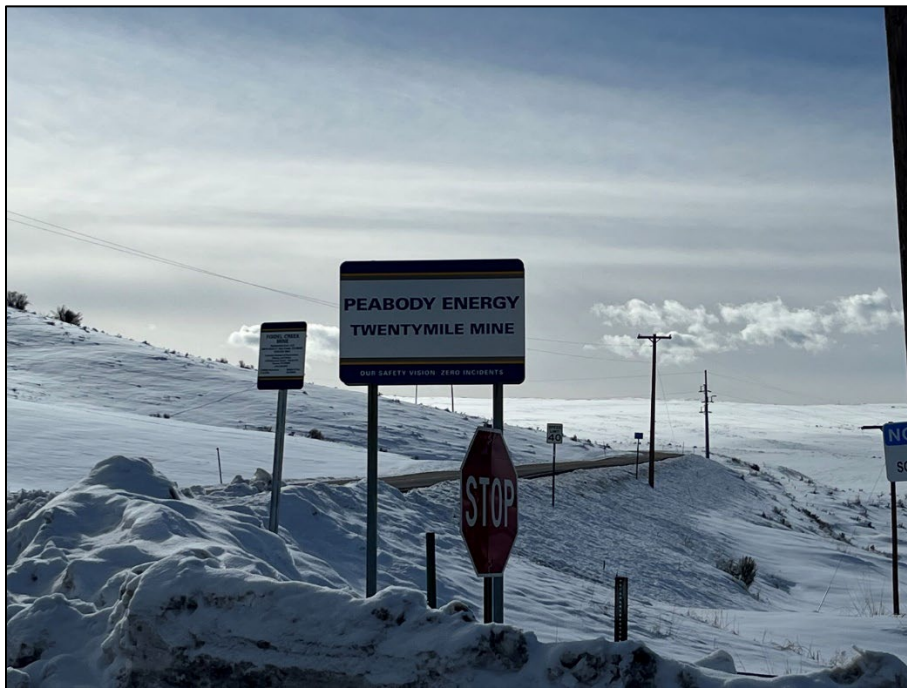
Mine identification markers were observed throughout the site (Photo 1). All information for compliance was present on mine signs. Signs were also noted along CR27 where the mine's permit boundary crosses the public road.

*Figure 1: Mine sign located at the access road entrance*

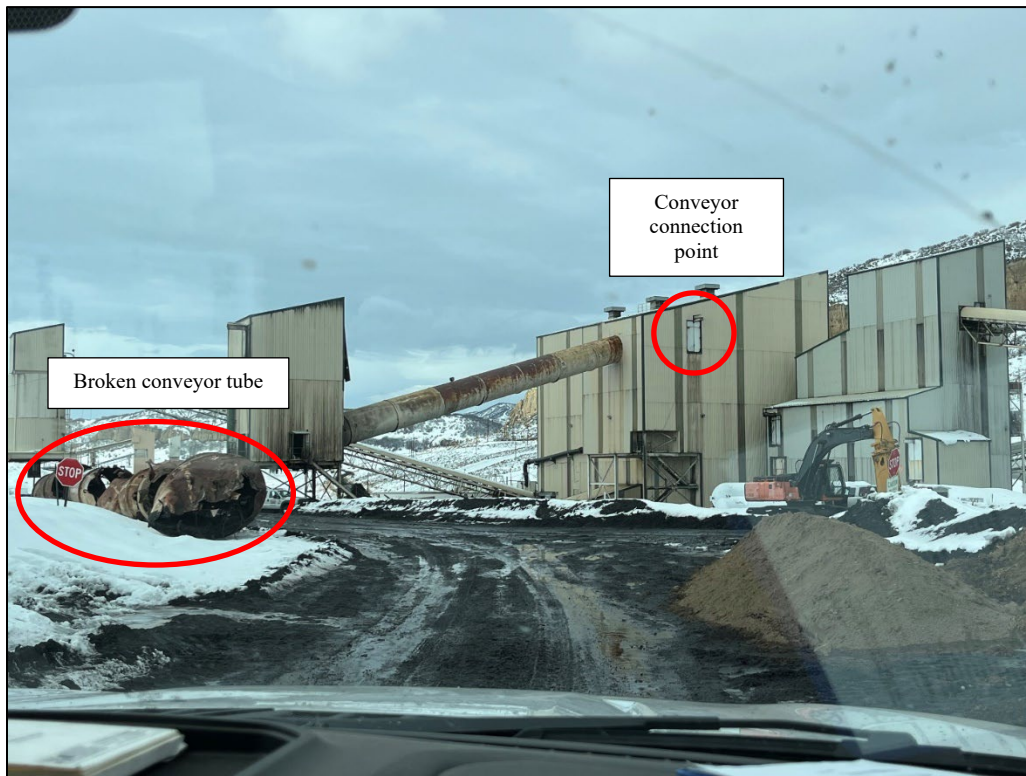
The Operator informed the Division that a large, old conveyor tube located on the eastern side of the wash plant facility had recently been damaged (Photo 2). The conveyor tube became overwhelmed with the weight of recent snow and ice and detached from the main wash plant building. No injuries occurred. As a result, no new coal was being washed and processed at the time of inspection. TC has plans to salvage surplus conveyor equipment from the nearby Peabody Sage Creek Mine to build a temporary replacement conveyor while a new conveyor tube is being fabricated. Coal was being reworked and piled by a dozer in the Coal Stockpile Loadout while wash plant activities are on hold (Photo 5).

*Figure 2: A conveyor tube connected to the east side of the Wash Plant was recently damaged, a temporary conveyor will be built in its place until a new tube can be fabricated.*

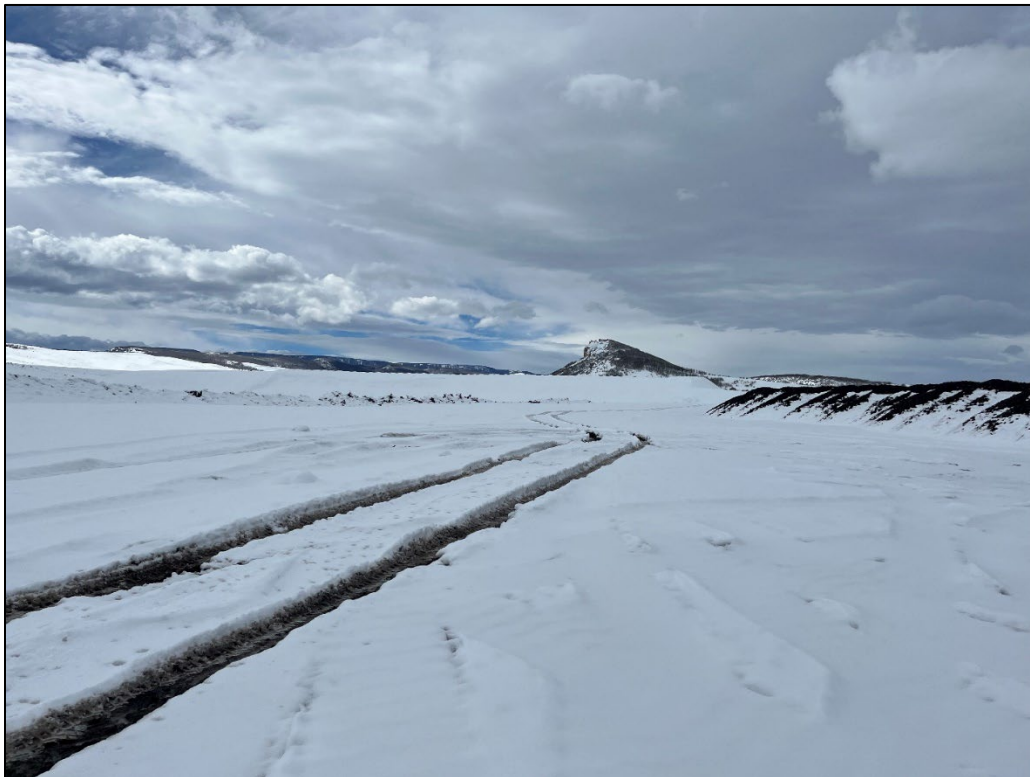
The refuse pile was not active at the time of inspection. No haul trucks were piling material as coal could not be washed and separated from spoil due to the wash plant damage. Piling and compaction of refuse material will continue once a temporary conveyor has been installed at the wash plant. Lifts three and four are currently under construction (Photos 3 and 4).

*Figure 3: View south, the refuse pile was not active at the time of inspection.*

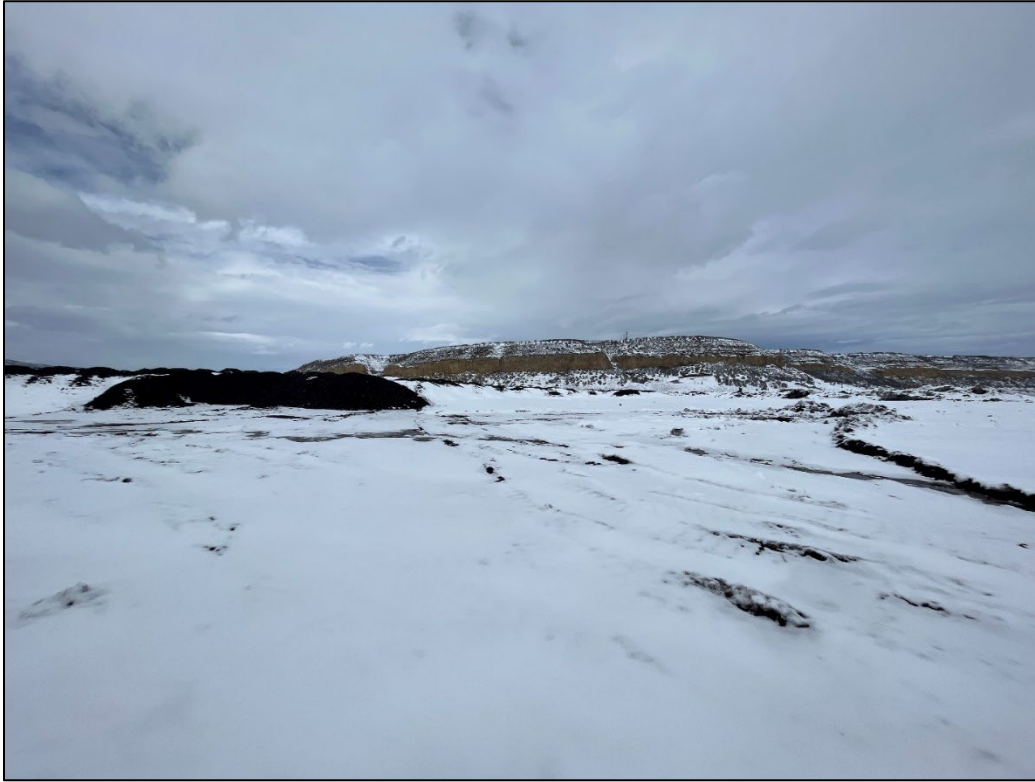
*Figure 4: View southwest, the refuse pile was not active at the time of inspection.*

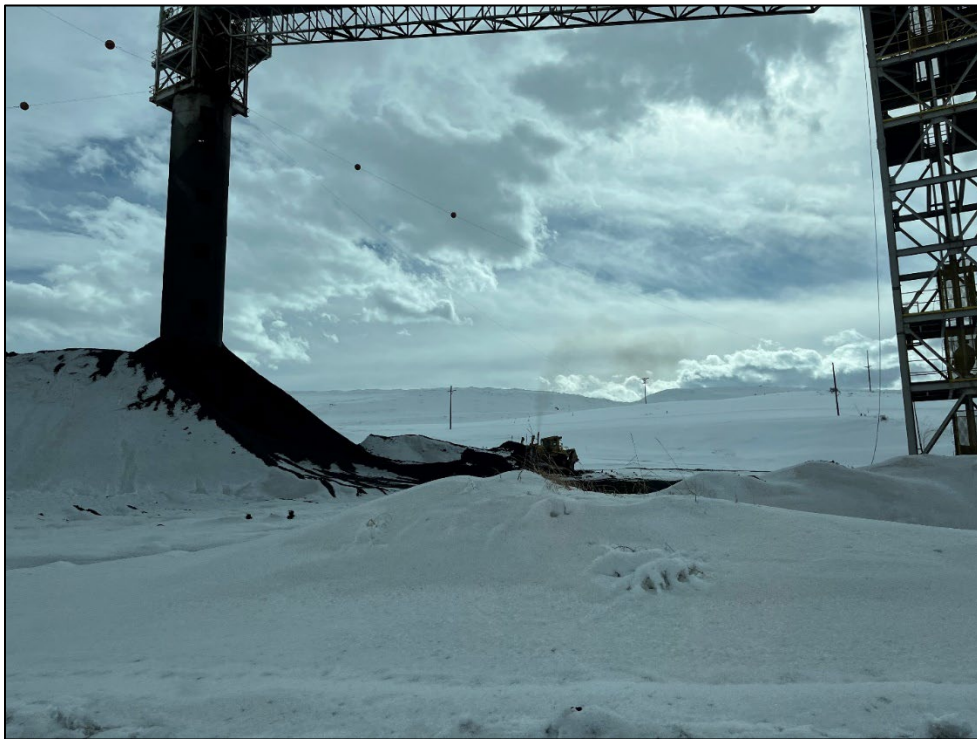
*Figure 5: Coal was being reworked and piled by a dozer in the Coal Stockpile Loadout while wash plant activities are on hold.*

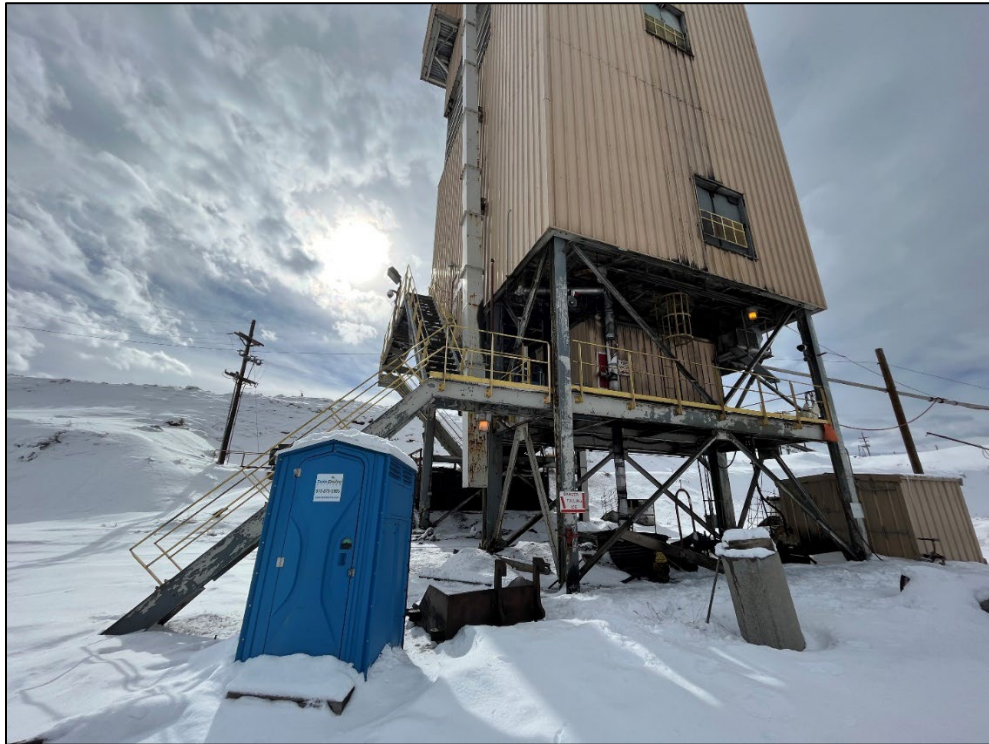
The train loadout area was inspected and found to be in good condition. Foidel Creek looked to be vegetated under the snow and buffer zones signs and barrel markers were still in place (Photos 6, 8, and 9).

*Figure 6: View east of the train loadout facility.*

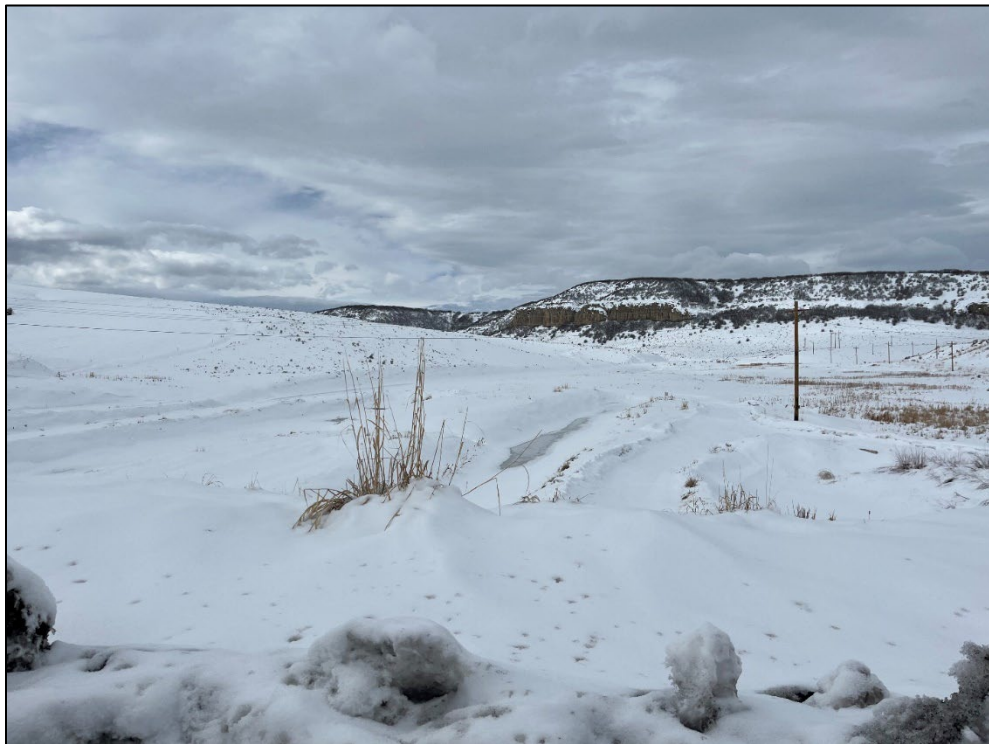
Most ponds across the site were frozen over and snow covered. However, Ponds E, D and B were noted to still be discharging slightly (Photos 7, 10, and 11) No erosional or structural issues were noted at any of the ponds.

*Figure 7: View south of Ponds B, snow covered but discharging.*

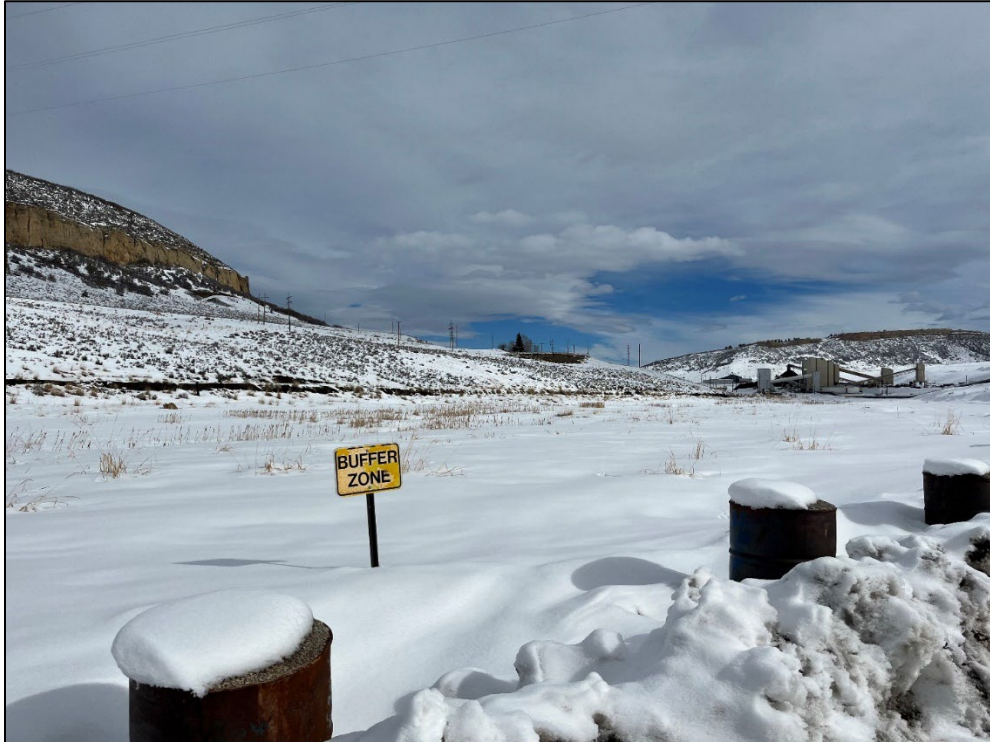
*Figure 8: View northwest of the buffer zone signs in place near the train loadout facility.*

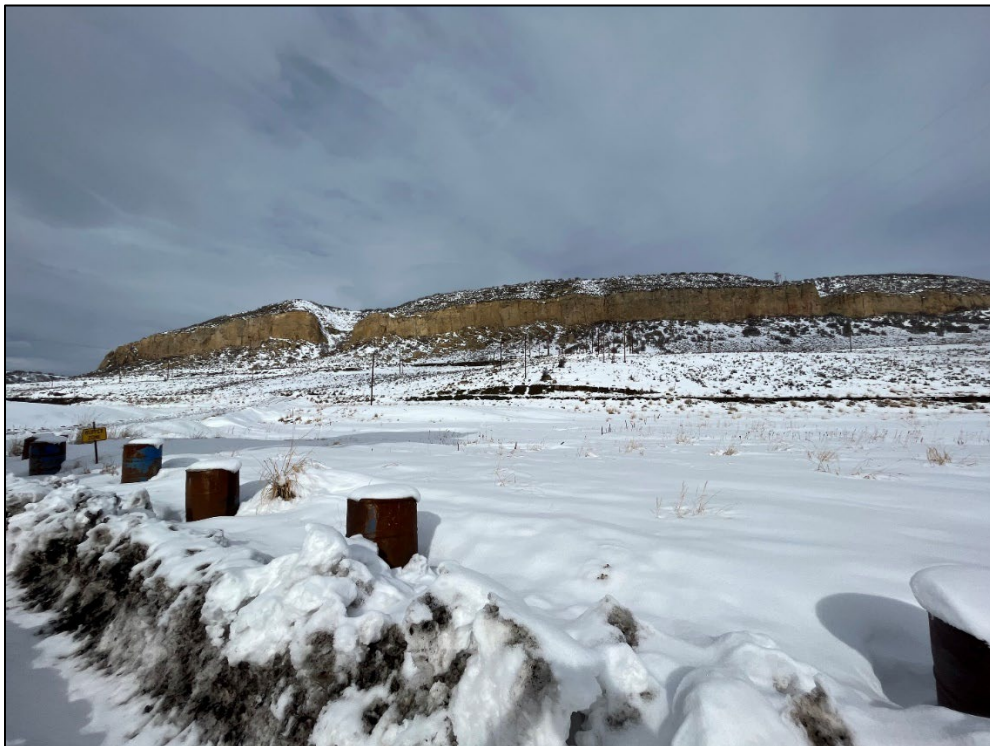
*Figure 9: View southwest of Foidel Creek and appropriate buffer zone signage.*

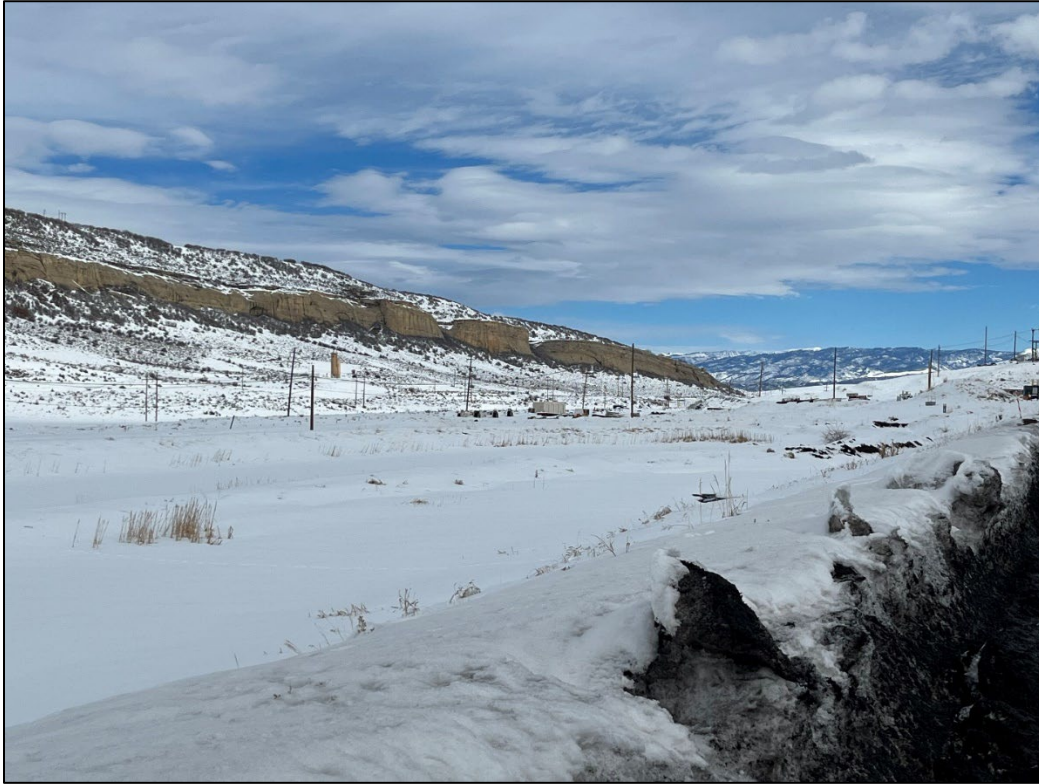
*Figure 10: Though snow-covered, Pond E was discharging at the time of inspection.*

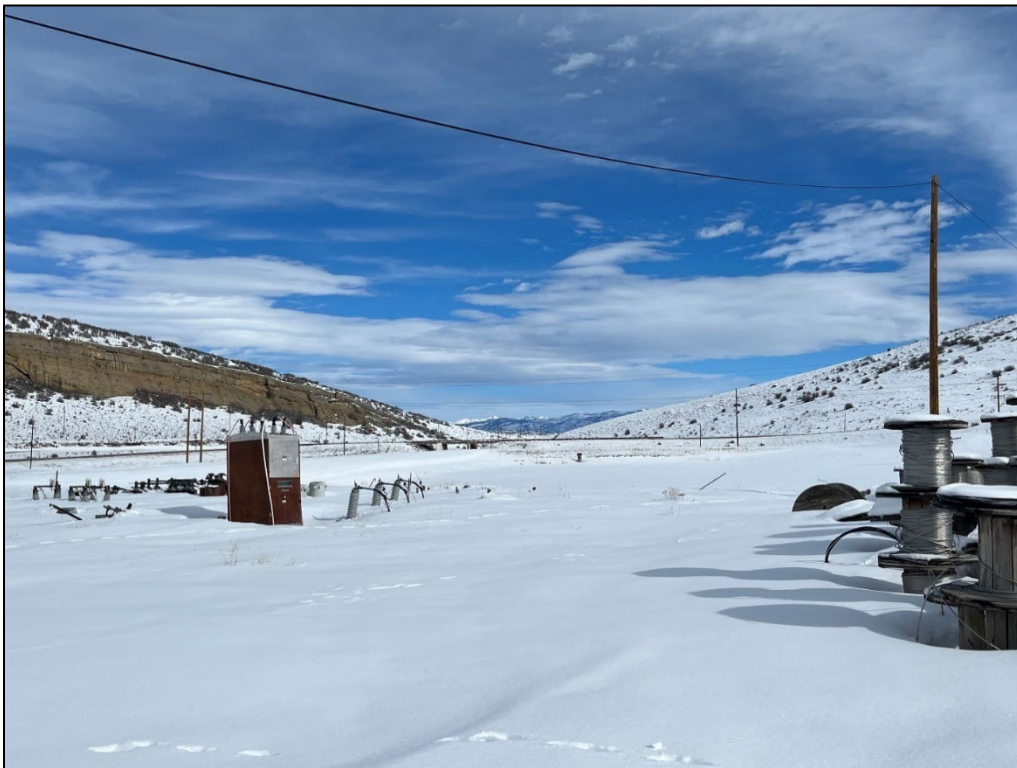
*Figure 11: Pond G was frozen over, snow-covered, and not discharging.*

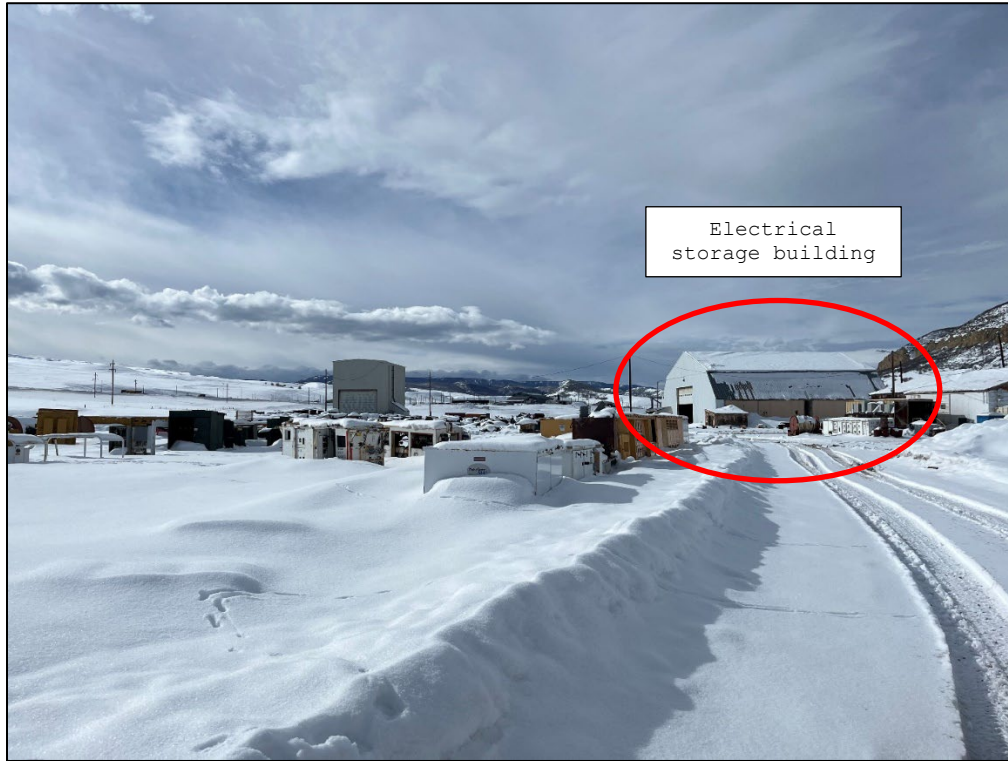
The Operator mentioned that the storage building, called the 'Electrical Storage Building' on Surface Facilities Map 24 and listed as the 'PM Bay' in Foidel's Reclamation Cost Estimate, is set to be torn down and replaced with a new storage facility (Photo 12). The new facility may be rebuilt on the existing pad, which is preferable, or it may be rebuilt elsewhere, but close to the original location. Depending on the design and size of the new storage building, this may have bonding implications for TC. TC is aware that any change to the support facilities will require submission of a Minor Revision to approve the new building placement and reevaluate the bond.

*Figure 12: View south of belt yard and surplus storage area. TC has plans to tear down and replace the electrical storage building seen to the west.*

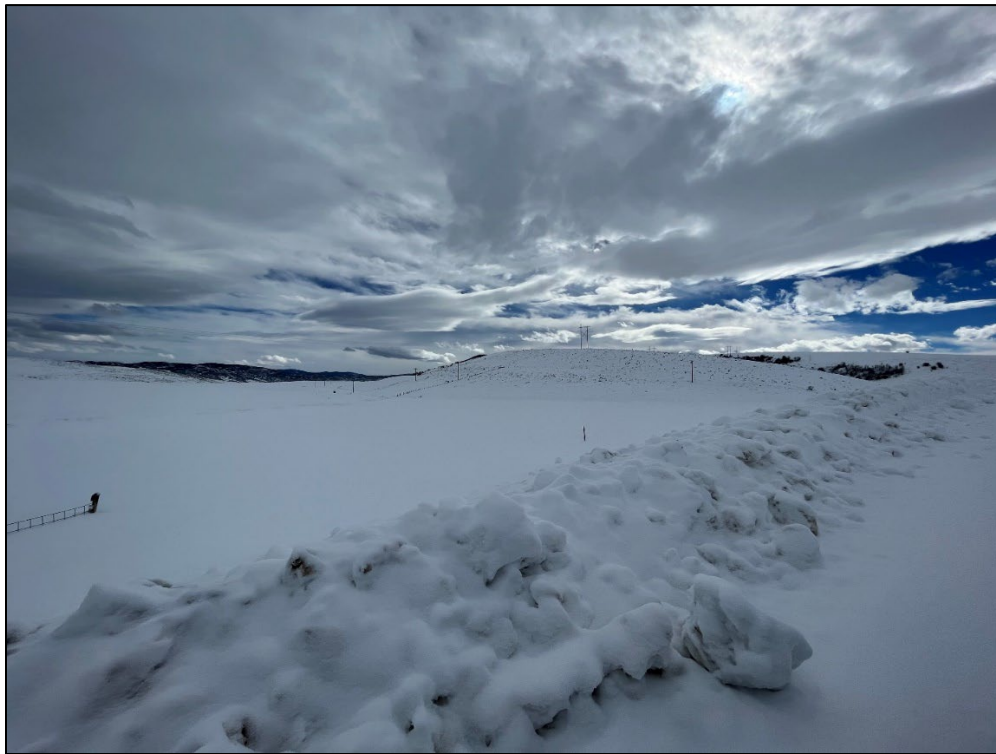
The northeastern corner of the permit was inspected, which includes the Tipple Pond (Photo 13), 9E Exhaust Blower Pad, and reclaimed 18 Right Borehole. Several topsoil piles are in place along the road through this area and look to be stable and vegetated under the snow. The roads had been plowed recently of heavier snowfall events. Culverts and the area's drainage ditch were unable to be inspected under the snow.

*Figure 13: View southeast of the Tipple Pond in the NE corner of the permit.*
