MINERALS PROGRAM INSPECTION REPORT

MINE NAME: Clear Spring Ranch Pit	MINE/PROSPECTING ID#: M-1992-074	MINERAL: Gravel	COUNTY: El Paso
INSPECTION TYPE: Monitoring	WEATHER: Clear	INSP. DATE: August 29, 2023	INSP. TIME: 09:10
OPERATOR: City of Colorado Springs	OPERATOR REPRESENTATIVE: Joe Houghton	TYPE OF OPERATION: 112c - Construction Regular Operation	
REASON FOR INSPECTION: Normal I&E Program	BOND CALCULATION TYPE: None	BOND AMOUNT: \$0.00	
DATE OF COMPLAINT: NA	POST INSP. CONTACTS: None	JOINT INSP. AGENCY: None	
INSPECTOR(S): Timothy Cazier, P.E.	INSPECTOR'S SIGNATURE:

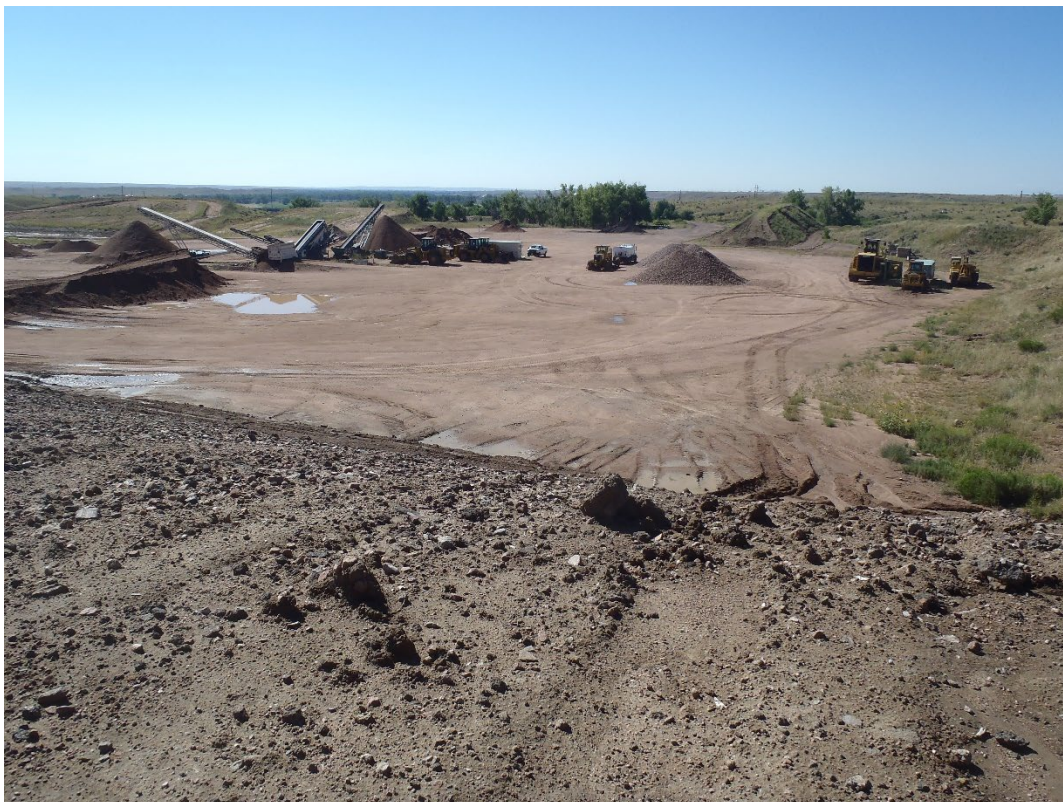
Hydrologic Balance: Some standing water was observed (see **Photo 1**) in the pit due to the estimated 0.75 inches of rain that fell the day before the inspection. No exposed groundwater was observed.

Support Facilities On-site: A screen plant, loaders, and grader were observed on site (see **Photo 1**).

Photo 1. Pit floor and equipment (looking south from top of C&D landfill, note large puddles from rain).
