MINERALS PROGRAM INSPECTION REPORT
PHONE: (303) 866-3567

MINE NAME: Clear Spring Ranch Pit	MINE/PROSPECTING ID#: M-1992-074	MINERAL: Gravel	COUNTY: El Paso
INSPECTION TYPE: Monitoring	WEATHER: Clear	INSP. DATE: August 29, 2023	INSP. TIME: 09:10
OPERATOR: City of Colorado Springs	OPERATOR REPRESENTATIVE: Joe Houghton	TYPE OF OPERATION: 112c - Construction Regular Operation	
REASON FOR INSPECTION: Normal I&E Program	BOND CALCULATION TYPE: None	BOND AMOUNT: \$0.00	
DATE OF COMPLAINT: NA	POST INSP. CONTACTS: None	JOINT INSP. AGENCY: None	
INSPECTOR(S): Timothy Cazier, P.E.	INSPECTOR'S SIGNATURE:

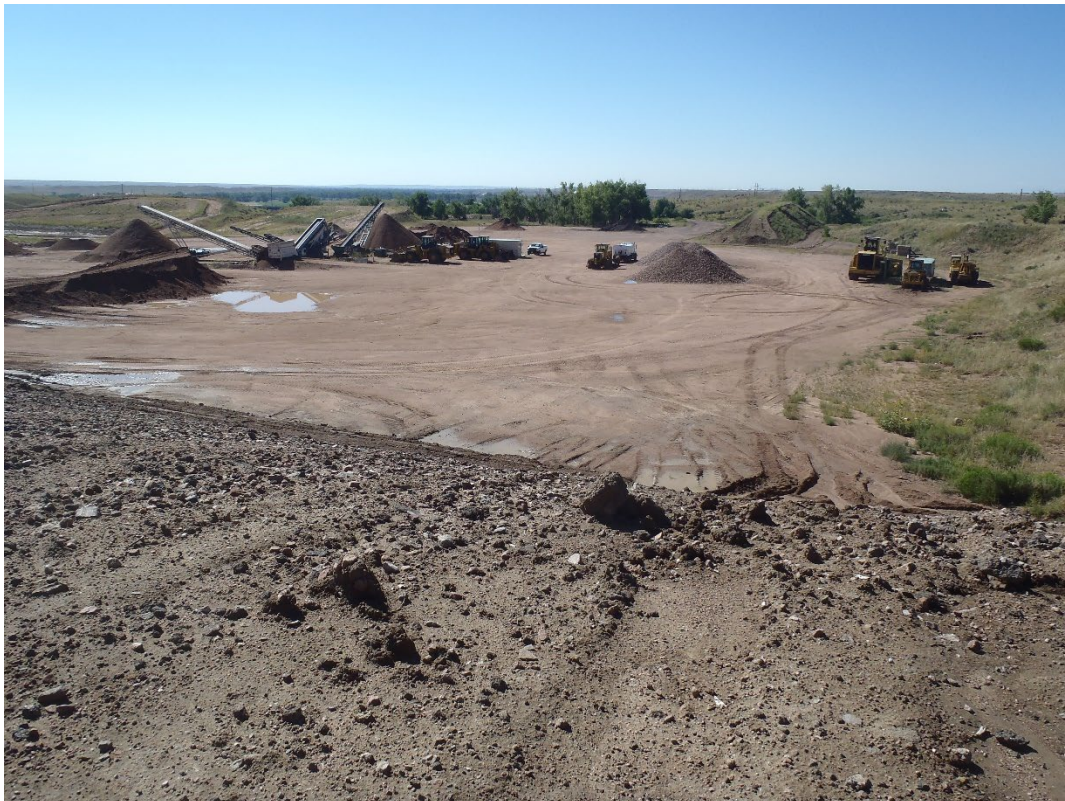
Hydrologic Balance: Some standing water was observed (see **Photo 1**) in the pit due to the estimated 0.75 inches of rain that fell the day before the inspection. No exposed groundwater was observed.

Support Facilities On-site: A screen plant, loaders, and grader were observed on site (see **Photo 1**).

Photo 1. Pit floor and equipment (looking south from top of C&D landfill, note large puddles from rain).

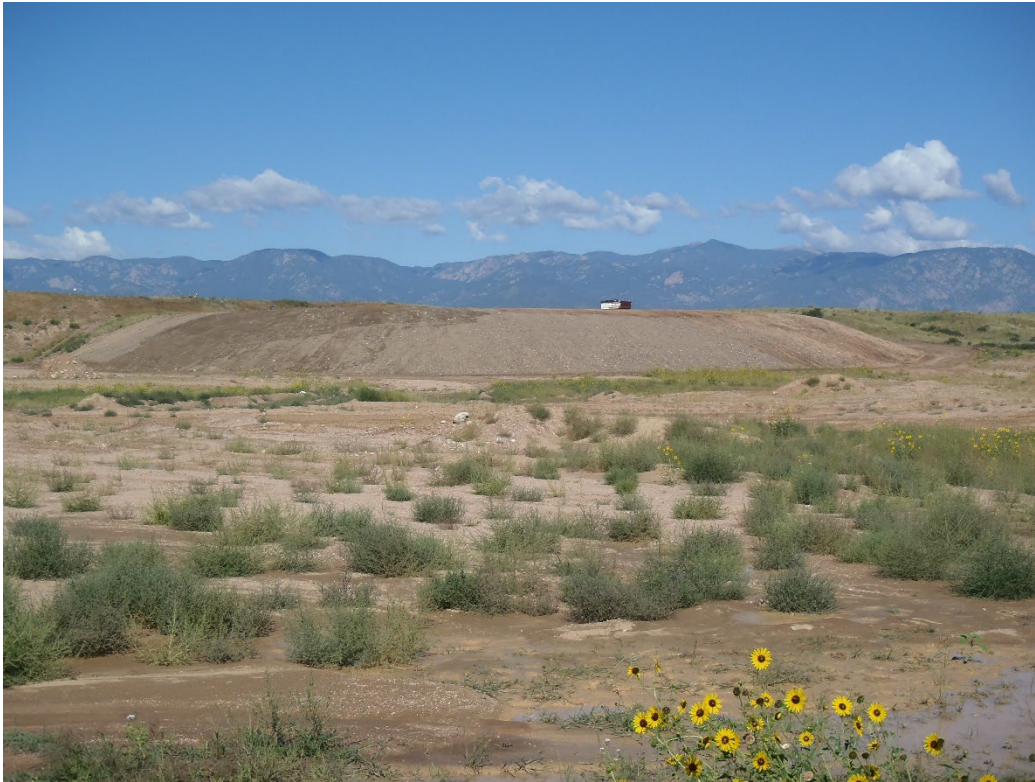
Processing Waste: Site representatives stated screening fines are used for cover material on the adjacent construction and demolition landfill area (see **Photo 2**), among various other uses.

Photo 2. Construction & Demolition landfill on NW corner (looking NW).

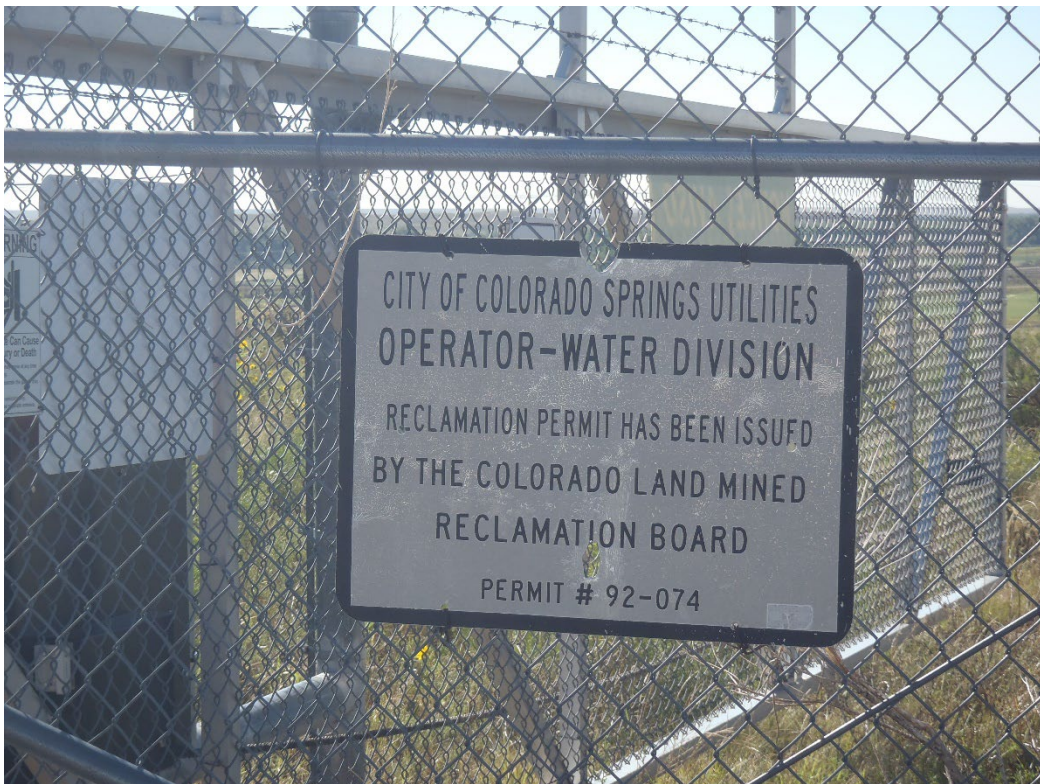
Signs and Markers: The permit sign was properly posted (see **Photo 3**) and boundary markers were observed to delineate the permit boundary (see **Photo 4**).

Photo 3. Permit sign at mine entrance.

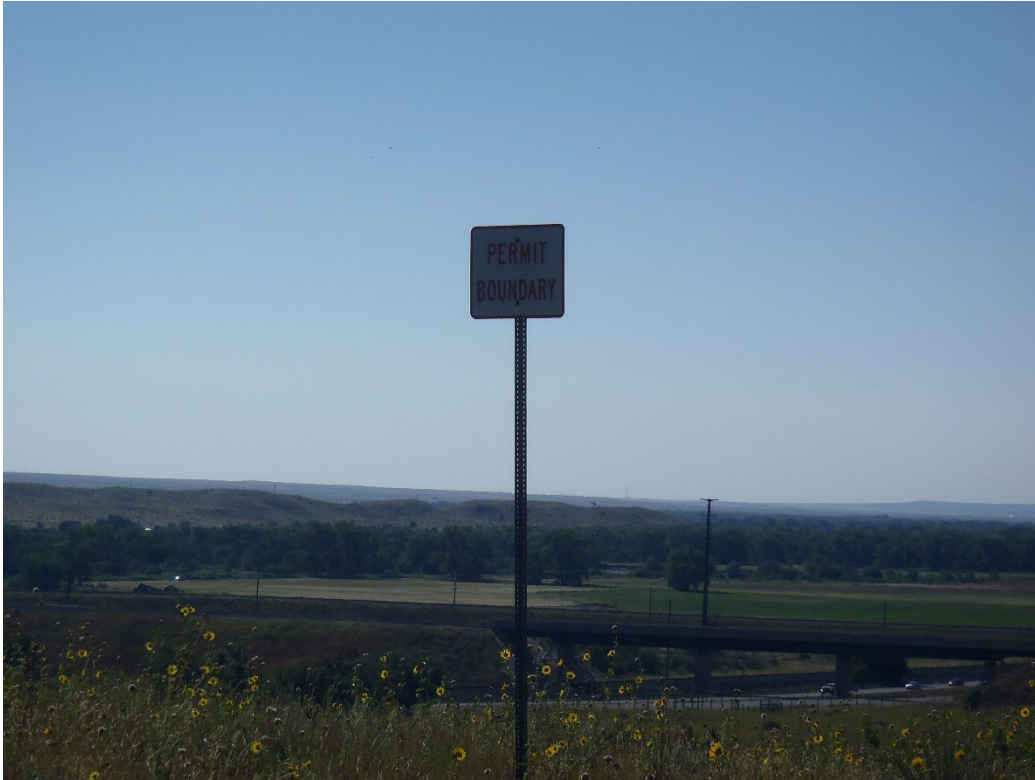
Photo 4. Typical permit boundary sign (east side looking east).

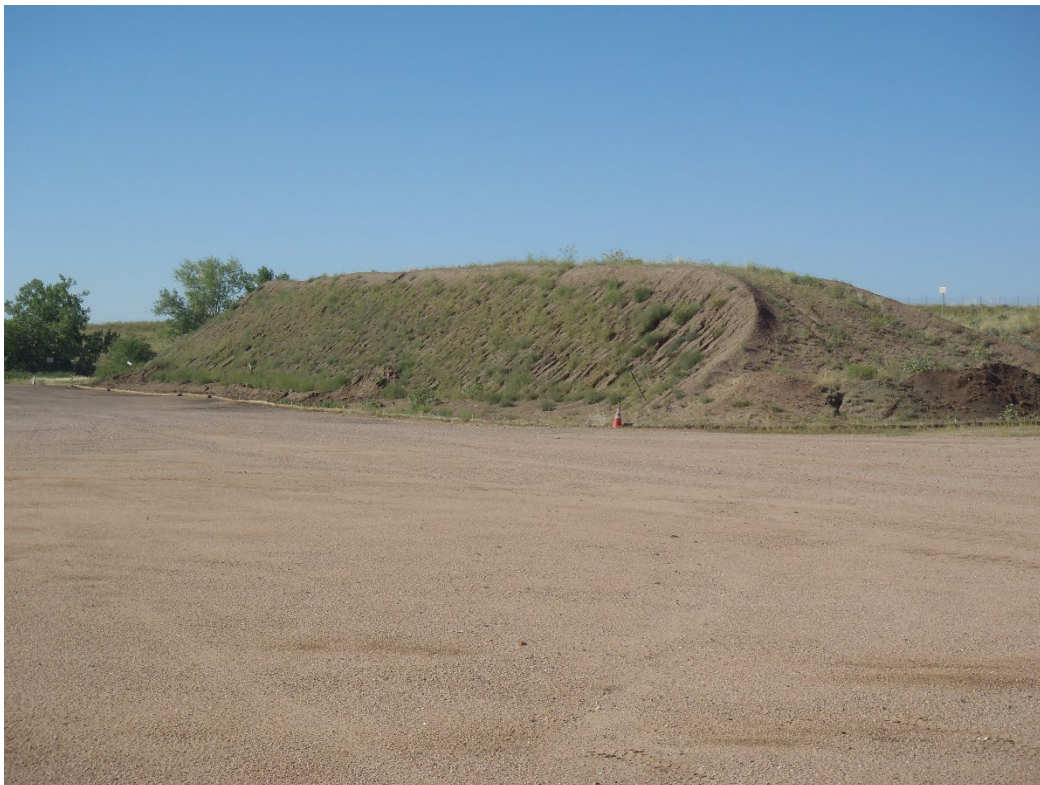
Topsoil: A topsoil stockpile is in the southwest corner of the pit (see **Photo 5**).

Photo 5. Topsoil stockpile (SW corner of site).

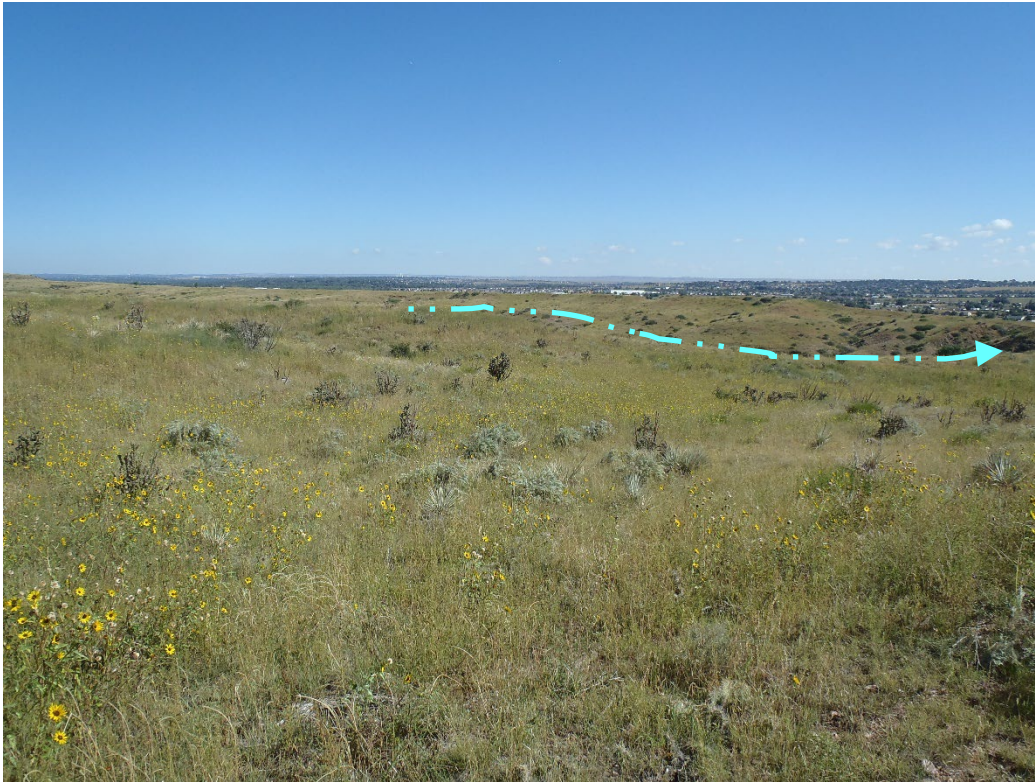
Structures: No new structures were observed within 200 feet of the affected area. The proposed expansion area was observed for man-made structures. None were observed. Site representatives stated there was a buried non-potable waterline on the other side of the unnamed drainage on the NE side of the expansion area (see **Photo 6**), but that the affected area boundary would be greater than 200 feet from the waterline. This was verified with the submittal of Exhibit C maps in AM-1.

Photo 6. Unnamed drainage on NE side of expansion area – buried non-potable waterline beyond.
