C1980007, West Elk Mine, February Inspection Report (Aerial)

PERMIT INFORMATION

Inspection Start Date: February 13, 2024 Inspection Start Time: 12:00 Inspection End Date: Inspection End Time:		Inspection Type: Aerial Inspection Inspection Reason: Normal I&E Program Weather: Clear	
Joint Inspection Agency: None		Joint Inspection Contacts:	
Post Inspection Agency: None		Post Inspection Contacts:	
Inspector(s): Leigh Simmons Brock Bowles	Inspector's Signature:

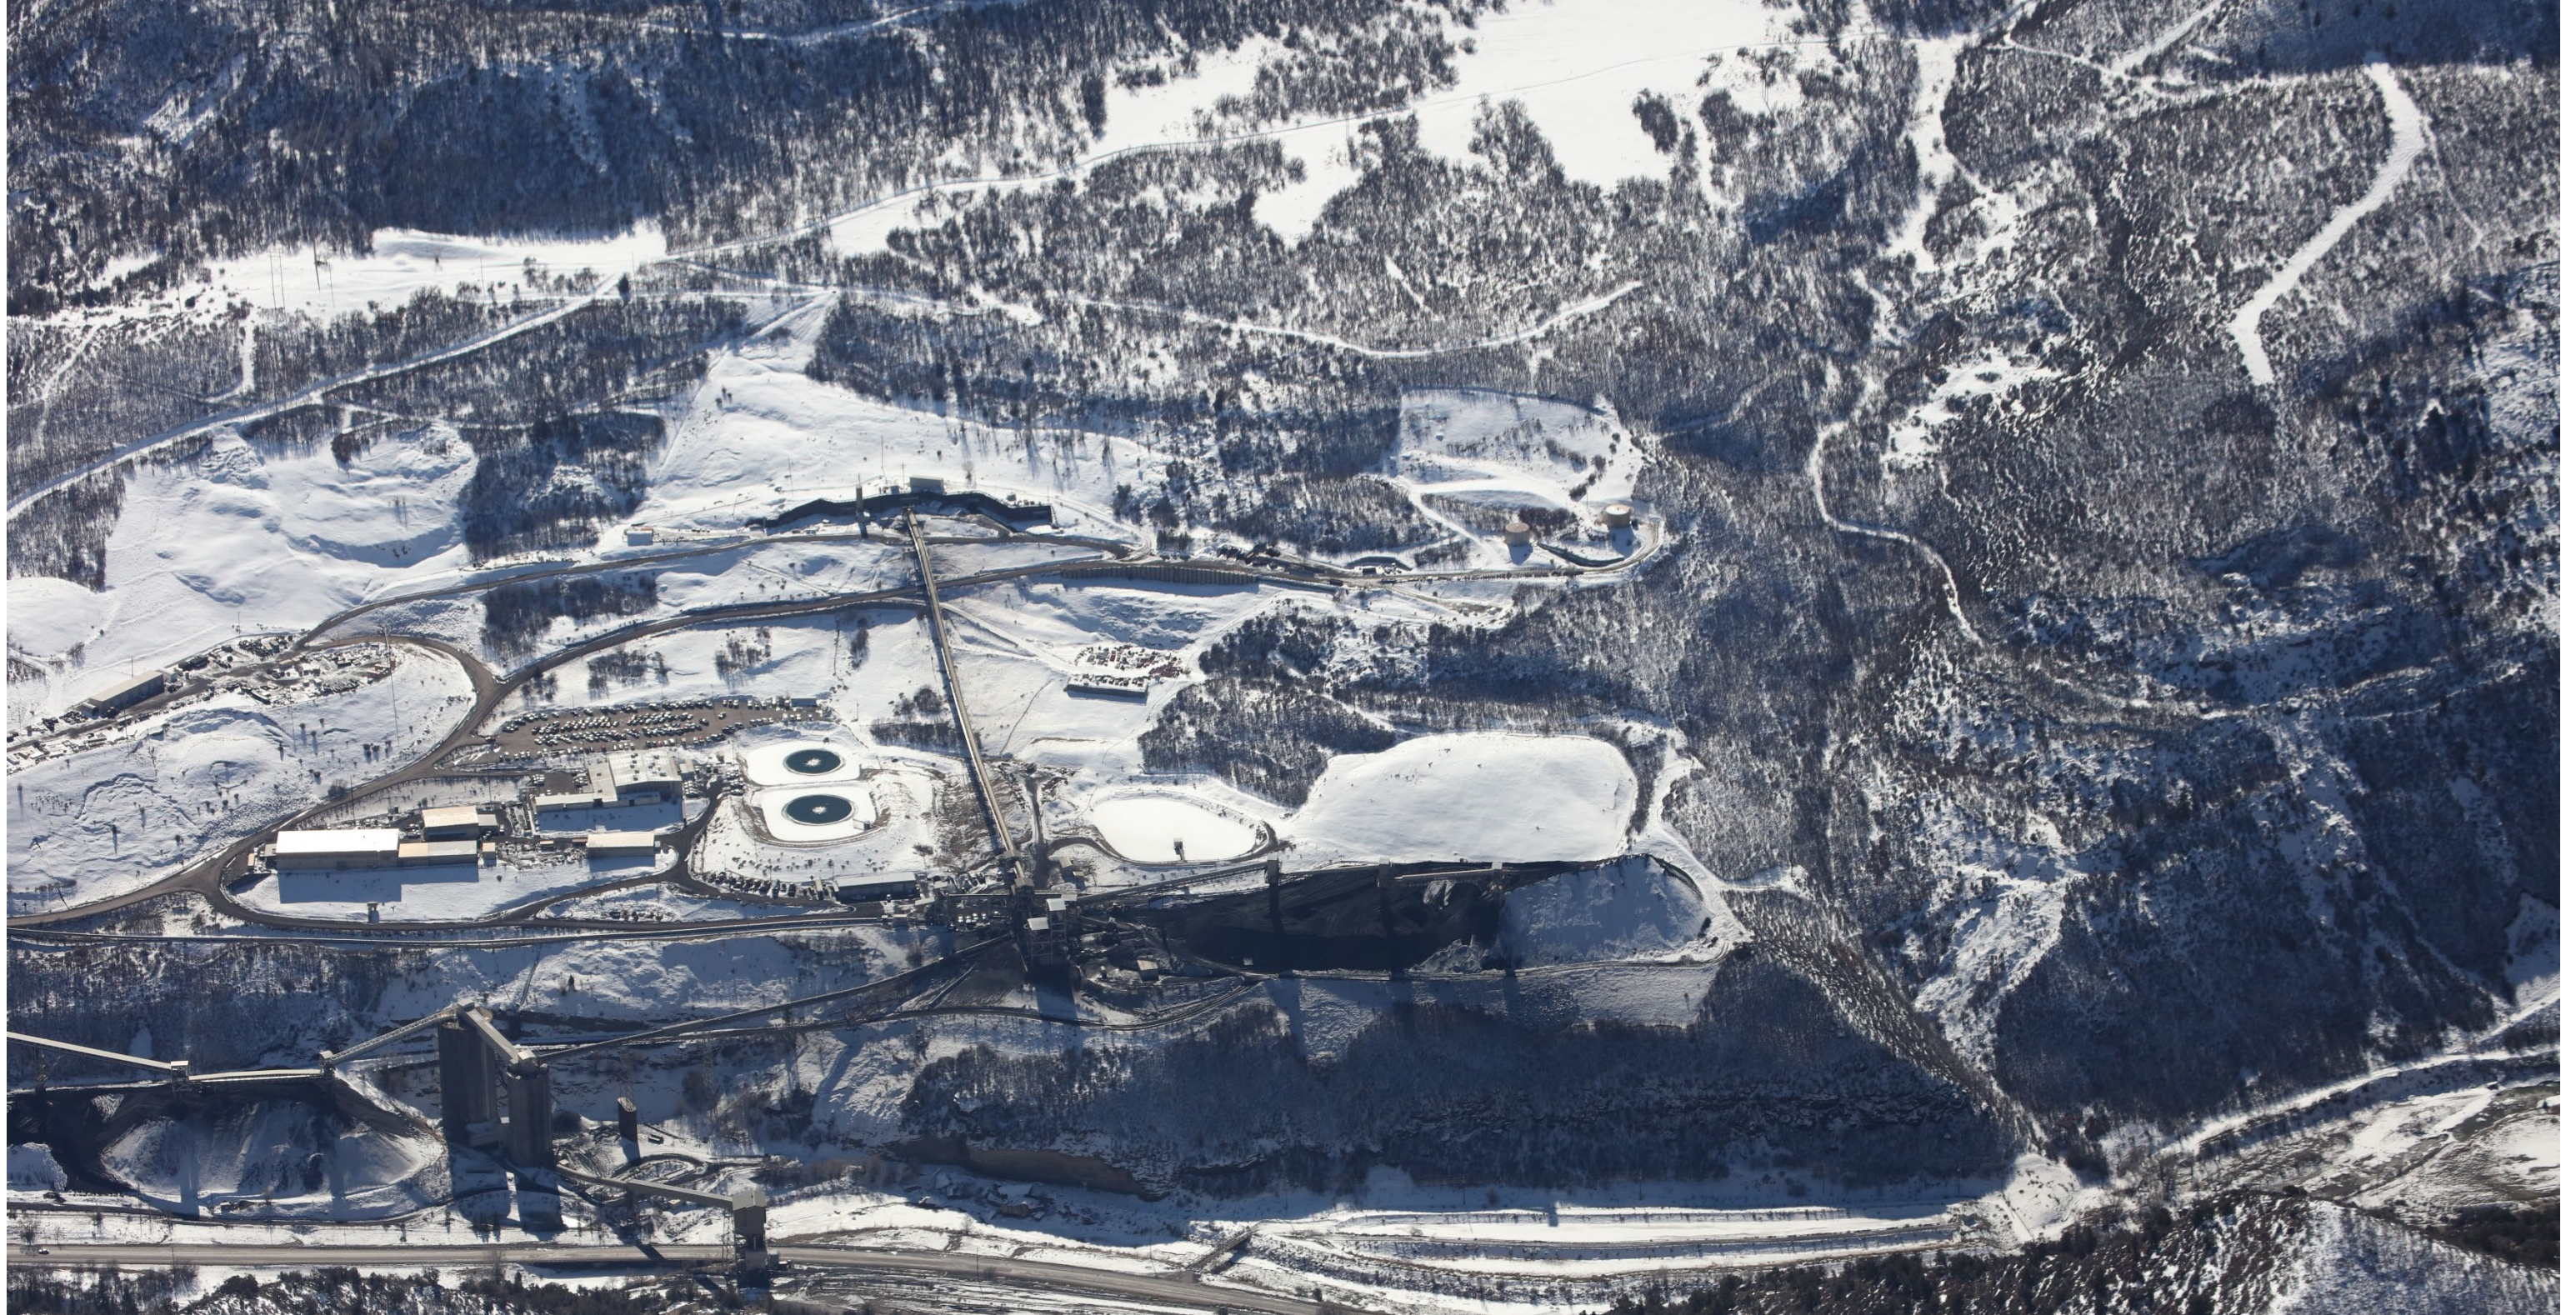
Figure 1: Lower facilities overview.

The slump on the MSB is very clear to see (Figures 1, 8 and 9), with the surface expressions showing up starkly on the snow covered surface.

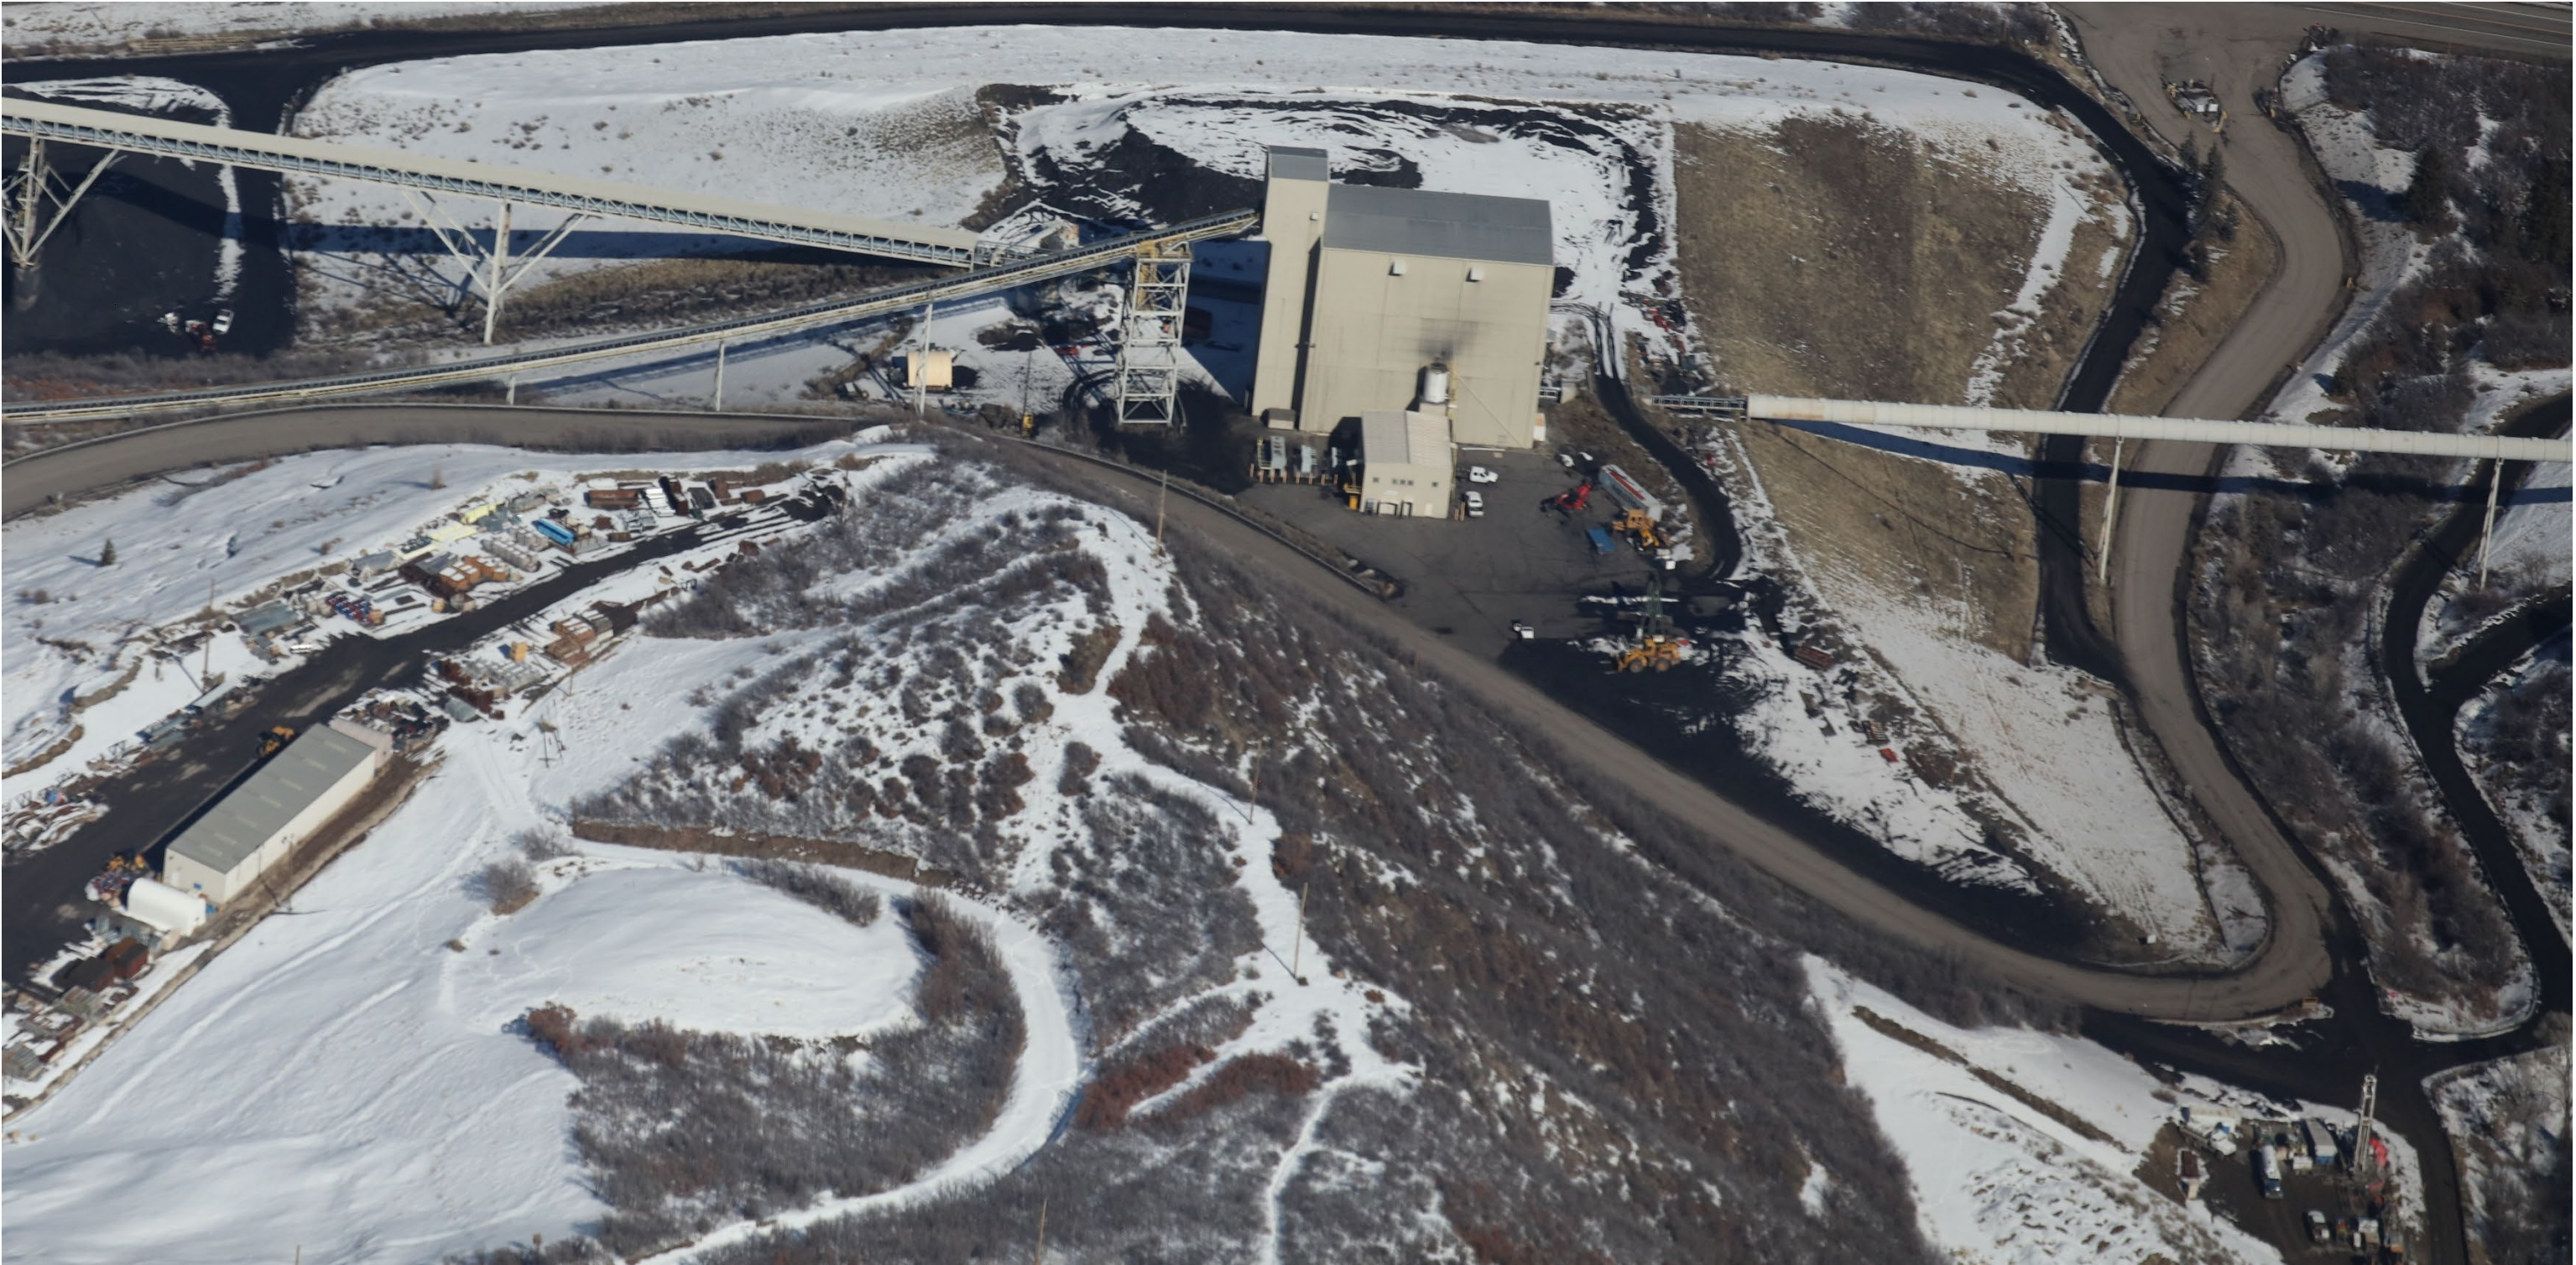
Figure 2: Wash plant and Lower Refuse Pile (LRP). Drill rig on site at the Box Canyon North Well.

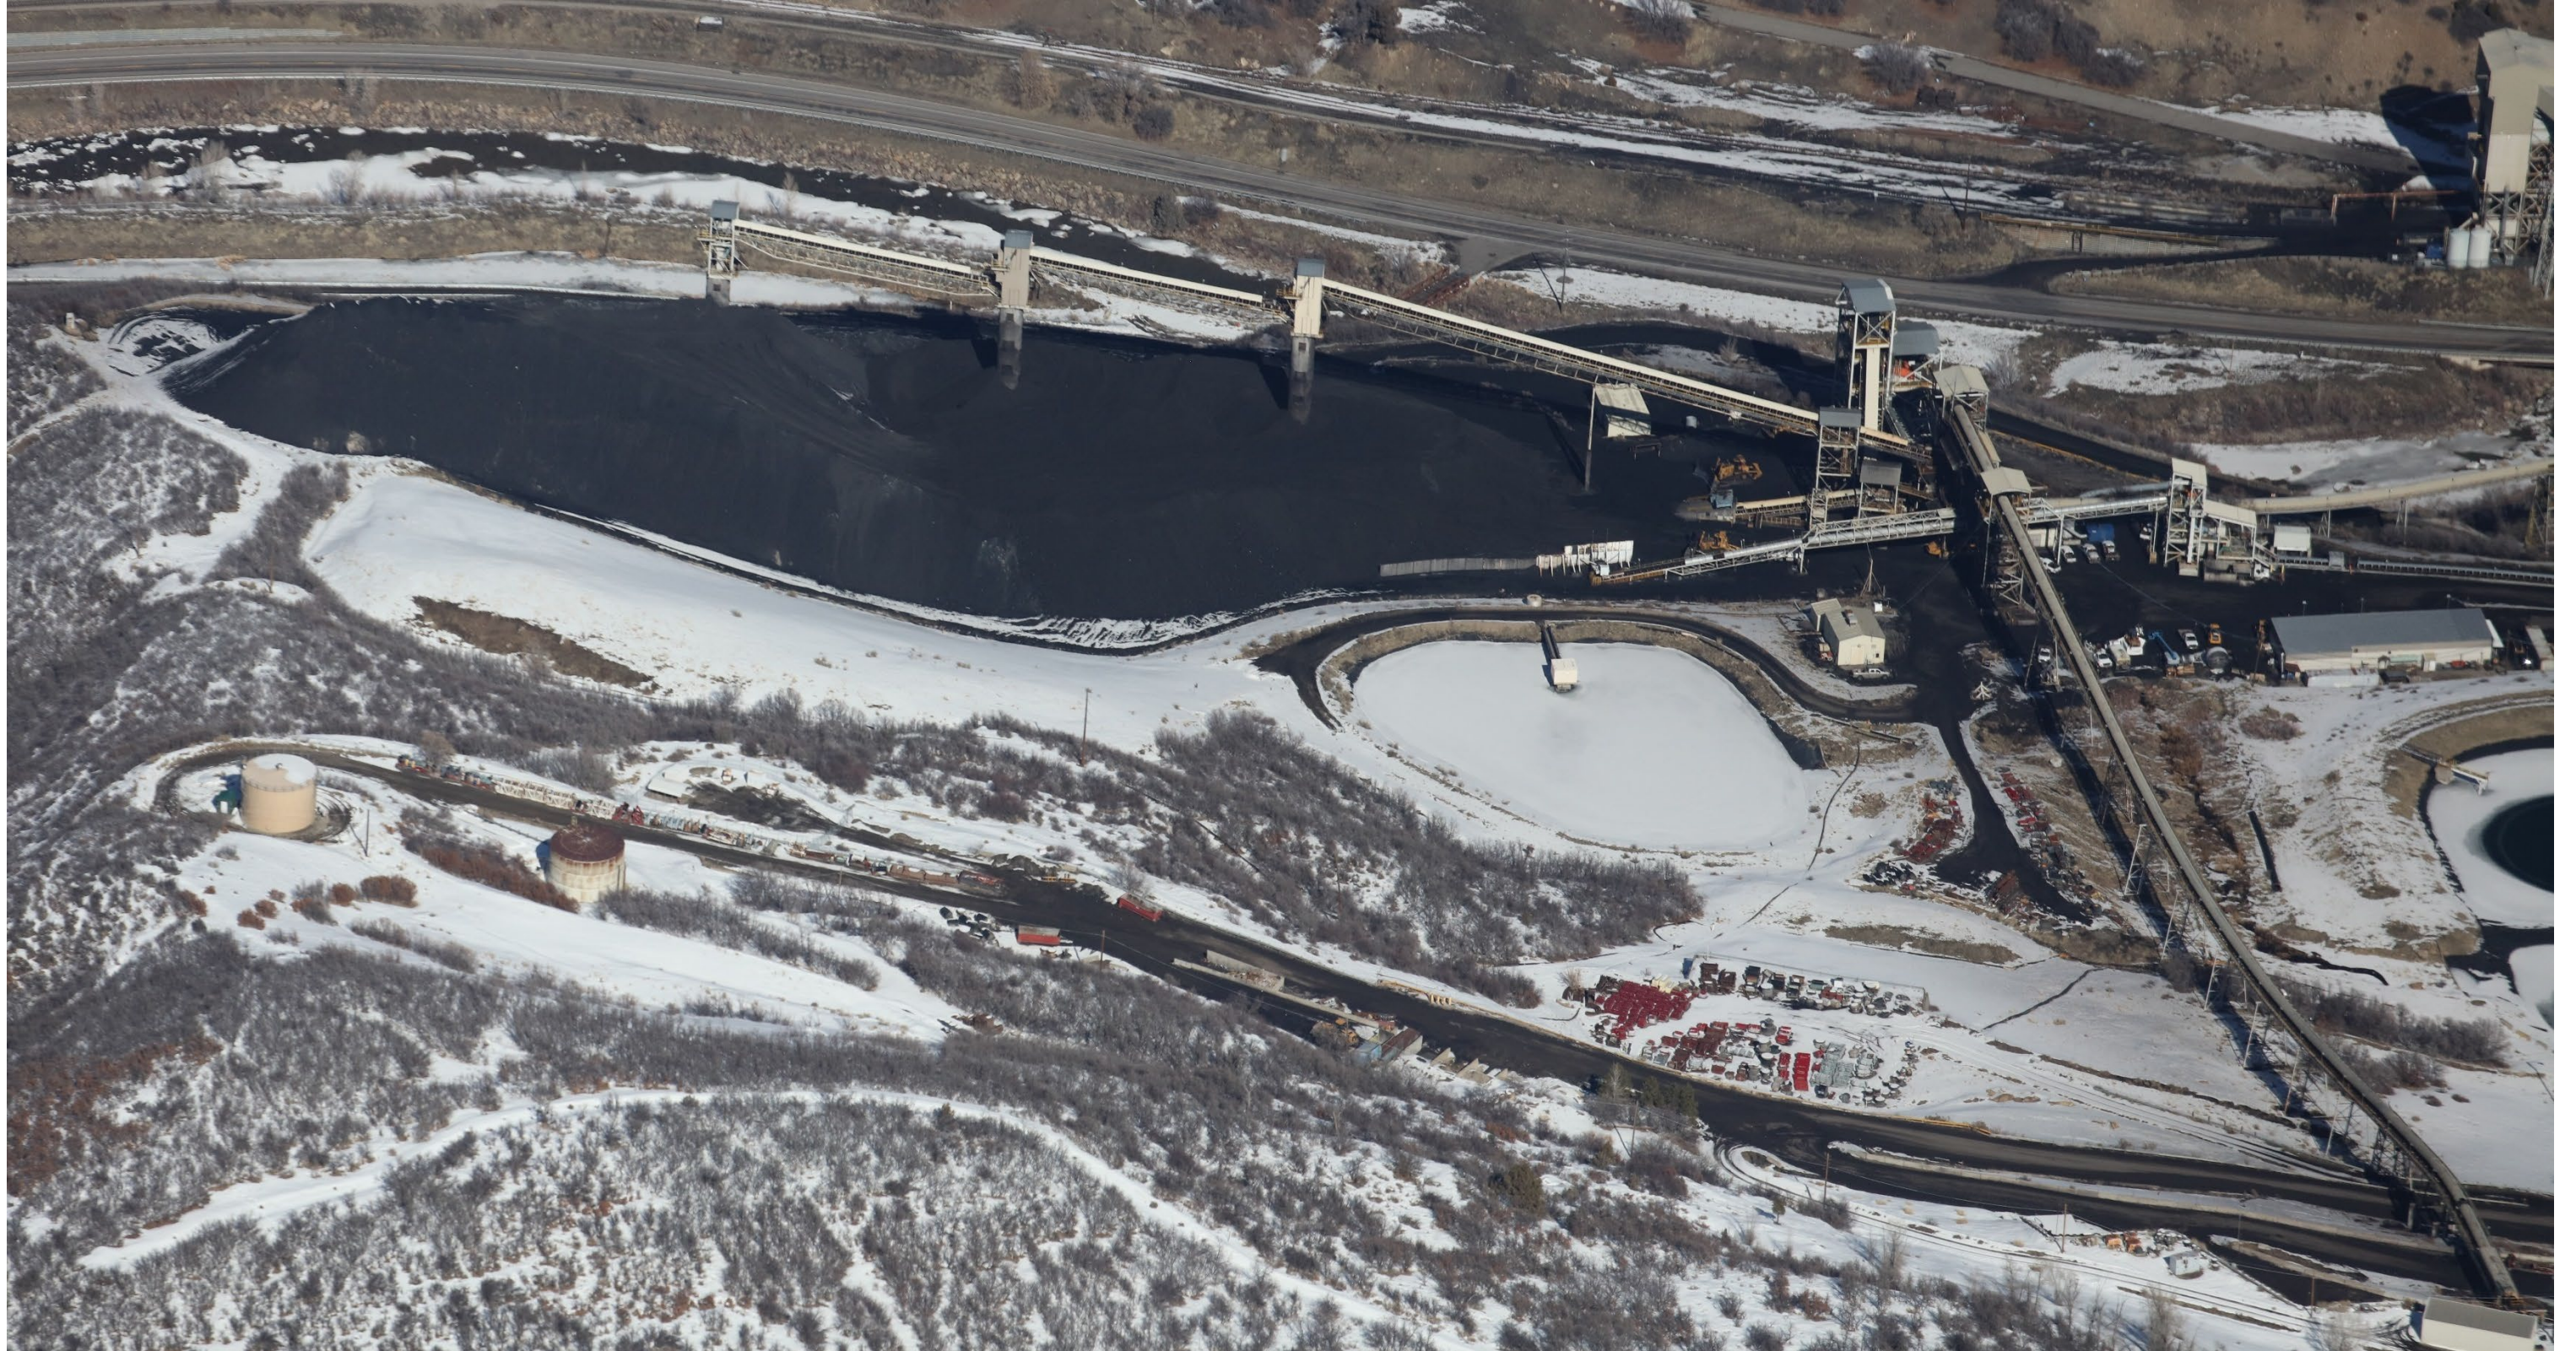
The volume of the Run-of-Mine coal stockpile appeared to have been drawn down from recent months. The fines pile at the western end of the stockpile pad also appeared to have been drawn down slightly.

Figure 4: C-1 conveyor, Breaker building, Run-of-Mine coal stockpile, FW-1 pond, Main Topsoil stockpile, water tanks.

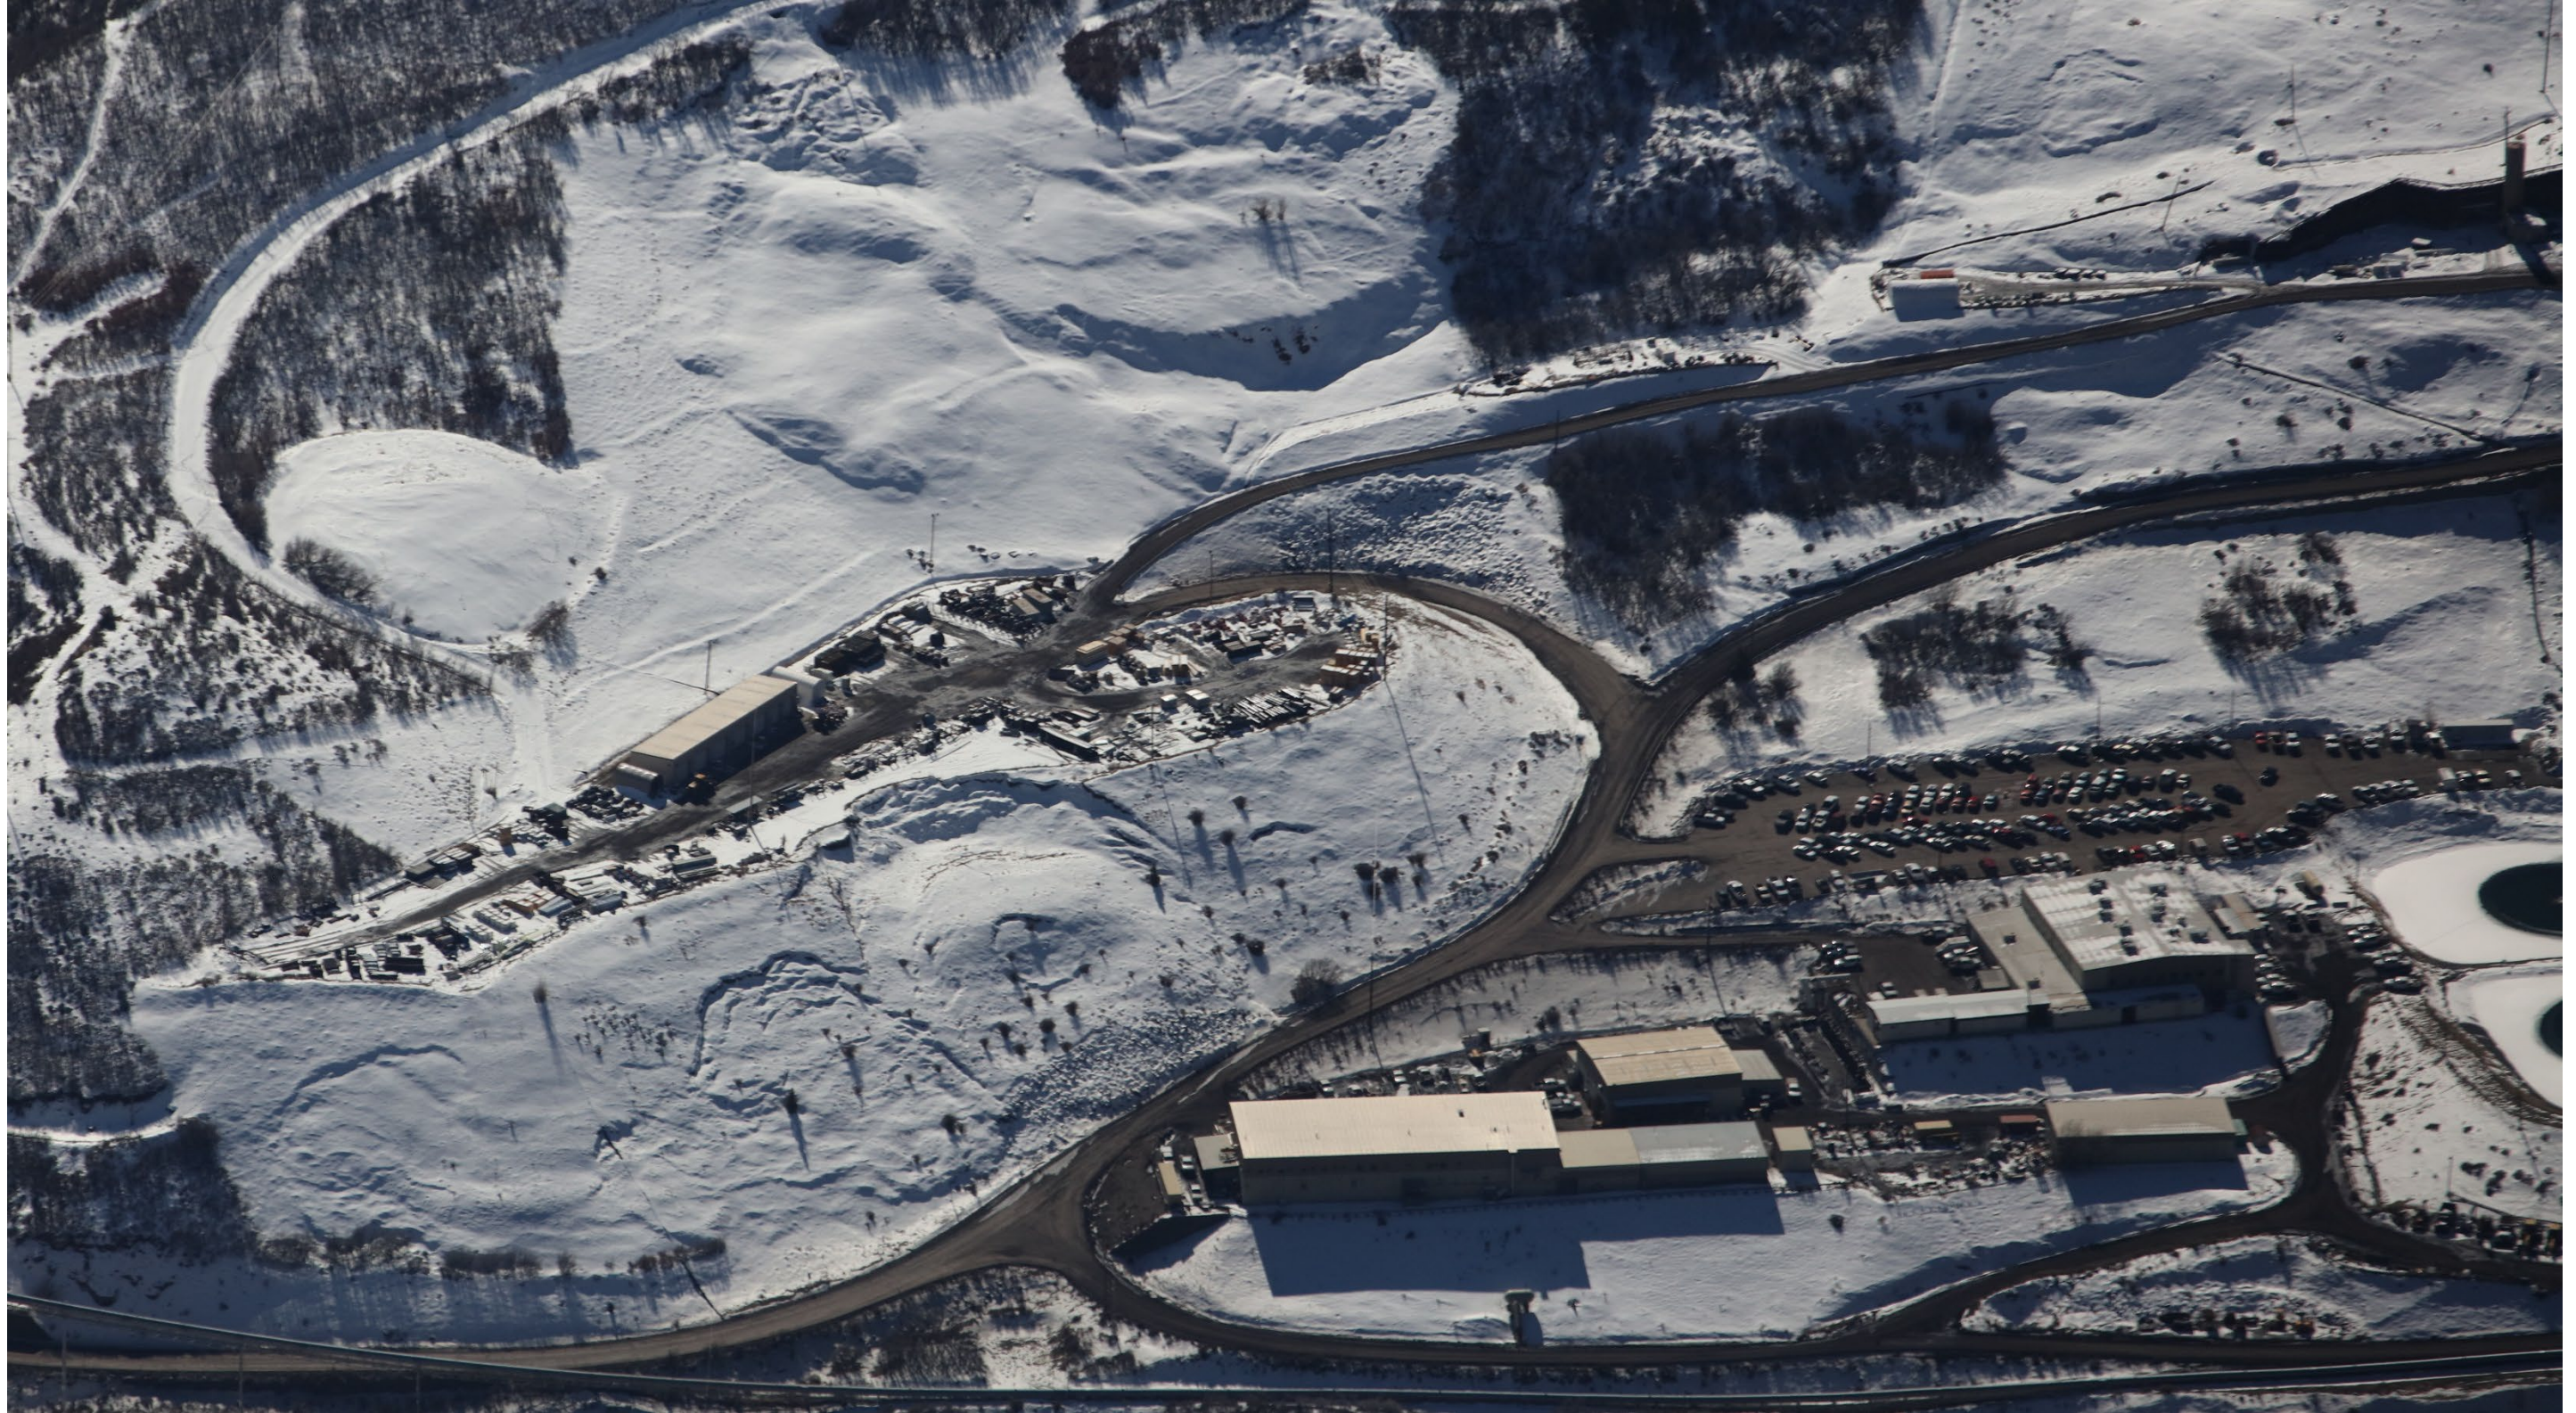
Figure 9: Office and shop area. Materials Storage Bench (MSB), showing slump on out-slope.

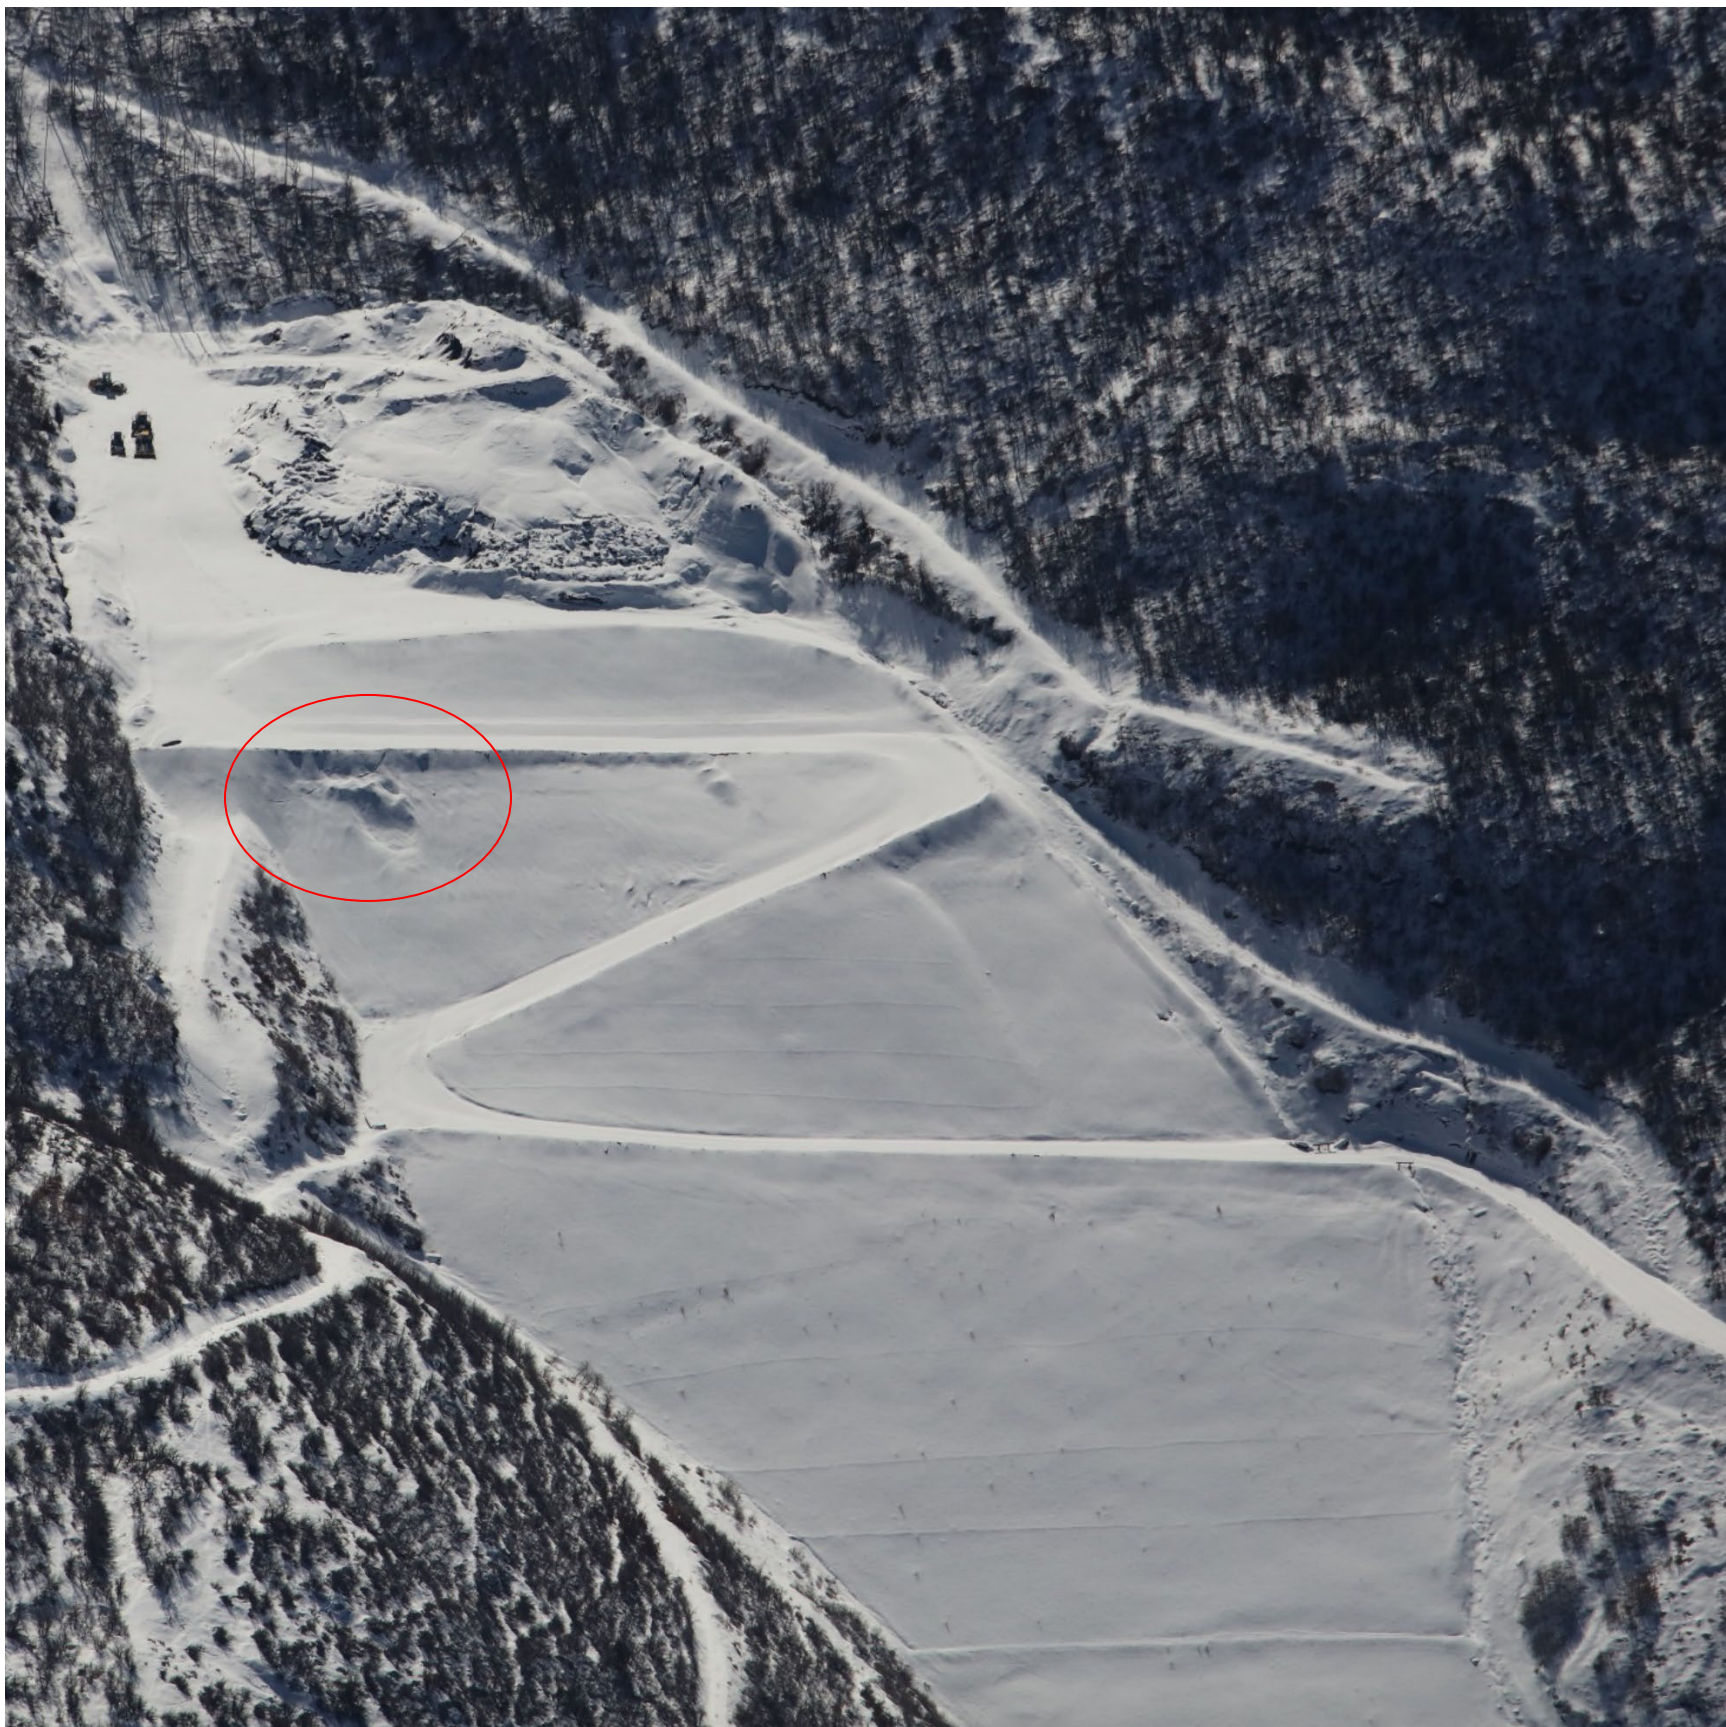
Figure 14: Top of RPEE

No processing waste had been produced or transported since the last inspection. Loosely piled material on the top of the RPEE will need to dry before it can be compacted. Figure 14 shows what appears to be a small surface instability in the compacted material just below the final hairpin on the RPEE, which will need to be addressed in the spring.
