**MINERALS PROGRAM INSPECTION REPORT**  
**PHONE: (303) 866-3567**

<b>MINE NAME:</b> Thunderbird Sand and Gravel	<b>MINE/PROSPECTING ID#:</b> M-2023-032	<b>MINERAL:</b> Sand and gravel	<b>COUNTY:</b> Pueblo
<b>INSPECTION TYPE:</b> Pre-operation Inspection	<b>WEATHER:</b> Cloudy	<b>INSP. DATE:</b> December 13, 2023	<b>INSP. TIME:</b> 11:00
<b>OPERATOR:</b> Martin Marietta Materials, Inc.	<b>OPERATOR REPRESENTATIVE:</b> Phillip Courtney	<b>TYPE OF OPERATION:</b> 112c - Construction Regular Operation	
<b>REASON FOR INSPECTION:</b> Pre-operation Inspection	<b>BOND CALCULATION TYPE:</b>	<b>BOND AMOUNT:</b> No Bond Held	
<b>DATE OF COMPLAINT:</b> NA	<b>POST INSP. CONTACTS:</b> None	<b>JOINT INSP. AGENCY:</b> None	
<b>INSPECTOR(S):</b> Joel Renfro Robert Zuber, P.E.	<b>INSPECTOR'S SIGNATURE:</b>

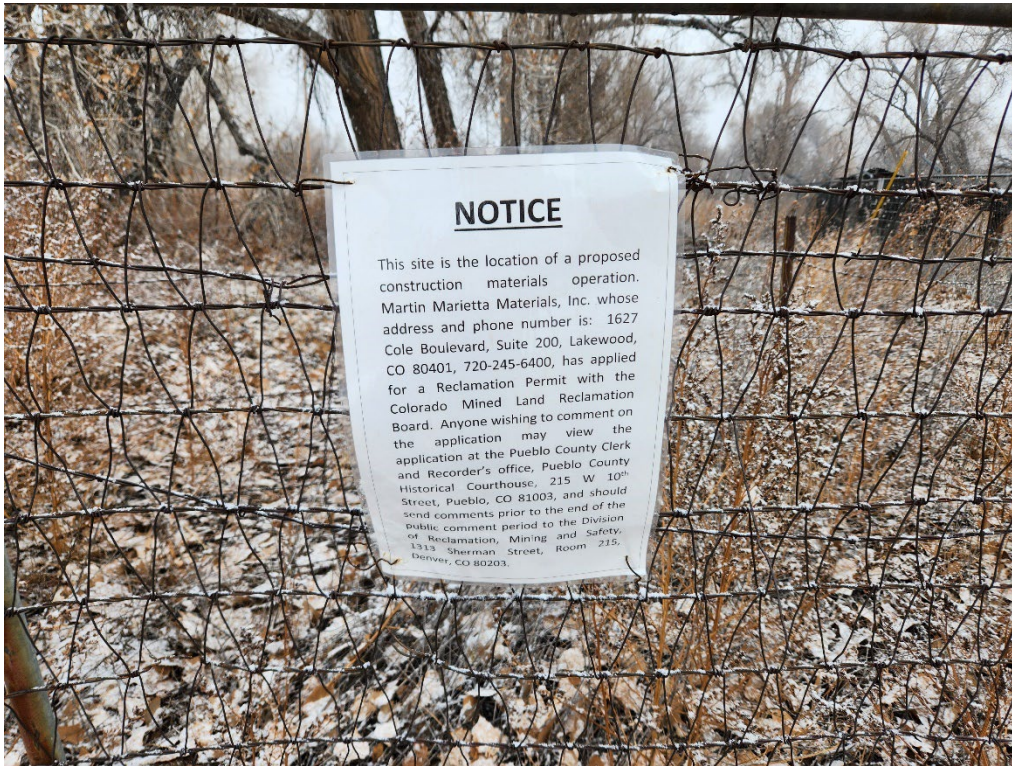
The proposed 112c sand and gravel operation permit area will be 543.5 acres and is located approximately 0.6 miles from Pueblo, CO. The maximum area of disturbance proposed by the applicant is also 543.5 acres. The proposed activities include surface mining for the extraction of construction aggregates, as well as on-site crushing and screening operations. During the inspection, the required notice sign was observed as per Rule 1.6.2(b). The proposed site entrance is situated east of Baxter Road.

**Photo 1.** Thunderbird Sand and Gravel notice sign.

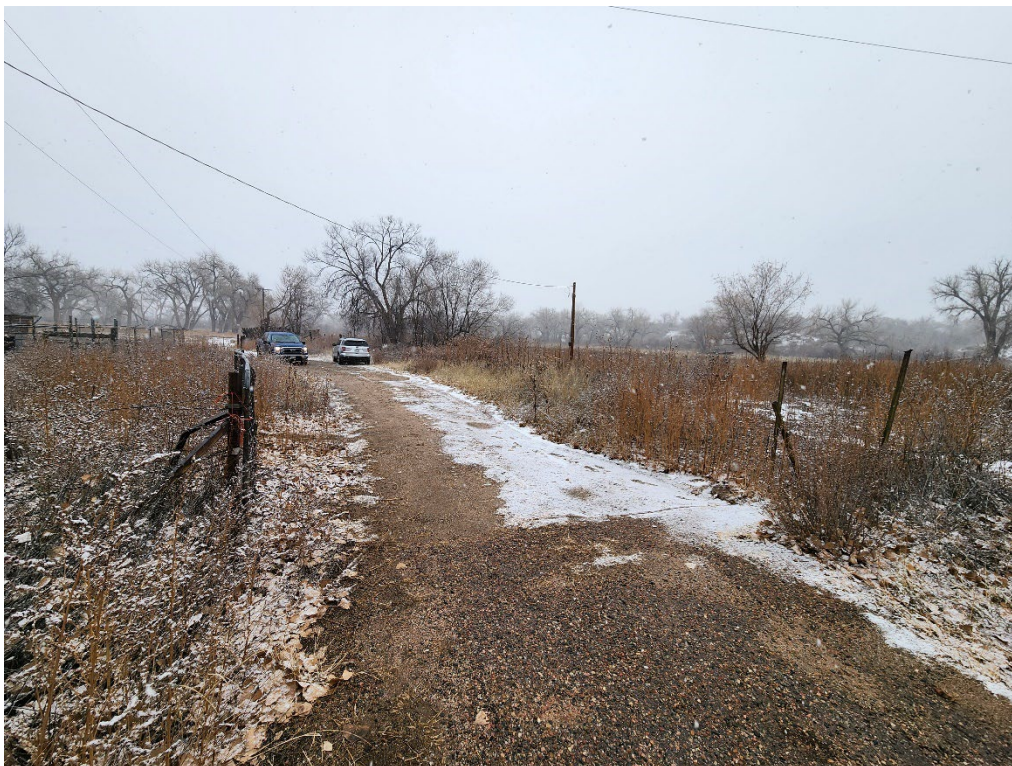
**Photo 2.** Proposed site entrance looking west.

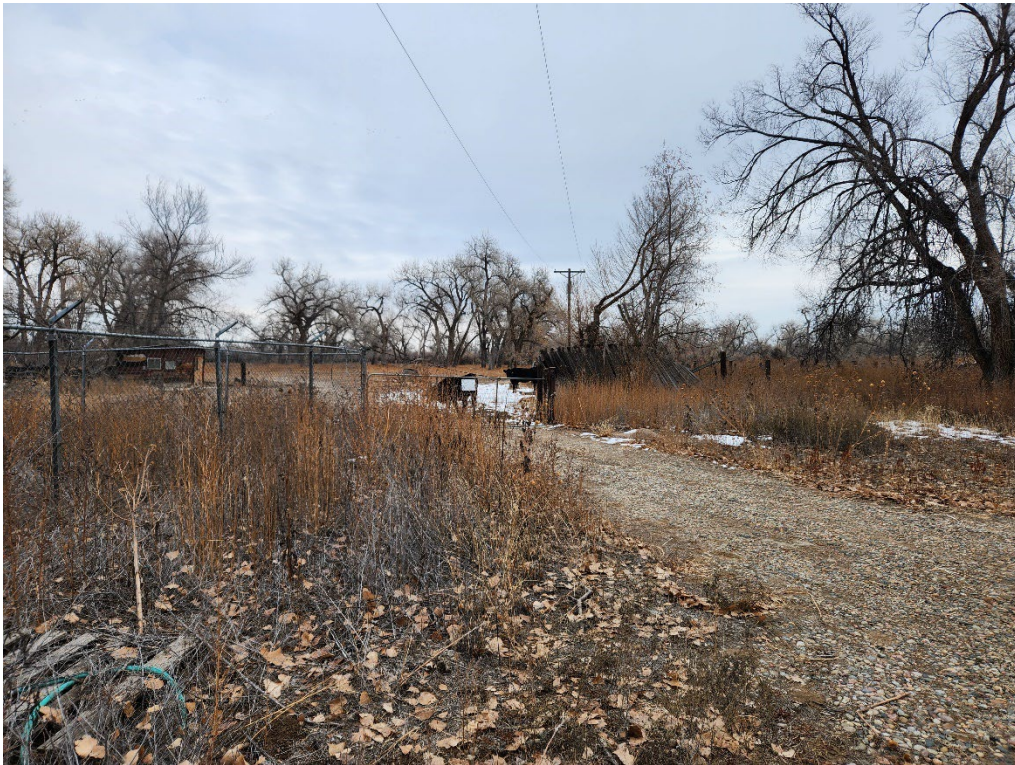
**Photo 3.** Proposed site entrance looking east.

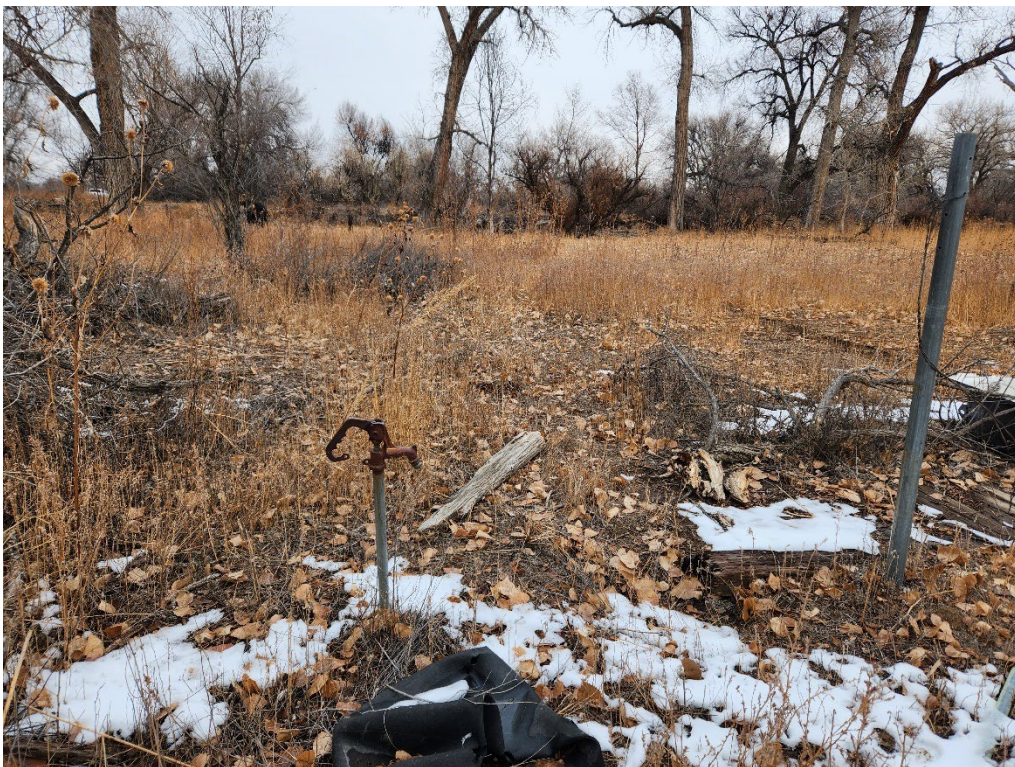
**Photo 4.** View of site from southwest corner of site looking northeast.

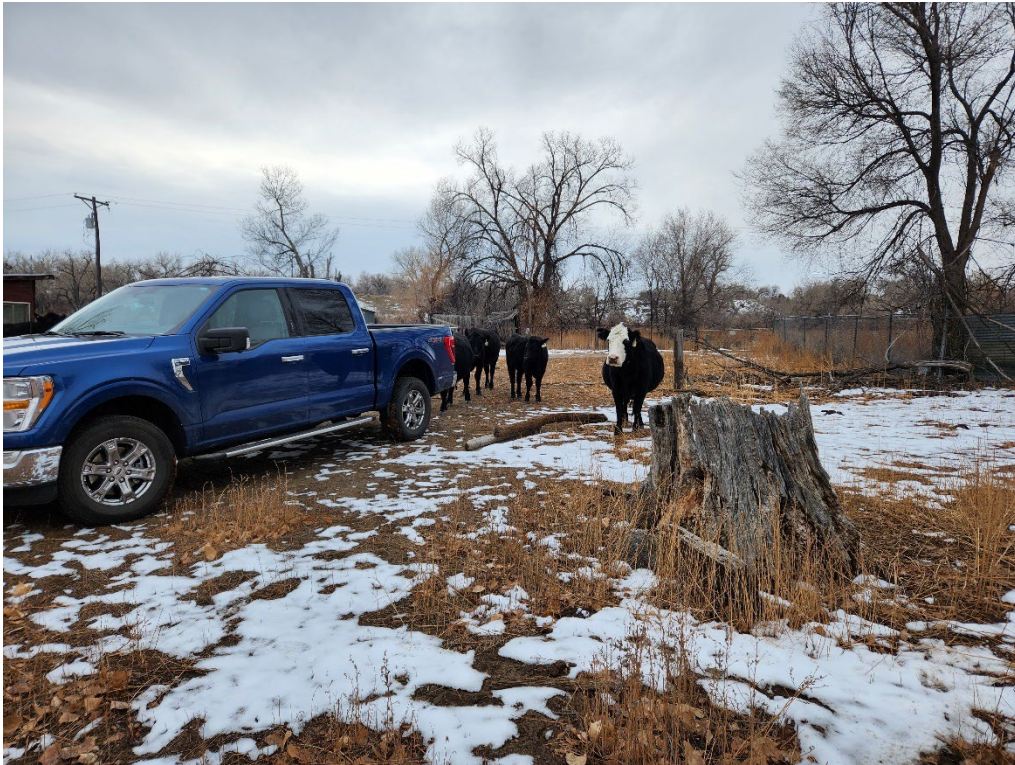
**Photo 5.** Existing fencing and electric lines from the southwestern edge of the site looking southeast.

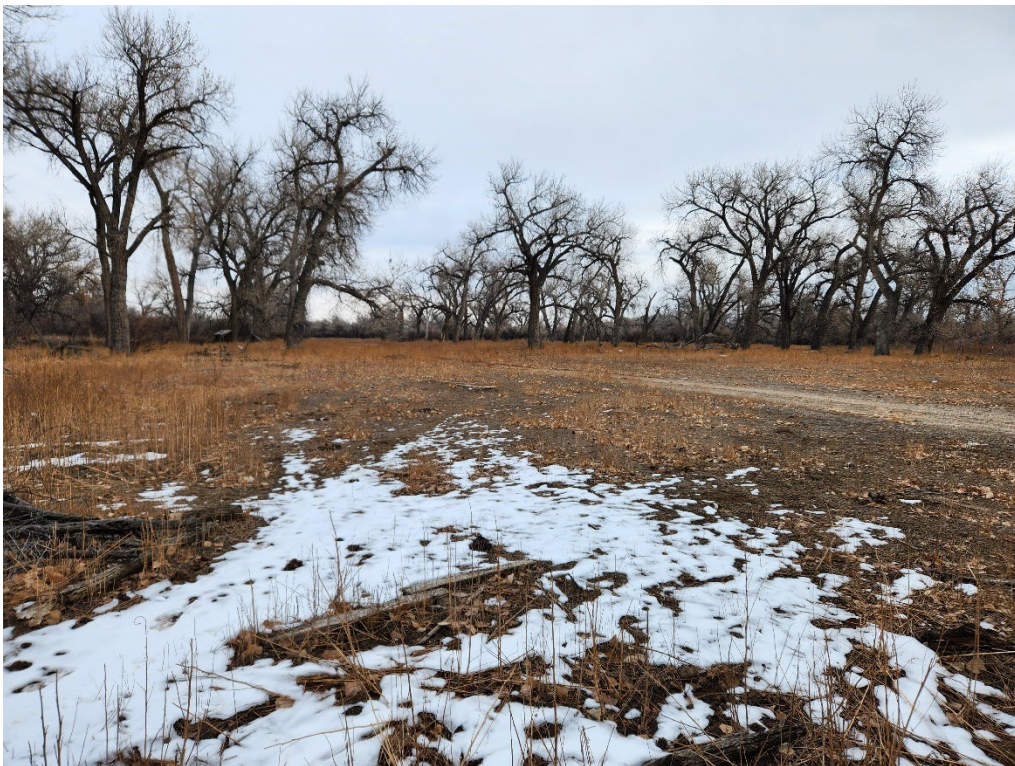
**Photo 6.** Existing dirt road located west of the proposed west pit, looking east.

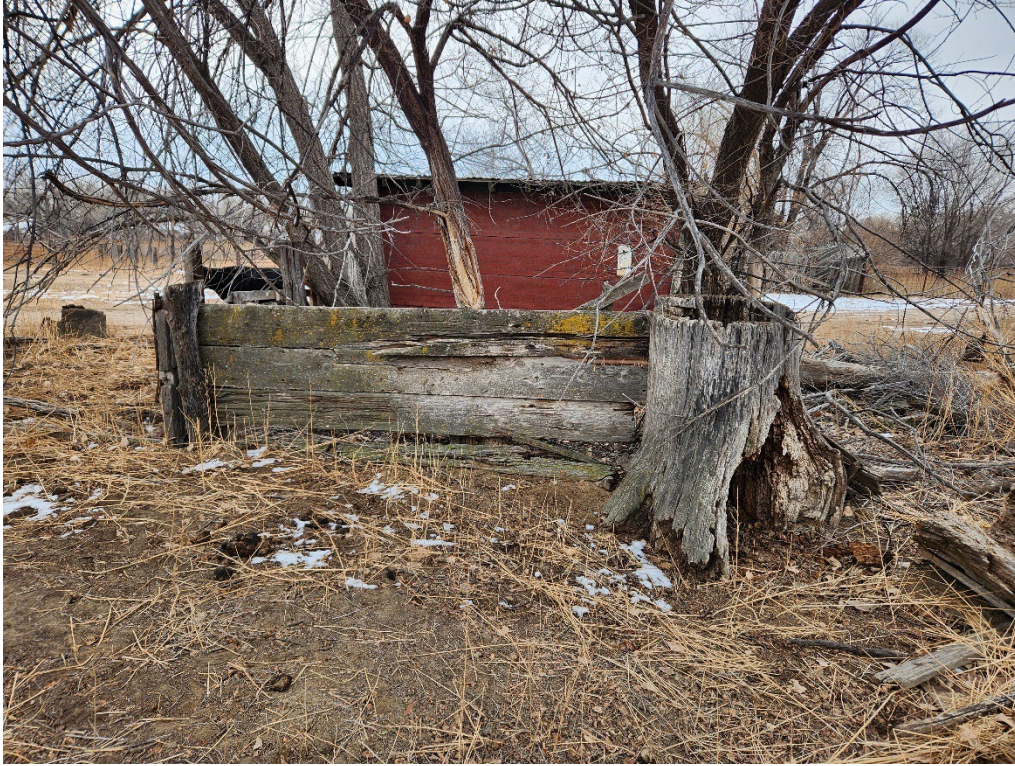
**Photo 7.** Structure located near site entrance looking south.

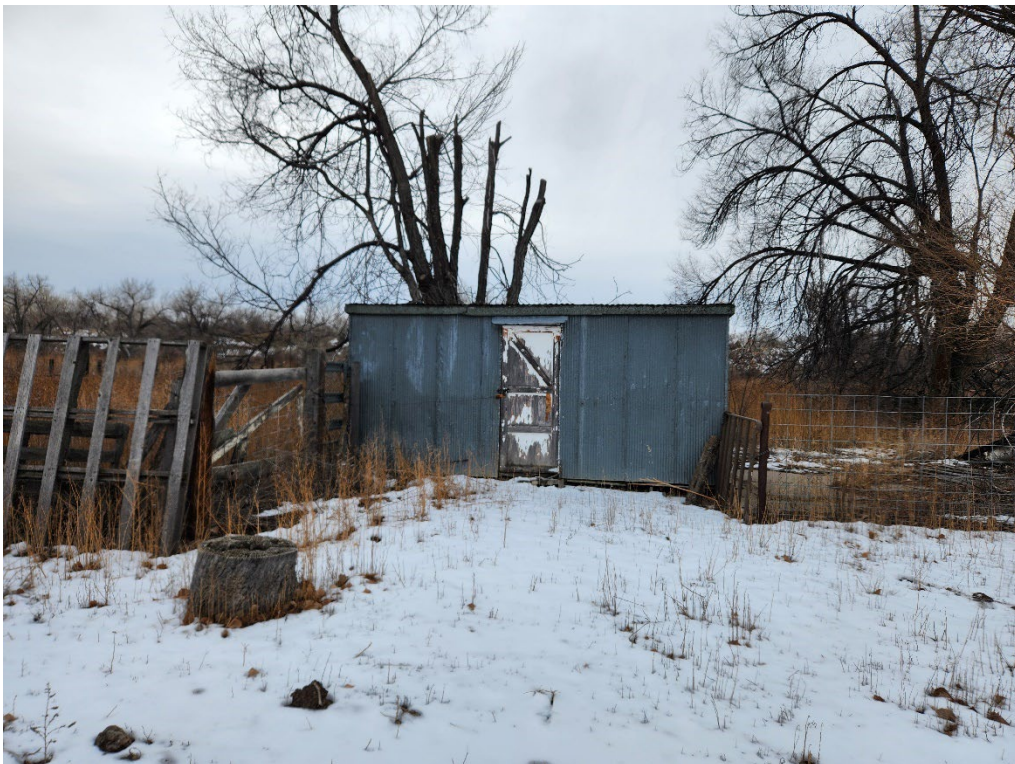
**Photo 8.** Structure located near site entrance looking south.

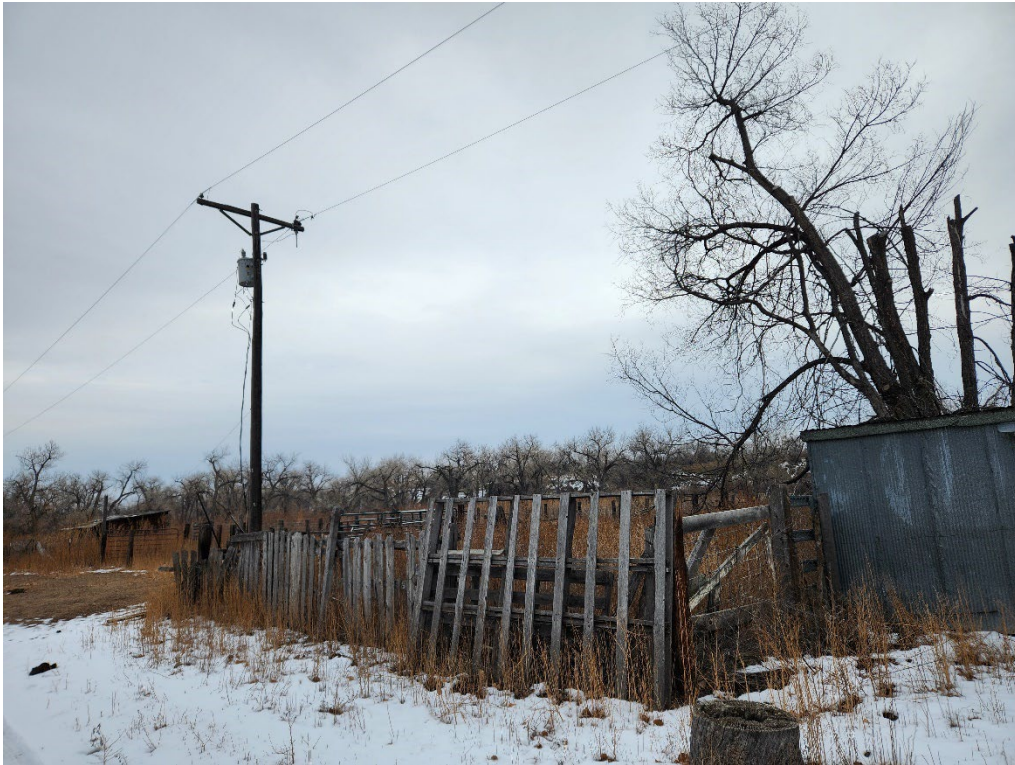
**Photo 9.** Existing fence and electric line along southern edge of site looking south.

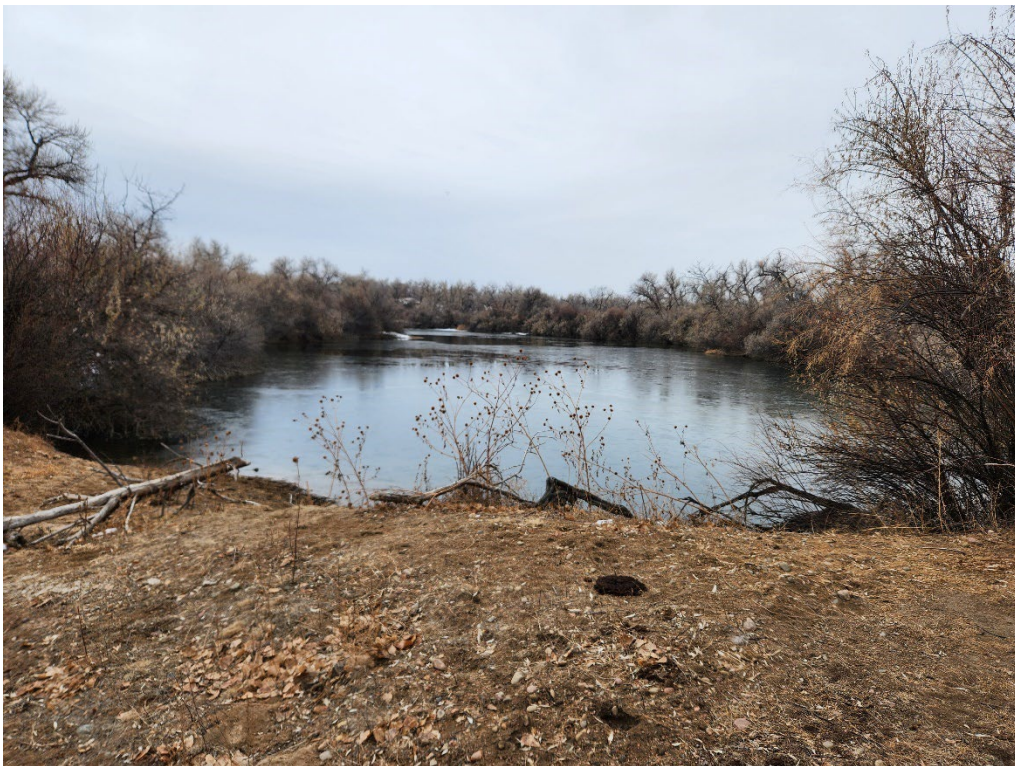
**Photo 10.** Thunderbird Lake looking south.

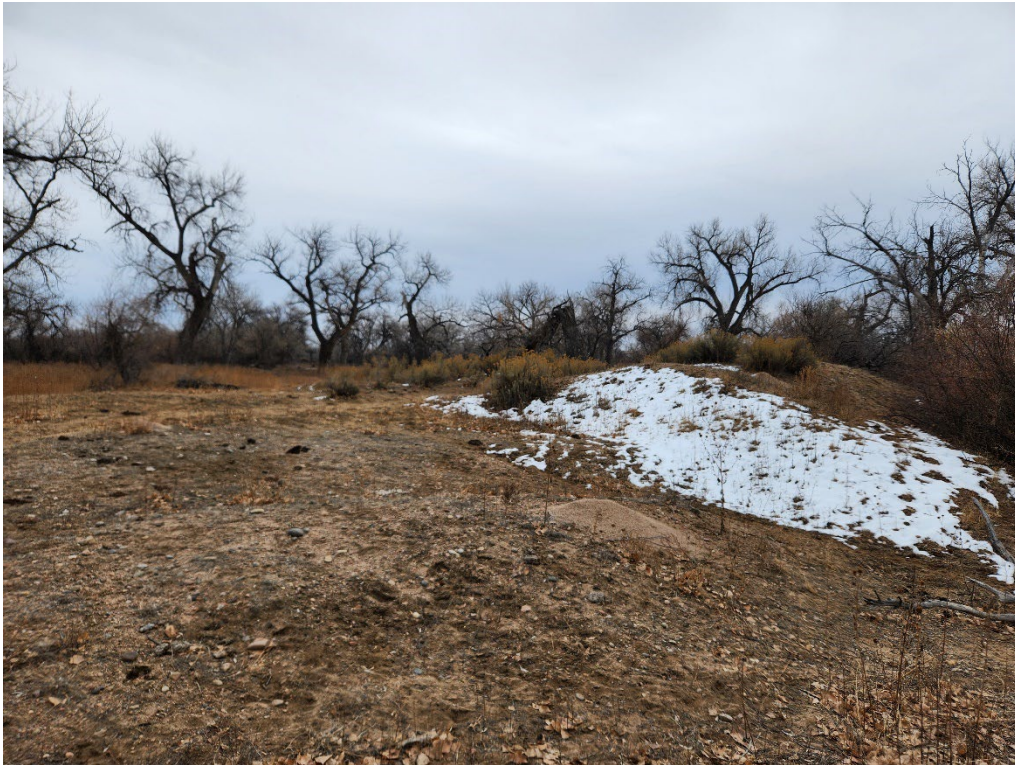
**Photo 11.** Eastern edge of Thunderbird Lake looking south.

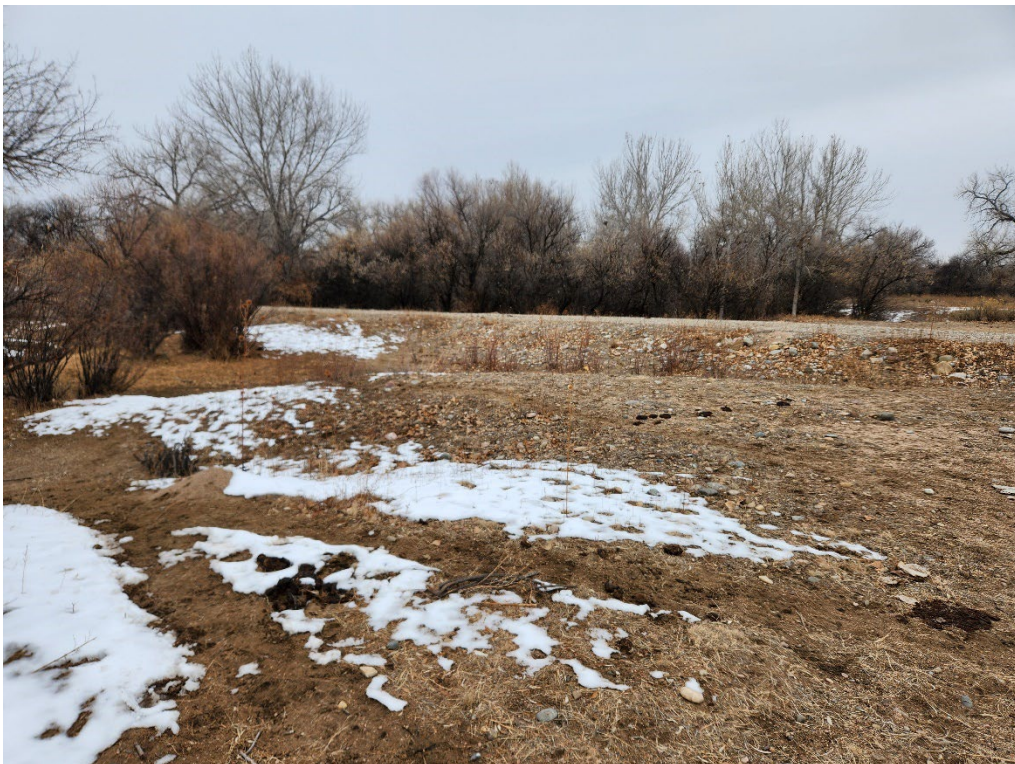
**Photo 12.** Existing dirt road north of Thunderbird Lake looking north.

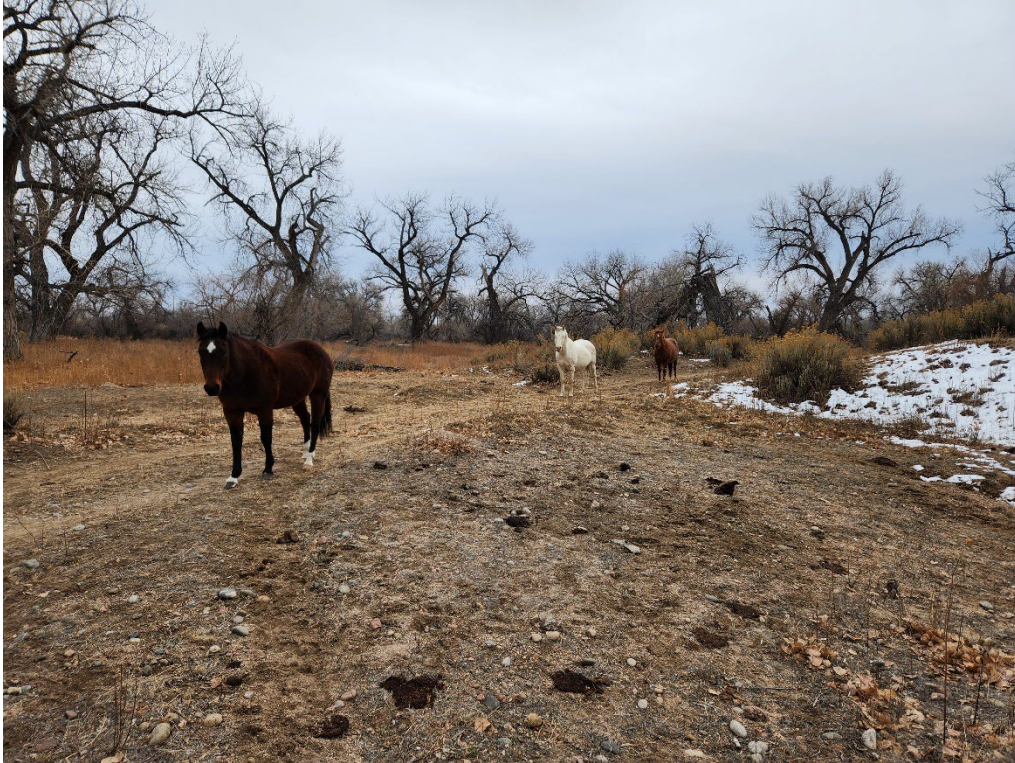
**Photo 13.** Existing dirt road that follows the eastern edge of Thunderbird Lake looking south.

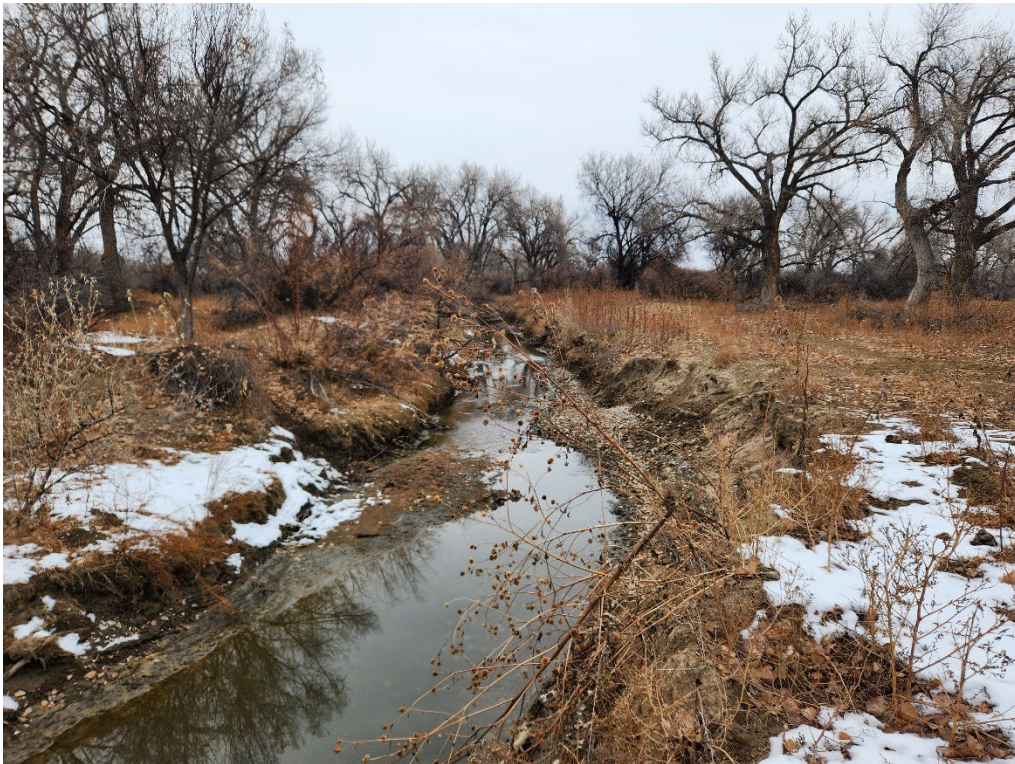
**Photo 14.** Excelsior Ditch looking northeast.

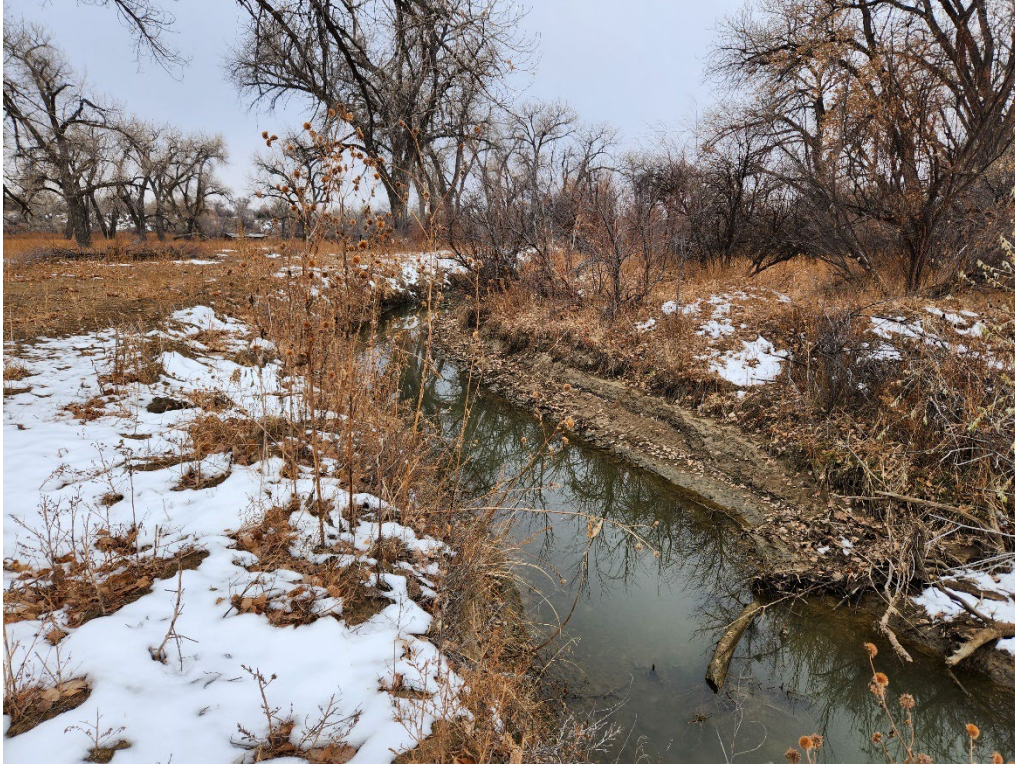
**Photo 15.** Excelsior Ditch looking southwest.

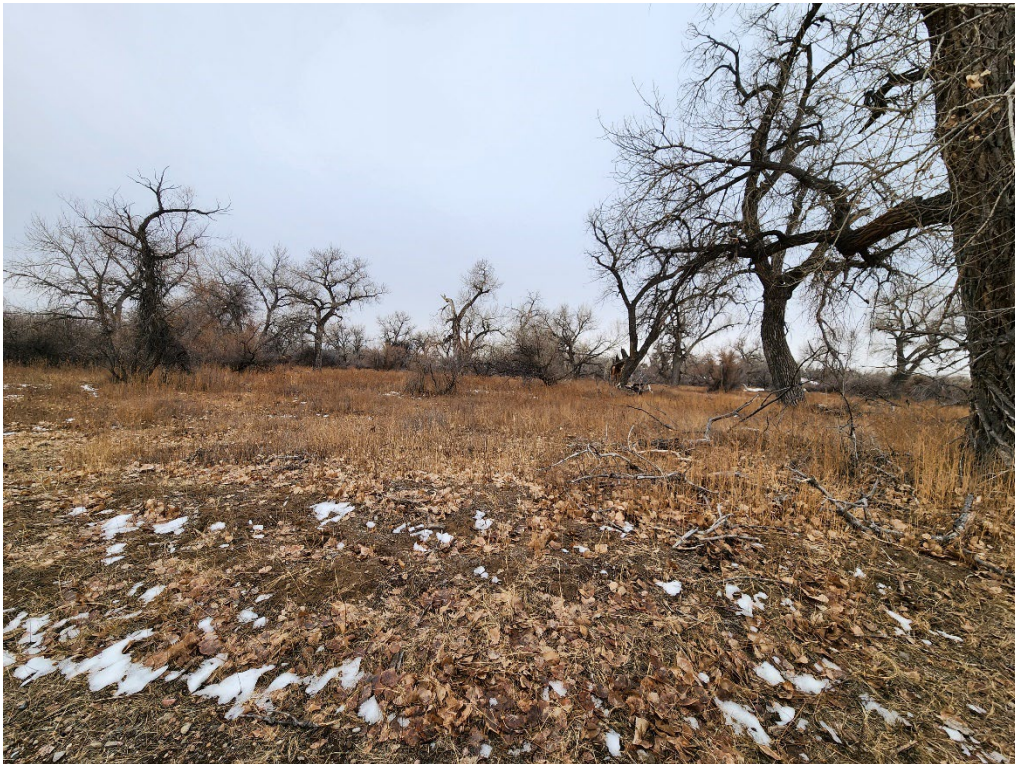
**Photo 16.** Proposed West Pit location looking east.

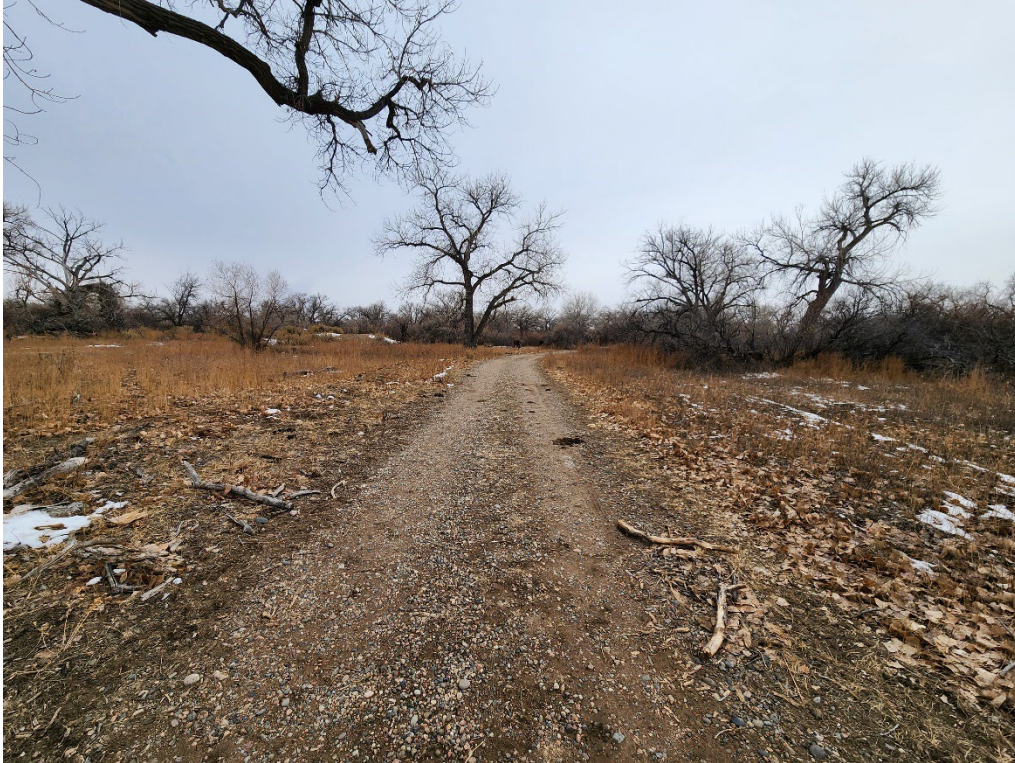
**Photo 17.** Existing dirt road located on proposed West Pit looking north.

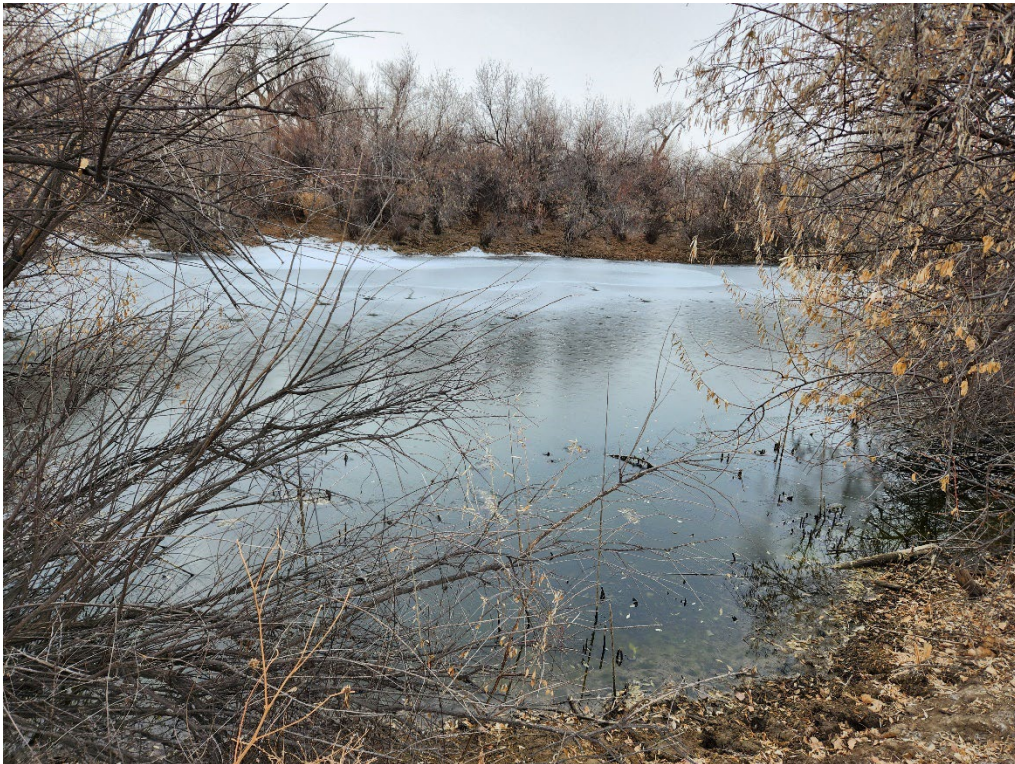
**Photo 18.** Unnamed pond located within southern portion of the proposed West Pit looking south.

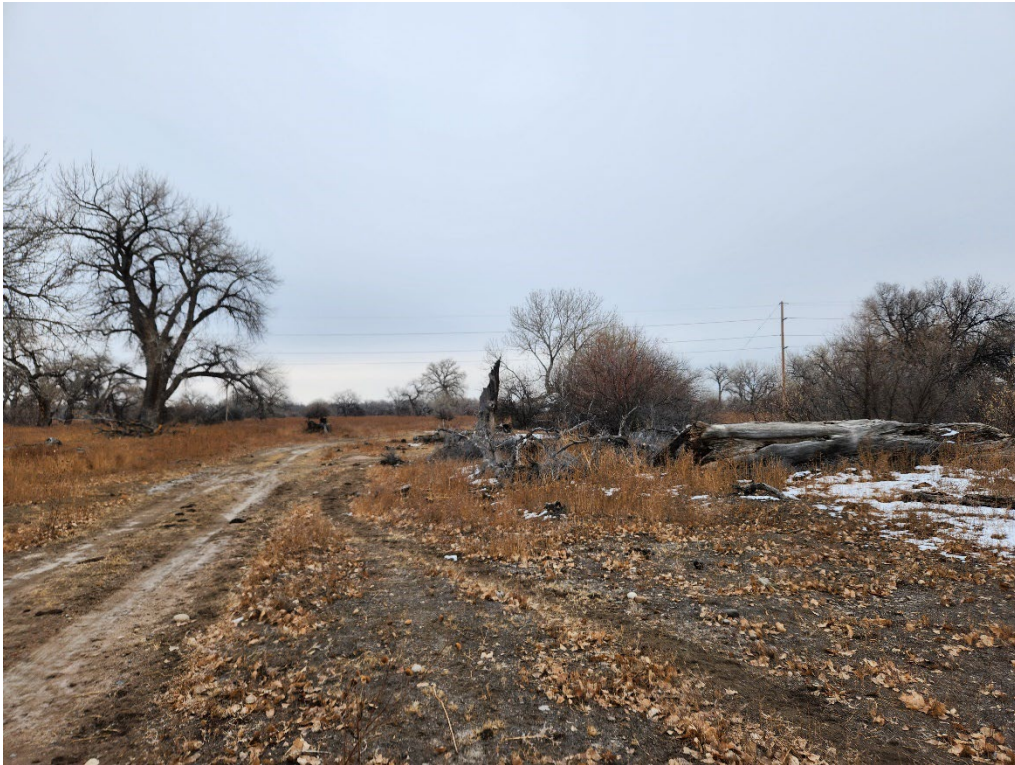
**Photo 19.** Existing dirt road located within proposed West Pit and electric lines along the east of the pit looking east.

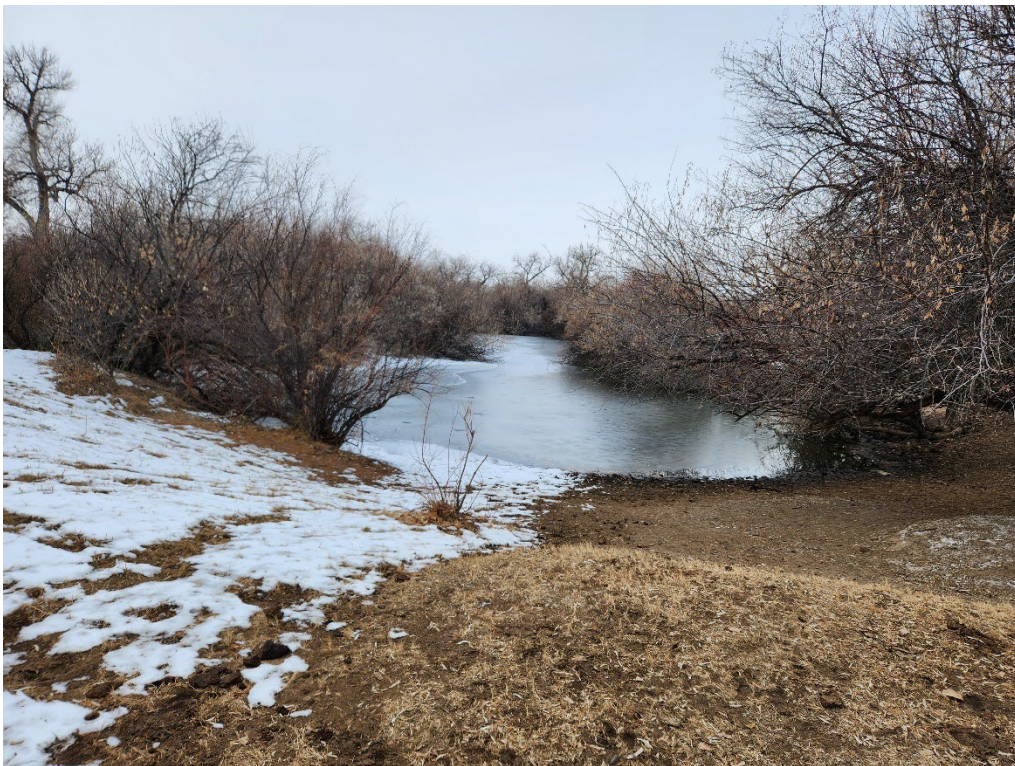
**Photo 20.** Unnamed pond located within the proposed West Pit looking west.

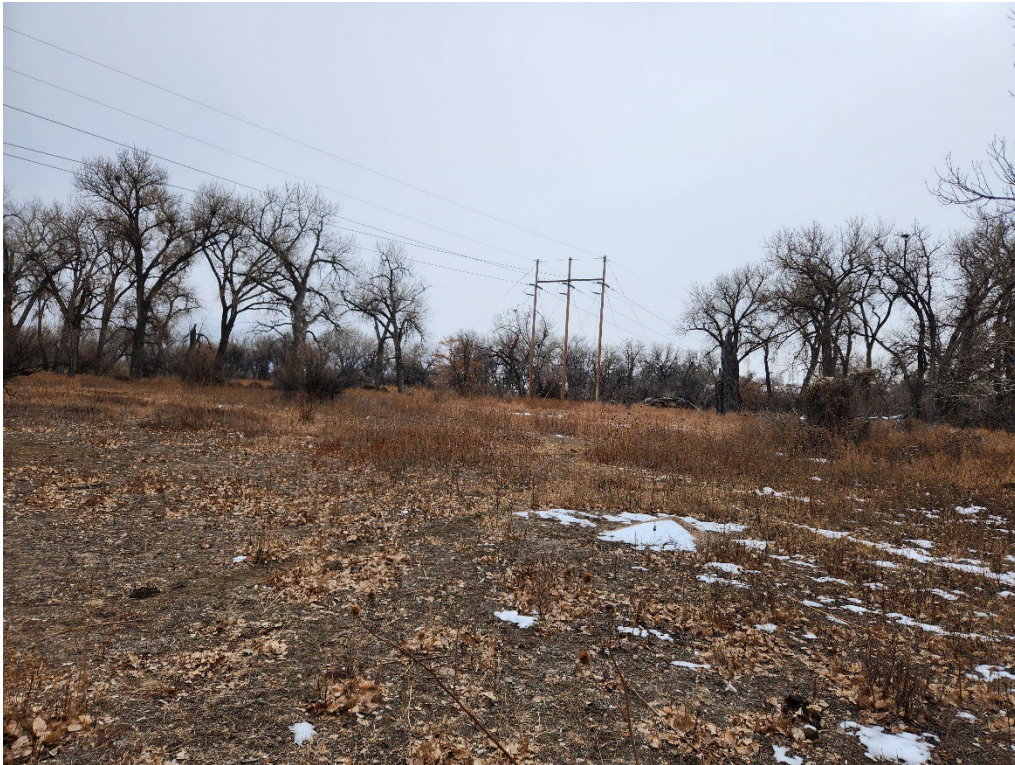
**Photo 21.** Electric lines running in between the proposed East and West Pits looking southeast.

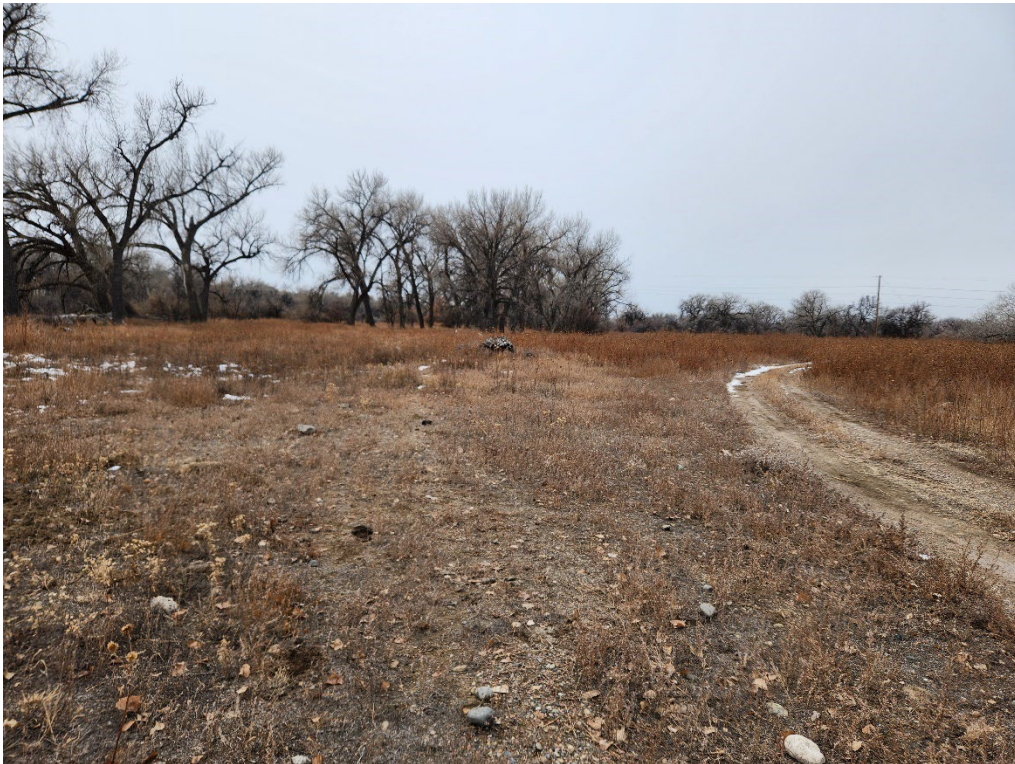
**Photo 22.** Existing dirt road running along the southern border of the proposed East Pit looking west.

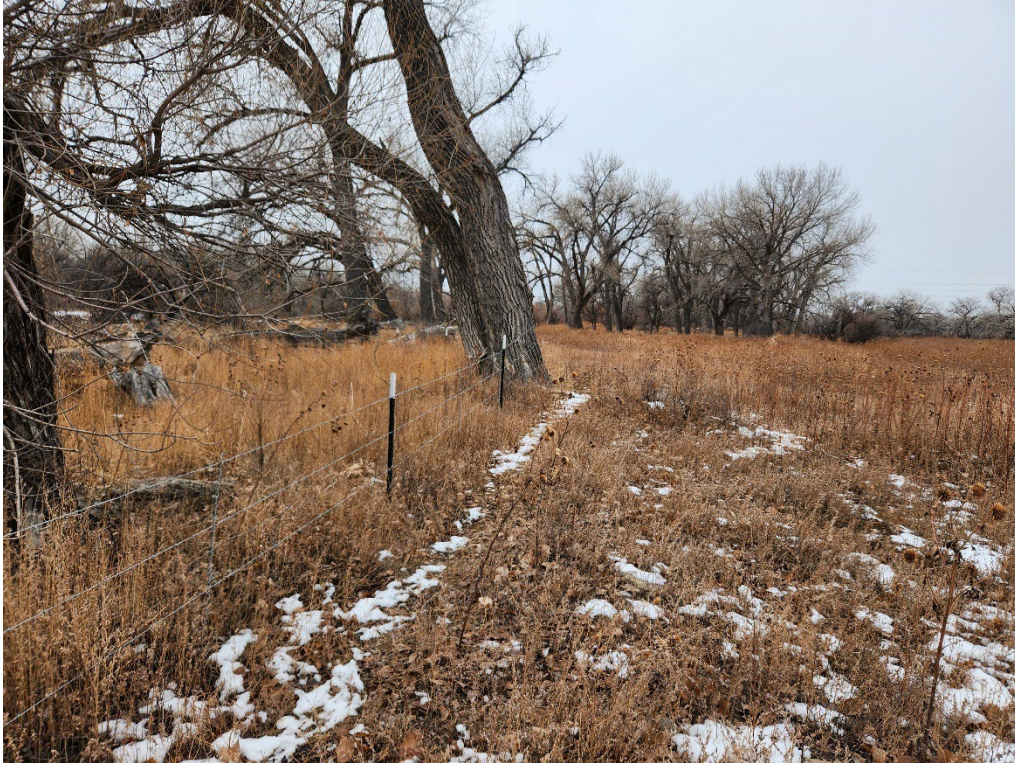
**Photo 23.** Existing fence located along the southern border of the proposed permit area looking west.

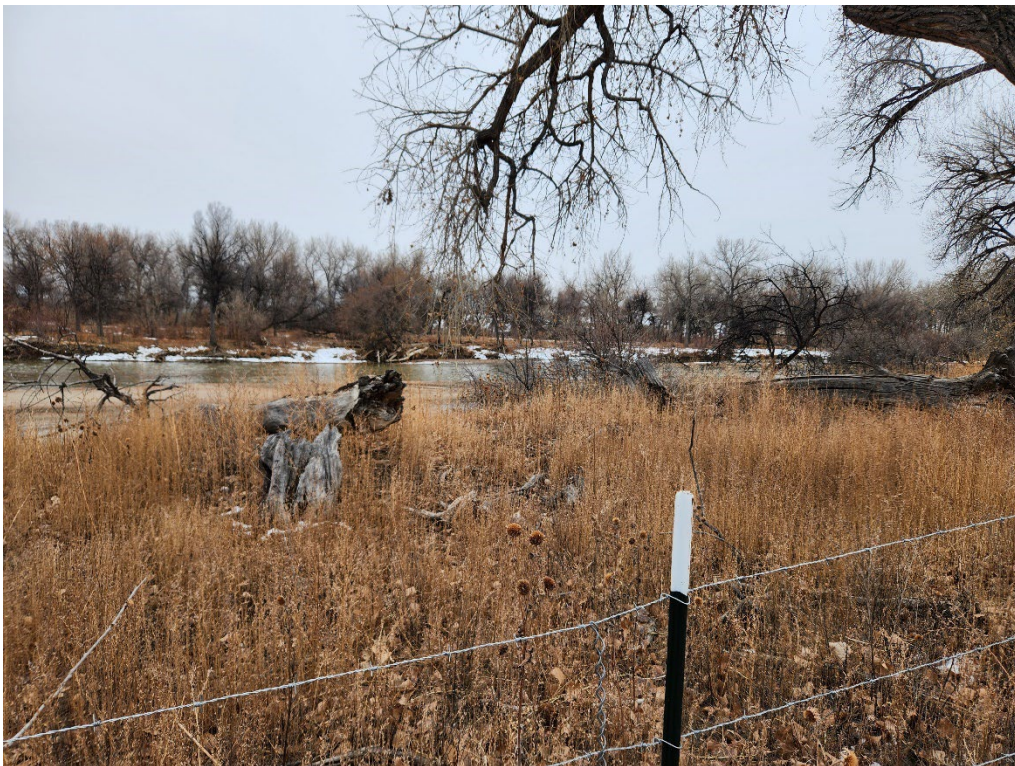
**Photo 24.** Arkansas River located south of the proposed East Pit looking south.

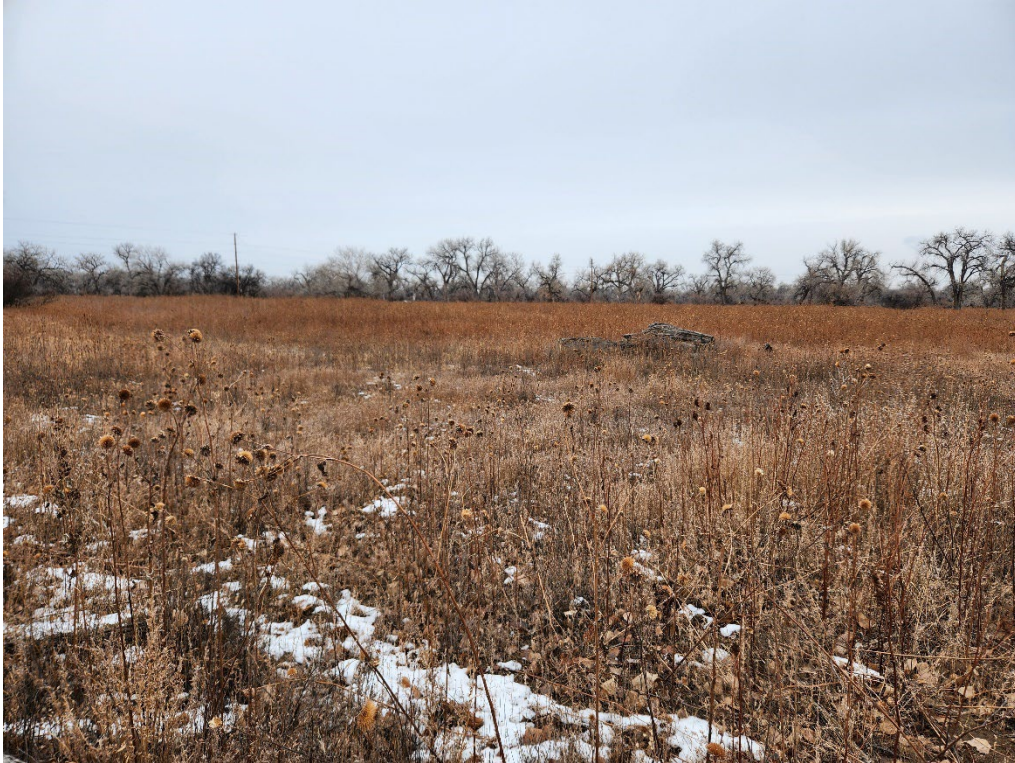
**Photo 25.** Area to be within the proposed East Pit looking west.

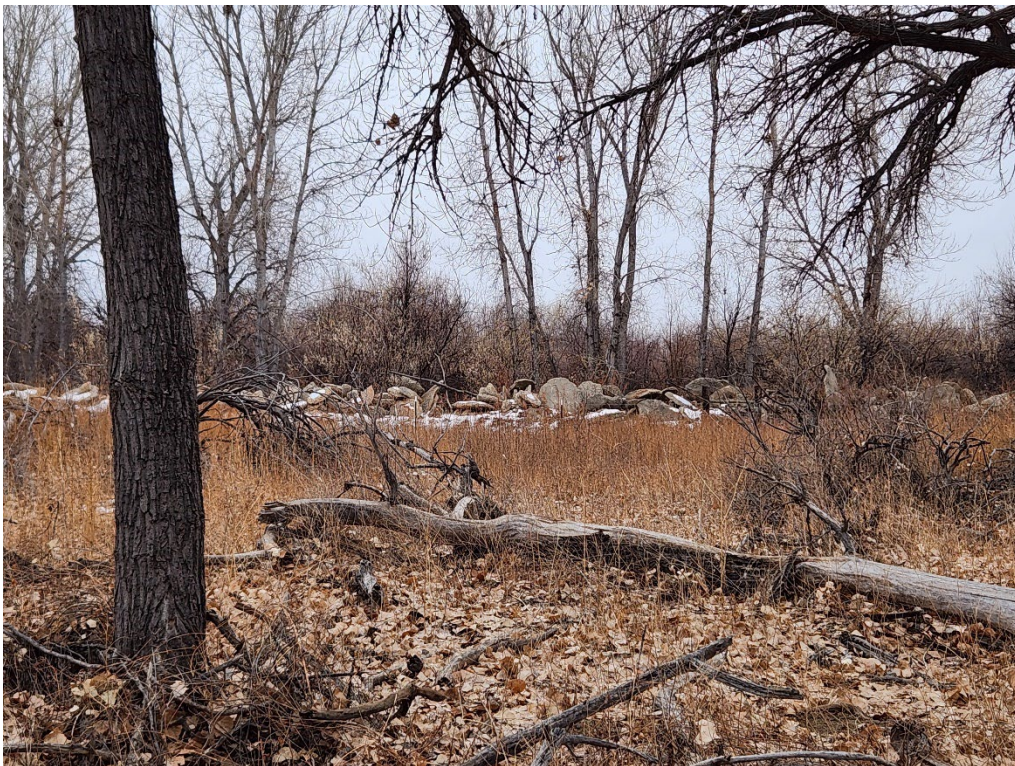
**Photo 26.** Concrete slab pile located east within the proposed East Pit looking north.

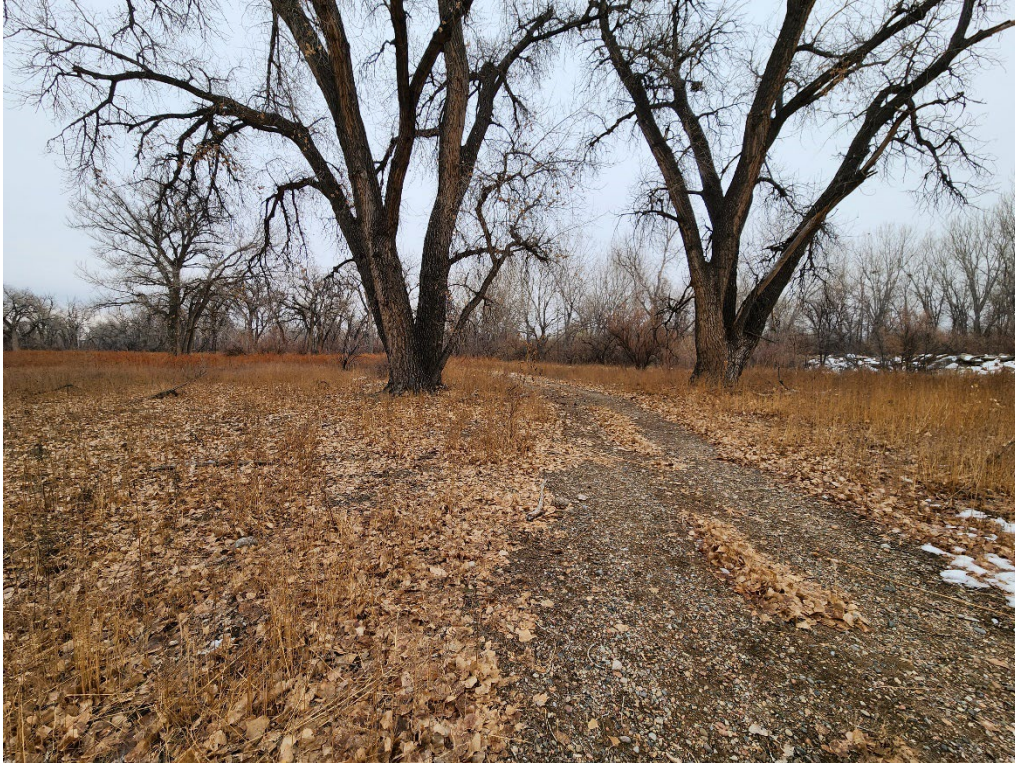
**Photo 27.** Existing dirt road located east within the proposed East Pit looking west.

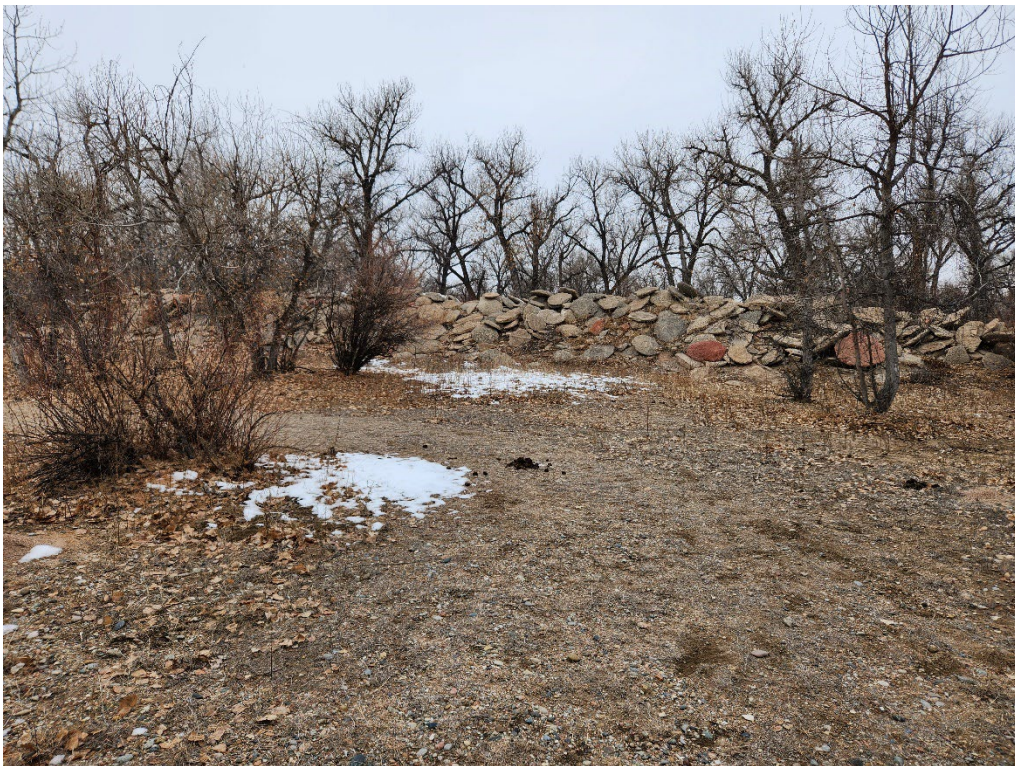
**Photo 28.** Concrete slab pile located east within the proposed East Pit looking northwest.
