**MINERALS PROGRAM INSPECTION REPORT**  
**PHONE: (303) 866-3567**

<b>MINE NAME:</b> Thunderbird Sand and Gravel	<b>MINE/PROSPECTING ID#:</b> M-2023-032	<b>MINERAL:</b> Sand and gravel	<b>COUNTY:</b> Pueblo
<b>INSPECTION TYPE:</b> Pre-operation Inspection	<b>WEATHER:</b> Cloudy	<b>INSP. DATE:</b> December 13, 2023	<b>INSP. TIME:</b> 11:00
<b>OPERATOR:</b> Martin Marietta Materials, Inc.	<b>OPERATOR REPRESENTATIVE:</b> Phillip Courtney	<b>TYPE OF OPERATION:</b> 112c - Construction Regular Operation	
<b>REASON FOR INSPECTION:</b> Pre-operation Inspection	<b>BOND CALCULATION TYPE:</b>	<b>BOND AMOUNT:</b> No Bond Held	
<b>DATE OF COMPLAINT:</b> NA	<b>POST INSP. CONTACTS:</b> None	<b>JOINT INSP. AGENCY:</b> None	
<b>INSPECTOR(S):</b> Joel Renfro Robert Zuber, P.E.	<b>INSPECTOR'S SIGNATURE:</b>

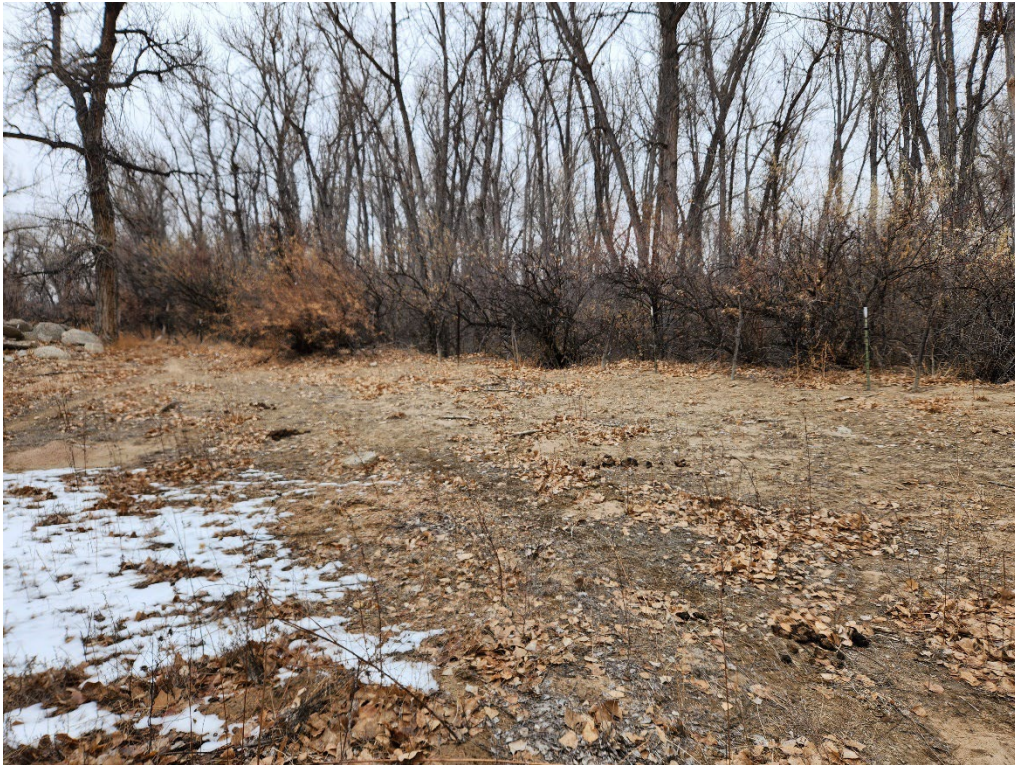
**Photo 29.** Existing fence located east of the proposed East Pit looking east.

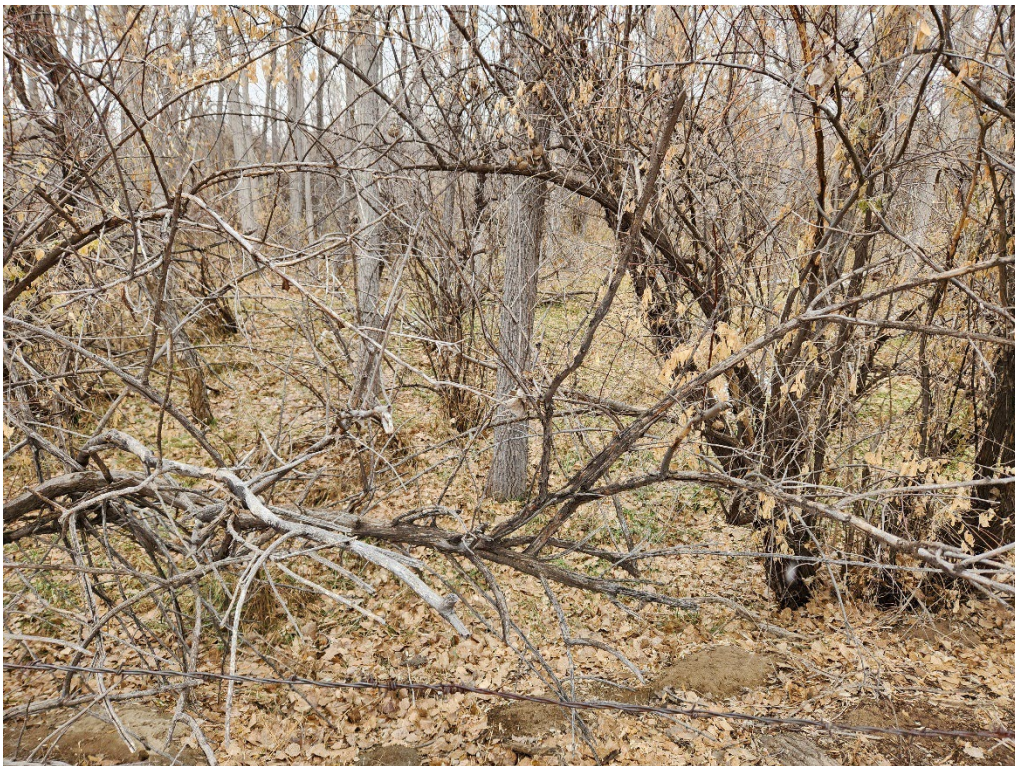
**Photo 30.** Dense trees located east of the proposed East Pit looking east.

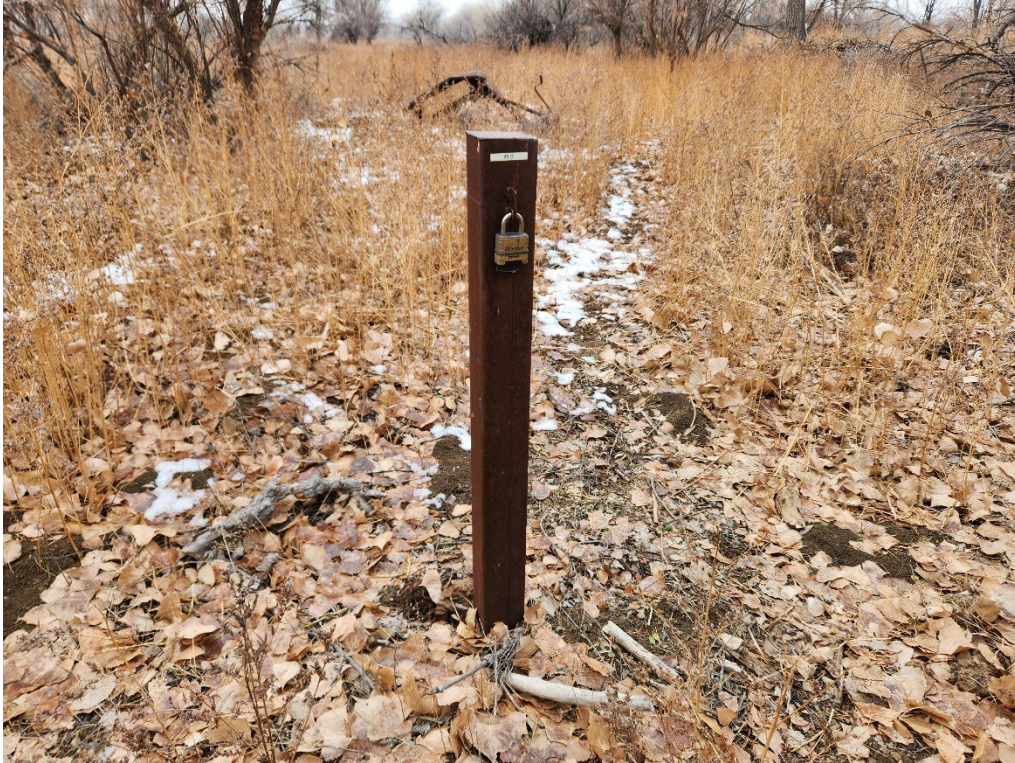
Two small buildings located near the entrance were observed during the inspection . A pile of crushed concrete slabs was found in the eastern portion of the proposed East pit as well. Some existing wells were observed during the inspection as seen in **Photos 31, 38, and 39**. The Division was unable to locate every well shown in the Exhibit-G1 Map, just the three imaged in this report.

**Photo 31.** Well found within the northeastern portion of the proposed East Pit.

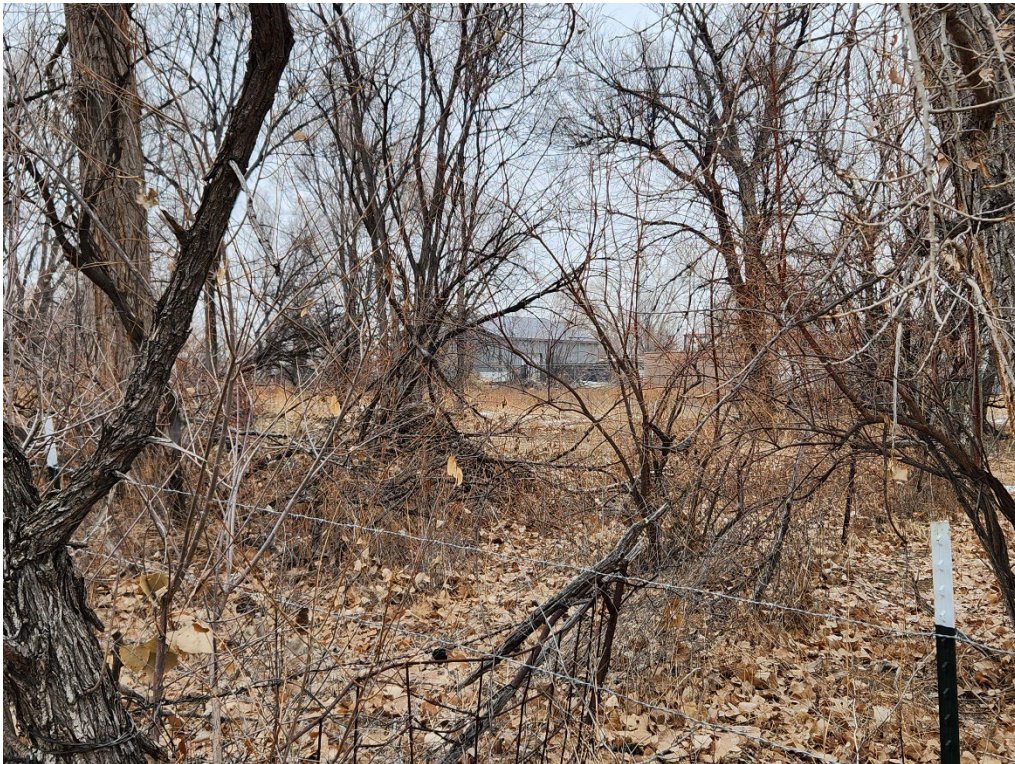
**Photo 32.** Existing fence running along the northern edge of the proposed East Pit, Excelsior ditch and structures beyond the fence looking north.

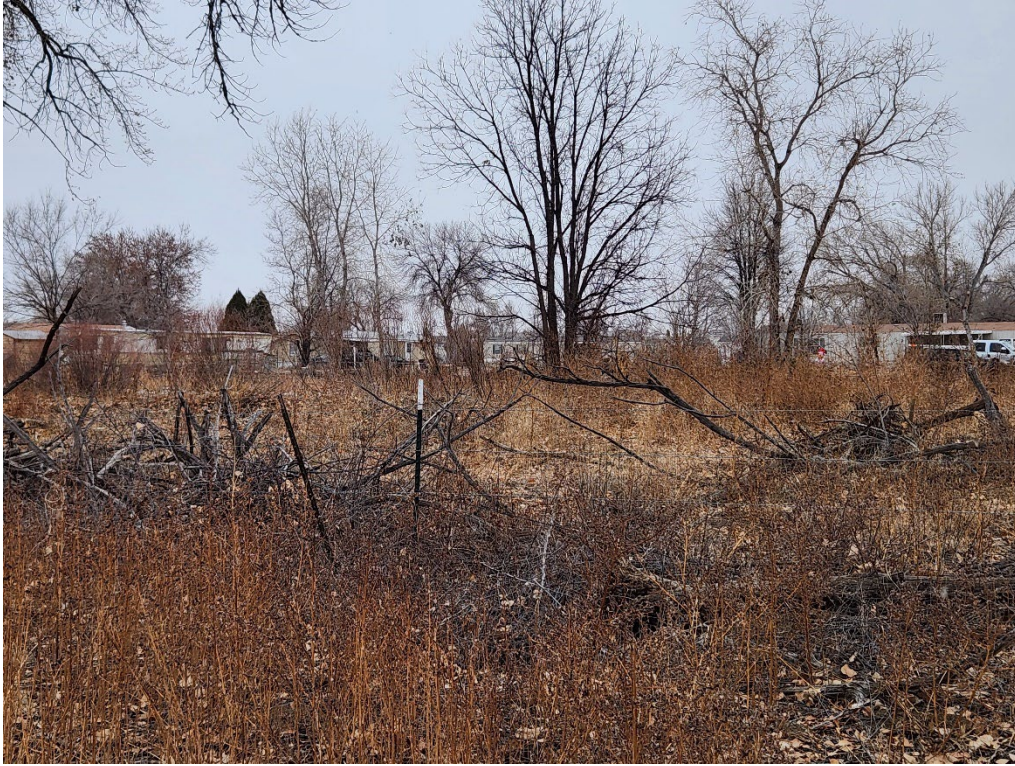
**Photo 33.** Existing fence running along the northern edge of the proposed East Pit, Excelsior ditch and structures beyond the fence looking north.

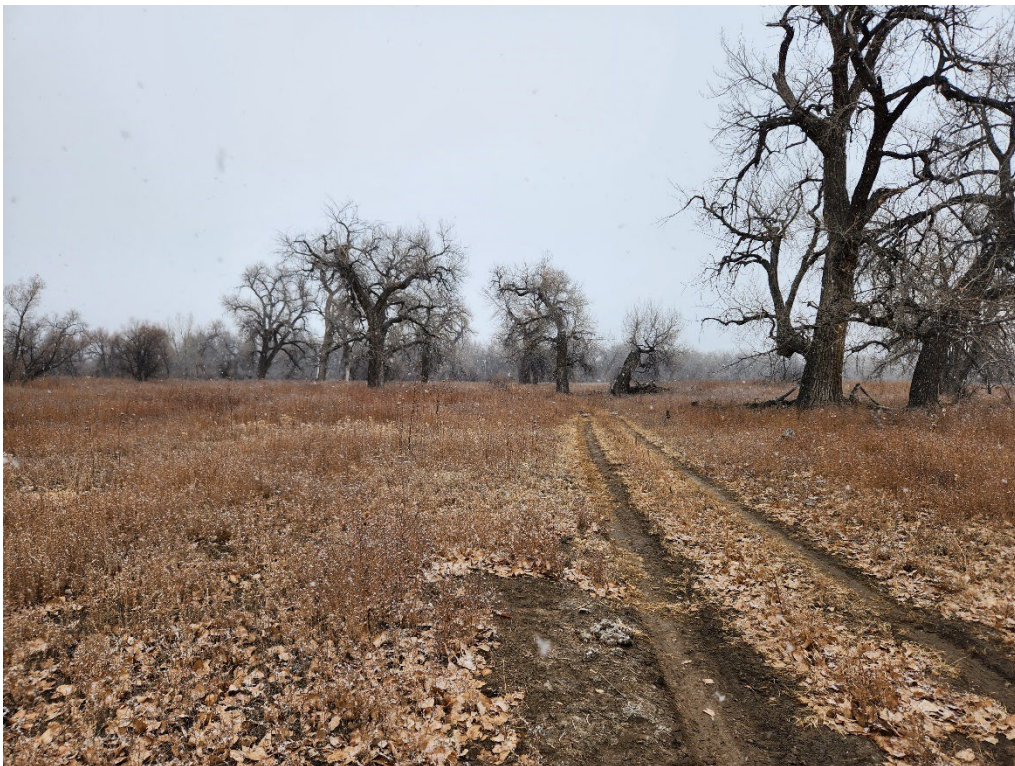
**Photo 34.** Existing dirt road within the northern portion of the proposed East Pit looking east.

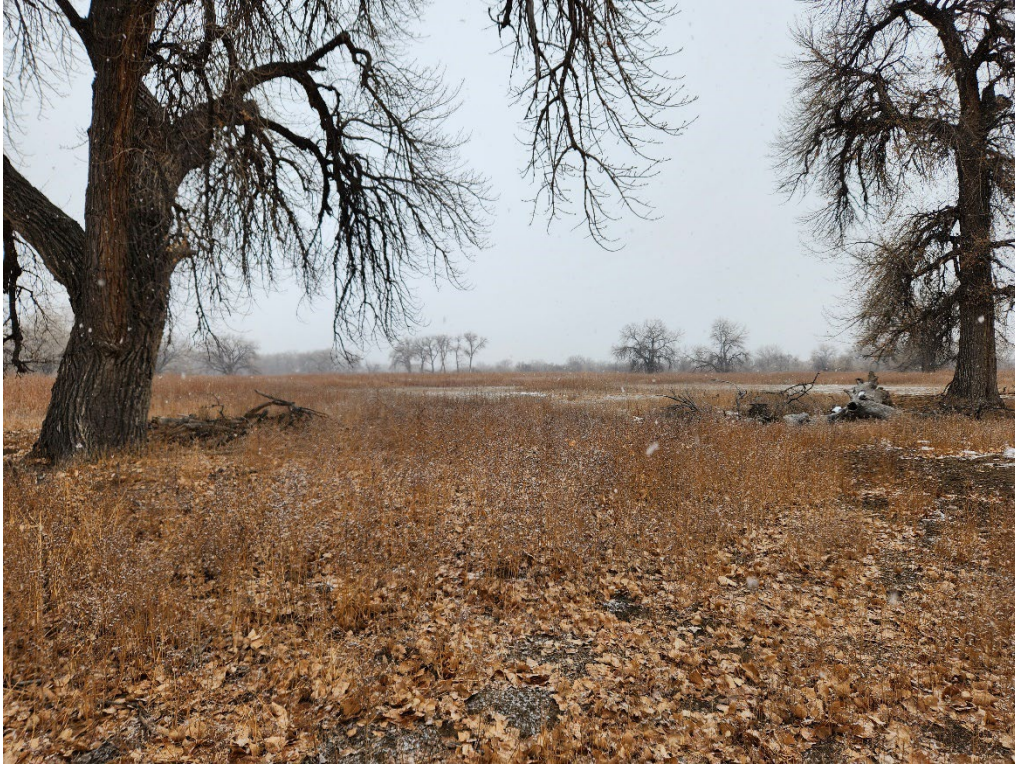
**Photo 35.** Area within the proposed East Pit looking southwest.

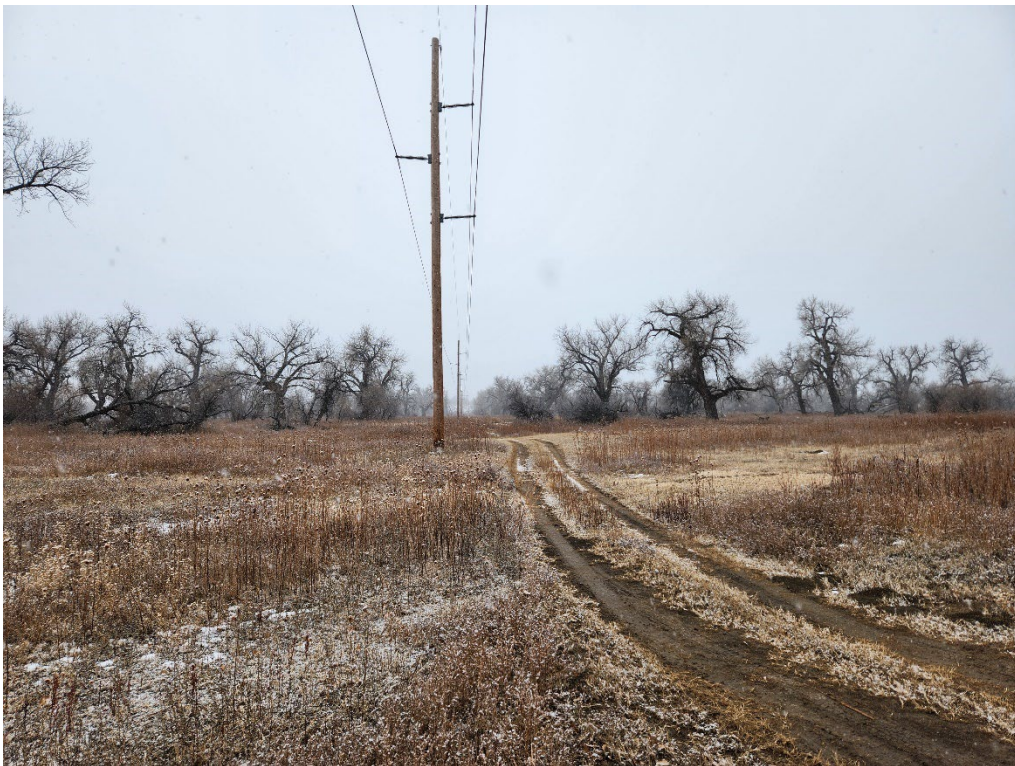
**Photo 36.** Existing dirt road running west of the electric lines looking south.

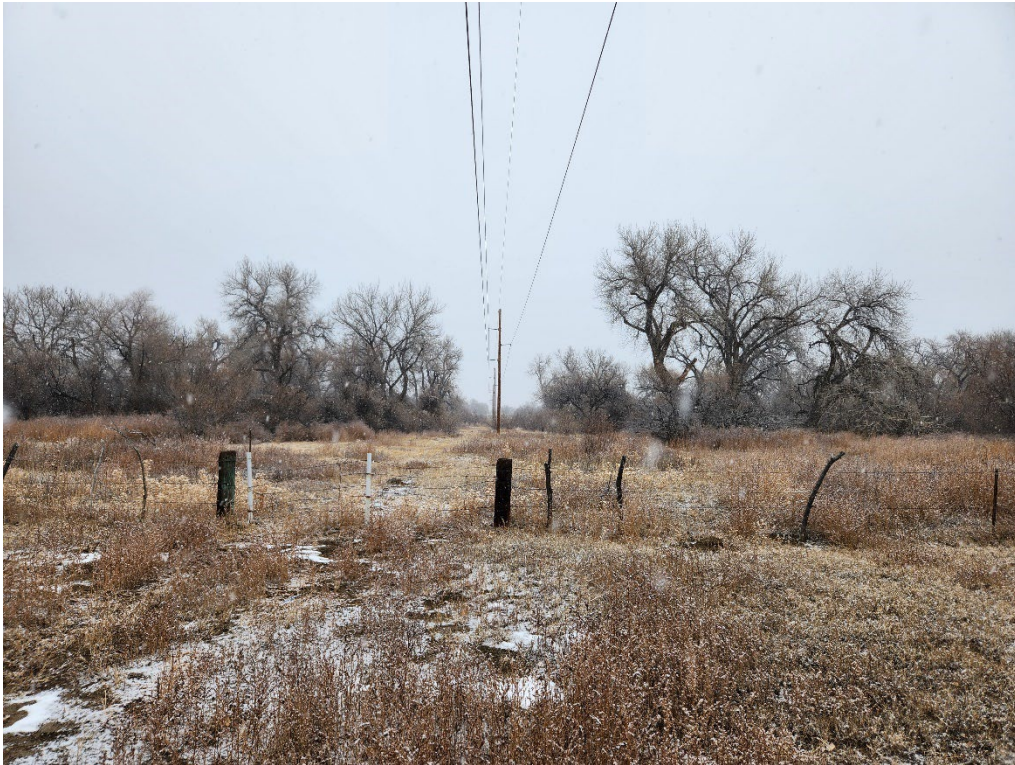
There is existing fencing on the site, but it does not officially mark the proposed permit boundary or affected area. It seems that some of the fencing, as seen in **Photo 37**, does align with the proposed permit boundary, but the Division will require accurate boundary markers to be installed as mandated by Rule 3.1.12(2) after the permit is approved.

**Photo 37.** Electric lines running through the site and an existing fence looking north.

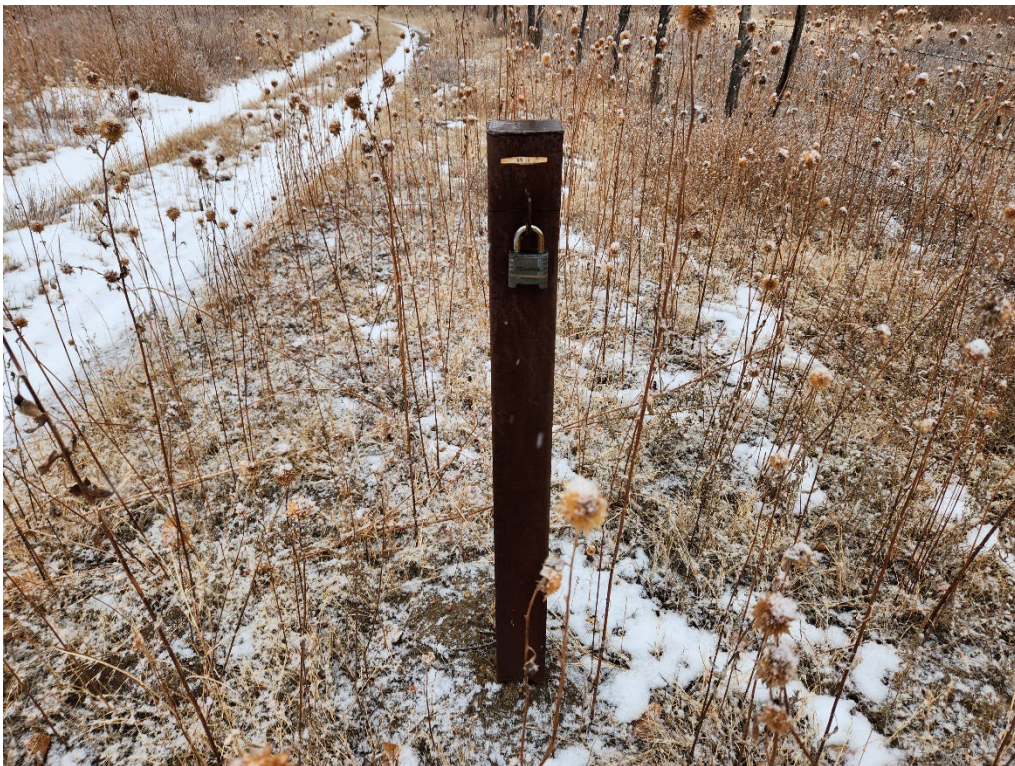
**Photo 38.** A well found north of the proposed West Pit looking west.

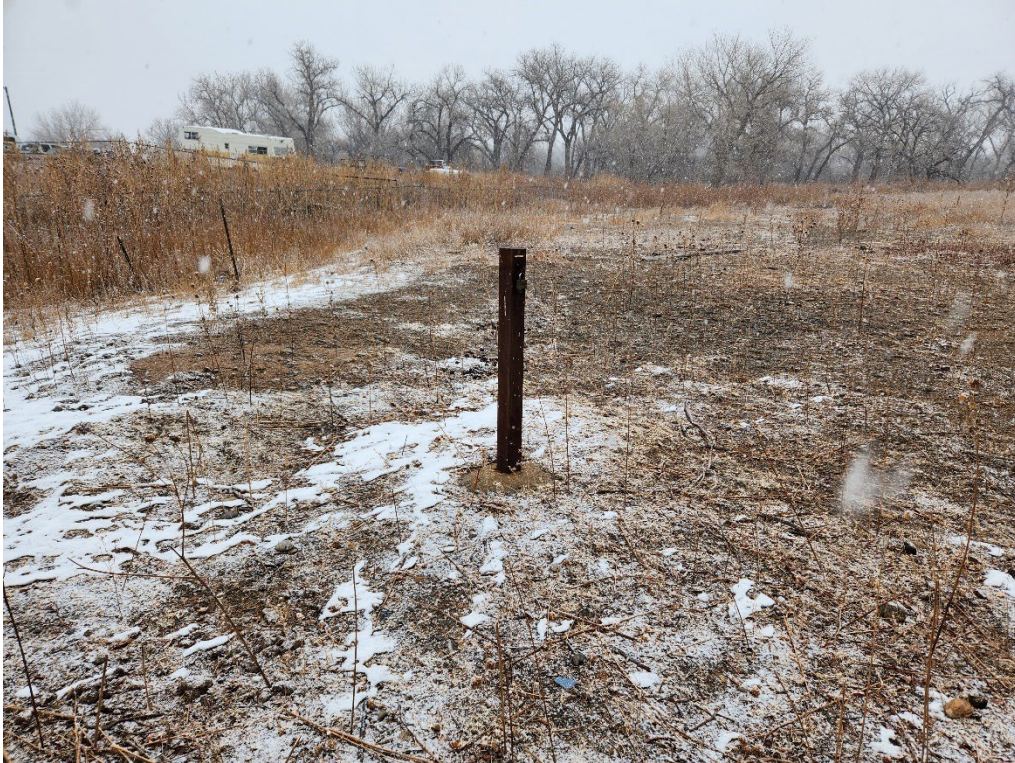
**Photo 39.** A well found in the northwest corner of the proposed permit area looking east.

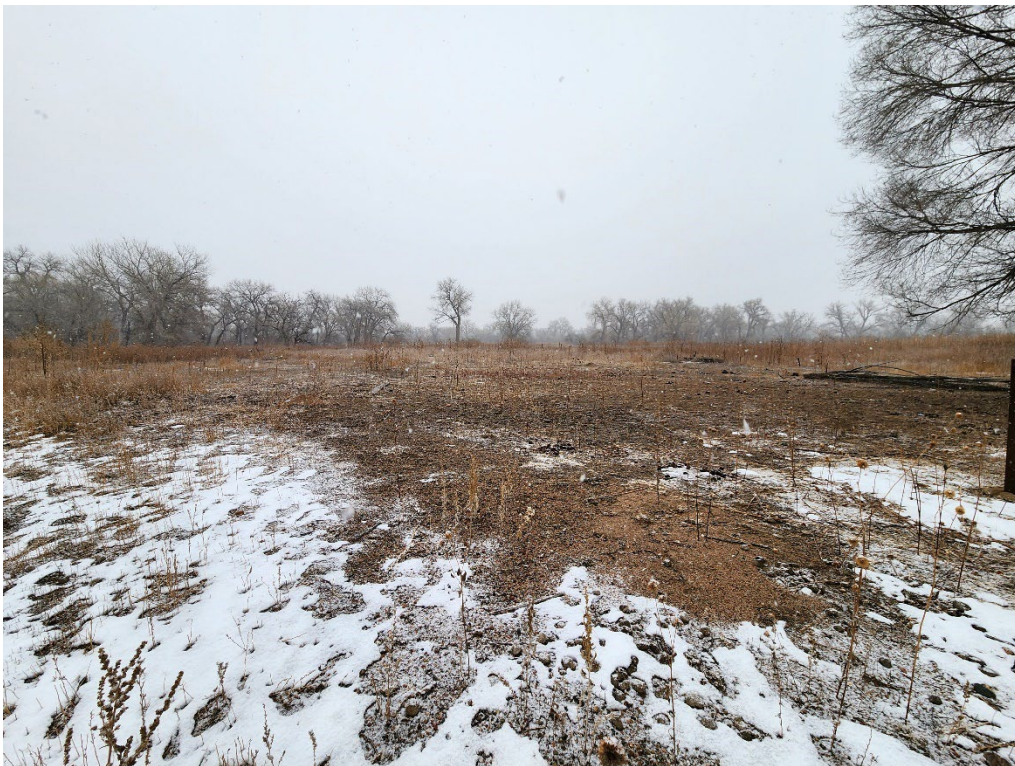
**Photo 40.** Northwest corner of the proposed permit area looking southeast.
