RE: Tamrock Gravel, LLC.
Shot Rock Pit - M-2012-023
Corrective action Boundary Markers

On behalf of my client Tamrock Gravel LLC, I am providing the following information to address the December 8, 2023 Inspection report Signs & Marker inspection topic.

TAMROCK GRAVEL COMPANY CORNER LOCATIONS SHOT ROCK PIT - M-2012-023

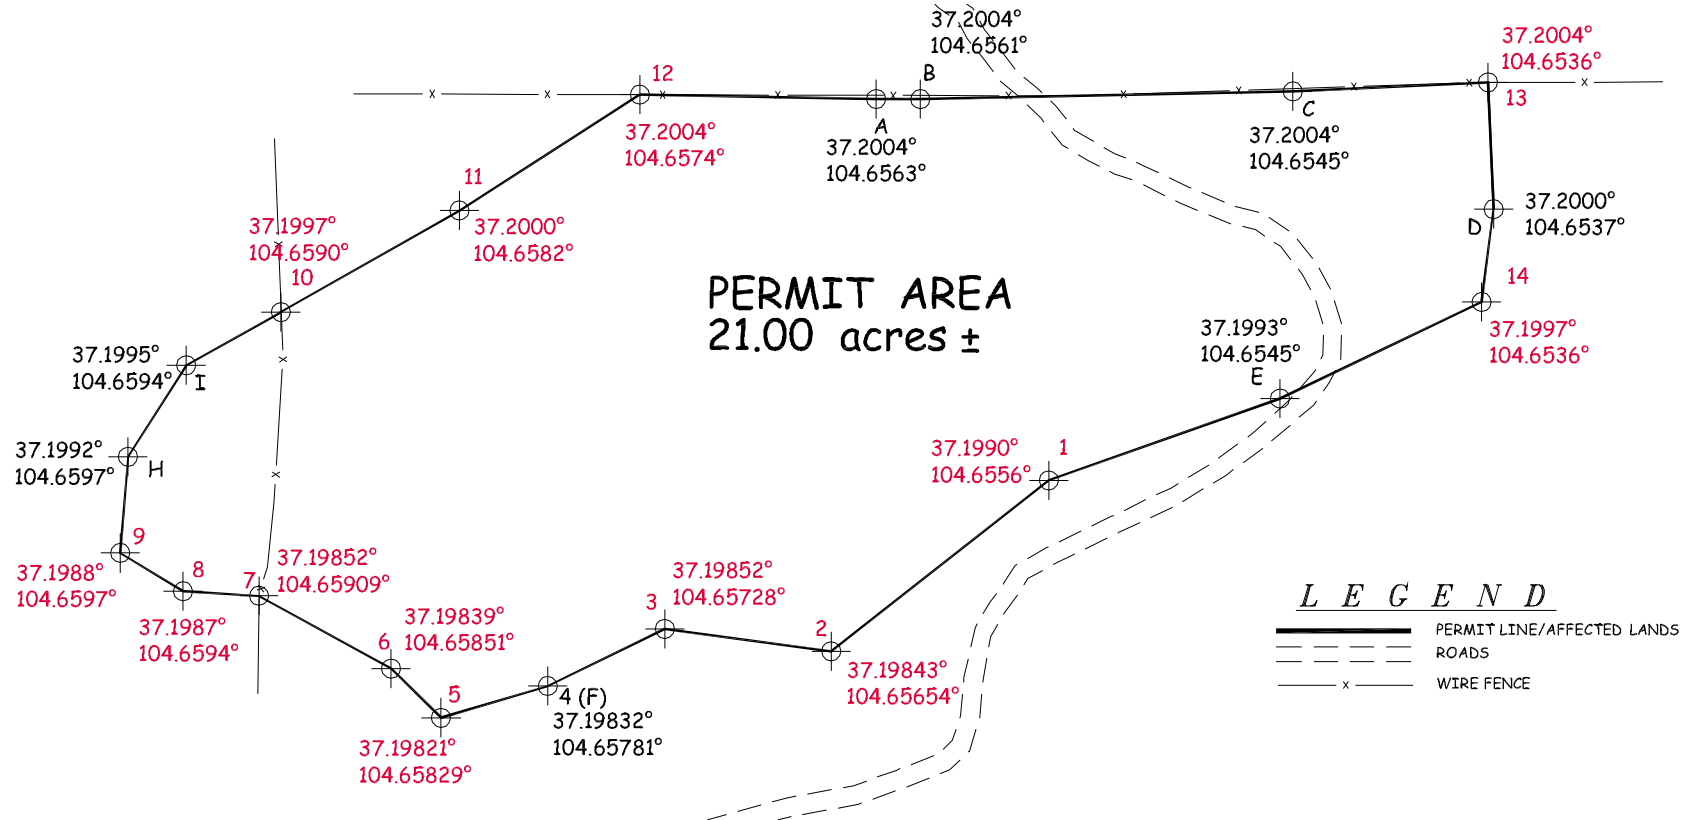
It is based on data collected when the original layout of the mine was done in 2012, where I recorded the Latitude/Longitude coordinates for each corner when we set them. I labeled the corners you were able to find at the inspection based on the letters on your **Map 1** (page 18 of 19) and then started using numbers to designate the ones Brent found. The corners you found are shown as black text and the ones you did not find are red. Corner 1 was the only missing marker that needed to be reset.

The black numbers and letters
are DRMS located points -
11-28-23.

The red numbers are ground
varuified. 2-13-24.

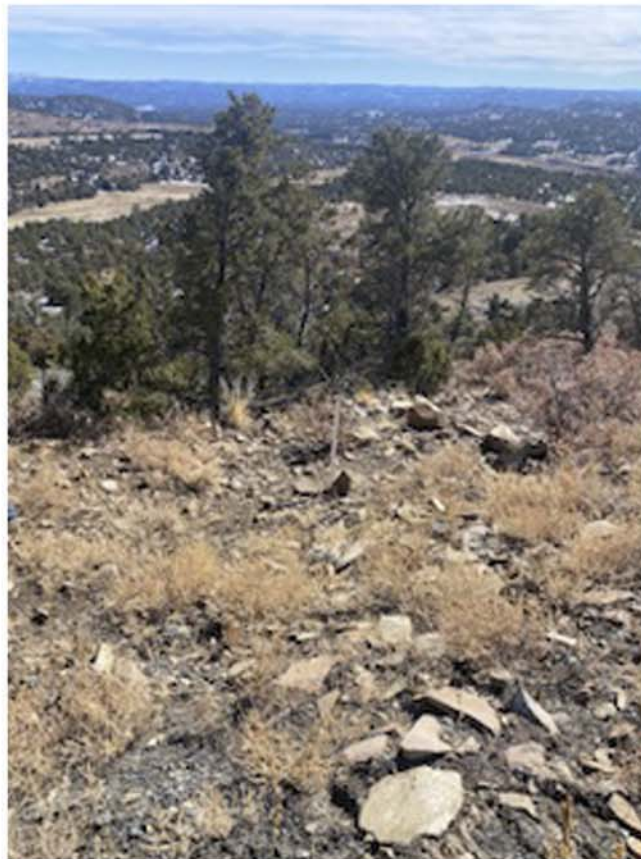
Corner 1 - looking from mine floor to marker

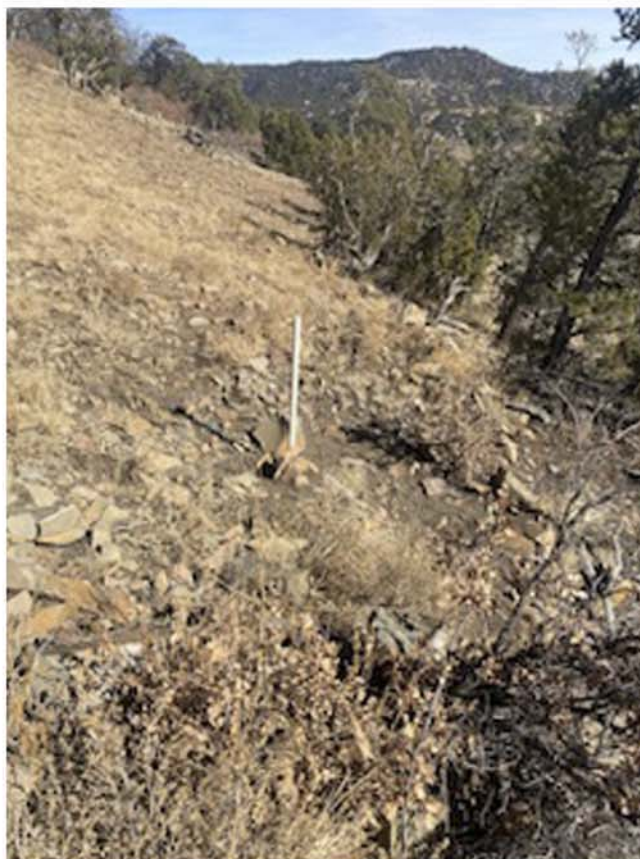
Corner 1 - looking east to Corner E

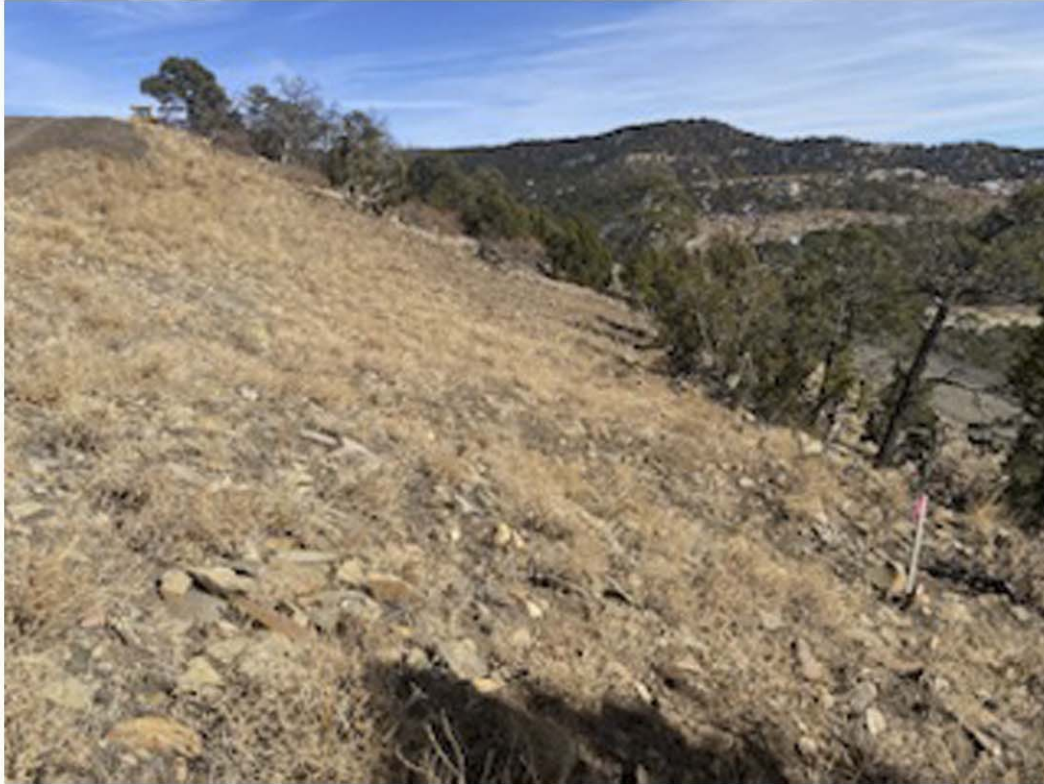
Corner 1 - looking east along slope towards Corner E

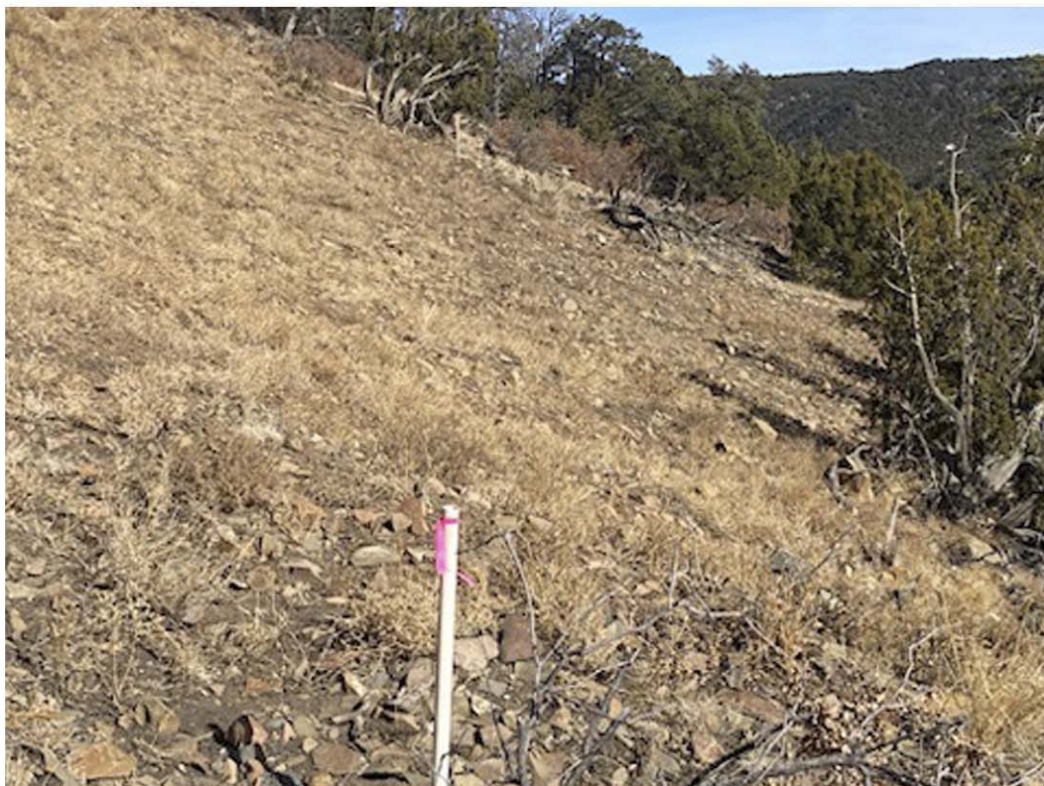
Corner 1 - Looking east from behind marker along line to Corner E

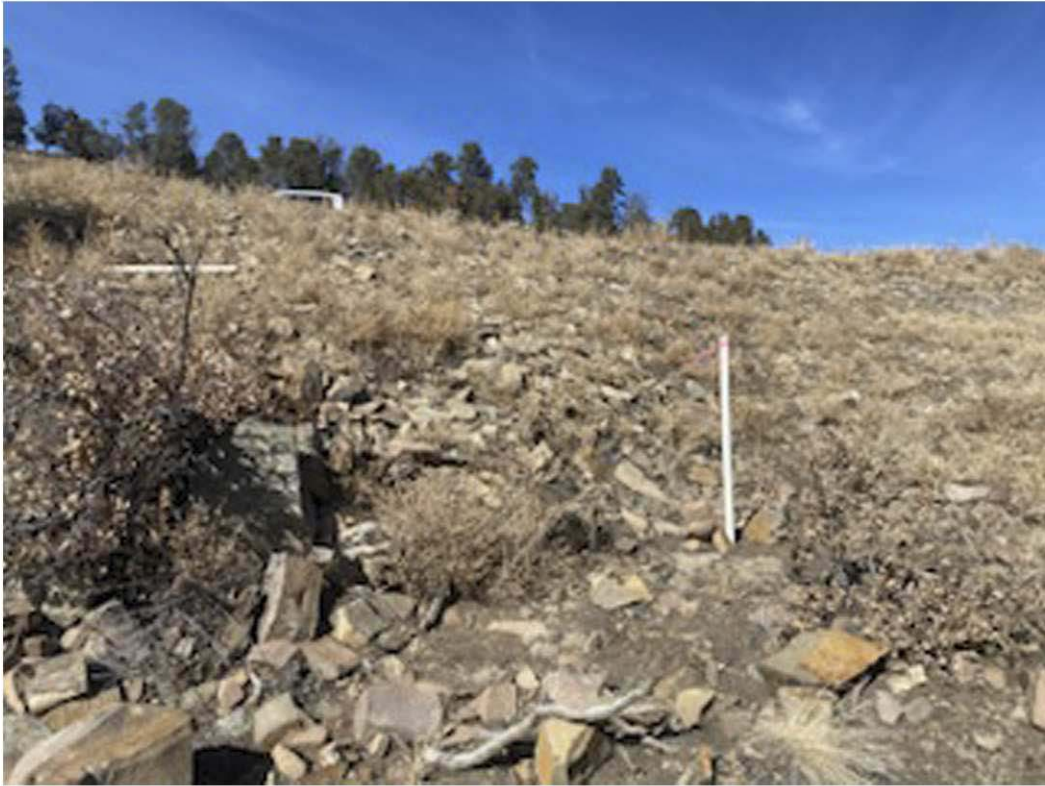
Corner 1 - Looking north into the mine area.

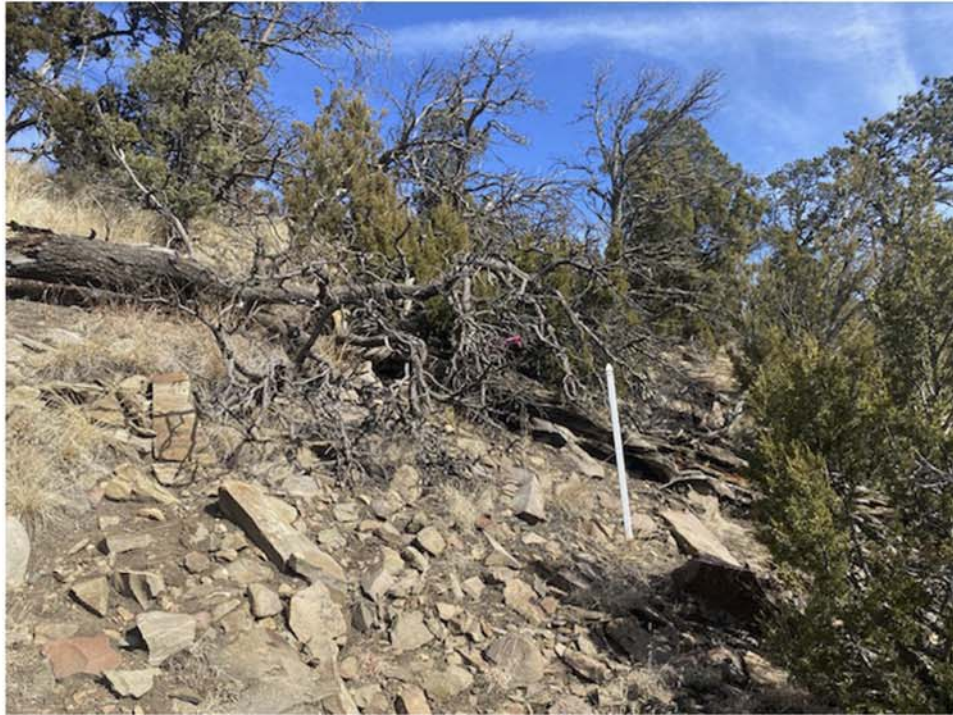
Corner2 - looking east towards Point 1. Permit area on left.

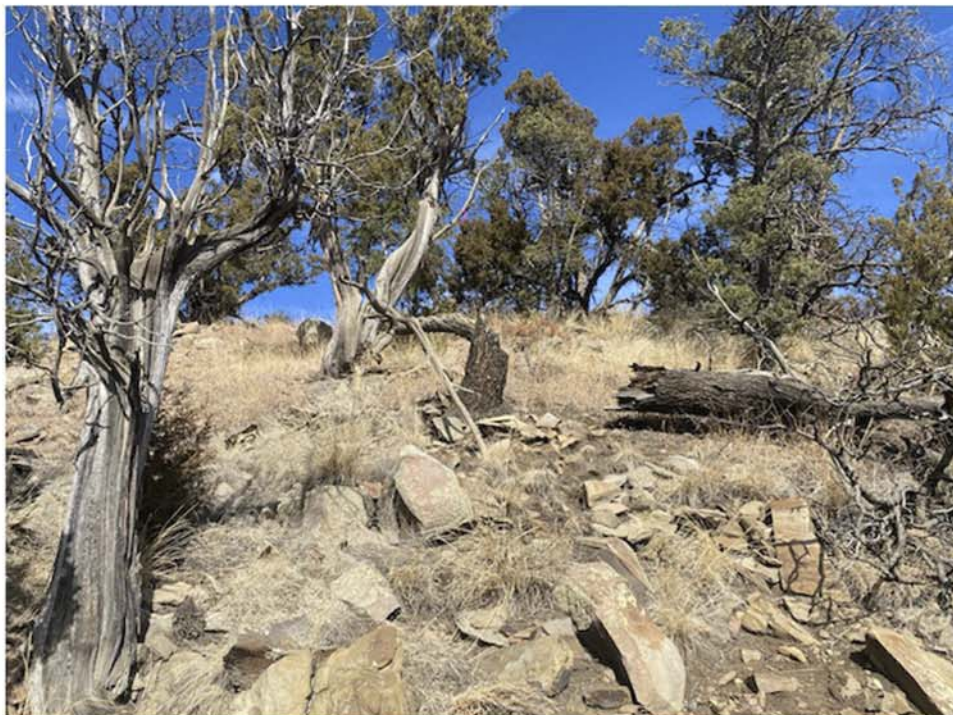
Corner 2 - looking up slope into permit area

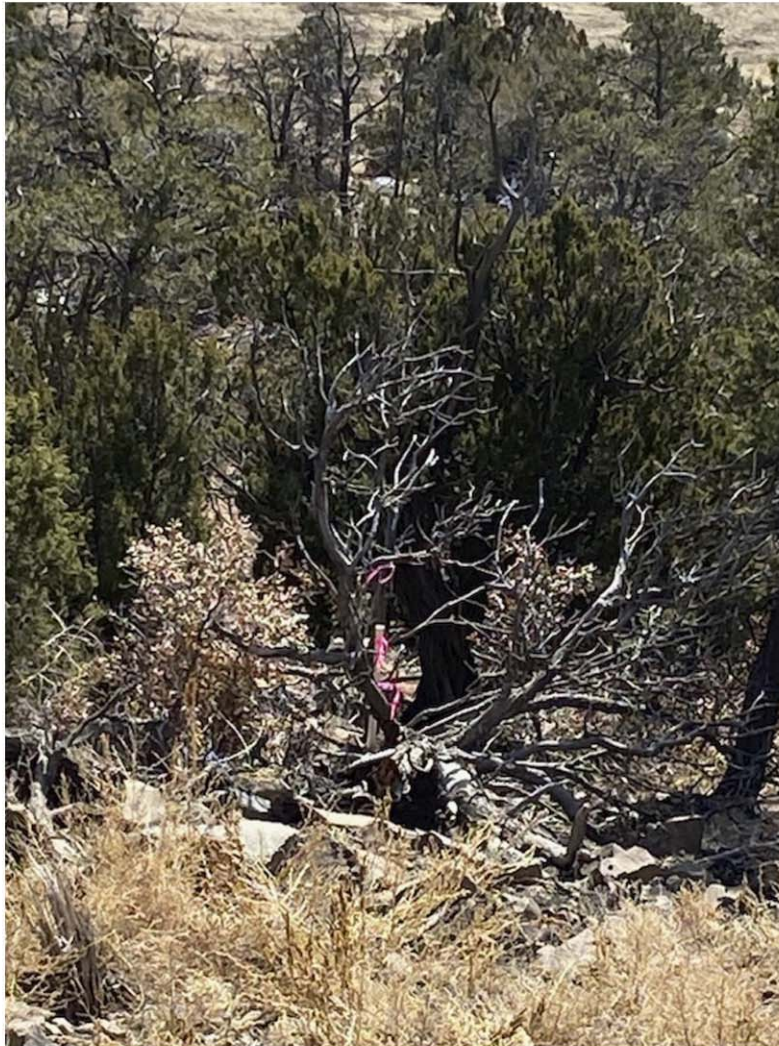
Corner 3 - Looking south from permit area.

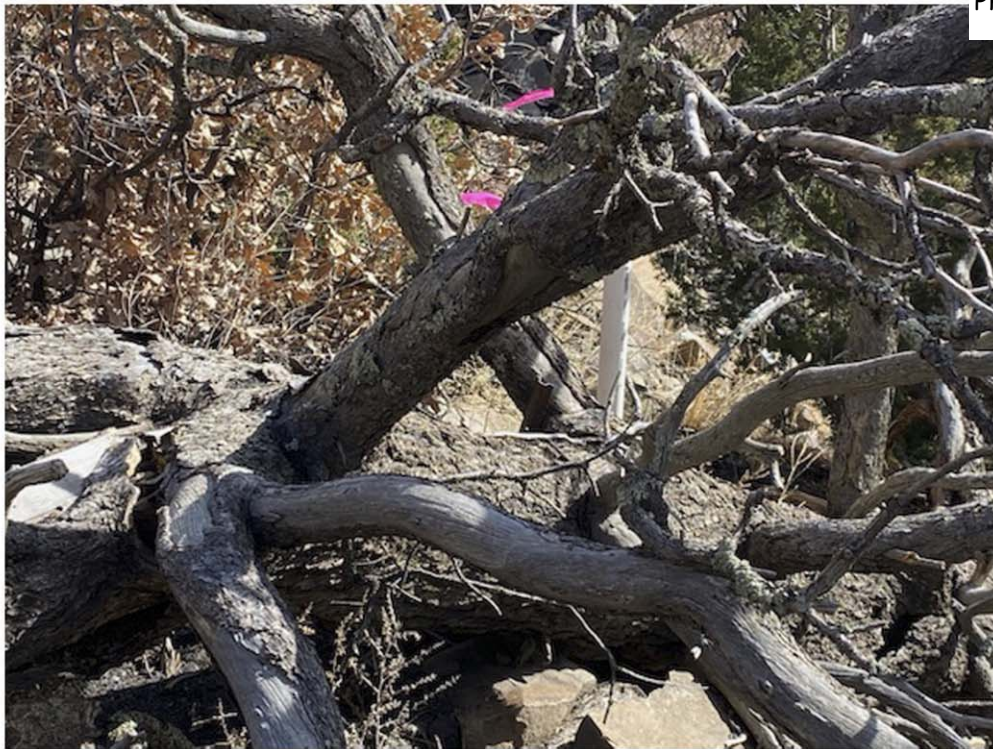
Corner 3 - looking from outside permit area

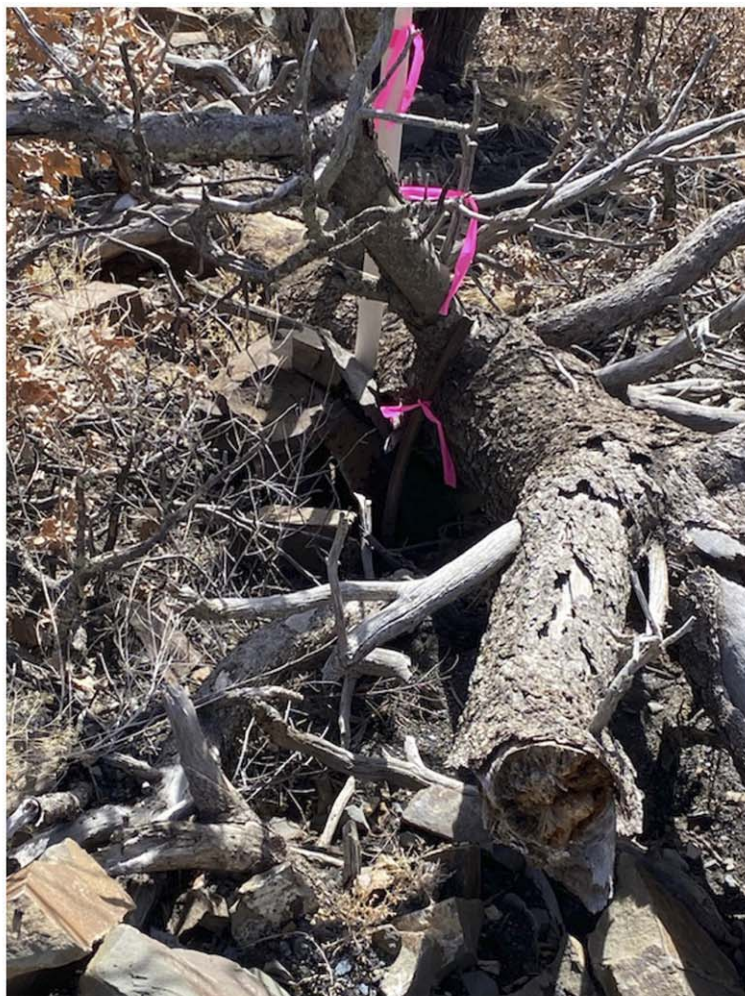
Corner 3 - in tree

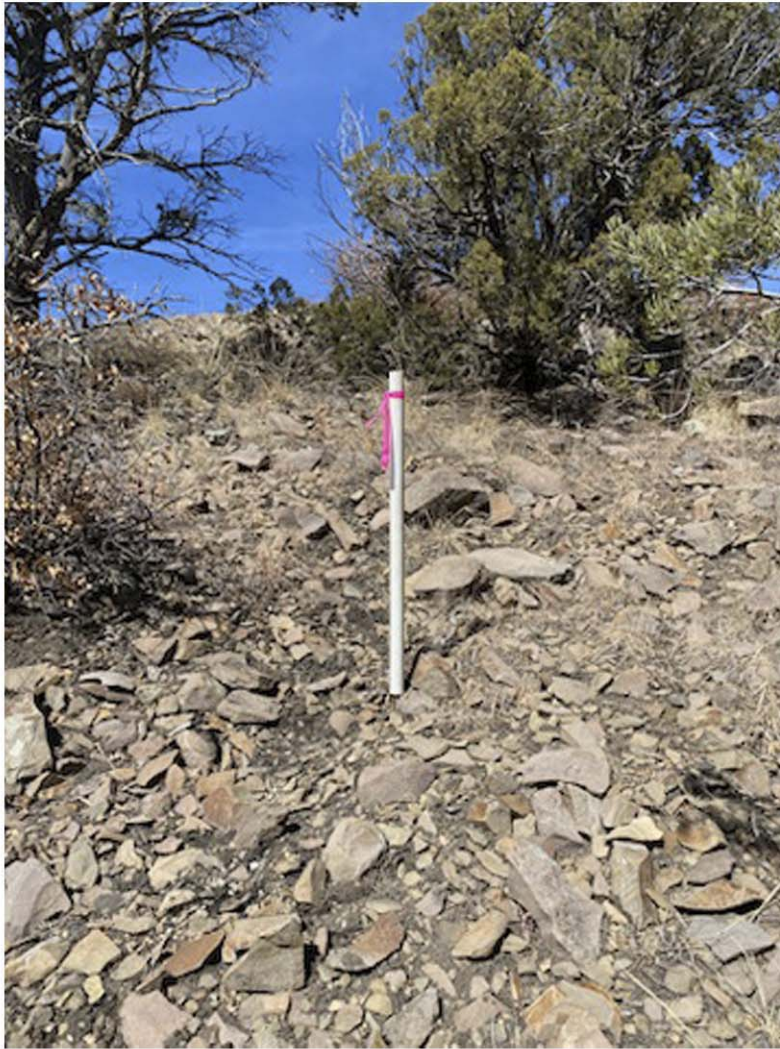
Corner 4 (F) - looking into the permit area

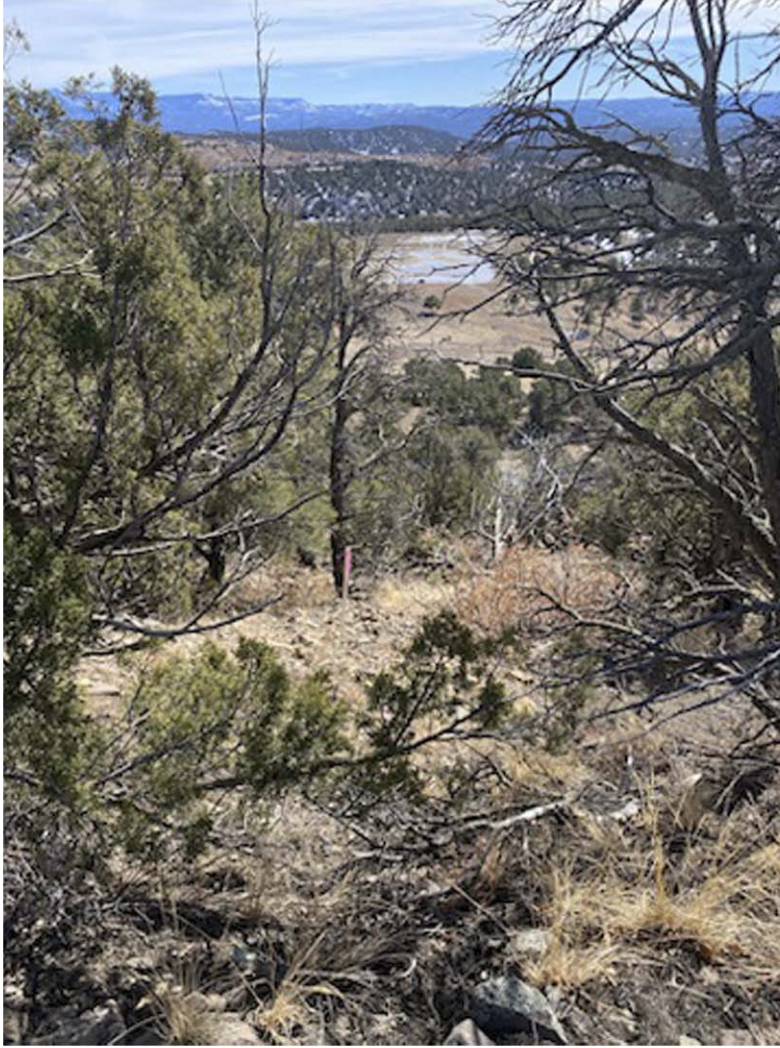
Corner 4 (F) - looking from permit area south to marker

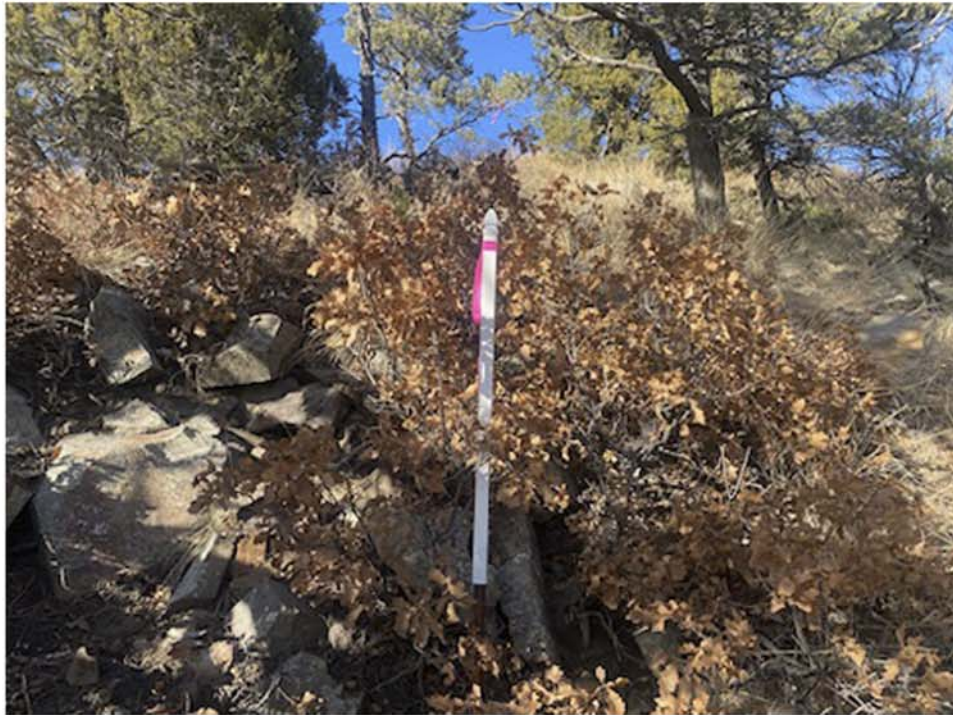
Corner 5 - Looking from down slope of marker into permit area.

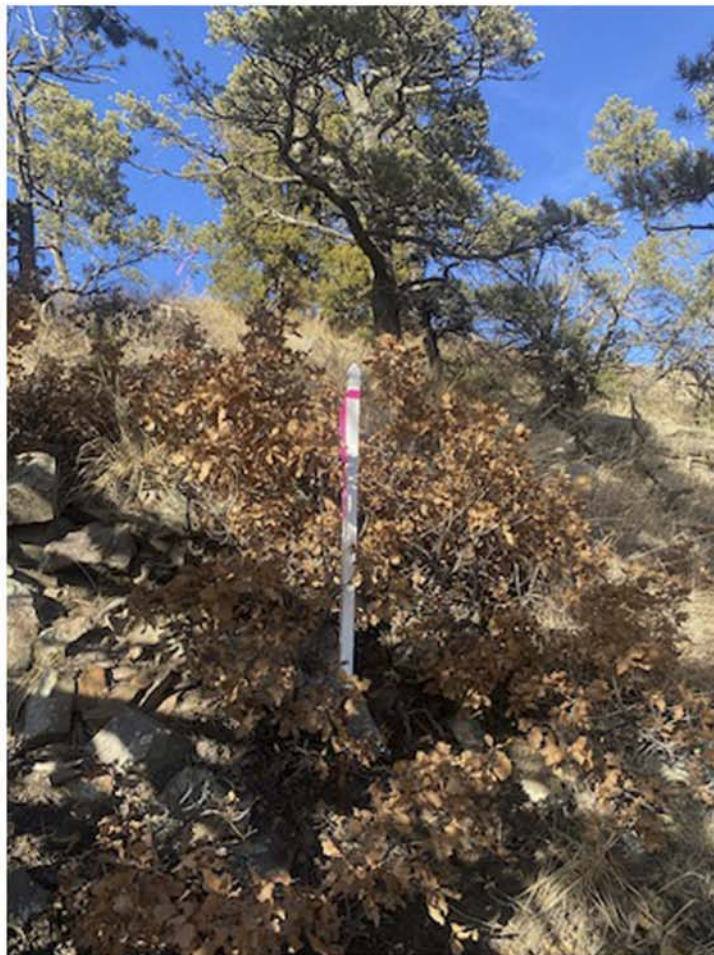
Corner 5 - Another view

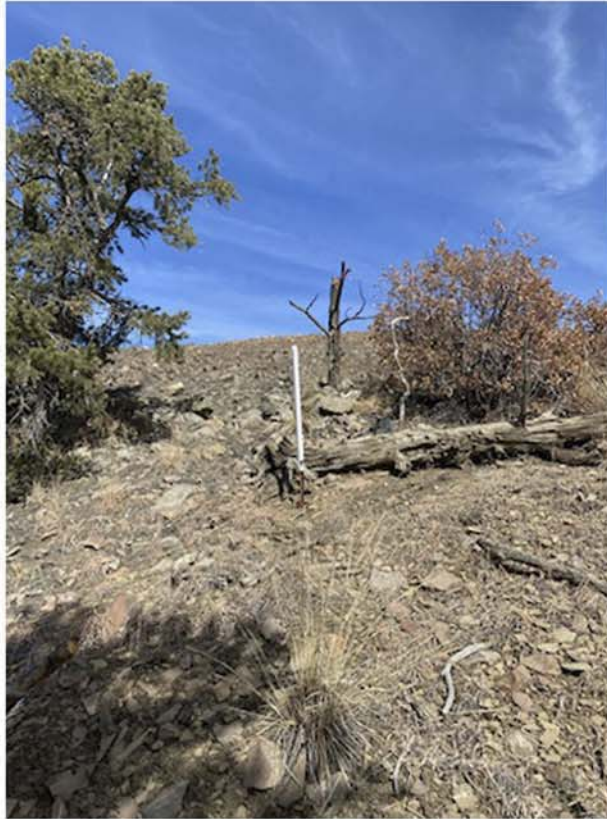
Corner 6 - Right side is permit area. no disturbance outside permt
line

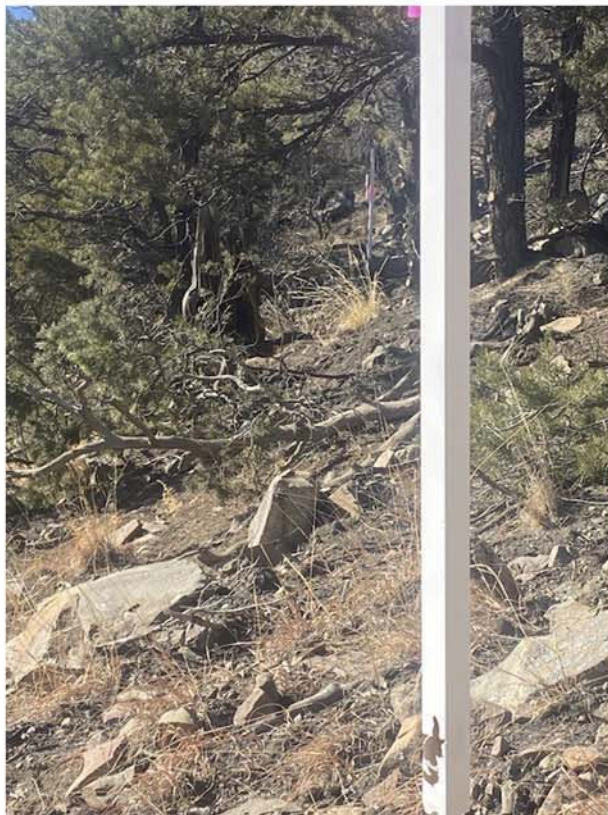
Corner 6 - looking west towards Corner 7. note line market and no
disturbance outside permit area

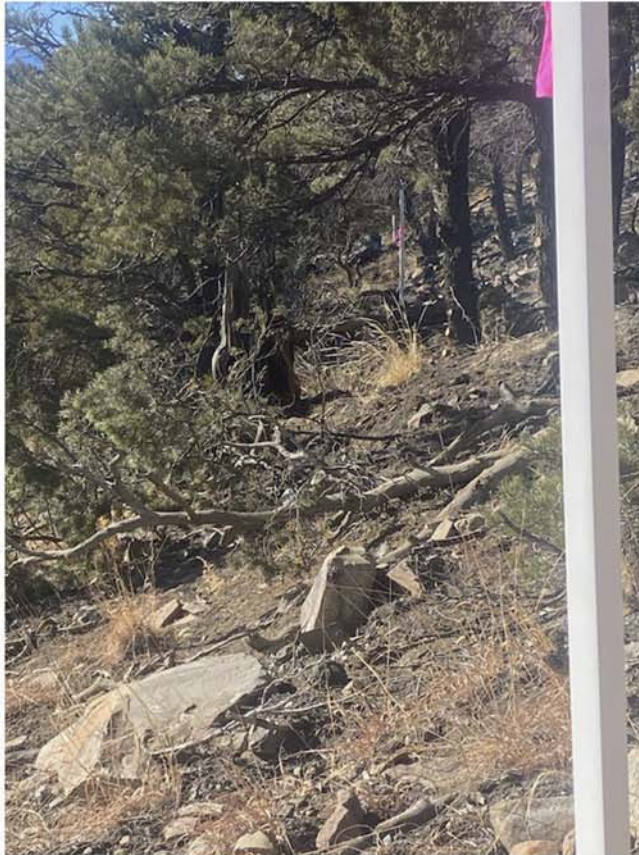
Corner 6 - looking west to Corner 7. Note line markers

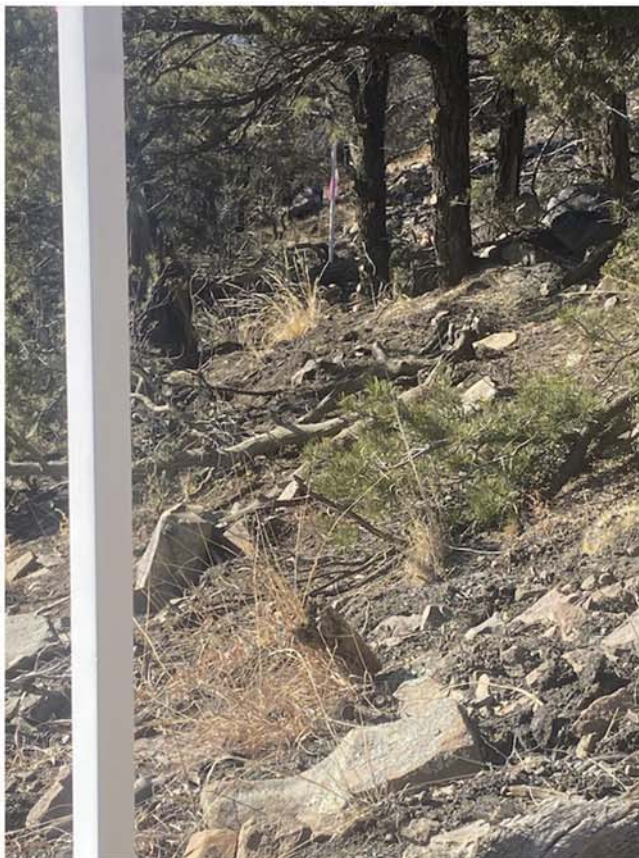
Corner 6 - Right side is permit area. no disturbance outside
permt line

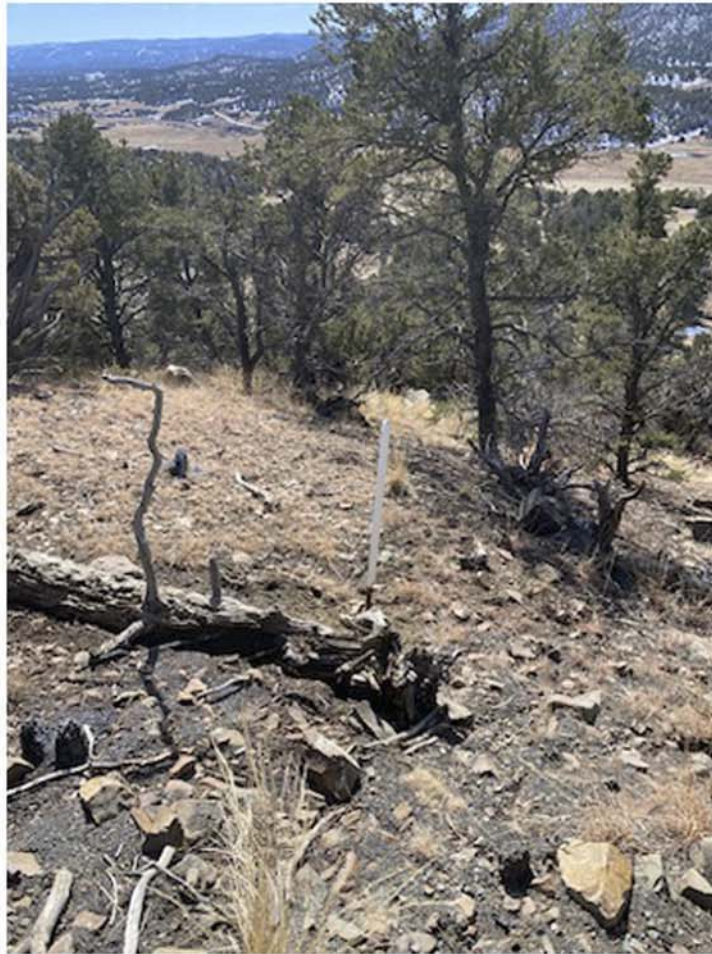
Corner 6 - looking south from permit area to marker

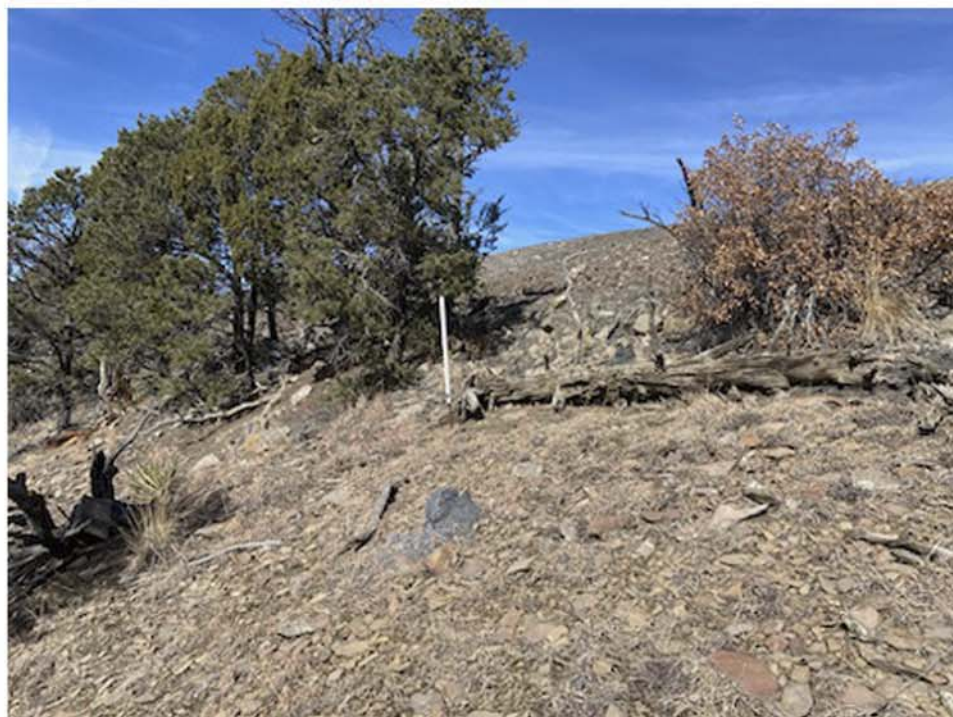
Corner 6 - looking north not reclaimed slope.

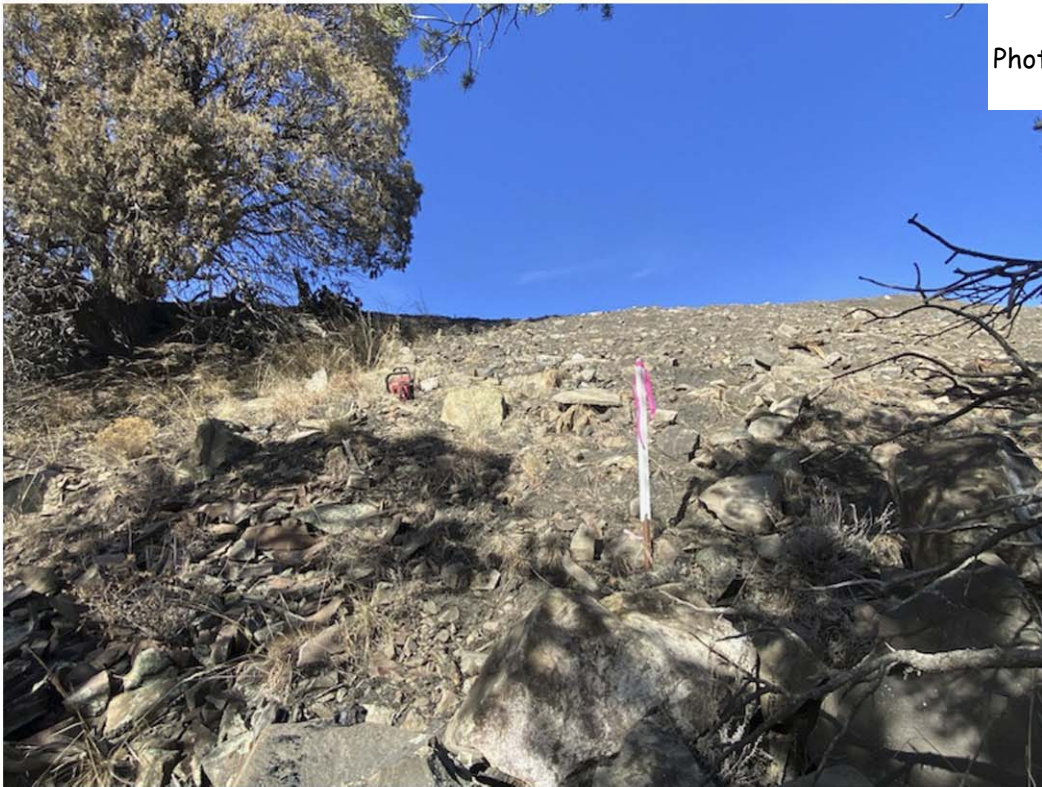
Corner 7 - looking from down slope of marker into permit area.
Saw is sitting on bottom line of graded slope

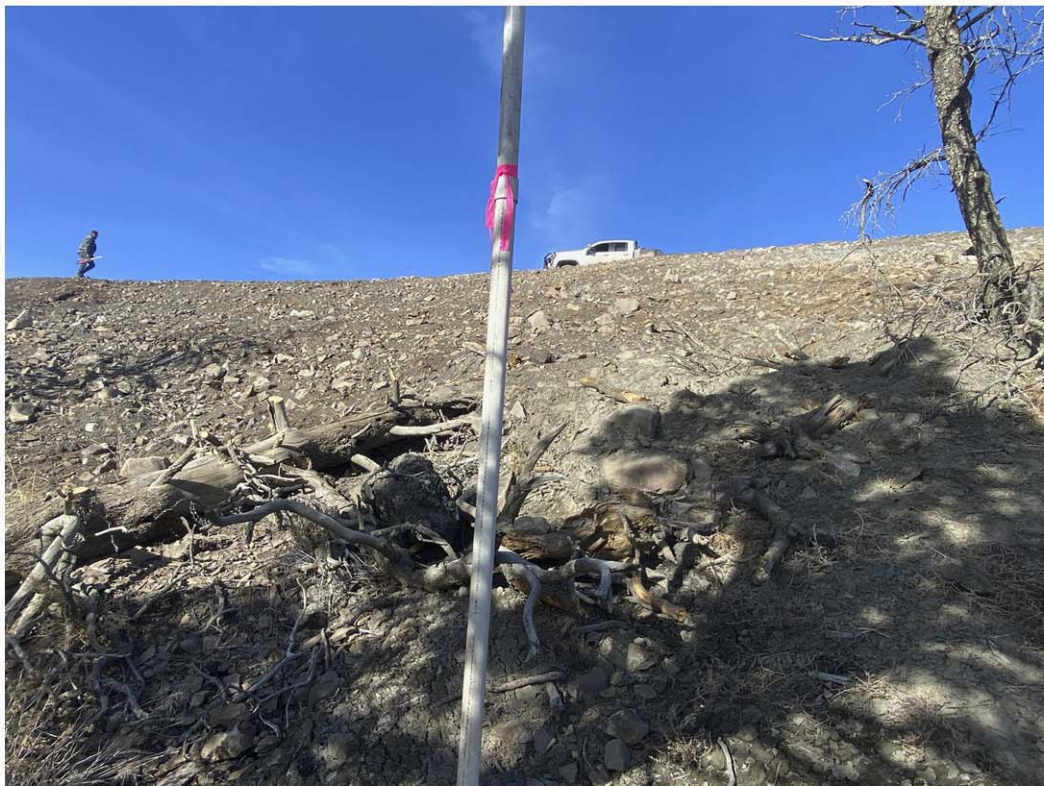
Mid point Corner 6 and 7 - looking north into mine.

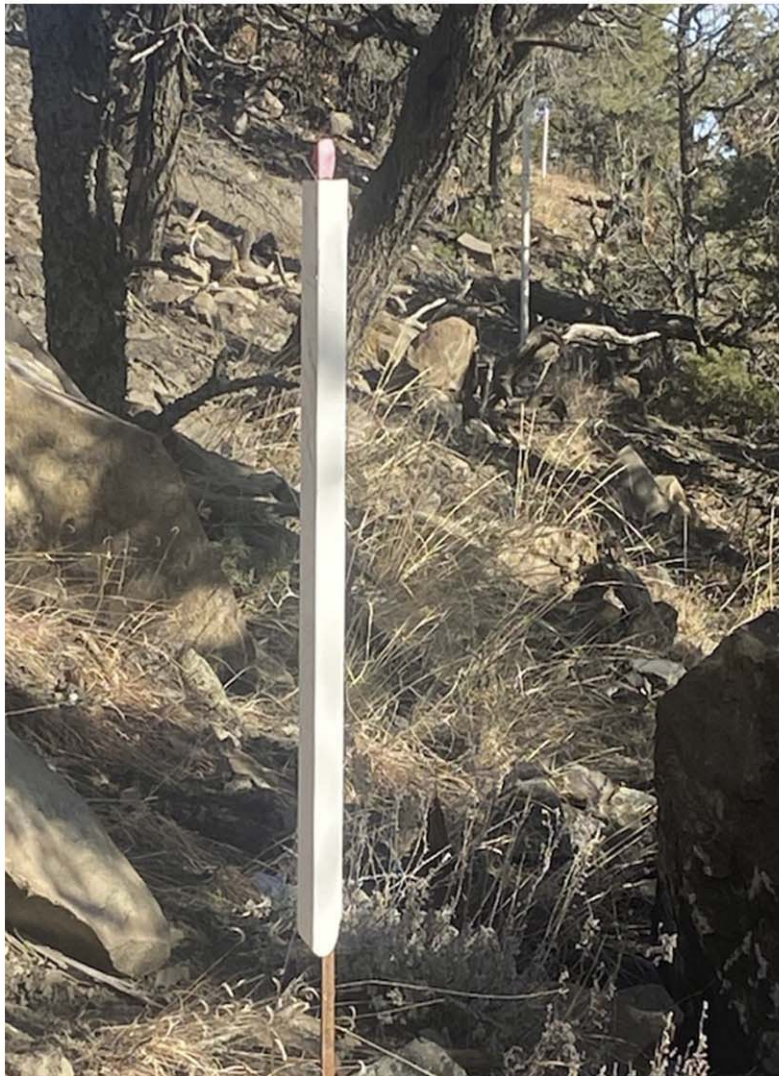
Corner 7 - looking east to Corner 6. note line markers and no disturbance on mine side (left) of line
