MINERALS PROGRAM INSPECTION REPORT

MINE NAME: South Asphalt Plant	MINE/PROSPECTING ID#: M-2009-004	MINERAL: Gravel and sand	COUNTY: El Paso
INSPECTION TYPE: Monitoring	WEATHER: Clear	INSP. DATE: August 29, 2023	INSP. TIME: 13:20
OPERATOR: Rocky Mountain Materials and Asphalt, Inc.	OPERATOR REPRESENTATIVE: Phil Courtney	TYPE OF OPERATION: 110c - Construction Limited Impact

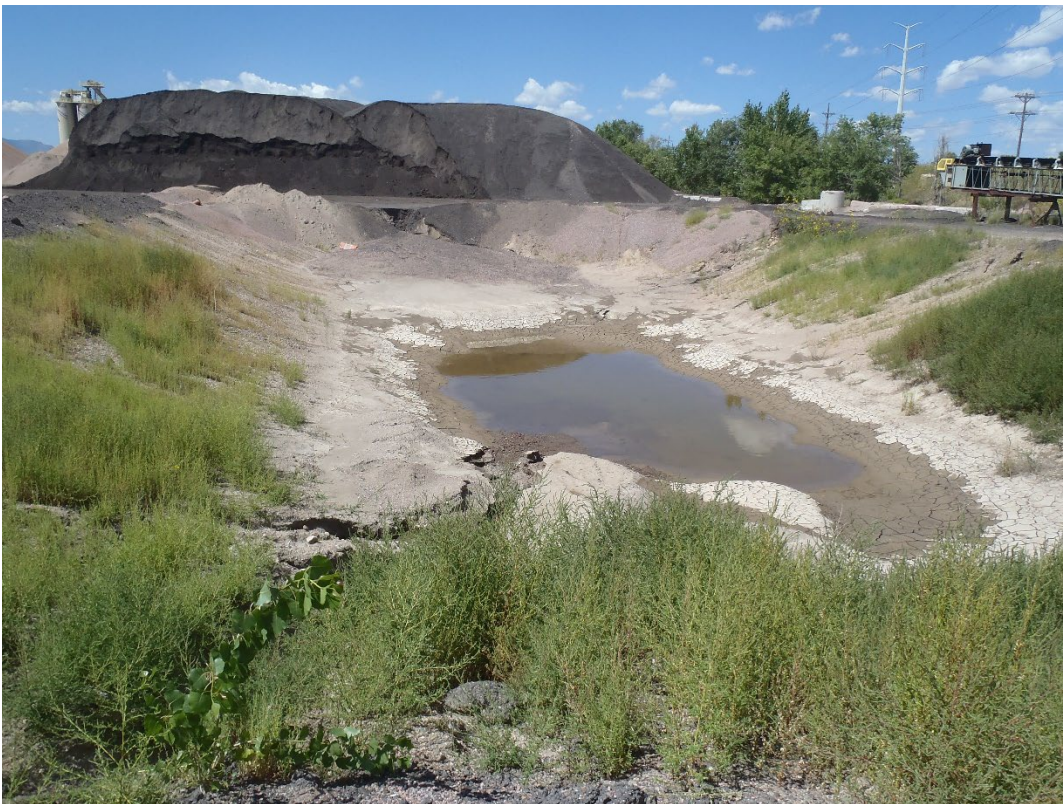
Hydrologic Balance: Some standing water was observed in the sediment pond (see **Photo 1**), but no exposed groundwater was observed.

Photo 1. Sediment pond (east side, midway north-south, looking north).

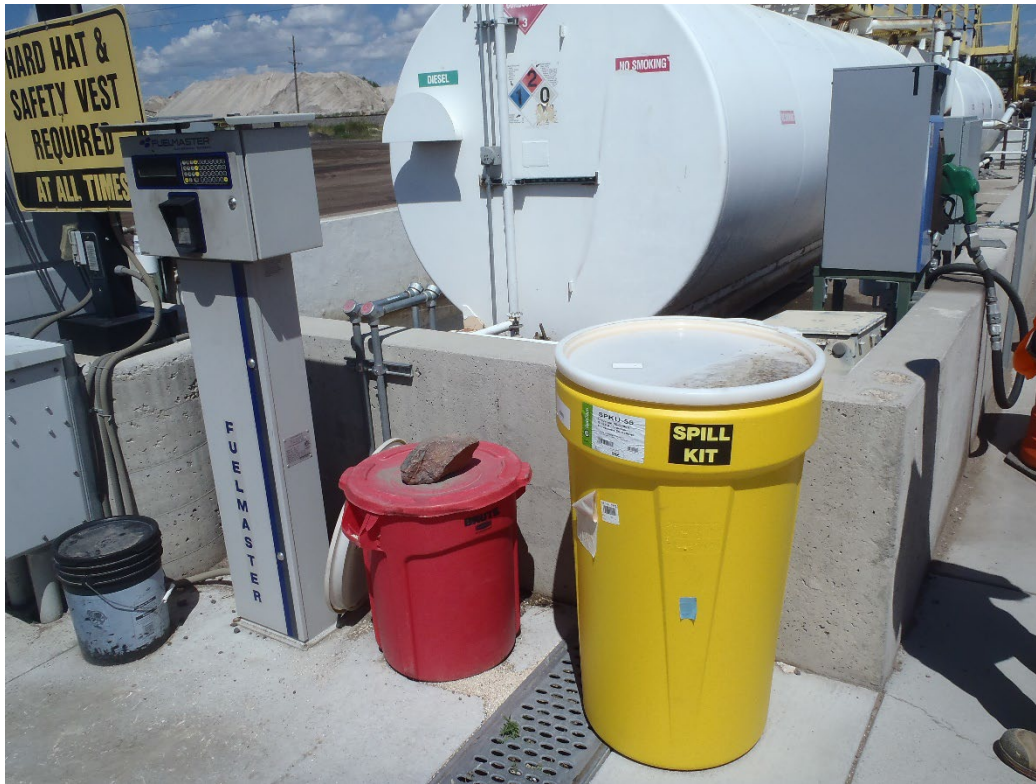
Acid And Toxic Materials: Above ground diesel storage tanks were observed and had adequate secondary containment (see **Photo 2**).

Photo 2. Diesel storage with secondary containment.

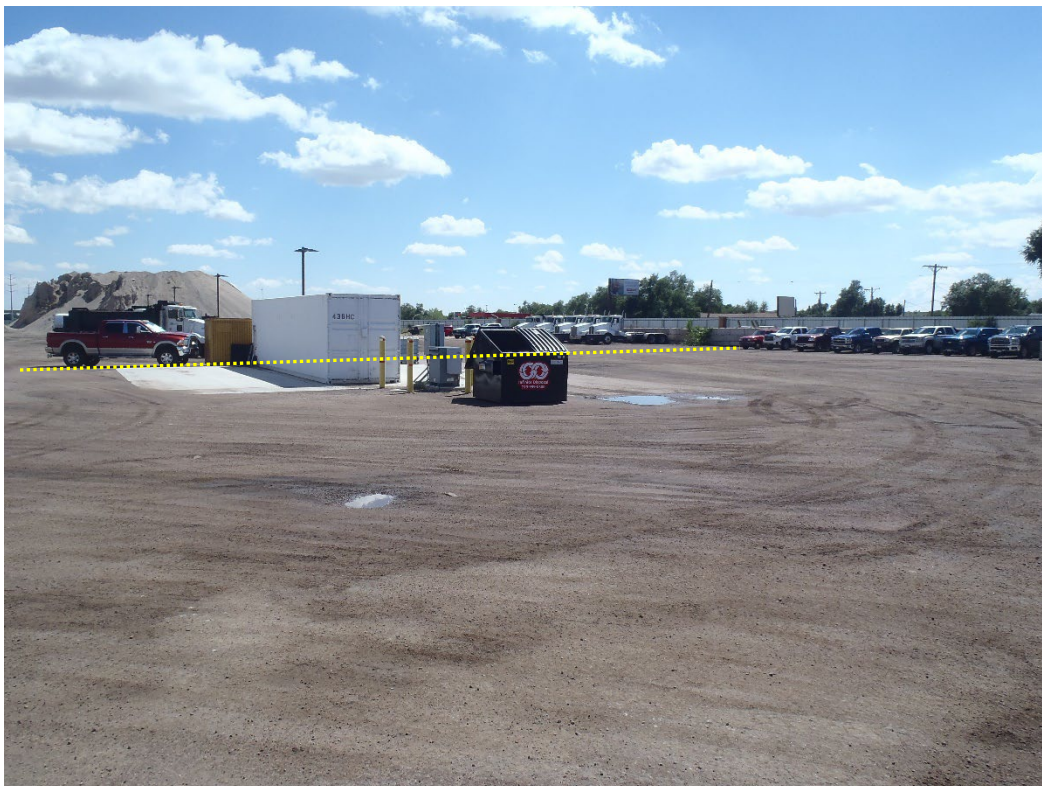
Gen. Compliance with Mine Plan: The site was active with truck traffic consistent with an industrial area operating a batch plant, which is outside the permit boundary, on the north end of the site. No activity was observed nor to have appeared to occur recently indicating native material extraction was being performed. The maximum allowed disturbed area is 9.9 acres. The permit boundary is offset from the property boundaries on the east and west side by a distance varying between 50 and 90 feet. The operator has been unable to mark the permit boundary with any kind of lasting marker as semi-truck traffic is nearly constant and the defined internal access roads and imported material stockpiles occur inside and outside the permit boundary. As such, it is not practical, nor in this case relevant to use GPS equipment or Google Earth to measure the disturbed area – it's all industrial (see **Photos 3 and 4**). No highwalls were observed, nor any mining activity inside or outside the permit boundary.

Photo 3. Typical industrial site conditions (south permit area, looking south, line is approximate boundary).

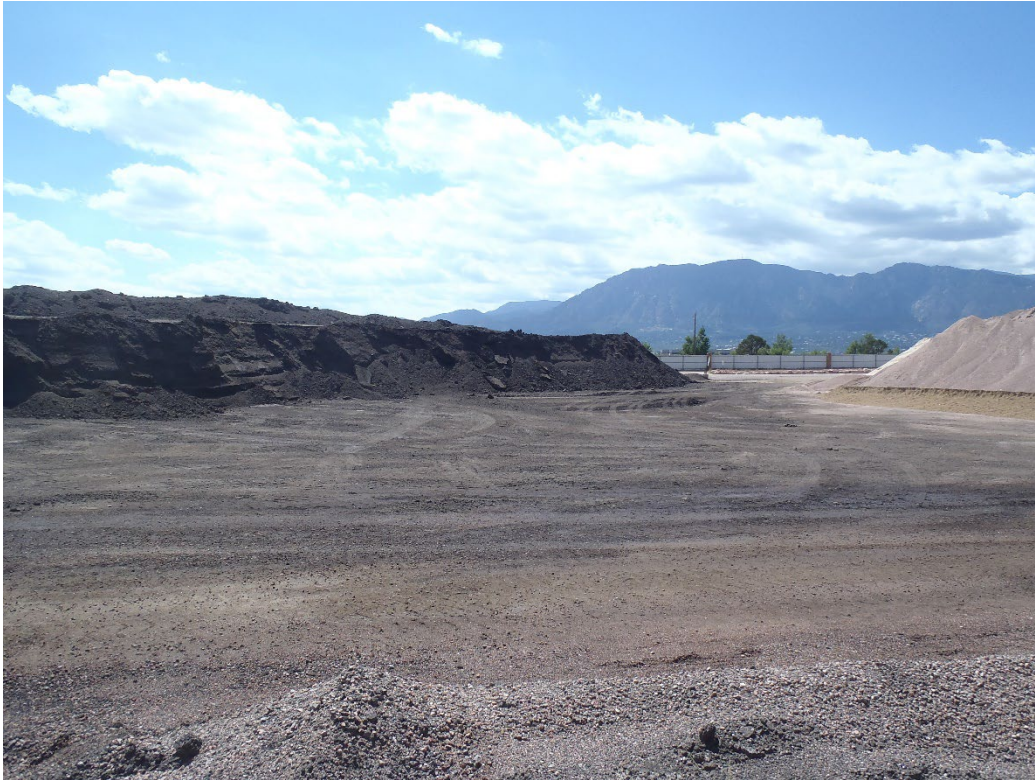
Photo 4. Recycled Asphalt and imported aggregate stockpiles (looking SW across site, midway North-South).

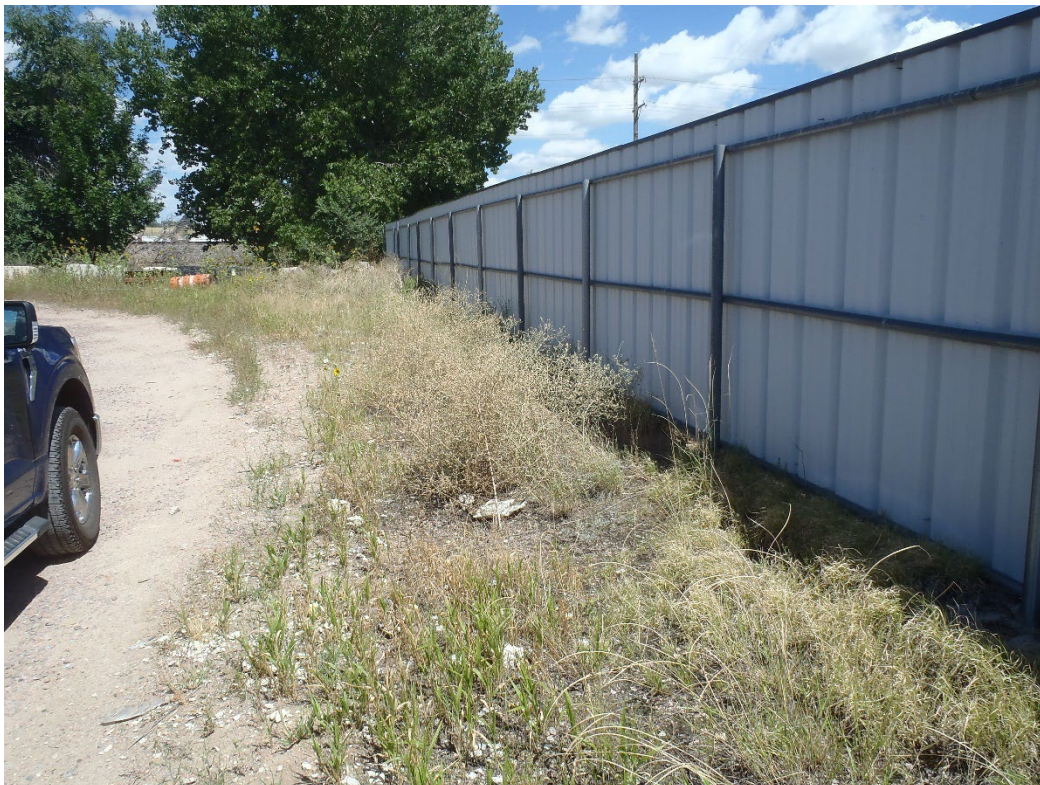
Revegetation: Some knapweed was observed in the southern end of the property (see **Photo 5**), but not within the permit boundary. The Permittee should monitor and/or treat the knapweed to ensure it does not establish itself within the permit boundary.

Photo 5. Knapweed on south end of property (NOT in permit boundary and NOT cited).

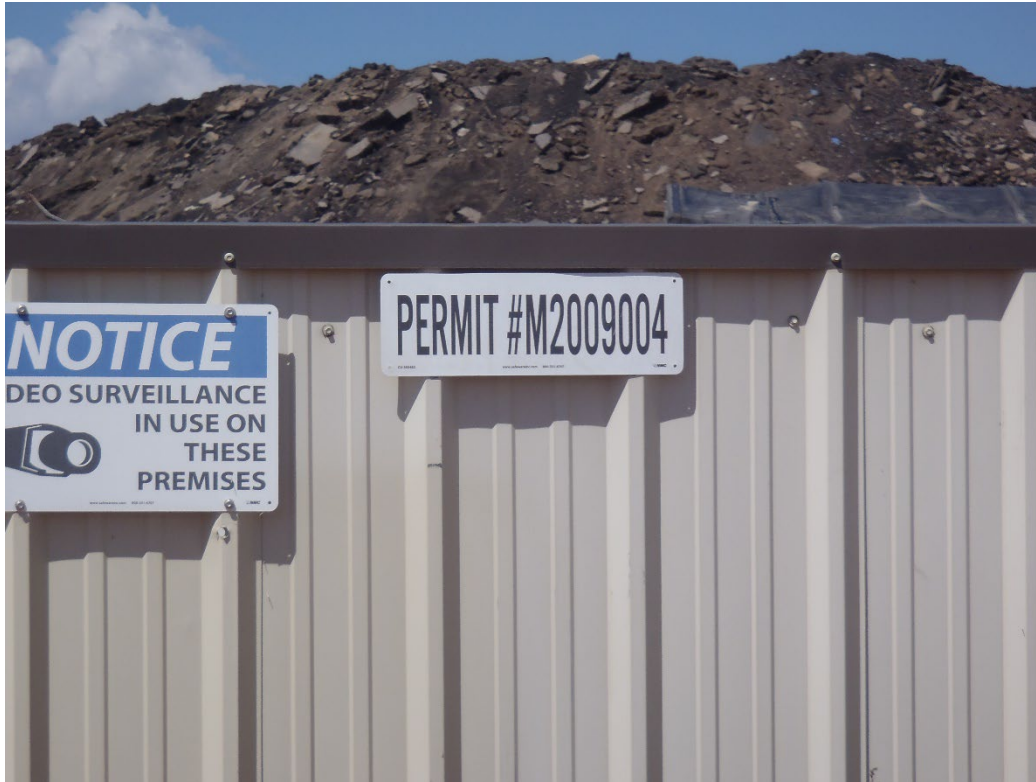
Signs and Markers: A sign displaying the permit number was posted (see **Photo 6**) was observed at the site entrance off Hwy 85/E. Las Vegas St. The sign was missing the name of the Operator, the operation name; and a statement that a reclamation permit for the operation has been issued by the Colorado Mined Land Reclamation Board. Mr. Courtney requested I provide him with the sign standards and information that is required to be included; and committed to getting a new sign placed. The requested information was emailed to him on August 30, 2023. As stated above, no durable boundary markers have been devised to delineate the permit boundary.

Photo 6. Permit sign – needs updating.

- Mr. Courtney requested permit sign requirements. The following requirements for Rule 3.1.12(1) were provided via email on 8/30/2023:
 - *At the entrance of the mine site the Operator shall post a sign, which shall be clearly visible from*

the access road, with a minimum size equaling one hundred and eighty-seven (187) square inches, such as eleven (11) inches in height and seventeen (17) inches in width, with appropriate font size, with the following:

- a) the name of the Operator and the operation name;*
- b) a statement that a reclamation permit for the operation has been issued by the Colorado Mined Land Reclamation Board; and*
- c) the permit number.*
