**Re: Permit No. M-1980-244; Cripple Creek & Victor Gold Mining Company; Cresson Project;**  
**Technical Revision 140 – Third Adequacy Review Response**

On February 6, 2024, Newmont Corporation's Cripple Creek and Victor Gold Mining Company (CC&V) received the Division of Reclamation, Mining and Safety (DRMS) Third Adequacy Review of Technical Revision (TR) 140 to Permit M-1980-244, regarding the VLF2, Phase 3 Stage A.2 Record of Construction Report. Below are DRMS comments in bold and CC&V's responses in *italics*.

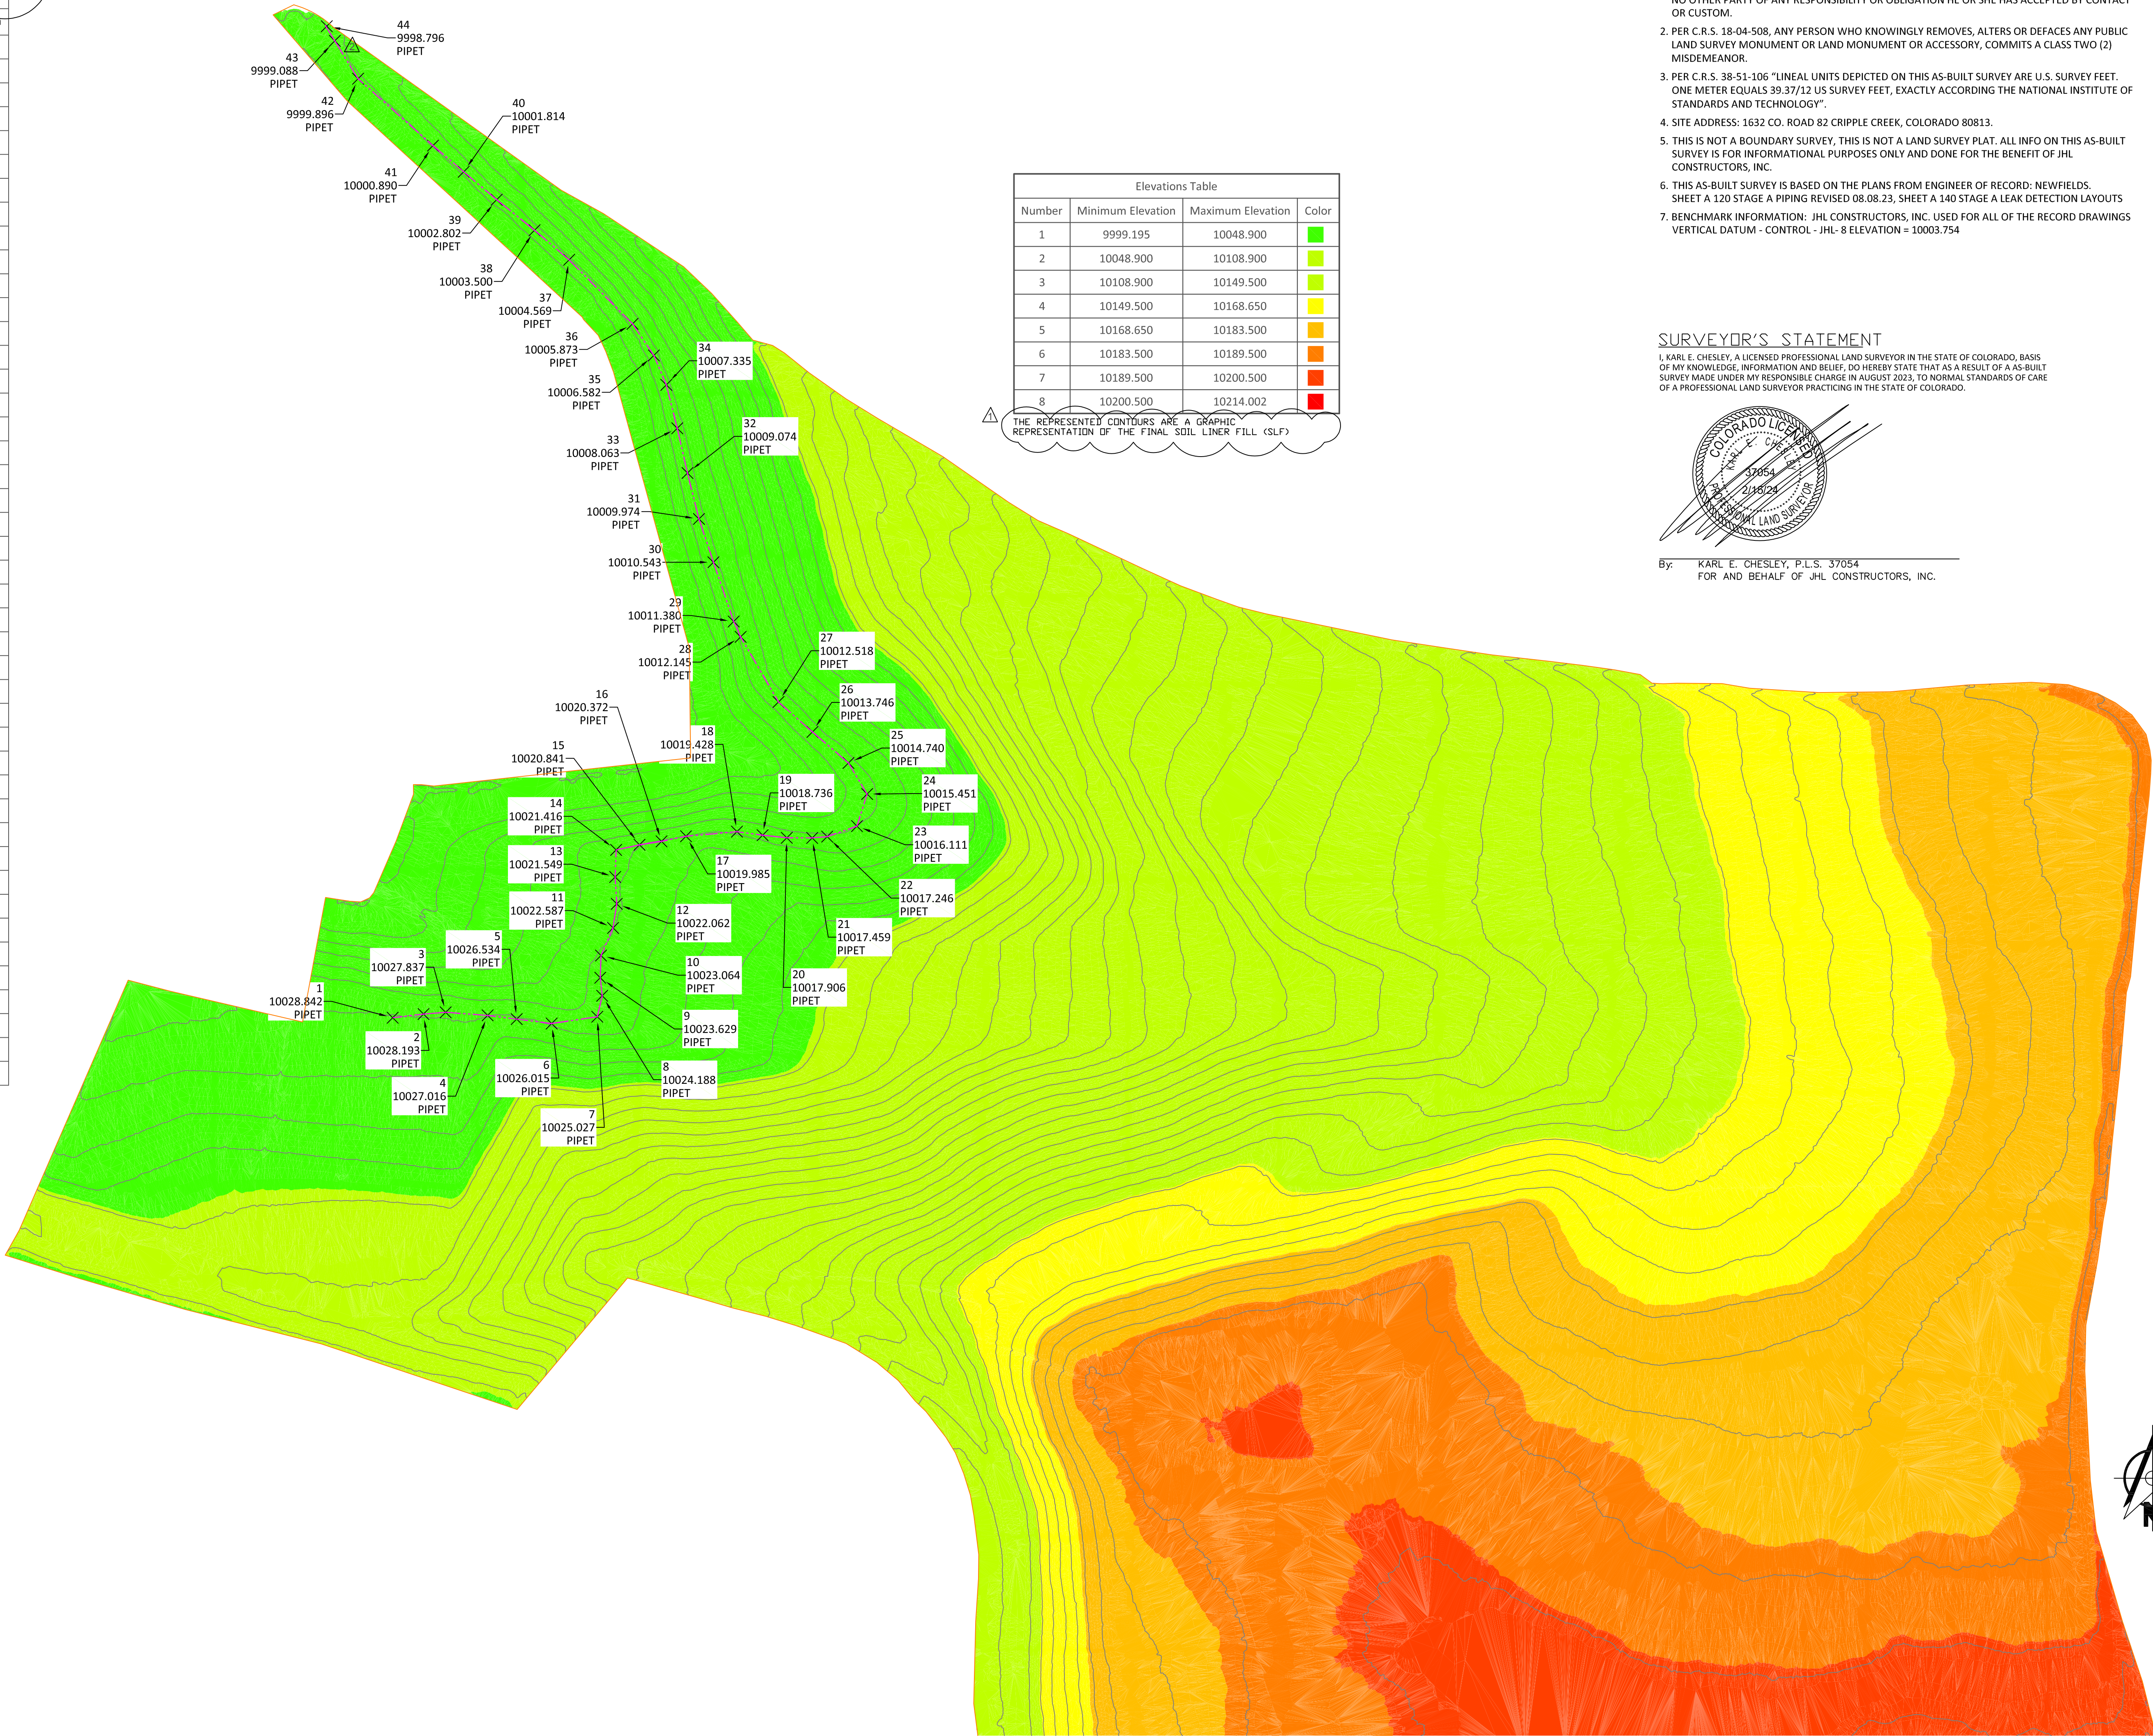
Leak Detection Trench 1  
As-Built

**Please see the three examples in Attachment A depicting the unsupported horizontal bends presented in the Leak Detection Trench As-Built drawings. Based on the information received to date there is either additional survey data that has not been reported but supports the existence of the additional horizontal bends in the Record Drawings; or the Record Drawings do not reflect the as-constructed conditions of the Leak Detection System (LDS) piping. Please explain the discrepancy and make the appropriate changes (either submit additional survey data and/or revise the record drawings) and resubmit to the Division.**

*The original drawing was generated to provide a plan view layout and was not intended to display elevation information on all the bends at frequencies shorter than 100 feet. The revised drawings are enclosed as Attachment 1 & 2.*

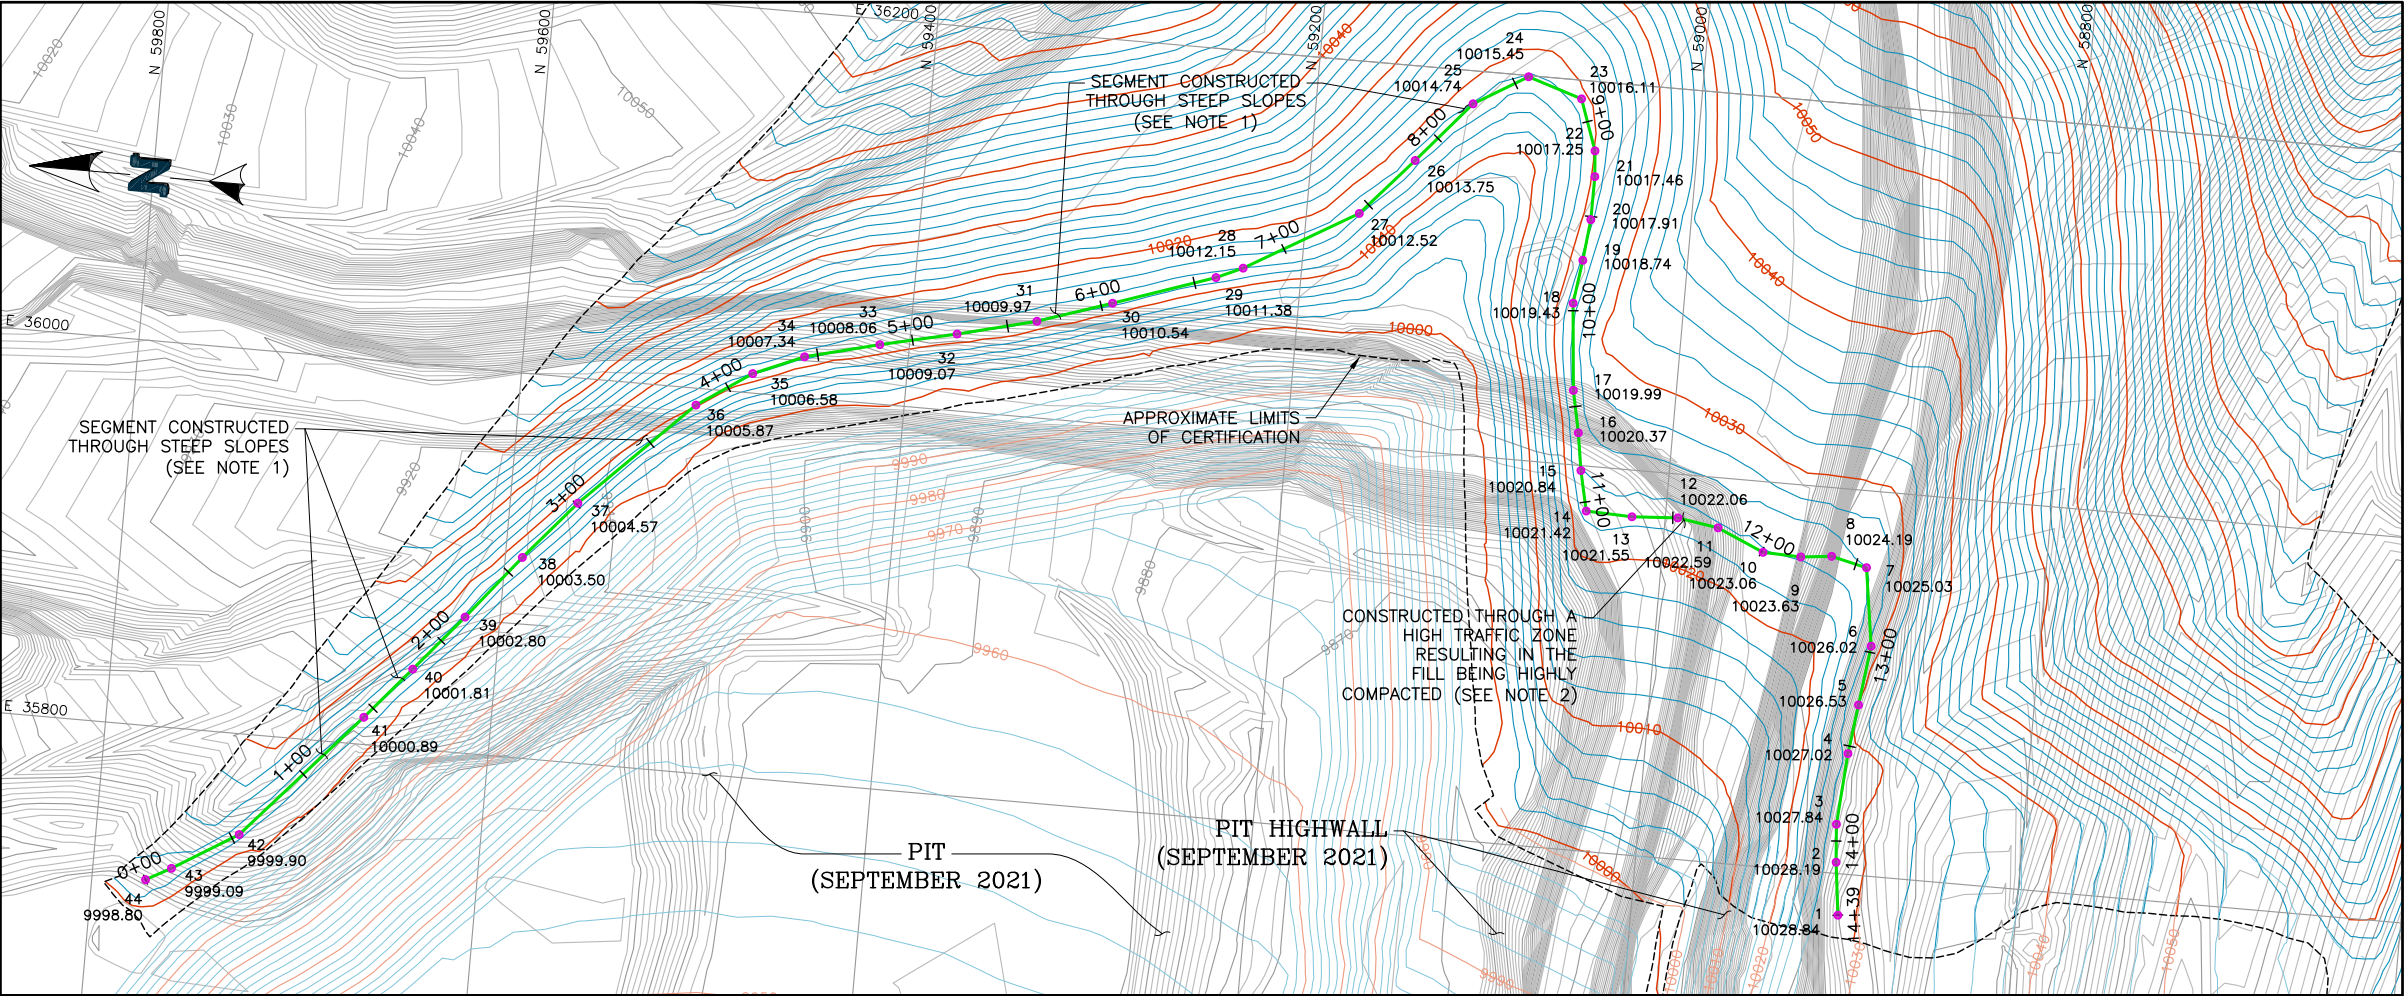
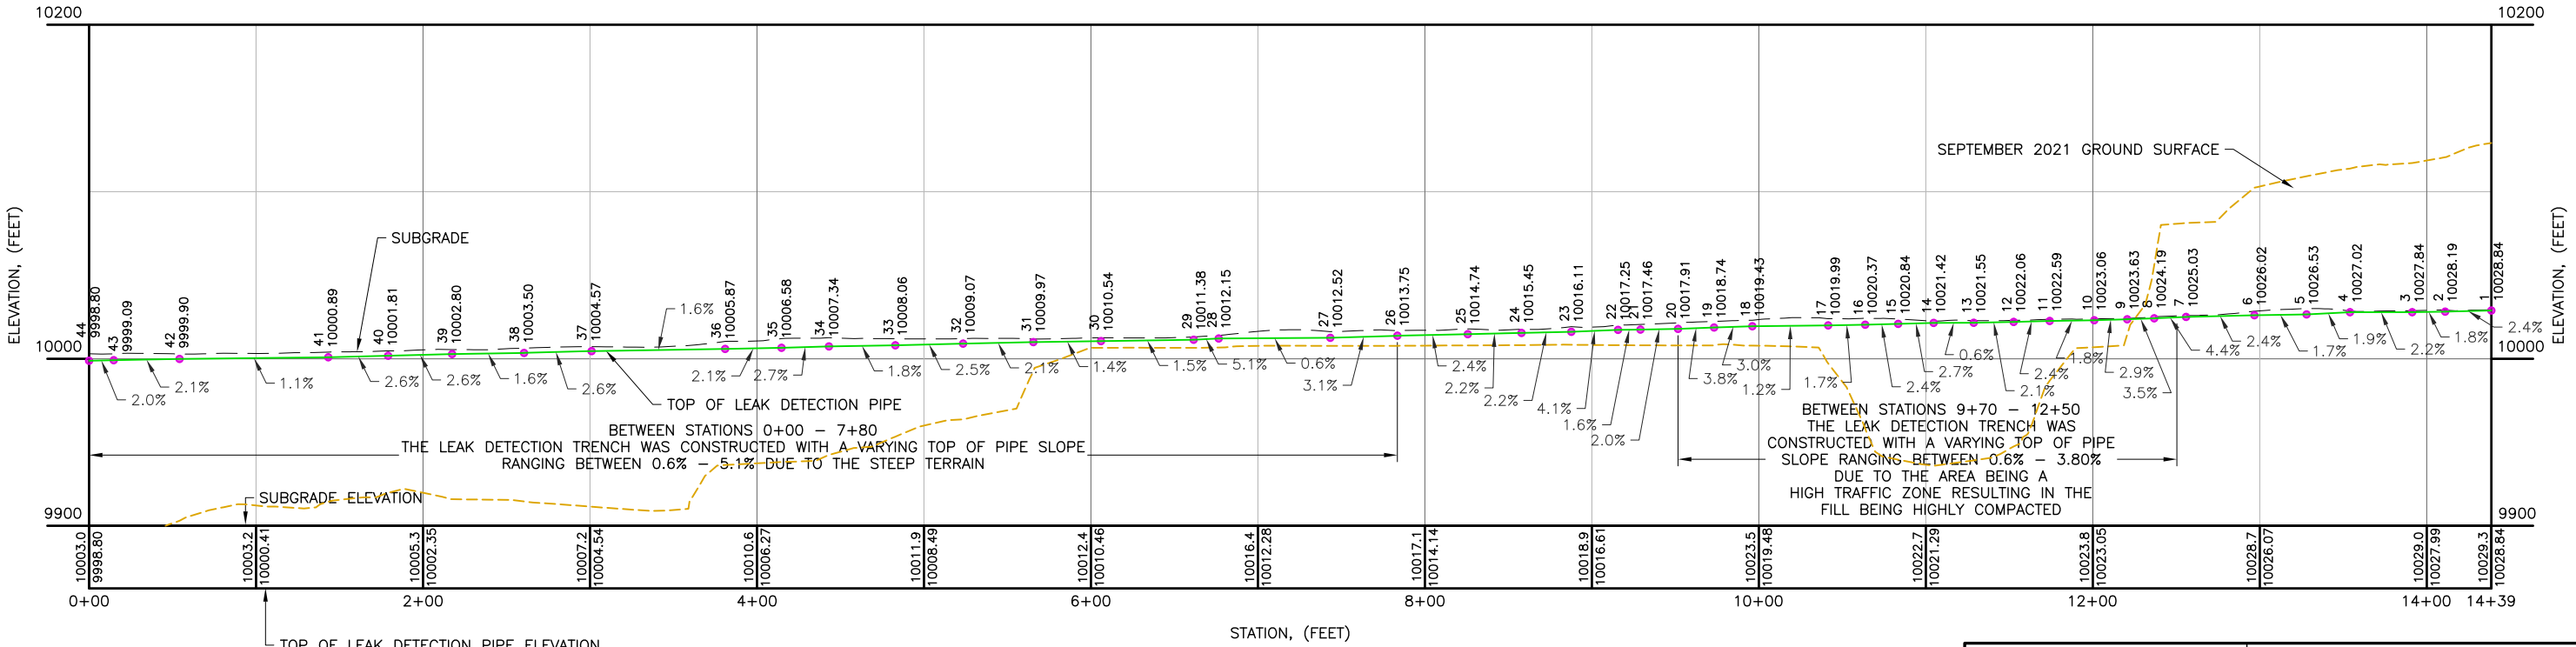
<b>NewFields</b>		CLIENT <b>CRIPPLE CREEK &amp; VICTOR GOLD MINING COMPANY</b>	
PROJECT		<b>VLF3 PHASE 3 STAGE A.2</b>	
TITLE <b>LEAK DETECTION TRENCH 1 AS-BUILT PLAN AND PROFILE</b>		FILENAME 0106.060.064F	REVISION
		FIGURE NO. <b>5</b>	<b>4</b>

- Slope indicators must be shown in the Profile Views on Figures 5 and 6.
- Beginning and ending stations where the 2% minimum slope was not adhered to, must be identified in the Profile View on Figures 5 and 6.
- The rationale for these segments of the Leak Detection System needing not meet approved drawings and specifications must clearly be directed at these specific segments either by a note with a leader specifying the beginning and ending stations or a note in the Profile View over the specific segments explaining why the approved grades were not met.

- SEGMENT CONSTRUCTED THROUGH STEEP SLOPES MAKING CONSTRUCTION AT EXACT SLOPE PROHIBITIVELY DIFFICULT.
- SEGMENT CONSTRUCTED THROUGH A HIGH TRAFFIC AREA (AUGUST 2021 - JUNE 2023) RESULTING IN A HIGHLY COMPACTED FILL. GIVEN THE LEVEL OF COMPACTION THIS AREA RECEIVED AS A RESULT OF THIS TRAFFIC, SETTLEMENT IS UNLIKELY.
- OVERALL SLOPE OF LOWER LEAK DETECTION TRENCH IS 2.1%.

*Enclosed as Attachments 3-5, Figures 5, 6a and 6b have been revised to include the location of the survey points, slopes, and an explanation for the reason why the minimum slope of less than 2% was allowed with the corresponding stationing in the profile view as requested.*

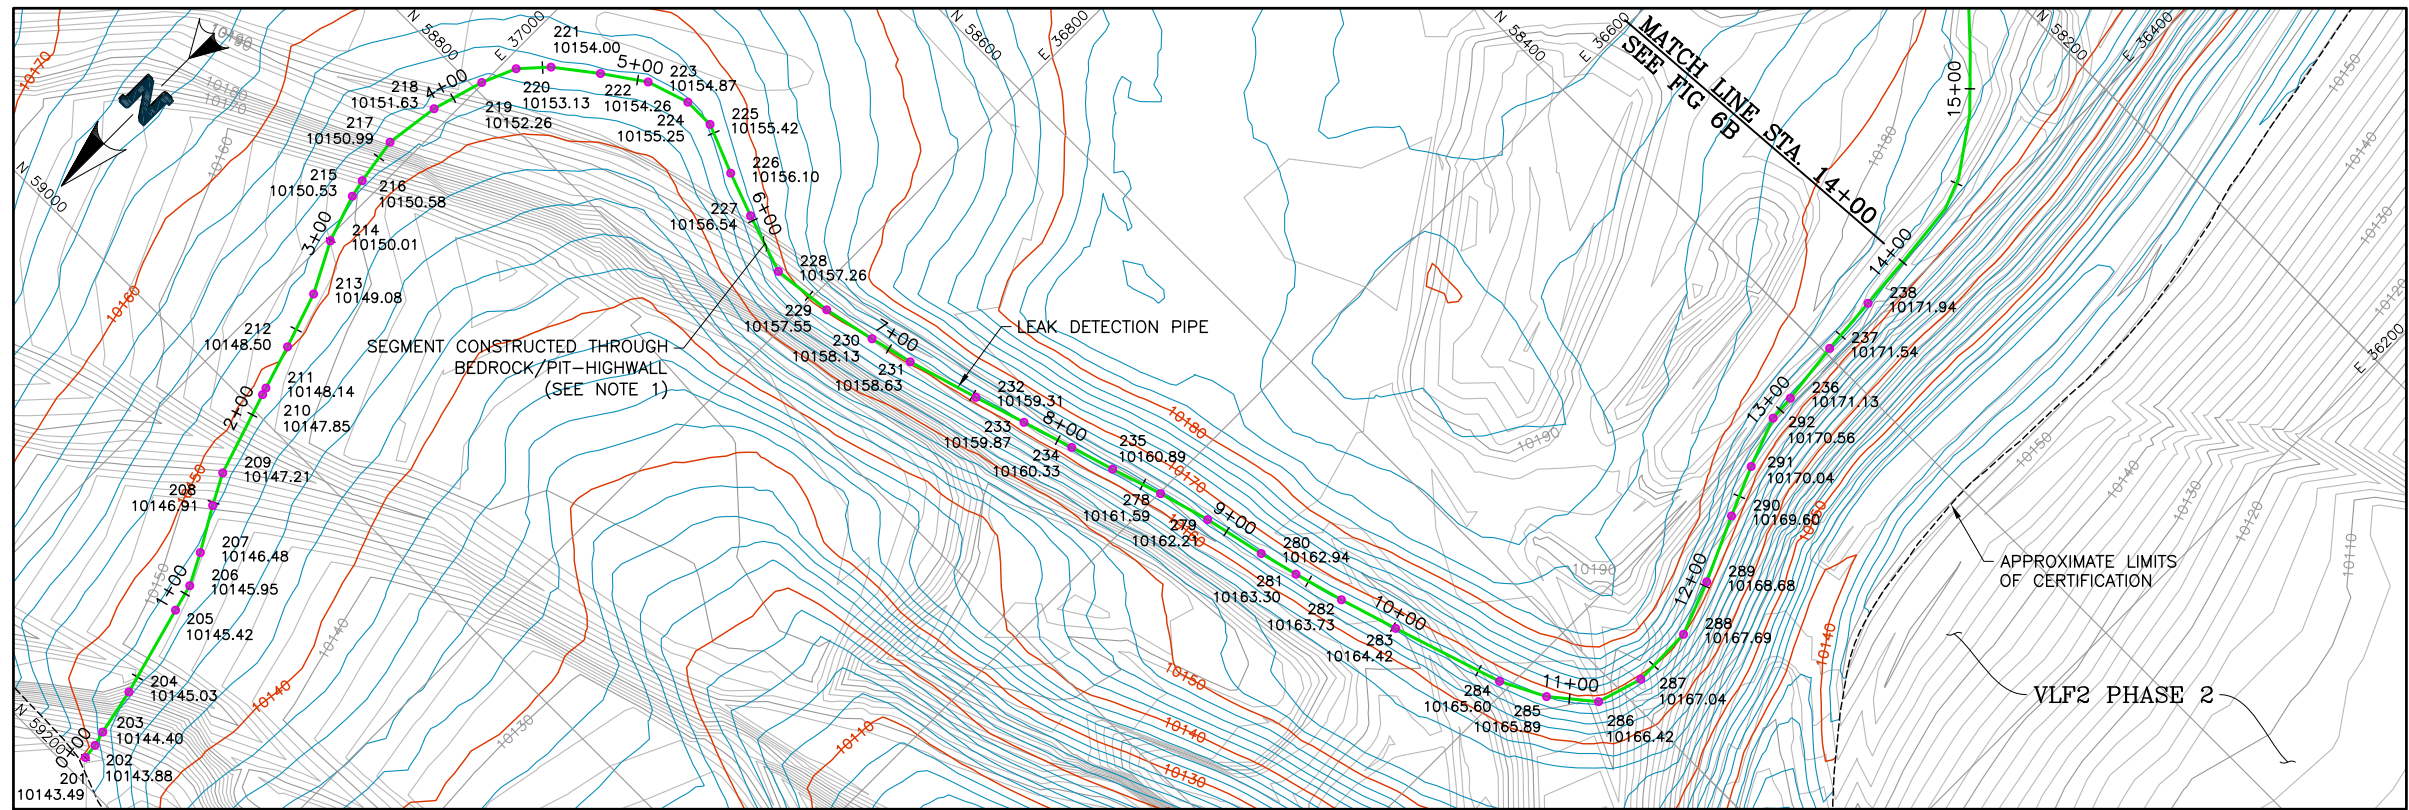
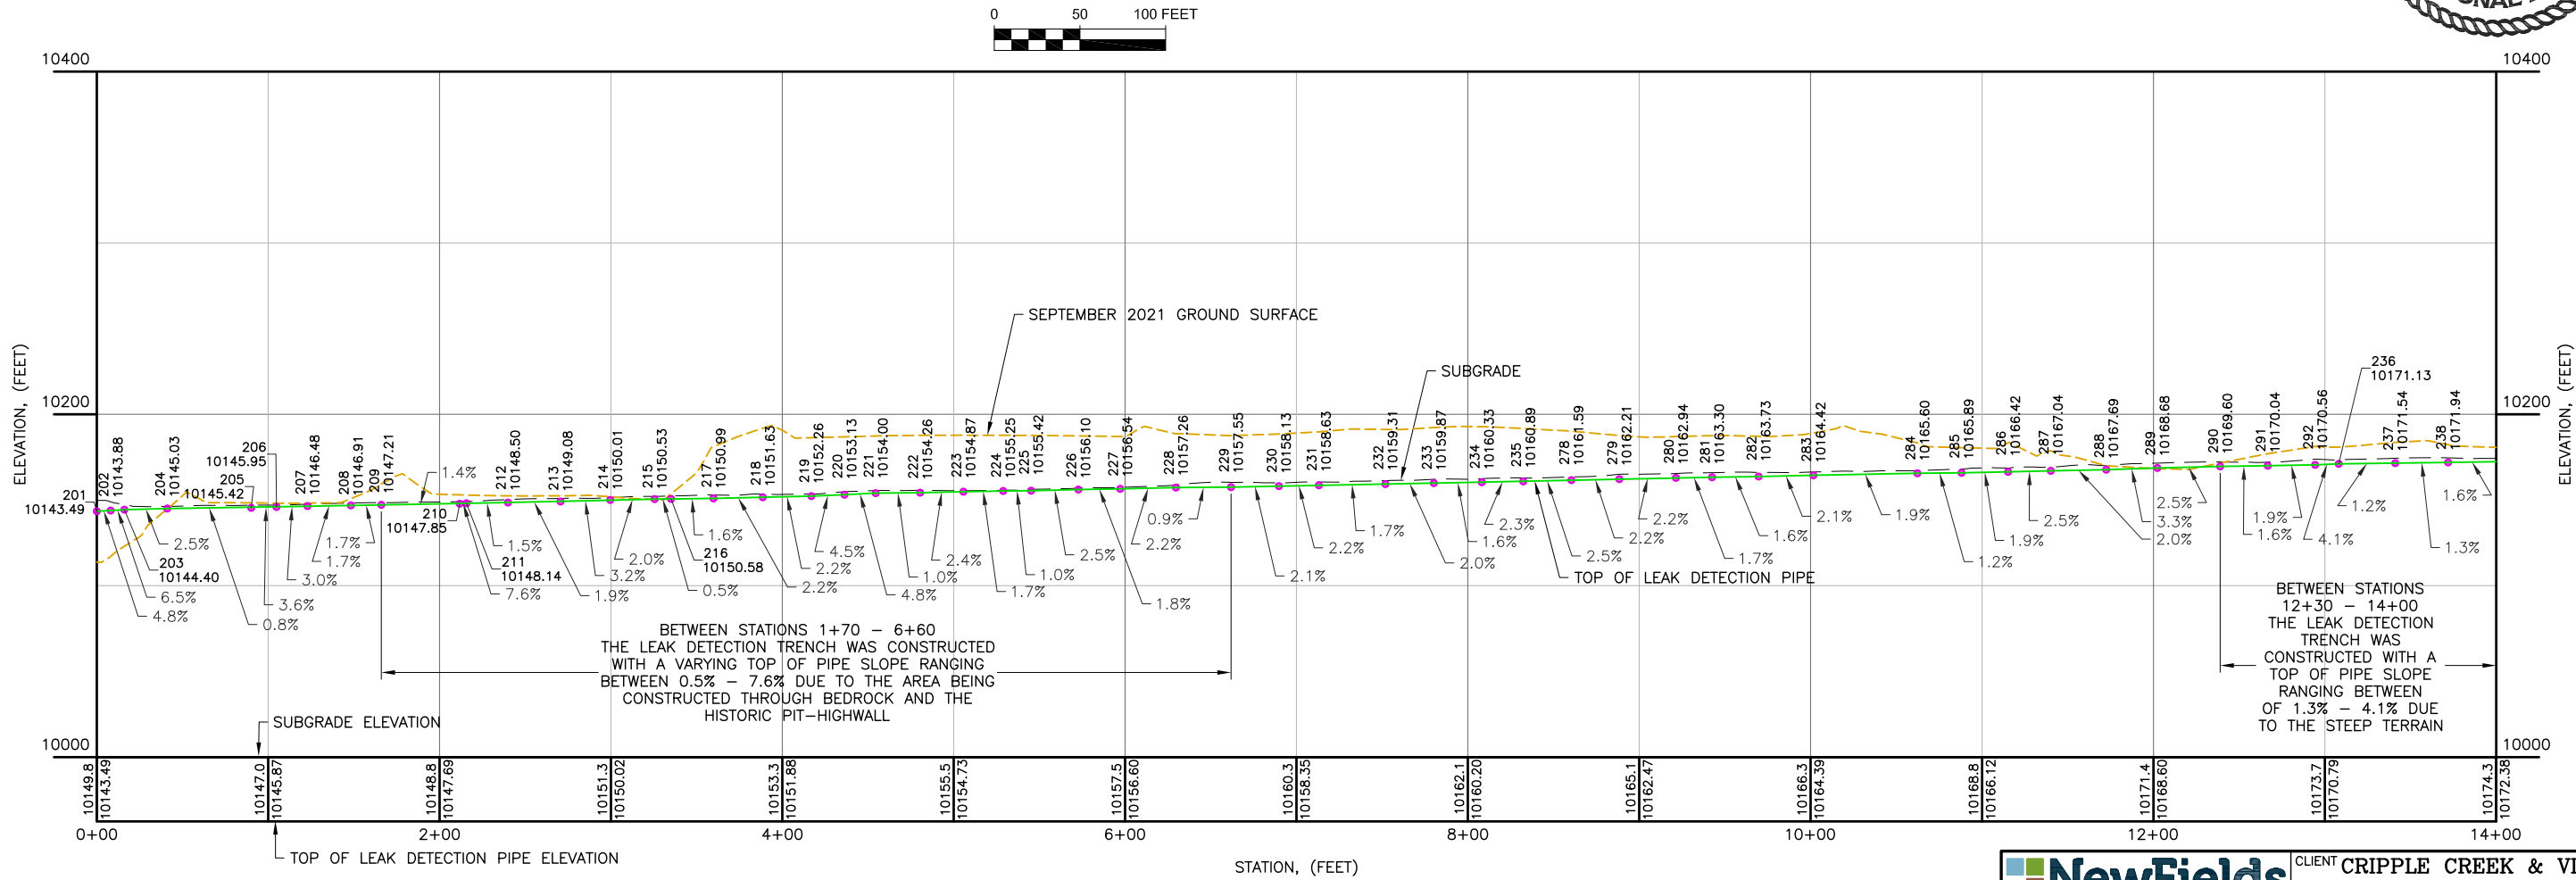
<b>NewFields</b>		CLIENT <b>CRIPPLE CREEK &amp; VICTOR GOLD MINING COMPANY</b>	
PROJECT		<b>VLF3 PHASE 3 STAGE A.2</b>	
TITLE	<b>LEAK DETECTION TRENCH 2 AS-BUILT PLAN AND PROFILE (1 OF 2)</b>	FILENAME 0106.060.064F	
		FIGURE NO. <b>6A</b>	REVISION <b>2</b>

- SEGMENT CONSTRUCTED THROUGH BEDROCK/PIT-HIGHWALL. METHODS NECESSARY FOR FURTHER EXCAVATION, SUCH AS BLASTING, WOULD BE LESS PRECISE AND ULTIMATELY DETRIMENTAL TO THE PROJECT. SETTLEMENT IN THESE AREAS IS UNLIKELY.
- SEGMENT CONSTRUCTED THROUGH IN-SITU FILL PLACED BEFORE 2012. SETTLEMENT IN THESE AREAS IS UNLIKELY.
- OVERALL SLOPE OF UPPER LEAK DETECTION TRENCH IS 2.0%.

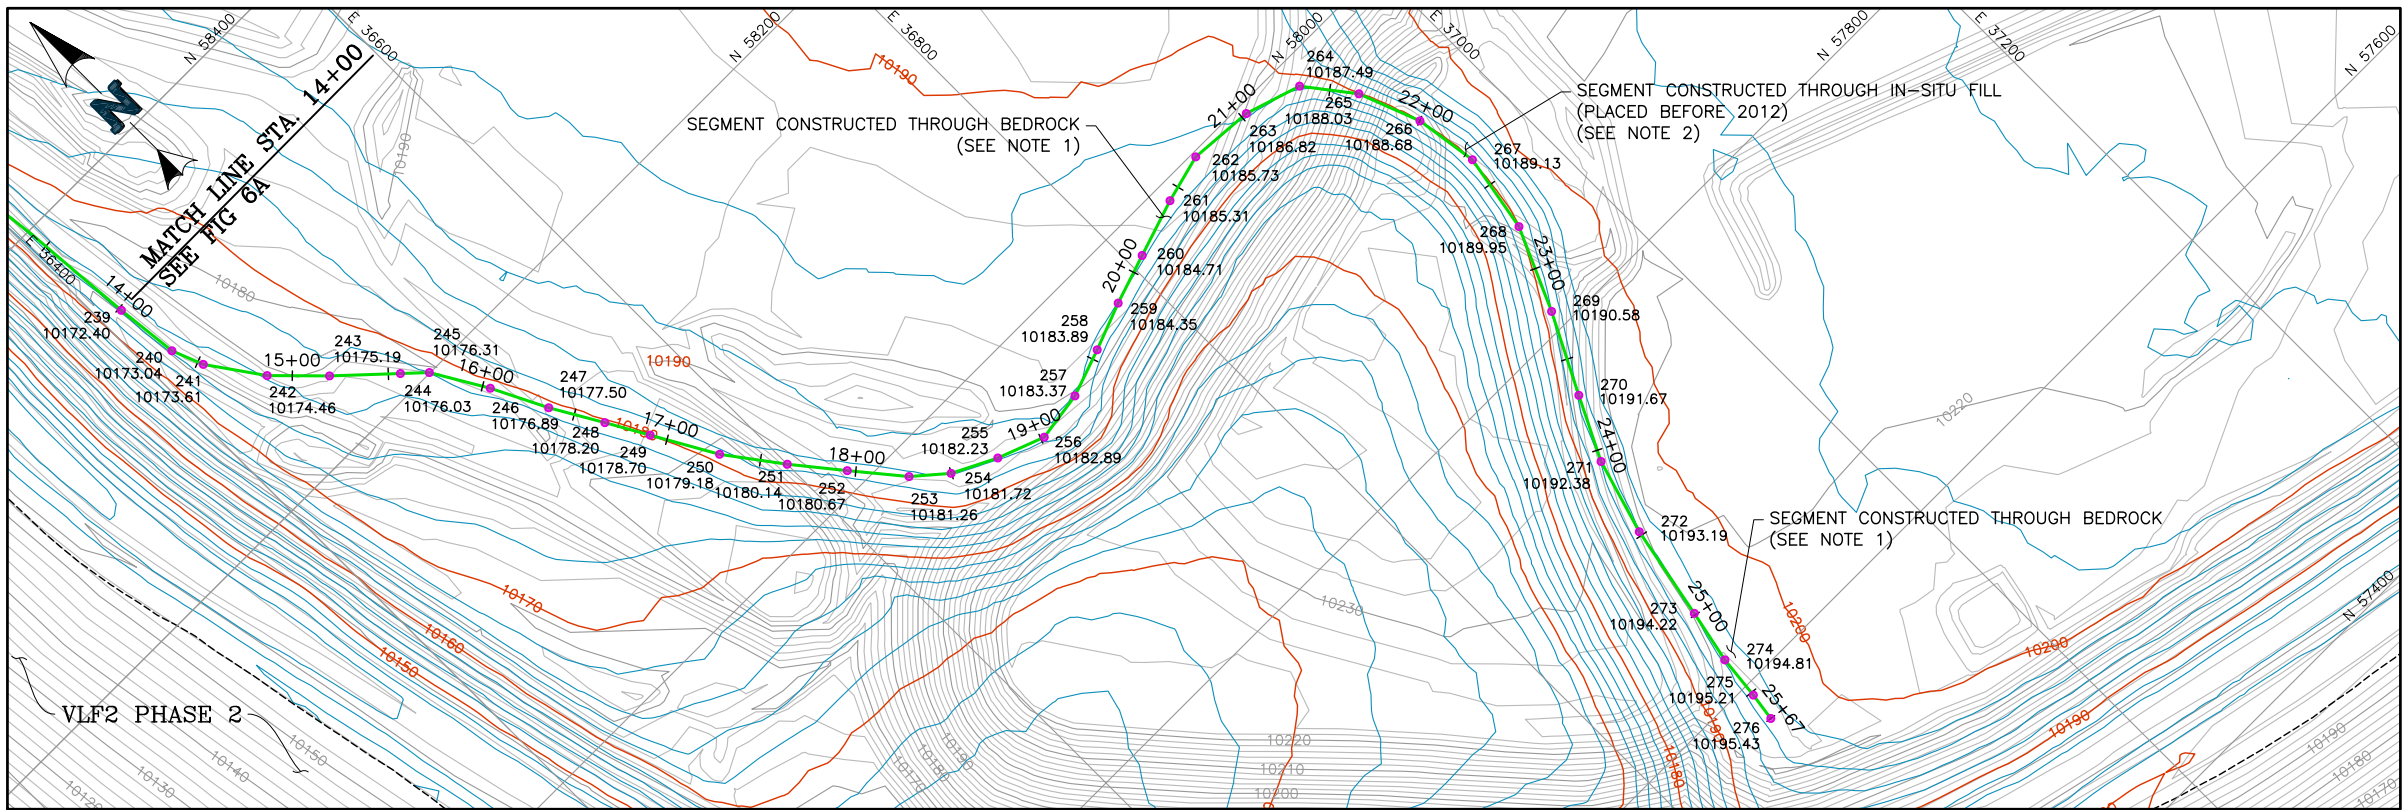
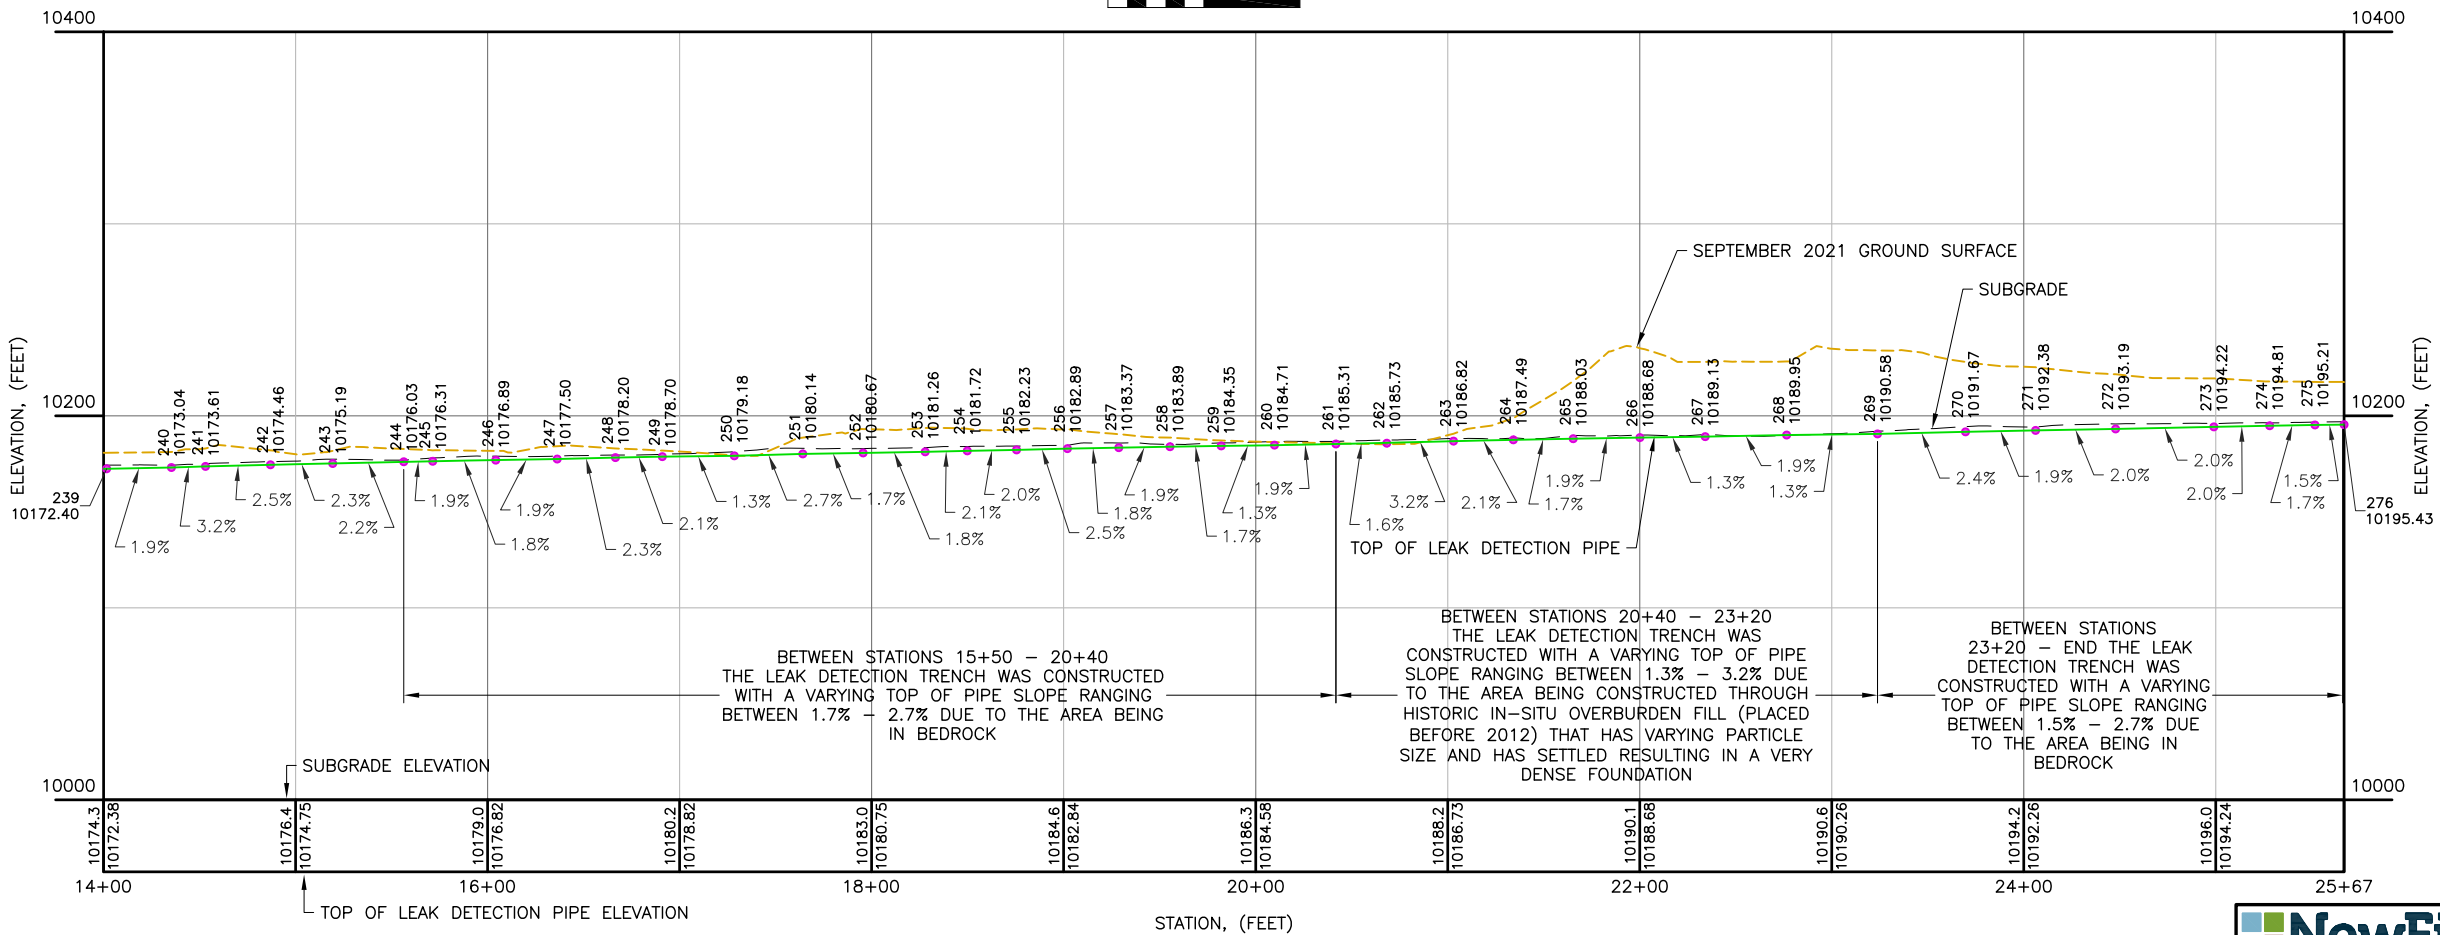
<b>NewFields</b>	CLIENT <b>CRIPPLE CREEK &amp; VICTOR GOLD MINING COMPANY</b>		
	PROJECT <b>VLF3 PHASE 3 STAGE A.2</b>		
TITLE	<b>LEAK DETECTION TRENCH 2 AS-BUILT PLAN AND PROFILE (2 OF 2)</b>		FILENAME
			0106.060.064F
	FIGURE NO.	REVISION	
	<b>6B</b>	<b>2</b>

- SEGMENT CONSTRUCTED THROUGH BEDROCK/PIT-HIGHWALL. METHODS NECESSARY FOR FURTHER EXCAVATION, SUCH AS BLASTING, WOULD BE LESS PRECISE AND ULTIMATELY DETRIMENTAL TO THE PROJECT. SETTLEMENT IN THESE AREAS IS UNLIKELY.
- SEGMENT CONSTRUCTED THROUGH IN-SITU FILL PLACED BEFORE 2012. SETTLEMENT IN THESE AREAS IS UNLIKELY.
- OVERALL SLOPE OF UPPER LEAK DETECTION TRENCH IS 2.0%.
