MINERALS PROGRAM INSPECTION REPORT
PHONE: (303) 866-3567

MINE NAME: Nelson Pit	MINE/PROSPECTING ID#: M-2020-040	MINERAL: Sand and gravel	COUNTY: Washington
INSPECTION TYPE: Monitoring	WEATHER: Clear	INSP. DATE: January 31, 2024	INSP. TIME: 08:00
OPERATOR: Washington County	OPERATOR REPRESENTATIVE: Steve Williams	TYPE OF OPERATION: 112c - Construction Regular Operation	
REASON FOR INSPECTION: Normal I&E Program	BOND CALCULATION TYPE: None	BOND AMOUNT: \$0.00	
DATE OF COMPLAINT: NA	POST INSP. CONTACTS: None	JOINT INSP. AGENCY: None	
INSPECTOR(S): Brock Bowles	INSPECTOR'S SIGNATURE:

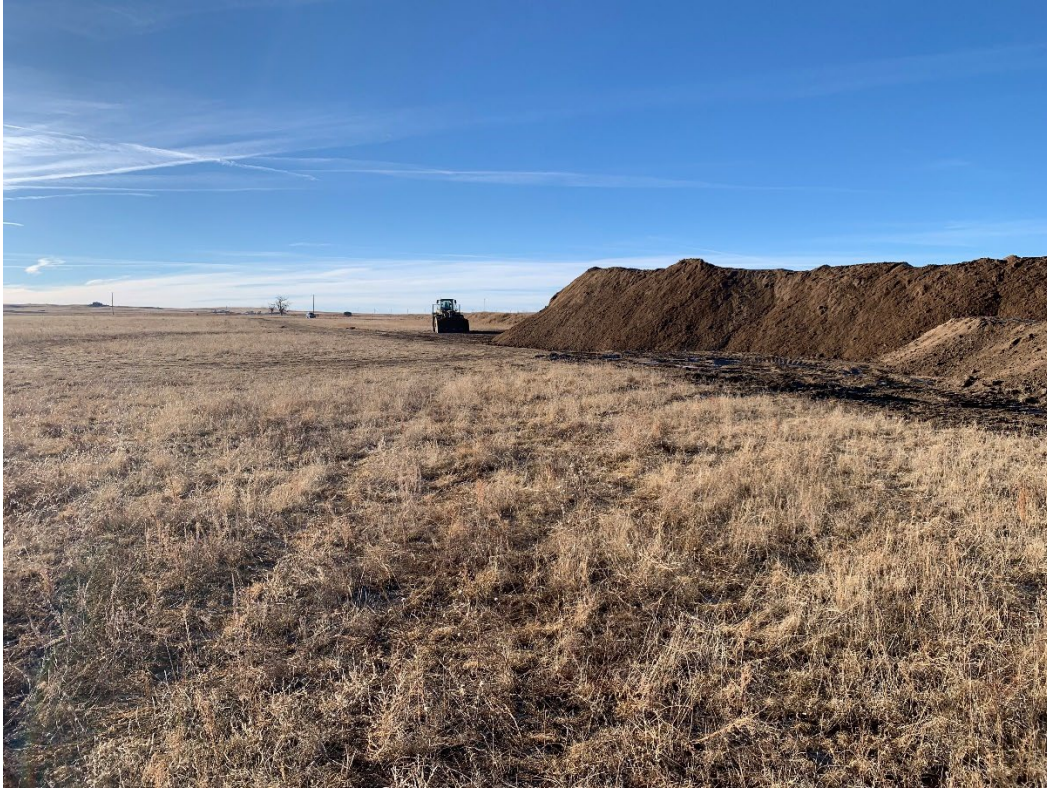
The Nelson Pit is located 9 miles south of Last Chance. The site is a 112c operation permitted for 52.7 acres and the post-mining land use is rangeland. A bulldozer was pushing material into piles while a front-end loader was loading dump trucks (photo 1).

Photo 1 – Front-end loader at dump truck loading area

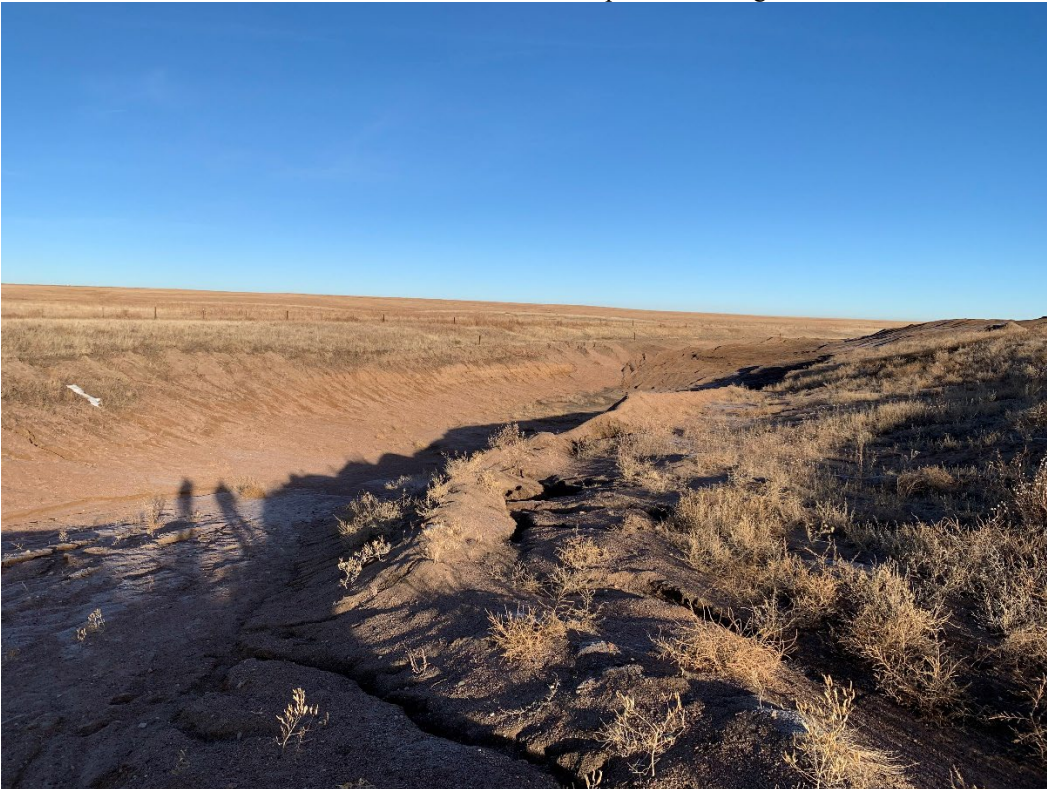
The bottom of the drainage was dug a little deep and had the potential to impound water if water were to flow (photo 2). No water was flowing, and no water had been impounded. Mr. Williams agreed to re-establish the creek bed by replacing salvaged overburden in this area to ensure water can freely pass through the mining area. He will submit pictures within 1 week to verify the channel has been re-established. Photos verifying the creek bottom has been re-established were submitted on Feb 8, 2024 (photo 3).

Photo 2 – Low spot in drainage that needs to be filled in.

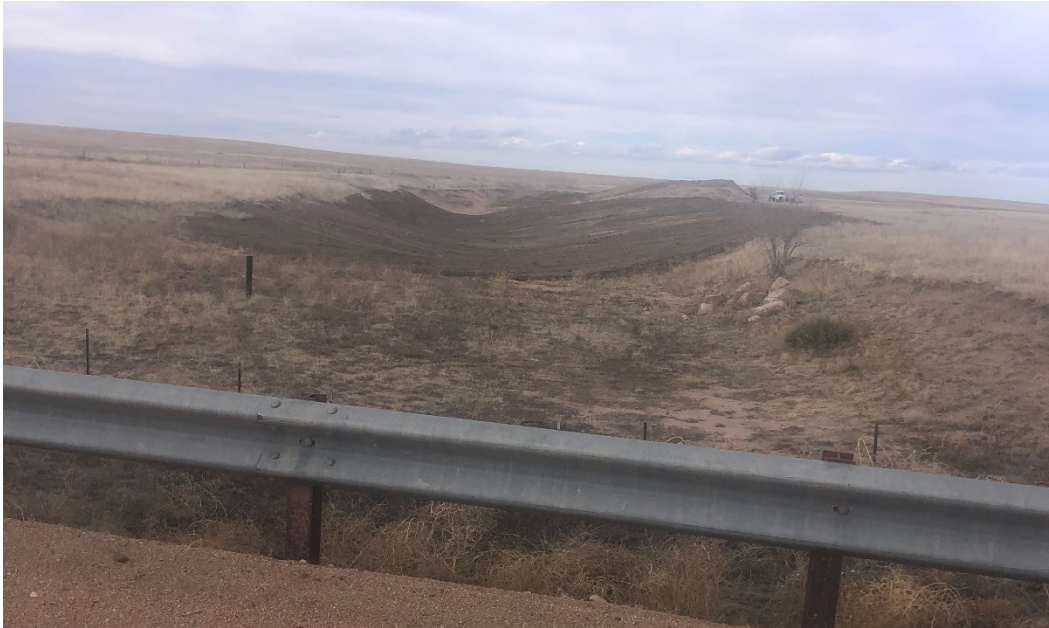
Photo 3 – Mr. Williams' photo showing drainage has been re-established.

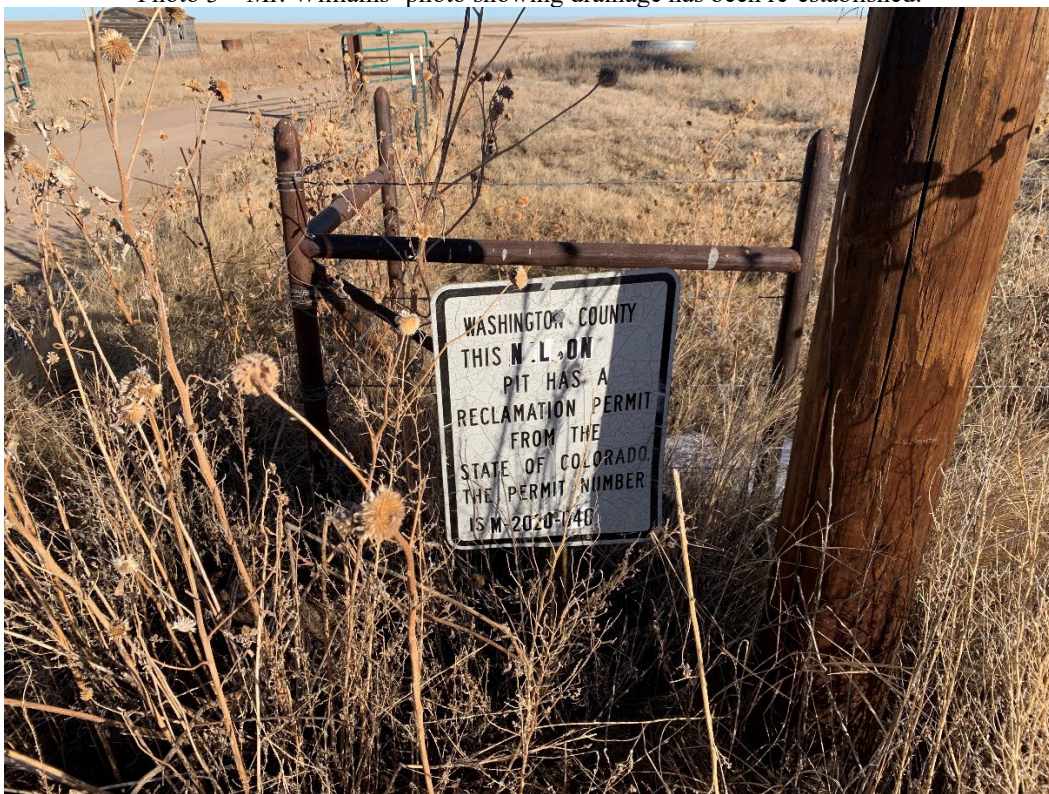
The mine entrance sign was in place facing CR 3 (photo 4).

Photo 4 – Mine entrance sign facing CR 3

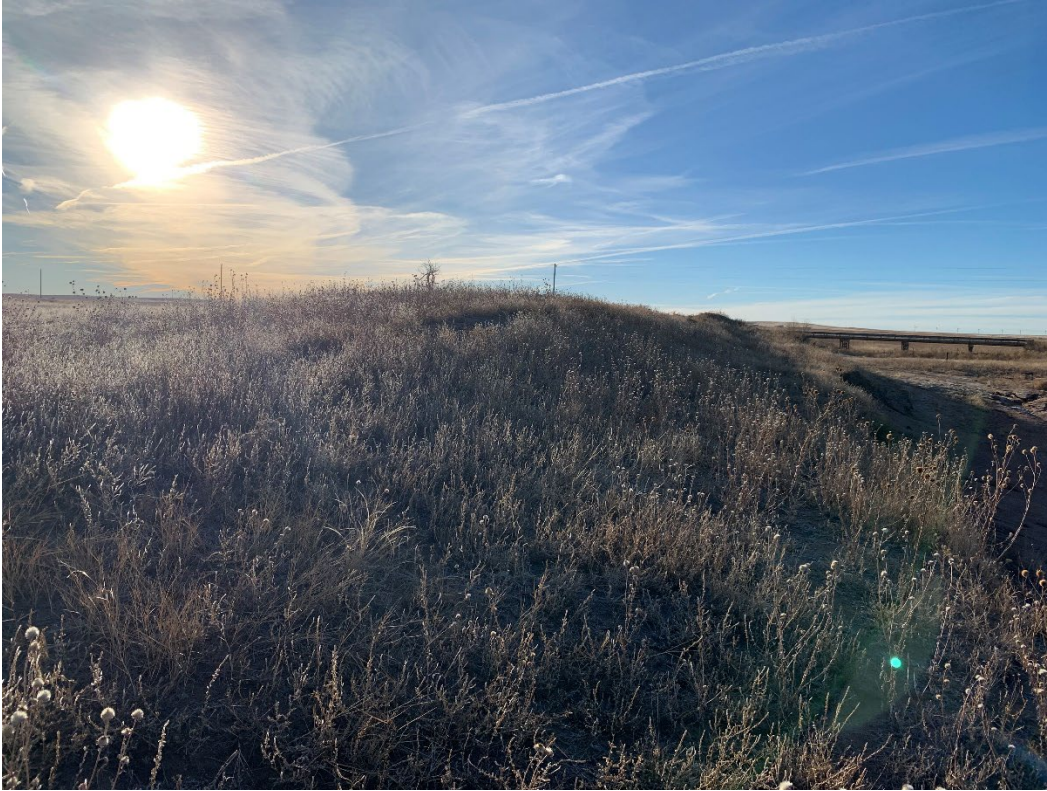
Two topsoil stockpiles were along the southern part of east bank (photo 5). The piles were well vegetated and there were no signs of erosion.

Photo 5 – Topsoil stockpile that is well vegetated.
