**MINERALS PROGRAM INSPECTION REPORT**  
**PHONE: (303) 866-3567**

<b>MINE NAME:</b> Brann Pit	<b>MINE/PROSPECTING ID#:</b> M-1984-136	<b>MINERAL:</b> Sand and gravel	<b>COUNTY:</b> Prowers
<b>INSPECTION TYPE:</b> Monitoring	<b>WEATHER:</b> Clear	<b>INSP. DATE:</b> February 14, 2024	<b>INSP. TIME:</b> 09:00
<b>OPERATOR:</b> Prowers County	<b>OPERATOR REPRESENTATIVE:</b> Mark Dorenkamp	<b>TYPE OF OPERATION:</b> 110c - Construction Limited Impact	
<b>REASON FOR INSPECTION:</b> Normal I&E Program	<b>BOND CALCULATION TYPE:</b> None	<b>BOND AMOUNT:</b> \$0.00	
<b>DATE OF COMPLAINT:</b> NA	<b>POST INSP. CONTACTS:</b> None	<b>JOINT INSP. AGENCY:</b> None	
<b>INSPECTOR(S):</b> Zach Trujillo	<b>INSPECTOR'S SIGNATURE:</b>

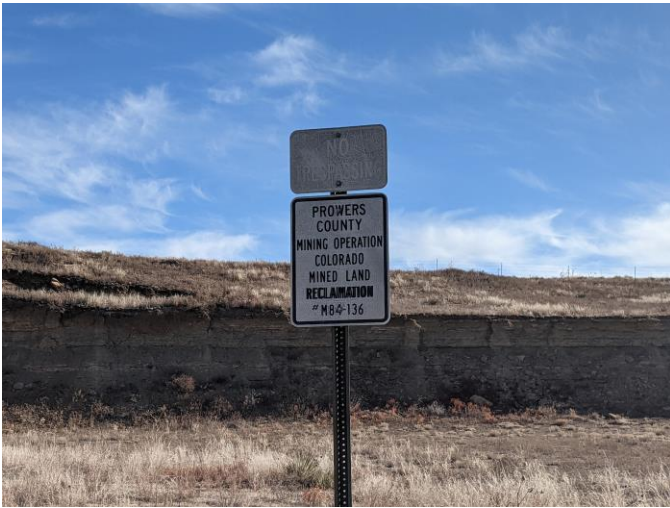
The mine identification sign was located at site entrance with all required information for compliance. The permit boundary was clearly marked in each corner of the site with metal posts. Each post was within line of sight of each other. The permit boundary runs on both sides of the county road but all current disturbances was observed east of the road.

Mine identification sign.

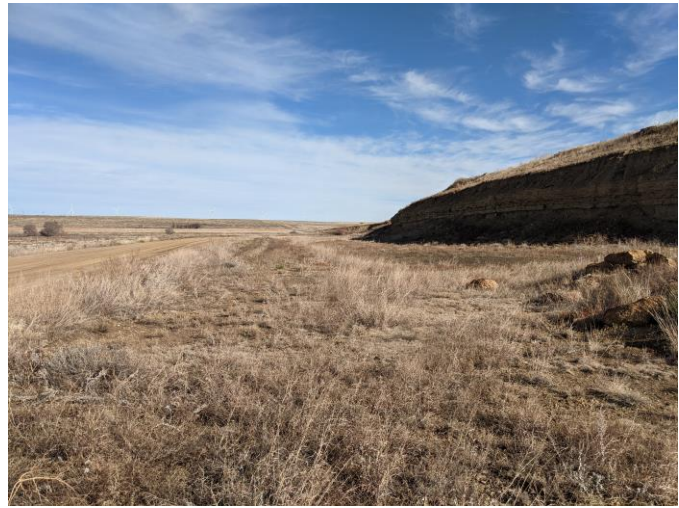
Mine site looking north.

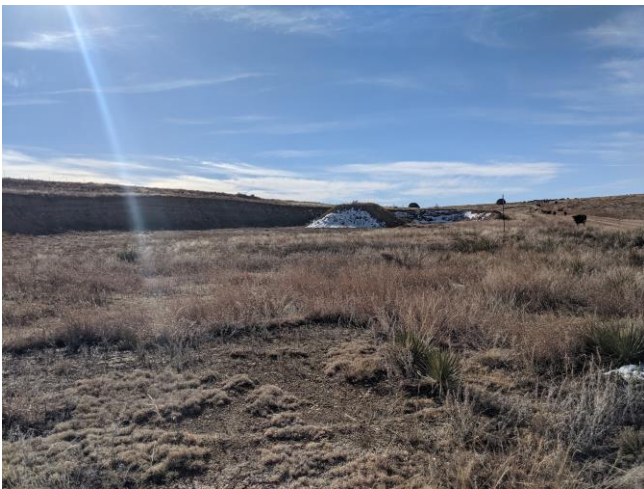
The site has a gravel stockpile stored along the southern portion of the pit area. Larger rock was observed stored within the pit area as well. Discussions with the Operator stated that the site has limited activity and material is pulled from the current stockpiles as needed. The mine was inactive at the time of the inspection with no equipment on site. The mine's affected boundary was inspected and is encompassed by a berm down gradient along the county road to ensure all surface disturbance stays within the approved boundary. The pit highwalls are sloped to approximately 1:1 or greater. Vegetative growth has begun to establish itself along the affected areas and no signs of erosion were observed throughout the site. Topsoil pile is located along the northern portion of the permit boundary and is vegetated.

Material stockpile along southern end of the site.
