**MINERALS PROGRAM INSPECTION REPORT**  
**PHONE: (303) 866-3567**

<b>MINE NAME:</b> Randy Shaw Pit	<b>MINE/PROSPECTING ID#:</b> M-1984-134	<b>MINERAL:</b> Sand and gravel	<b>COUNTY:</b> Prowers
<b>INSPECTION TYPE:</b> Monitoring	<b>WEATHER:</b> Clear	<b>INSP. DATE:</b> February 14, 2024	<b>INSP. TIME:</b> 10:00
<b>OPERATOR:</b> Prowers County	<b>OPERATOR REPRESENTATIVE:</b> None	<b>TYPE OF OPERATION:</b> 112c - Construction Regular Operation	
<b>REASON FOR INSPECTION:</b> Normal I&E Program	<b>BOND CALCULATION TYPE:</b> None	<b>BOND AMOUNT:</b> \$0.00	
<b>DATE OF COMPLAINT:</b> NA	<b>POST INSP. CONTACTS:</b> None	<b>JOINT INSP. AGENCY:</b> None	
<b>INSPECTOR(S):</b> Zach Trujillo	<b>INSPECTOR'S SIGNATURE:</b>

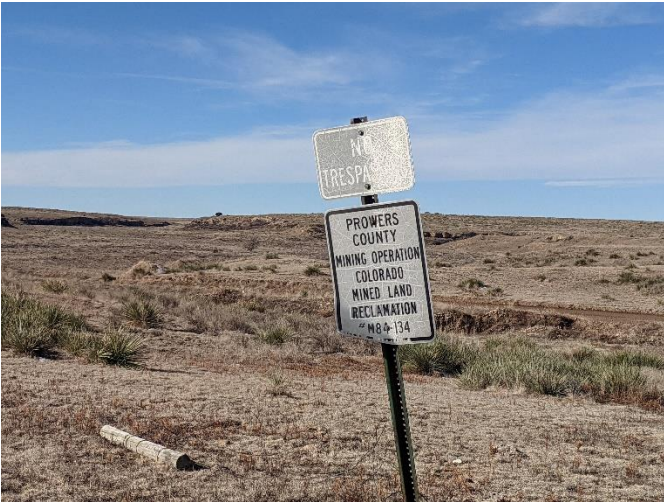
The mine identification sign was located at the gated site entrance with all required information for compliance. No equipment was on site during the inspection. The mine site runs adjacent to the Two Butte Creek which only receives surface runoff from seasonal weather events. The creek is dry most of the year and mining activities are approved at a 300 foot set back from the creek. Mining time frame at the Randy Shaw Pit is limited to only dry seasons.

Mine identification sign at gated entrance.

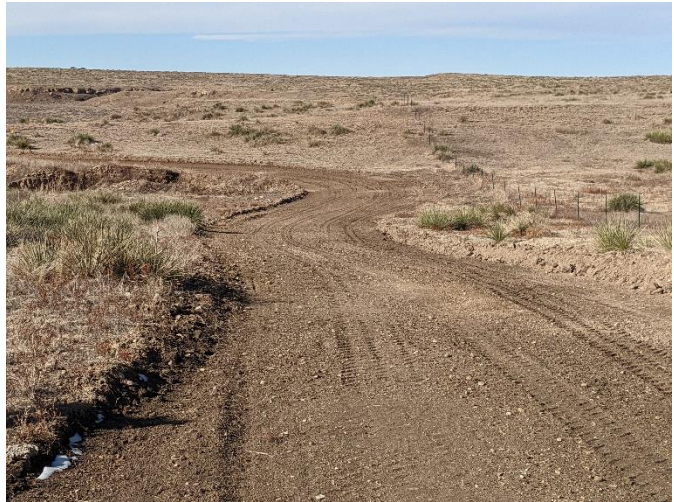
Mine access road.

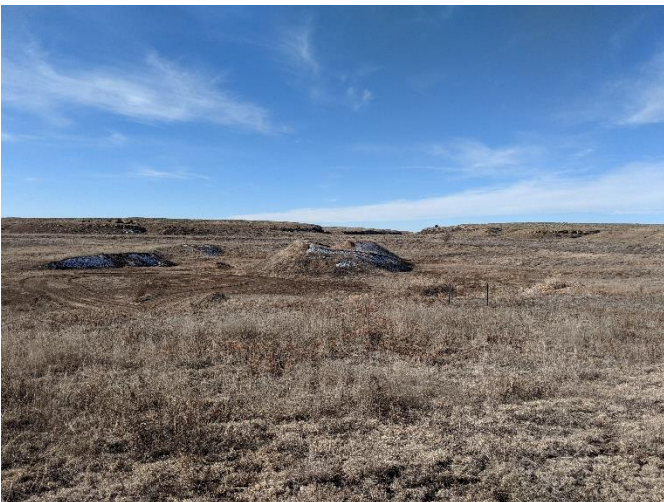
Mine site overview.

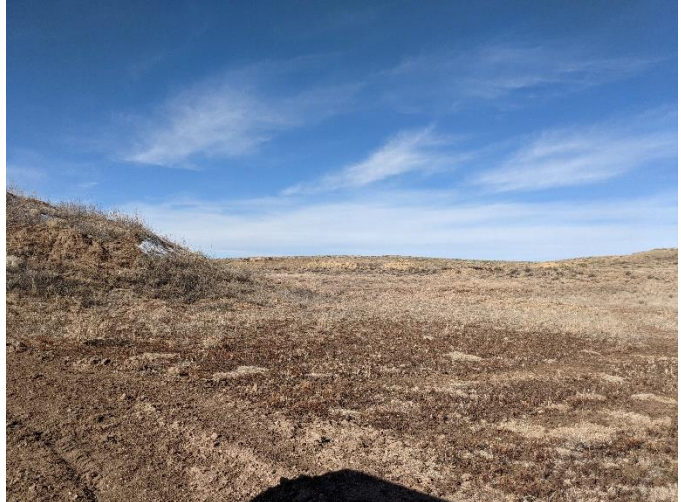
The mining depths at the site is approximately 10 feet with pit walls sloped to approximately 3:1. Multiple stockpiles are located within the pit. Based on vegetated growth in the affected areas, it appears mining has not occurred recently. The haul route was well established with signs of usage. Haul roads associated with the site are to be reclaimed however the landowner access road is to remain permanently post-mining. As noted earlier, disturbed areas at the site have "self-healed" with native vegetation encroachment. No signs of erosion was observed during the inspection.

Vegetative growth along pit floor.
