MINERALS PROGRAM INSPECTION REPORT
PHONE: (303) 866-3567

MINE NAME: Randy Shaw Pit	MINE/PROSPECTING ID#: M-1984-134	MINERAL: Sand and gravel	COUNTY: Prowers
INSPECTION TYPE: Monitoring	WEATHER: Clear	INSP. DATE: February 14, 2024	INSP. TIME: 10:00
OPERATOR: Prowers County	OPERATOR REPRESENTATIVE: None	TYPE OF OPERATION: 112c - Construction Regular Operation	
REASON FOR INSPECTION: Normal I&E Program	BOND CALCULATION TYPE: None	BOND AMOUNT: \$0.00	
DATE OF COMPLAINT: NA	POST INSP. CONTACTS: None	JOINT INSP. AGENCY: None	
INSPECTOR(S): Zach Trujillo	INSPECTOR'S SIGNATURE:

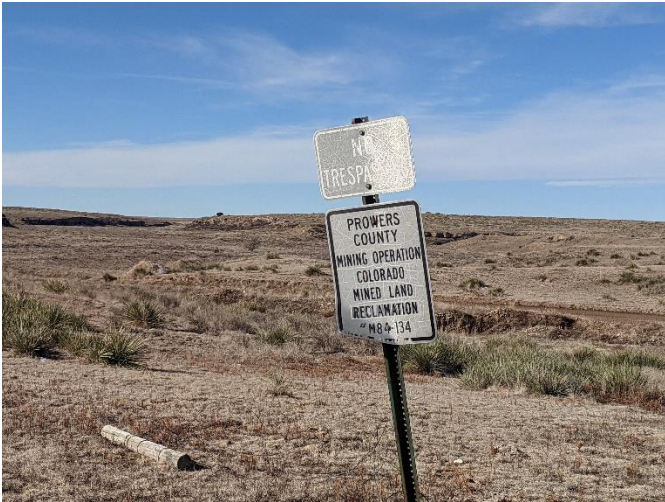
The mine identification sign was located at the gated site entrance with all required information for compliance. No equipment was on site during the inspection. The mine site runs adjacent to the Two Butte Creek which only receives surface runoff from seasonal weather events. The creek is dry most of the year and mining activities are approved at a 300 foot set back from the creek. Mining time frame at the Randy Shaw Pit is limited to only dry seasons.

Mine identification sign at gated entrance.

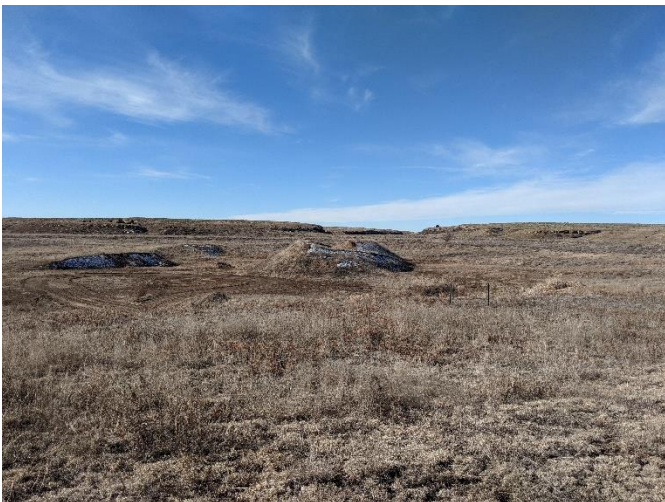
The mining depths at the site is approximately 10 feet with pit walls sloped to approximately 3:1. Multiple stockpiles are located within the pit. Based on vegetated growth in the affected areas, it appears mining has not occurred recently. The haul route was well established with signs of usage. Haul roads associated with the site are to be reclaimed however the landowner access road is to remain permanently post-mining. As noted earlier, disturbed areas at the site have "self-healed" with native vegetation encroachment. No signs of erosion was observed during the inspection.

Mine site overview.

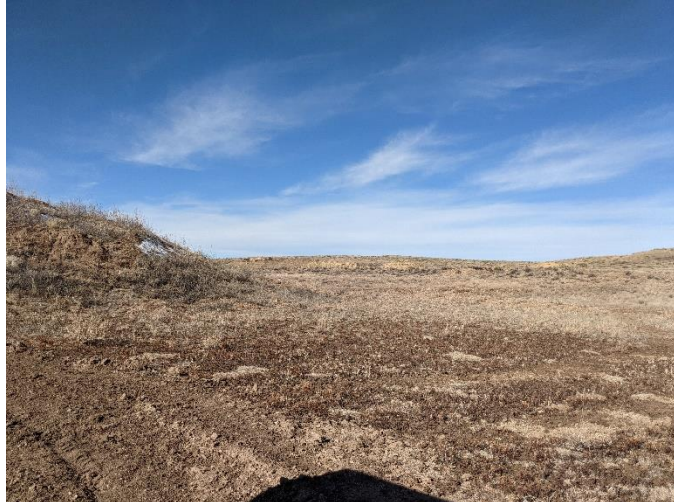
Vegetative growth along pit floor.
