**MINERALS PROGRAM INSPECTION REPORT**  
**PHONE: (303) 866-3567**

<b>MINE NAME:</b> Walker Pit North	<b>MINE/PROSPECTING ID#:</b> M-1984-140	<b>MINERAL:</b> Sand and gravel	<b>COUNTY:</b> Prowers
<b>INSPECTION TYPE:</b> Monitoring	<b>WEATHER:</b> Clear	<b>INSP. DATE:</b> February 14, 2024	<b>INSP. TIME:</b> 11:00
<b>OPERATOR:</b> Prowers County	<b>OPERATOR REPRESENTATIVE:</b> None	<b>TYPE OF OPERATION:</b> 110c - Construction Limited Impact	
<b>REASON FOR INSPECTION:</b> Normal I&E Program	<b>BOND CALCULATION TYPE:</b> None	<b>BOND AMOUNT:</b> \$0.00	
<b>DATE OF COMPLAINT:</b> NA	<b>POST INSP. CONTACTS:</b> None	<b>JOINT INSP. AGENCY:</b> None	
<b>INSPECTOR(S):</b> Zach Trujillo	<b>INSPECTOR'S SIGNATURE:</b>

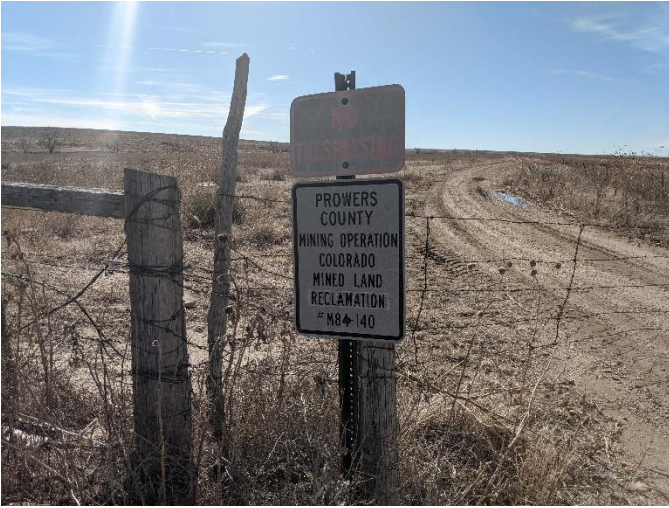
The mine identification sign was located at the gated site entrance with all required information for compliance. Permit boundary markers are metal yellow poles and were observed along the corners of the permit boundary within line of sight of each other. No equipment was on site during the inspection. The mine site runs adjacent to a natural drainage east of the site which only receives surface runoff from seasonal weather events. The creek is dry most of the year and mining activities are approved at a 100 foot set back from the creek. Due to the mine's relative location, little to no topsoil salvaging was possible due to scouring from high flows within the adjacent creek.

Mine identification sign.

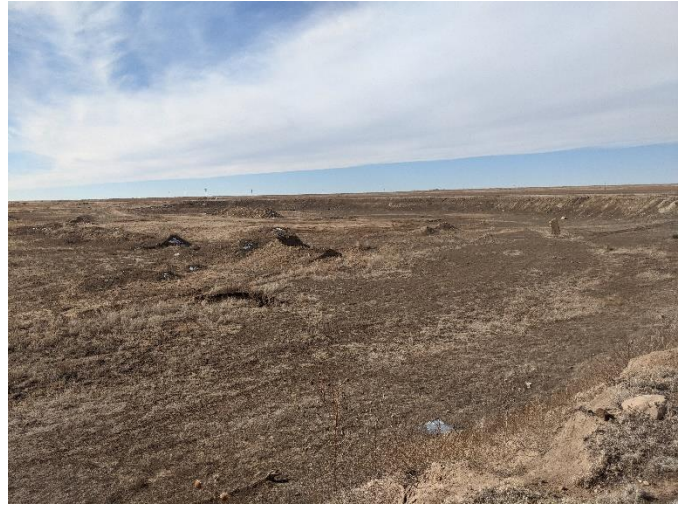
Mine site overview looking southeast.

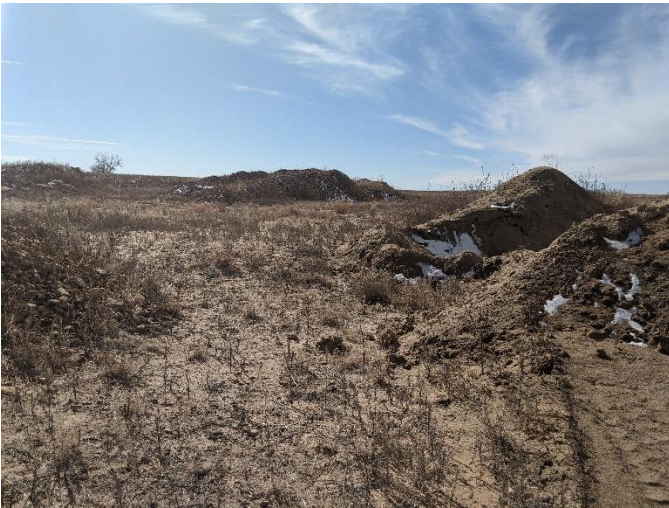
Multiple material stockpiles were observed on site within the pit floor. Highwalls are sloped to approximately 3:1 and were around 10 feet in depth. The mined highwalls follows the current haul road along the western portion of the site. The road was stable and maintained. Native vegetative encroachment has occurred due to the lack of recent mining along the highwall slopes and base of the pit. No major erosion was observed. Earlier discussions with Mr. Dorenkamp stated that stockpiles on site are used intermittently for road maintenance as needed by the county.

Material stockpiles.

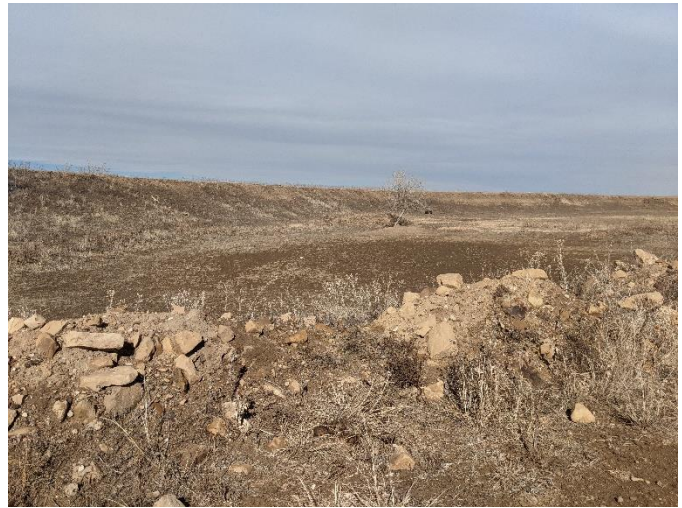
Pit floor and highwall.
