Poudre Ponds Bank Stabilization

Basis of Design Report

Revised: February 20, 2024

Otak, Inc.
371 Centennial Parkway, Suite 210
Louisville, CO 80027

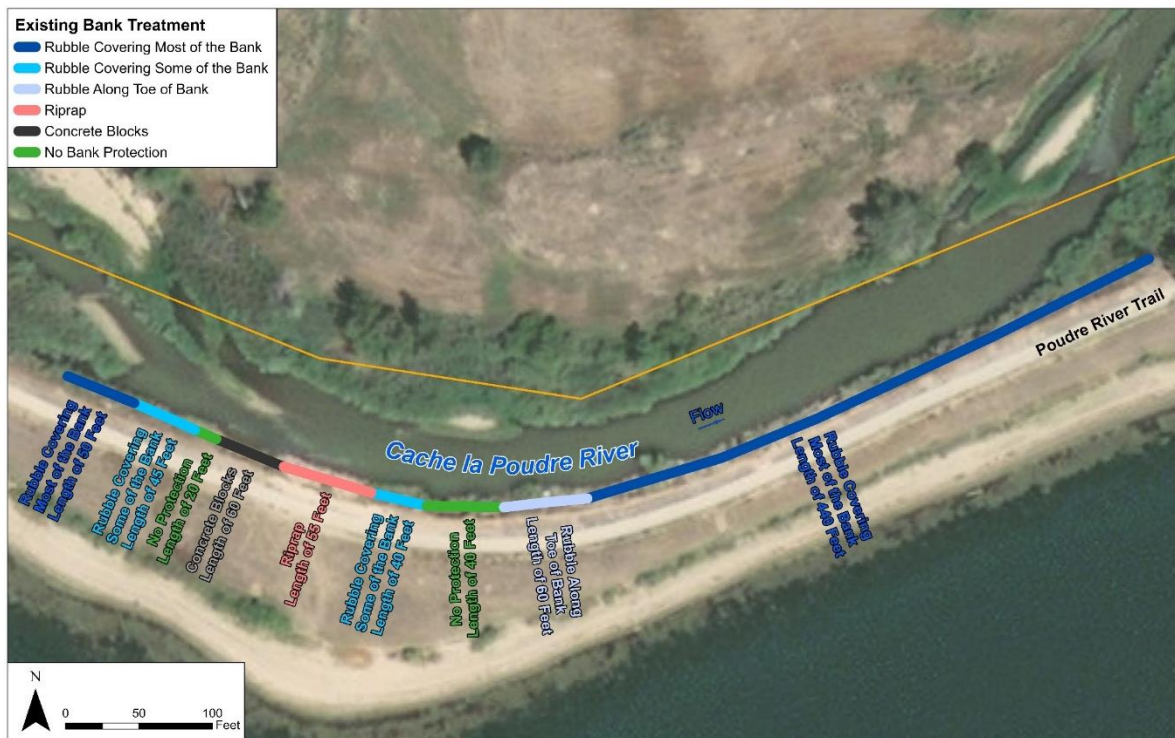
Figure 2: Existing Bank Treatments

The current condition of the bank in the project area is summarized in Figure 2 with the extents of each bank treatment highlighted. Areas where bank protection is absent, the banks are actively scalloping (Photo 1) and are at risk of failure during higher flow events. Historical aerial imagery shows that the top of the bank has eroded away by approximately 15 feet from 2014 to 2016 (Figure 3). Existing bank protection treatments include ecology blocks, riprap, poured asphalt, and concrete rubble (Photo 2, Photo 3, Photo 4, Photo 5). Some of these bank treatments are poorly installed, unstable, and have a high risk of undermining (especially the poured concrete slabs). Movement or undermining of the slabs would put

the bank at risk and is a threat to the safety of boaters, fishermen, and anyone exploring the riverbank from the trail. Transition zones in the existing bank treatments also have the potential to fail, given the lack of tie-in from one treatment to another.

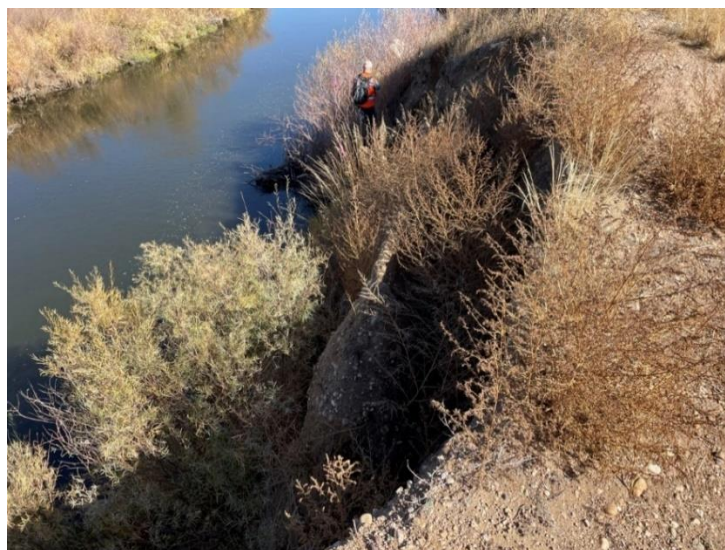
Photo 1: Actively Scalloping Bank

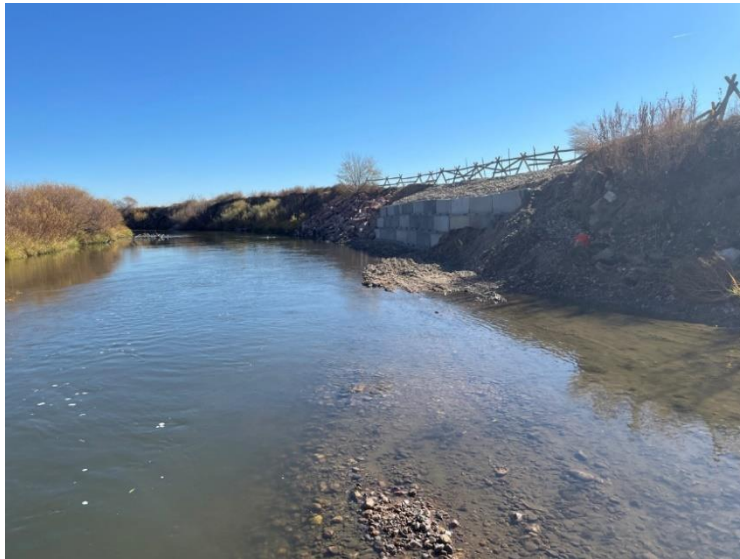
Photo 2: Ecology Blocks

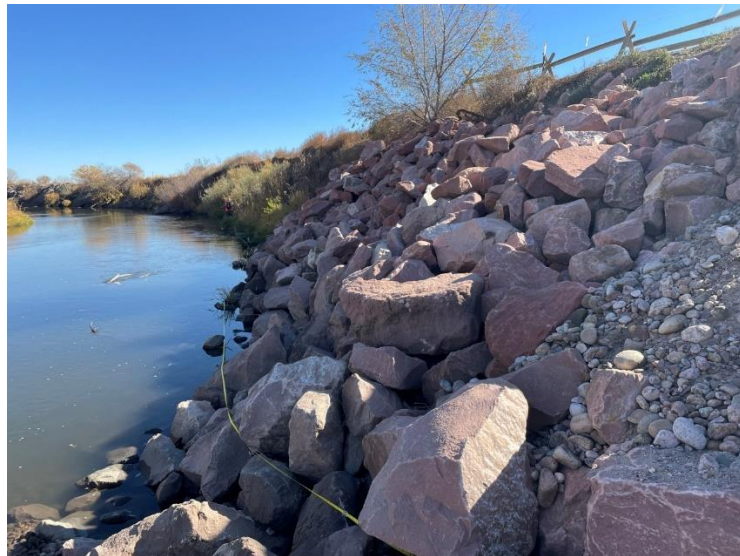
Photo 3: Rip Rap

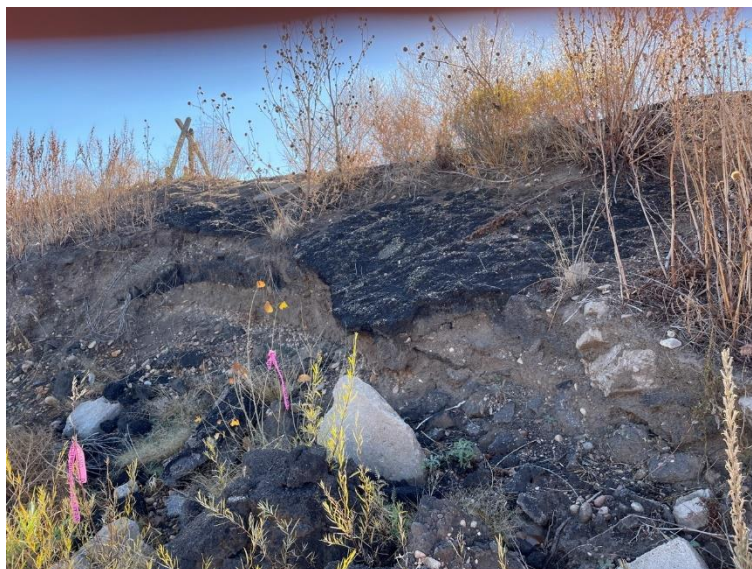
Photo 4: Poured Asphalt

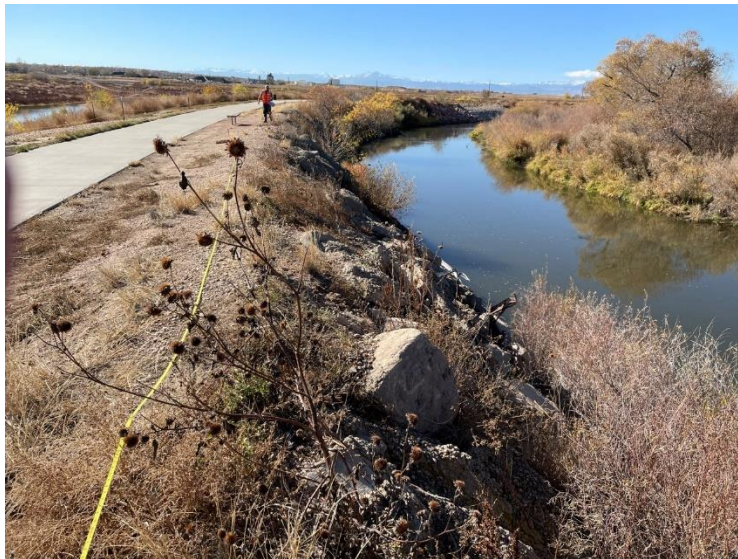
Photo 5: Concrete Rubble

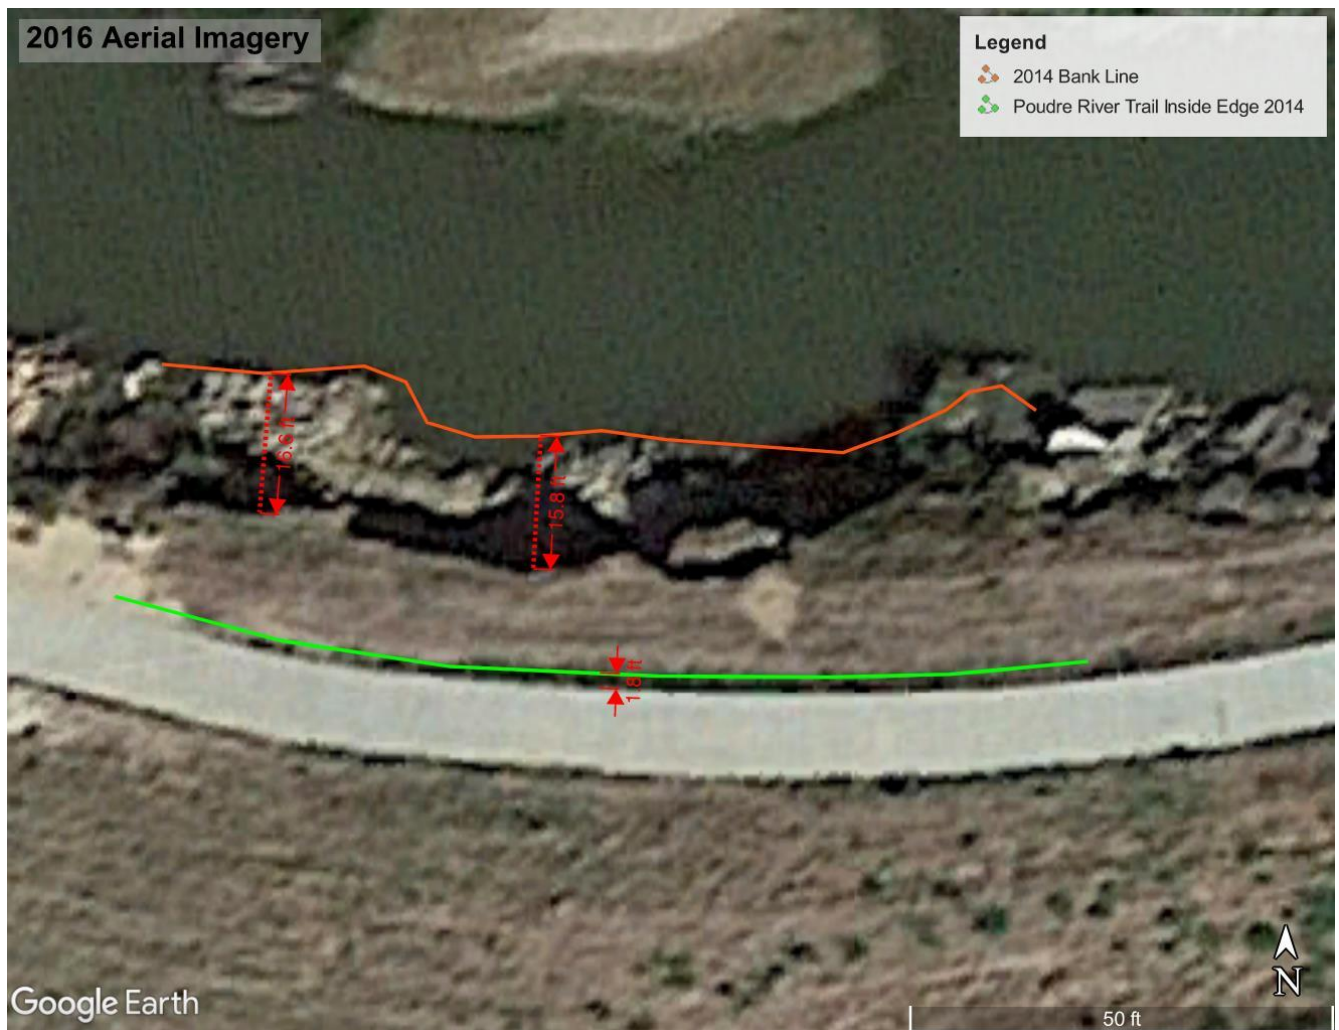
Figure 3: 2014 Bank Lines Superimposed upon Aerial Imagery from 2016
(Showing Approximately 15 feet of Top of Bank Movement)

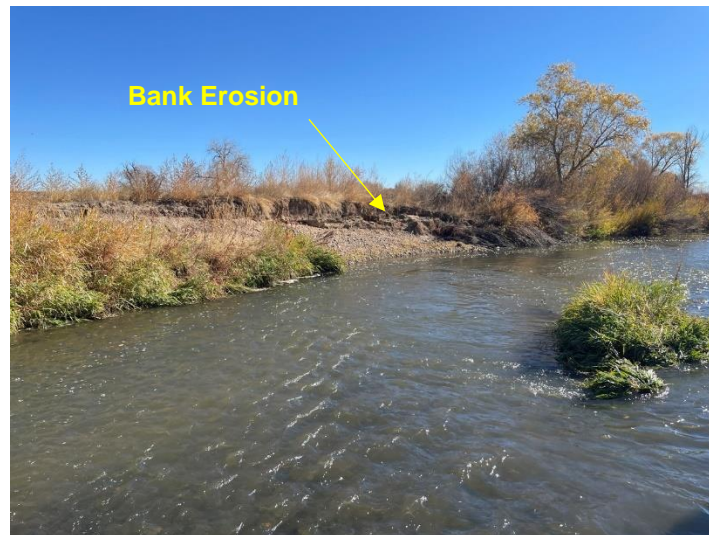
Within the project area, the river left channel banks were generally 2.5 feet tall, moderately sloped, and stable, in part due to their location on the inside of the meander bend. Limited bank failure was observed on river left upstream of the project area (Photo 7). The banks on river right were 6 to 12 feet tall, nearly vertical, and stability of the banks are dependent on the bank protection present (where banks were unstable and actively eroding where no treatments were located). Bank material predominantly consists of cohesive sands and gravels, with layers of cobbles also present (Photo 8). The bank material is very difficult to break apart when dry; however, when wetted, the banks have the potential to fail, due to the increased mass of the wetted soil, as well as reductions in frictional shear stresses. There is a significant amount of loose bank material along the toe of the bank as a result of the 15 feet of bank migration in this area. Large wood was minimally present within the project area, however, two beaver dams were observed under the N 35th Avenue Bridge (Photo 9, Photo 10). Additionally, a wood jam was identified on a side channel upstream of the project area (Photo 11). AlpineEco observed beaver entering and exiting the concrete rubble along the bank. Beaver may be utilizing the concrete rubble as a den. The river is fairly stable both upstream and downstream of the project area, with the exception of one other location just upstream of the project reach where bank erosion was observed on the outside of the meander bend (Photo 7). In terms of stream evolution, the project reach is in the stage of degradation and widening (Cluer and Thorne, 2014).

Photo 7: Evidence of Bank Failure on River Left

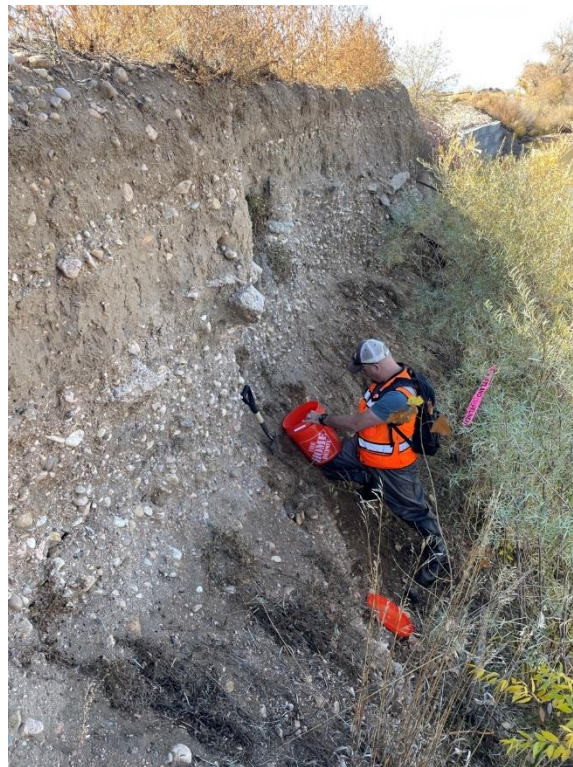
Photo 8: Unprotected Bank Material within Project Reach

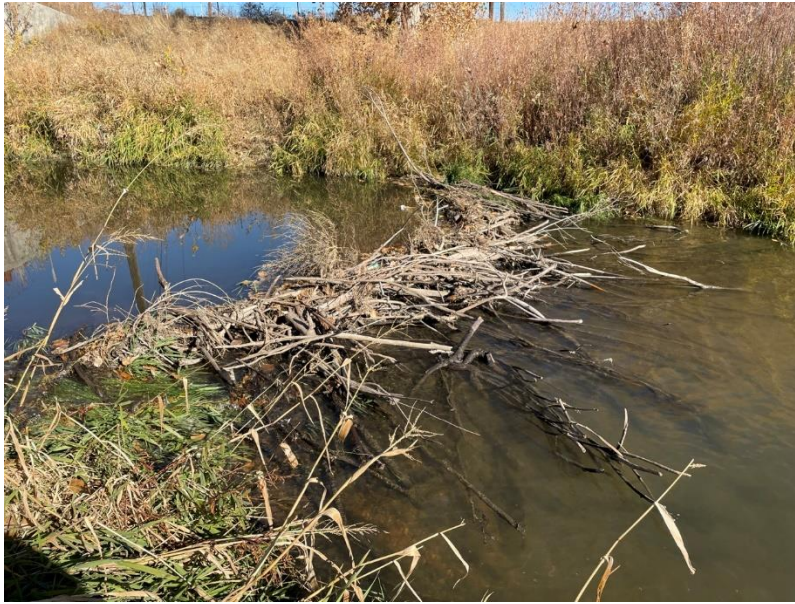
Photo 9: Beaver Dam Located on River Left

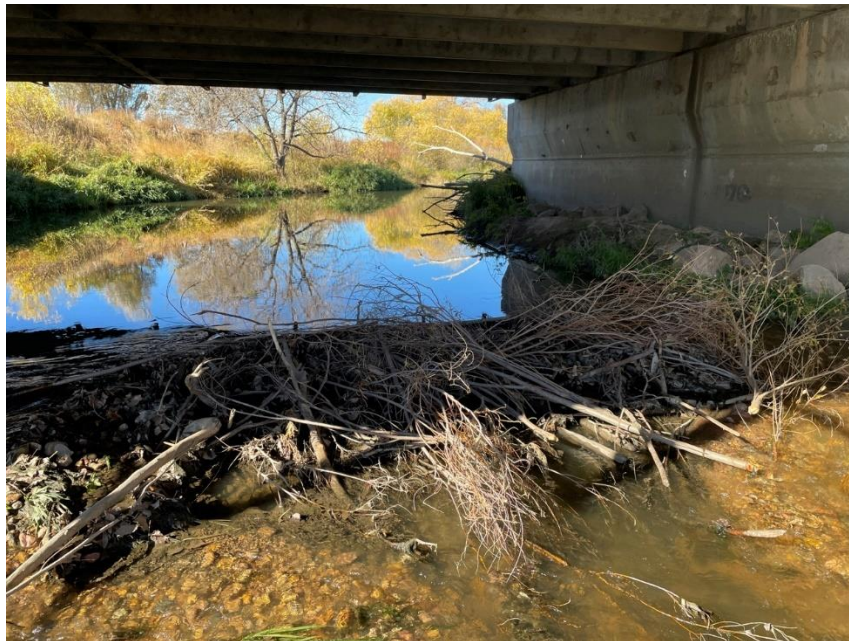
Photo 10: Beaver Dam Located on River Left

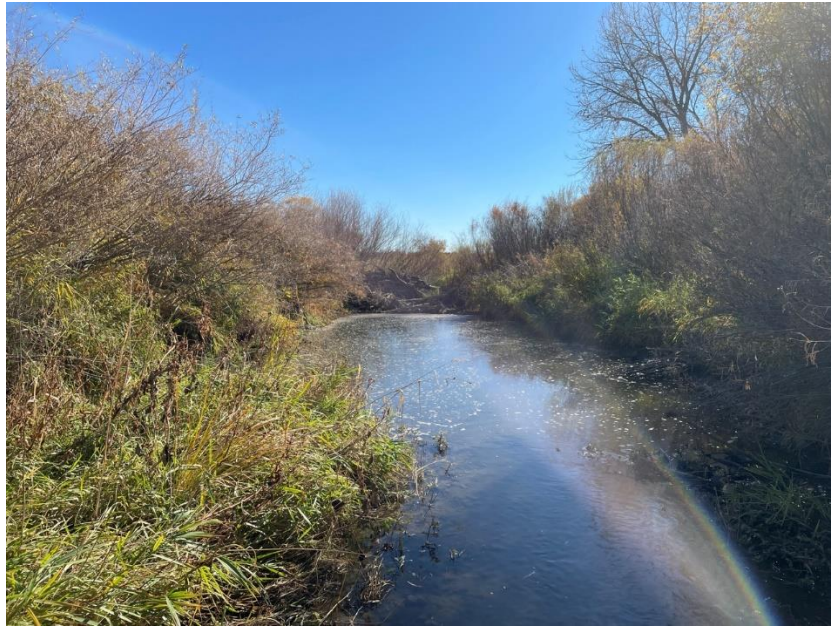
Photo 11: Wood Jam Within Side Channel

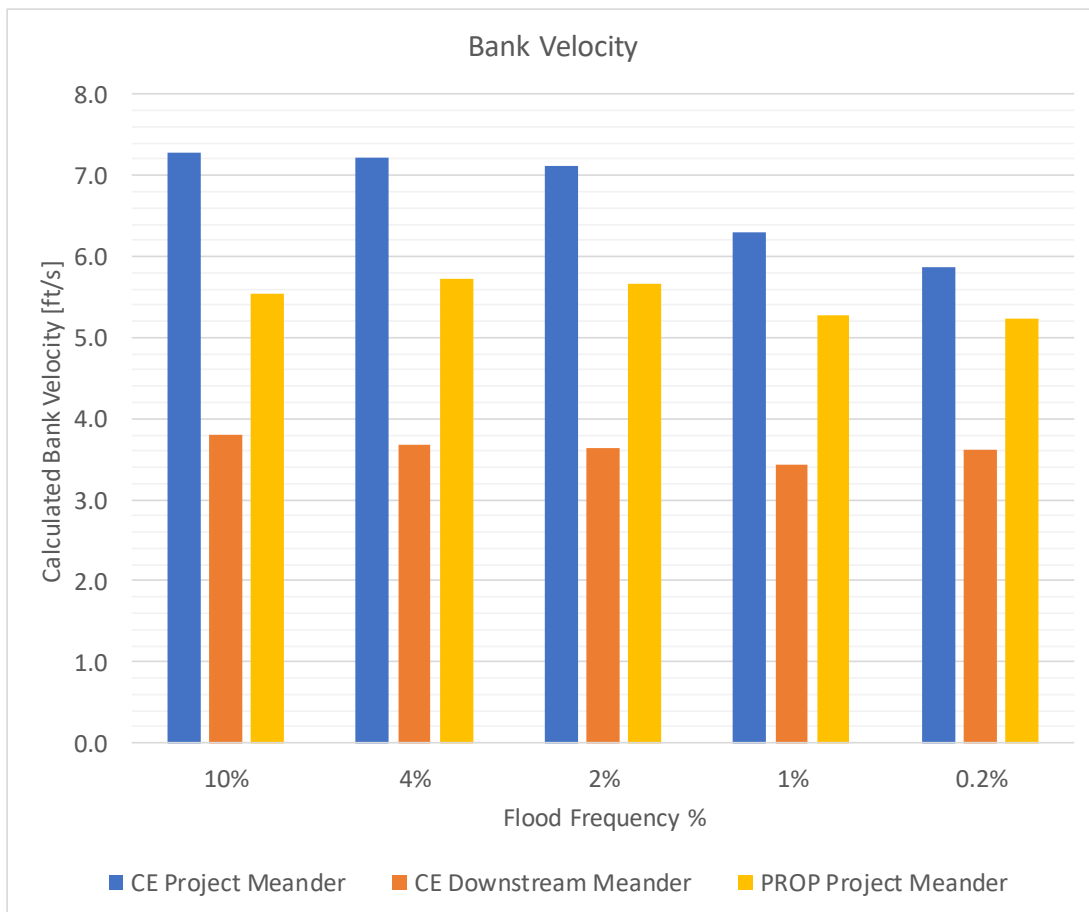
Figure 7: Bank Velocity Estimates

The results of the Existing Conditions model show that the average channel velocity through the meander bend is about 4.9 ft/s during the 10-year event. In contrast, the average channel velocity in the downstream meander bend, which has a natural floodplain bench and is stable, is around 2.4 ft/s. Research indicates that velocities along the outside of a meander bend are greater than the channel average. Average channel velocities were used to estimate velocities along the banks using methods outlined in USACE Engineering Manual No. 1110-2-1601¹. The resulting bank velocities are presented in Figure 7 for the existing project meander (CE Project Meander), the existing downstream meander (CE Downstream Meander) for a range of flows (10-yr to 500-yr).

The hydraulic modeling results indicate that widening the floodplain reduces the flow velocity along the bank from 7.3 ft/s to 5.5 ft/s for the 10-year event, and from 6.3 to 5.3 for the 100-year event ("PROP Project Meander" in Figure 7). While these reductions would be a benefit to the stability of the outside bank and to the river function in this area, they do not appear to be large enough to justify a softer approach to the bank treatment.

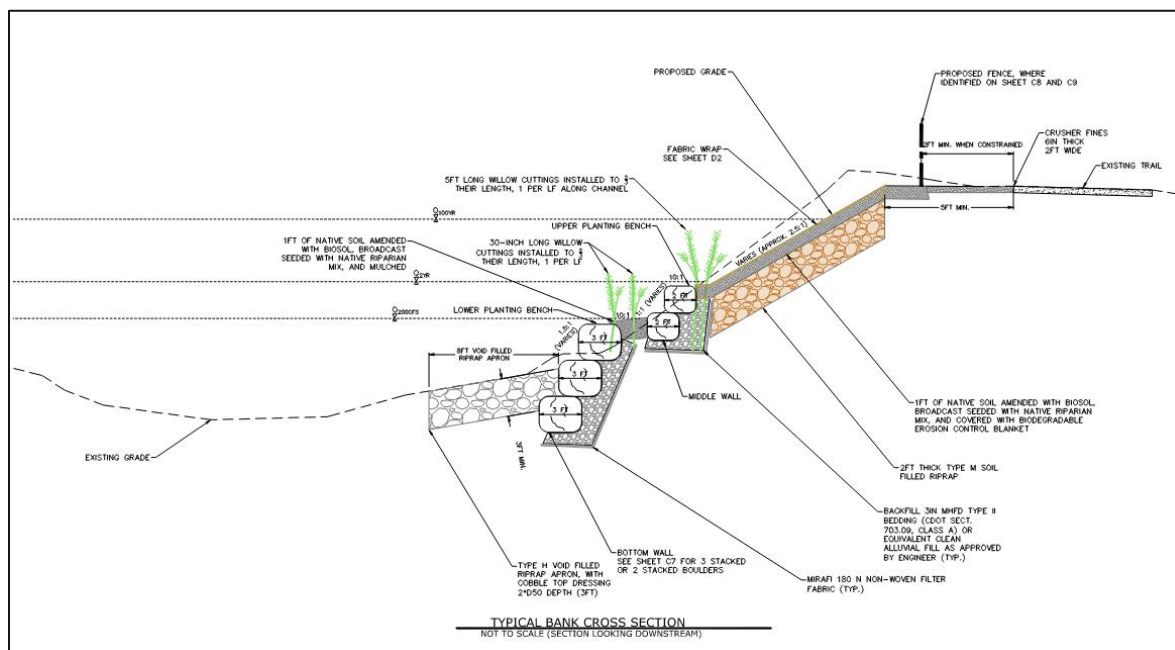
Figure 10: Typical Bank Cross Section

As the design was developed and the associated construction costing updated, it was determined that the boulder wall with soil lifts concept would need to be refined to reduce the overall cost of the project. The resulting modified design includes two walls (“bottom wall” and “middle wall”) with narrow planting benches in between (Figure 10). The final design plans can be found in Appendix A.
