MINERALS PROGRAM INSPECTION REPORT
PHONE: (303) 866-3567

MINE NAME: Davis Pit	MINE/PROSPECTING ID#: M-2002-062	MINERAL: Sand and gravel	COUNTY: Prowers
INSPECTION TYPE: Monitoring	WEATHER: Clear	INSP. DATE: February 14, 2024	INSP. TIME: 12:00
OPERATOR: Prowers County	OPERATOR REPRESENTATIVE: None	TYPE OF OPERATION: 112c - Construction Regular Operation	
REASON FOR INSPECTION: Normal I&E Program	BOND CALCULATION TYPE: None	BOND AMOUNT: \$0.00	
DATE OF COMPLAINT: NA	POST INSP. CONTACTS: None	JOINT INSP. AGENCY: None	
INSPECTOR(S): Zach Trujillo	INSPECTOR'S SIGNATURE:

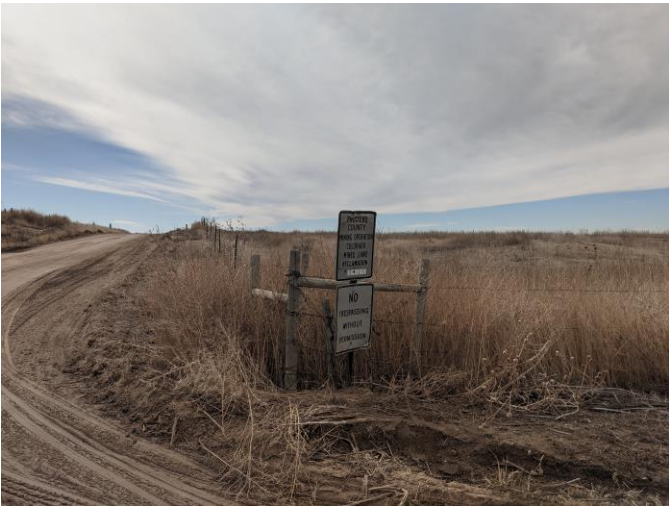
The mine identification sign was located at the gated site entrance with all required information for compliance. Permit boundary markers were observed along the corners of the site. The site was active at the time of the inspection with load and haul operations being conducted. No mining activities were occurring. A loader was on site pulling from stockpiled material within the base of the pit. Two loaded haul trucks were observed leaving the site. A screen and crusher was staged within the pit floor but was not operating at the time of the inspection.

Mine identification sign.

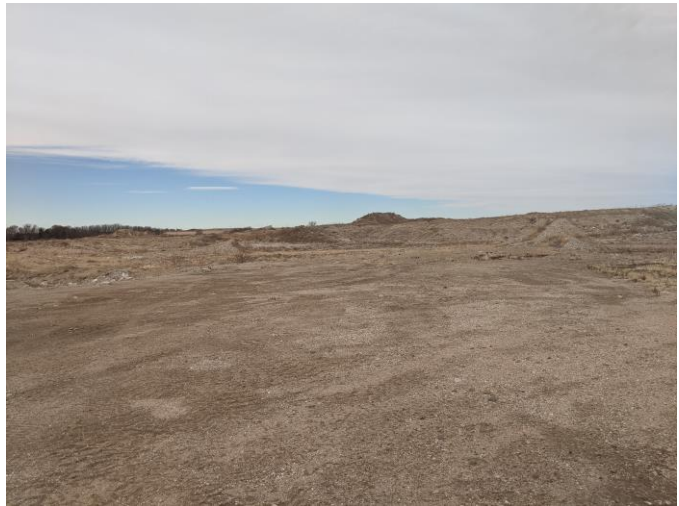
Western portion of pit disturbance.

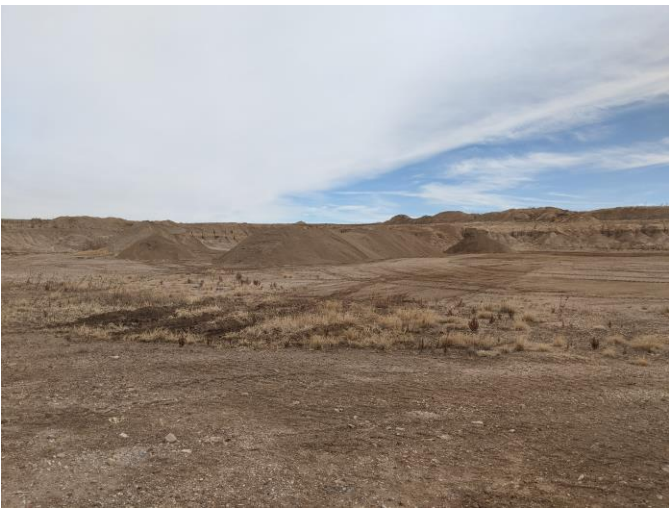
Material stockpiles on site.

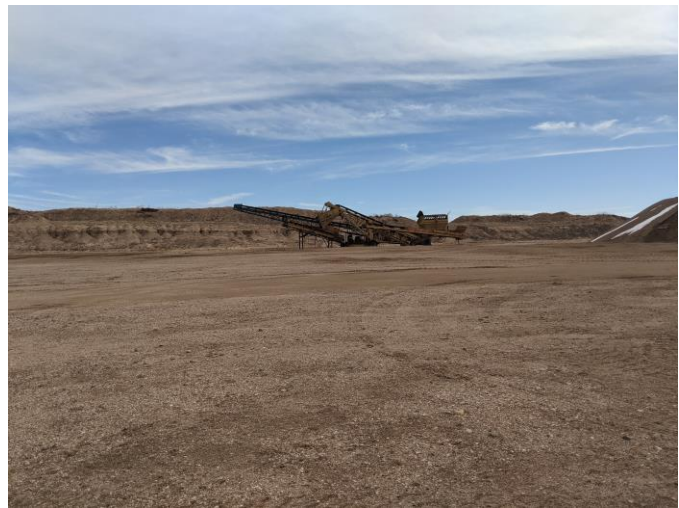
Screen and crusher.

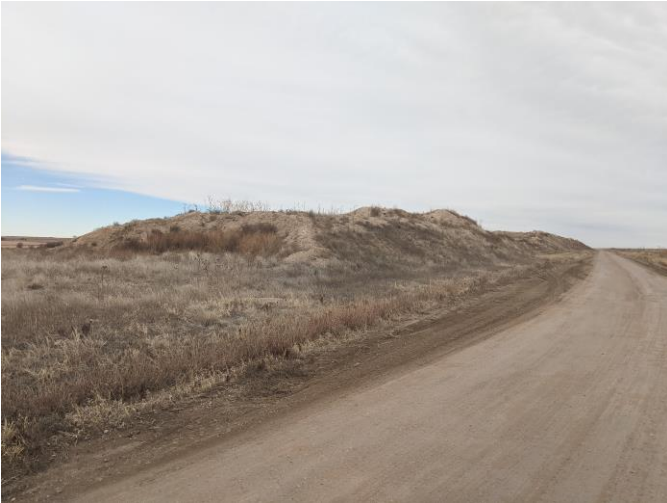
Topsoil stockpile is observed along the length of the haul road above the mined highwall. Topsoil stockpiles were sparsely vegetated with no erosion observed along the pile. Multiple material stockpiles were observed throughout the pit. Highwall slopes were most notably along the north and eastern portion of the site ranging from approximately 1:1 to 3:1 slopes. Steeper portions were generally along the eastern end of the pit. Disturbance along the western portion of the pit was graded with little to no slope. Vegetation has begun to establish itself along the western portion of disturbance from lack of activities in those areas. No signs of erosion was observed throughout the site.

Topsoil stockpile along haul road.
