RE: Corrective Actions in Response to Inspection Reports P-2007-015 and P-2008-043 dated November 2, 2023

ATTACHMENT A

Location and Temporary Sealing Report for BH836 and BH842

Centennial Project Visit and Missing Well Work

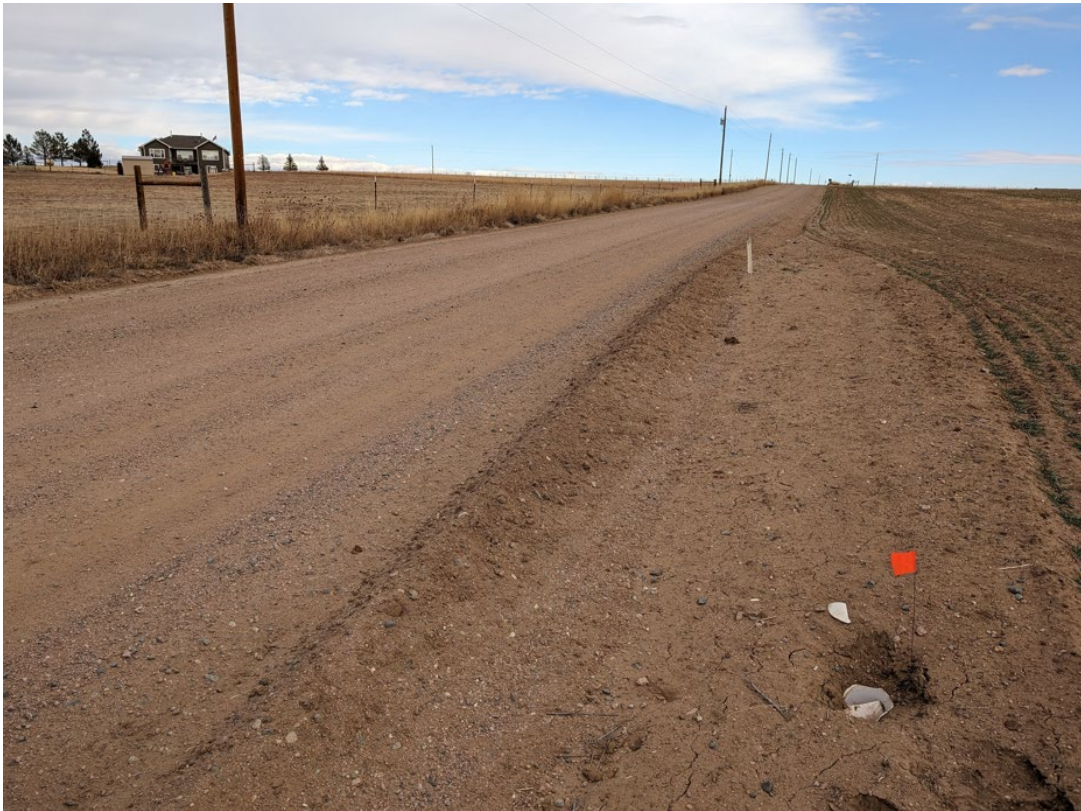
Upon arriving at the coordinates for BH-842 I saw that the field looked like it had been recently disc'd. The soil is extremely sandy and due to the recent work, the top of the well casing was immediately visible. The top of the open casing had a small chunk broken off, but the casing was in overall good condition.

Well BH-842 upon initial discovery:

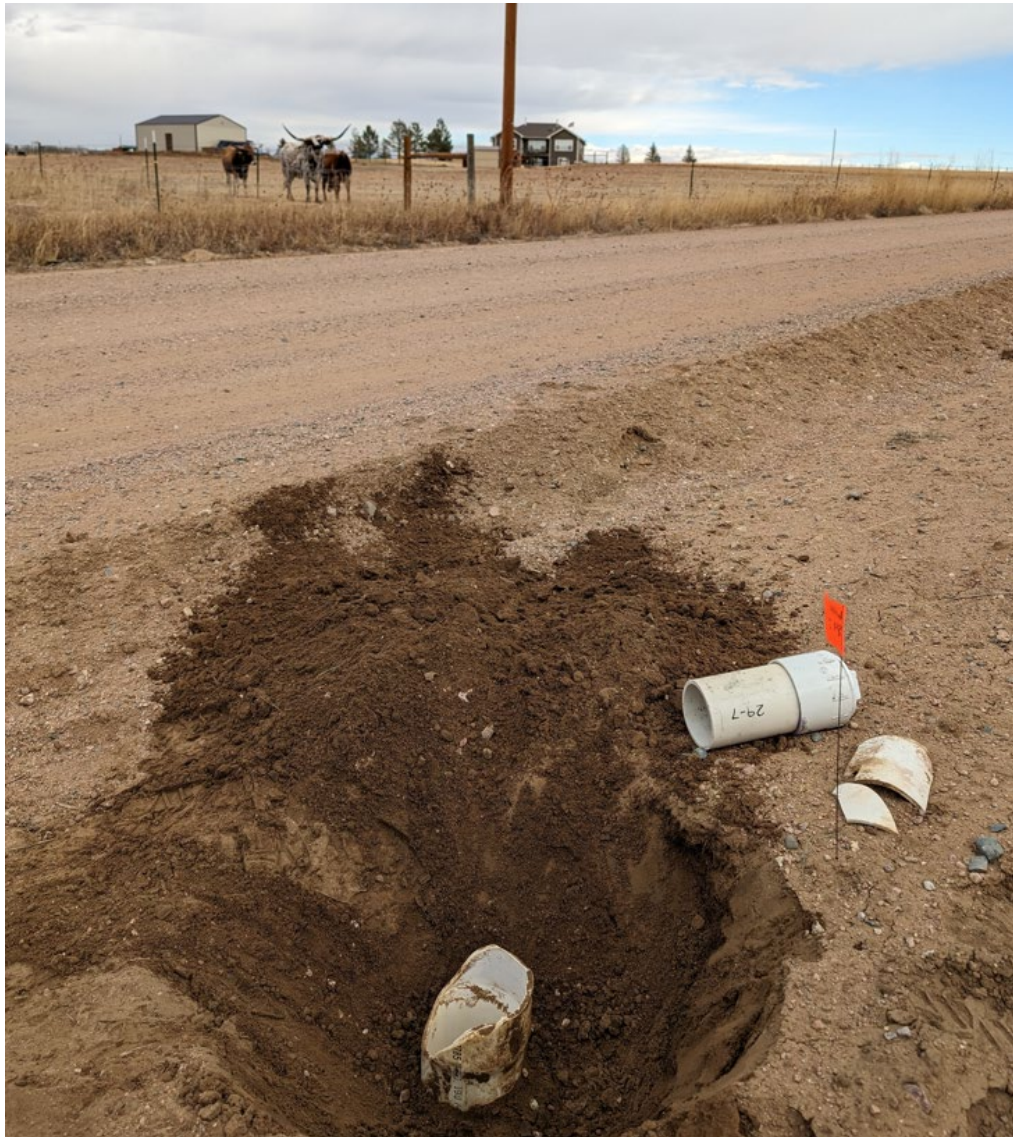
After some minor digging with a shovel, I was able to make some quick measurements so that I could plan a temporary fix which I completed on Tuesday. The previously installed wellhead was not present.

Well BH-842 after minor digging:

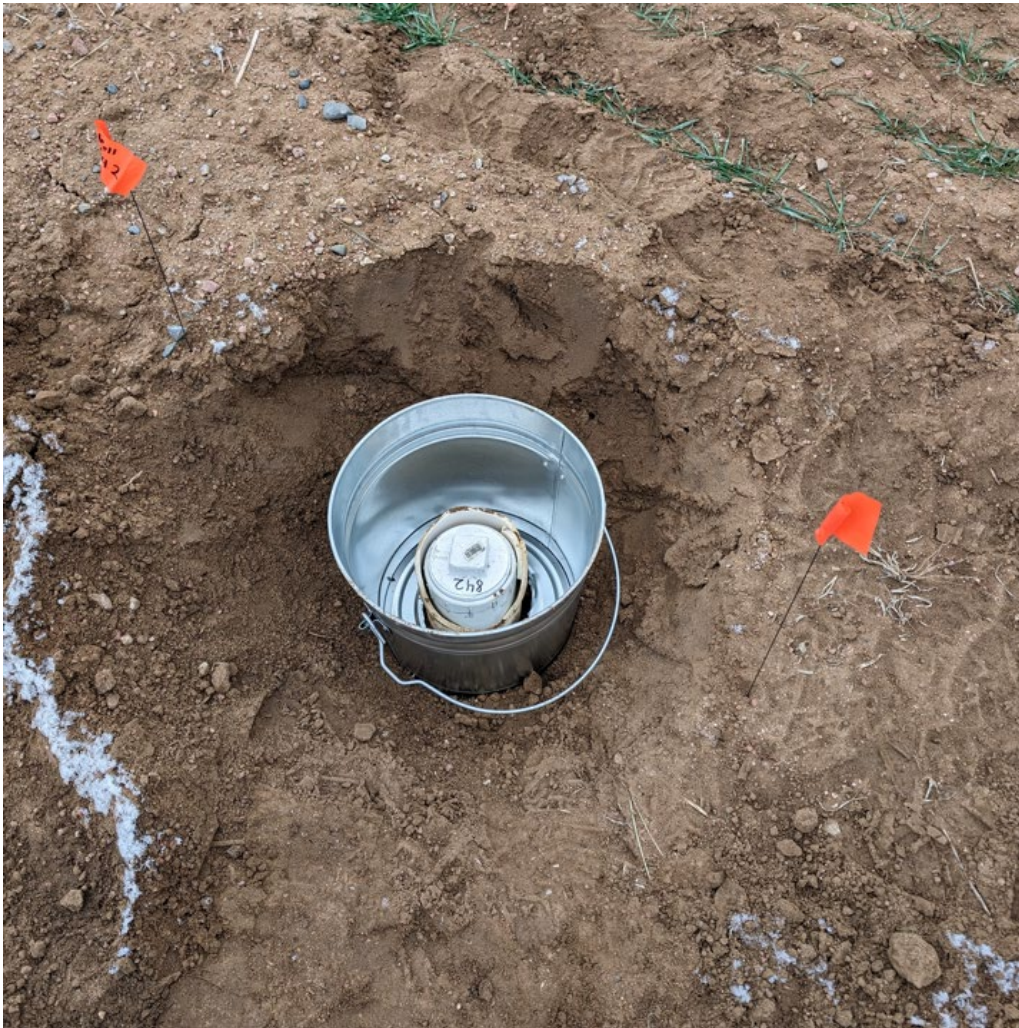
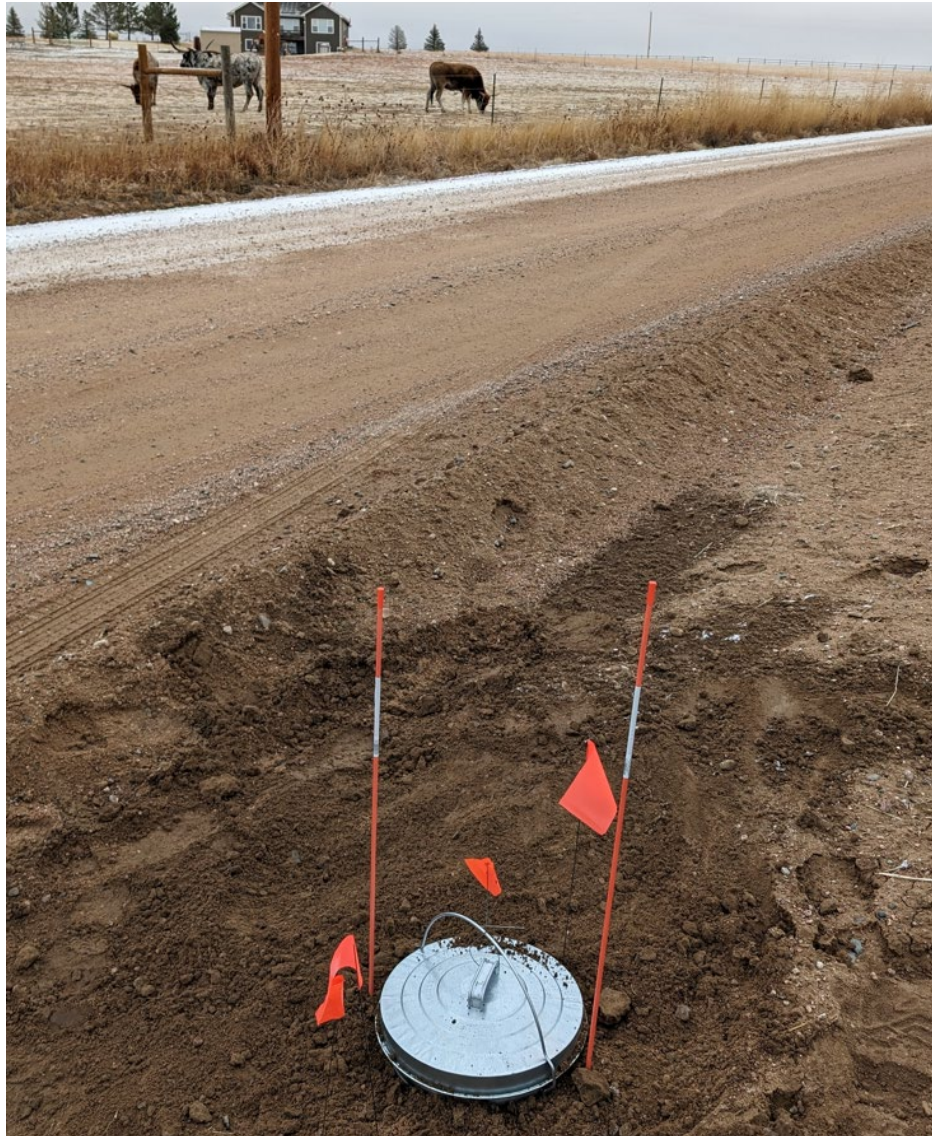
Well BH-842 after temporary cap and cover installed:

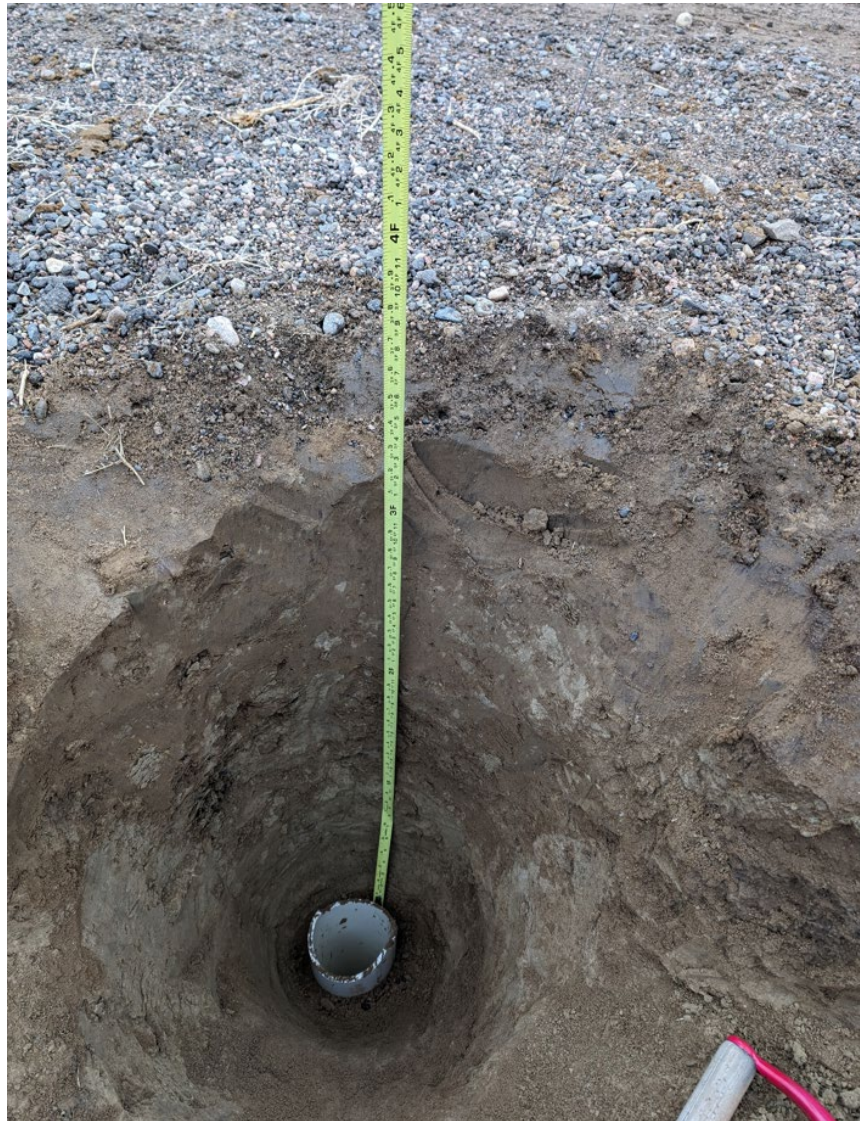
Locating well 836 required considerably more work. Upon arrival at the site, I noticed a metal t post laying in the dirt near the coordinates of 836. Digging an area approximately 5x5 feet yielded only the padlock and some concrete chunks from the wellhead pad. I spent 3 hours digging on Monday without finding the well. That evening using historical aerial imagery I measured distances from well 837 and a nearby metal culvert. Swinging arcs using these distances gave me a target area approximately 4x4' right at the edge of the new road alignment. After digging 3.5 feet below the road surface, I located the top of the broken well casing. After taking some measurements I drove back into Wellington and bought supplies and tools to complete a temporary fix. The well is located 42' from BH-837 and 49.5' from the closest culvert. I spoke with Justin Smith during excavation and after finding the well. We both agreed that a flush mount wellhead would be best here if the well is not abandoned, which brings me to my

next point. **Well BH-836 is dry and/or partially filled with dirt that no doubt fell in after the accident. I recommend abandoning this well if possible.**

Well BH-836 upon discovery:

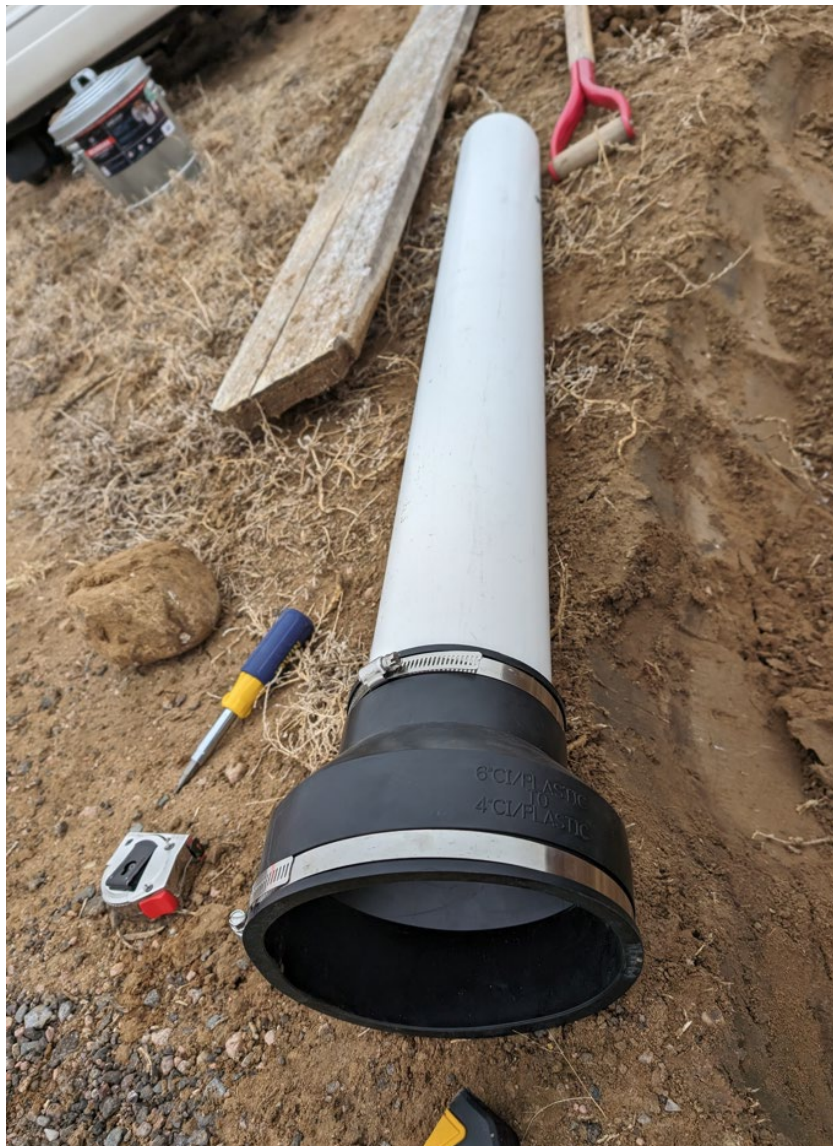
Temporary extension:

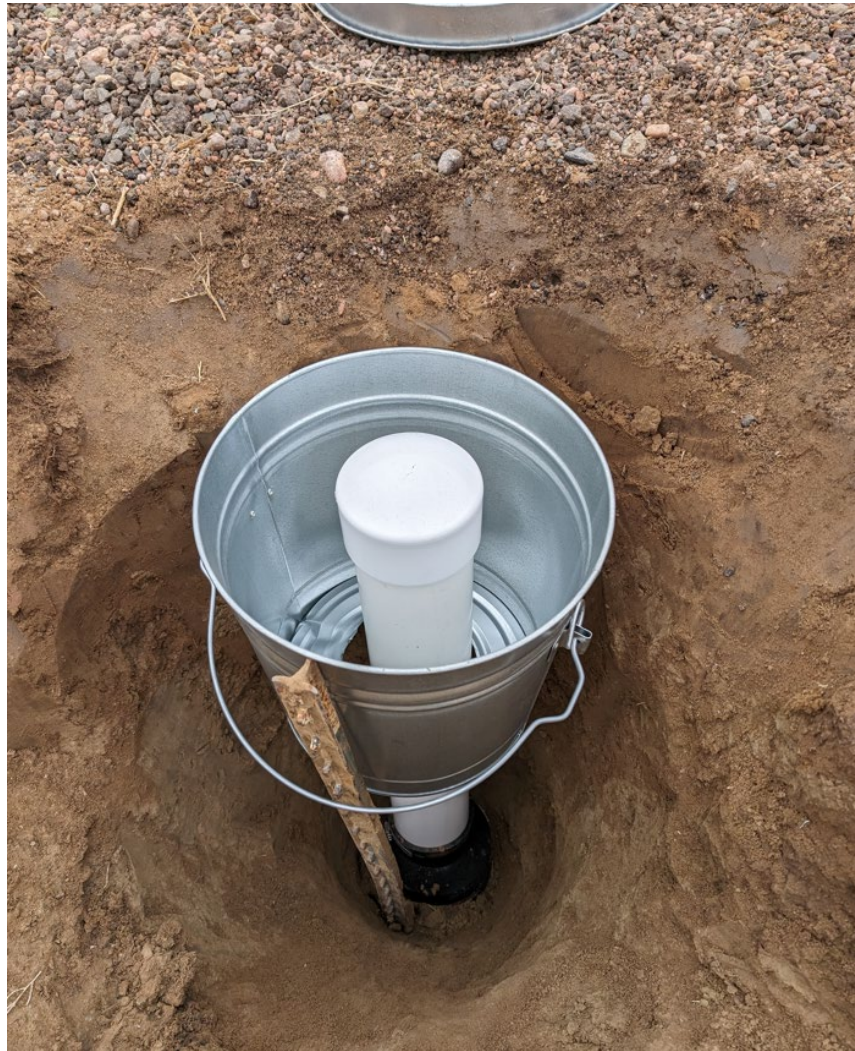
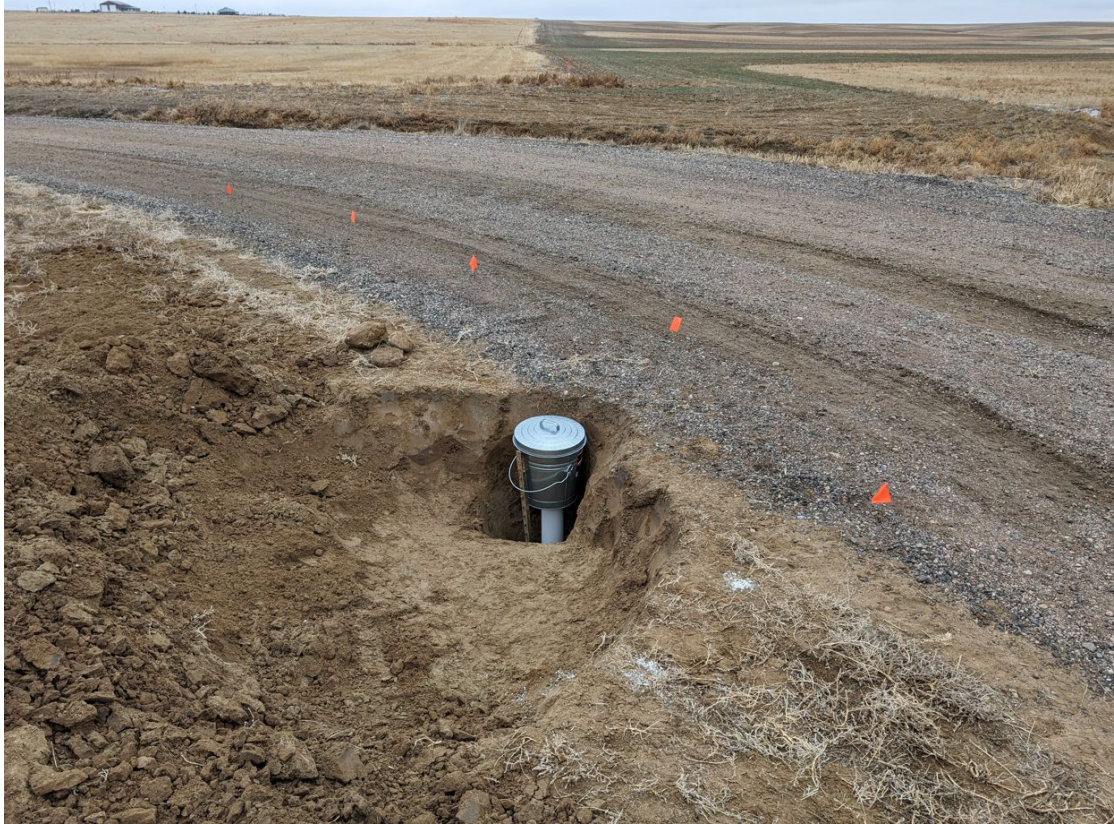
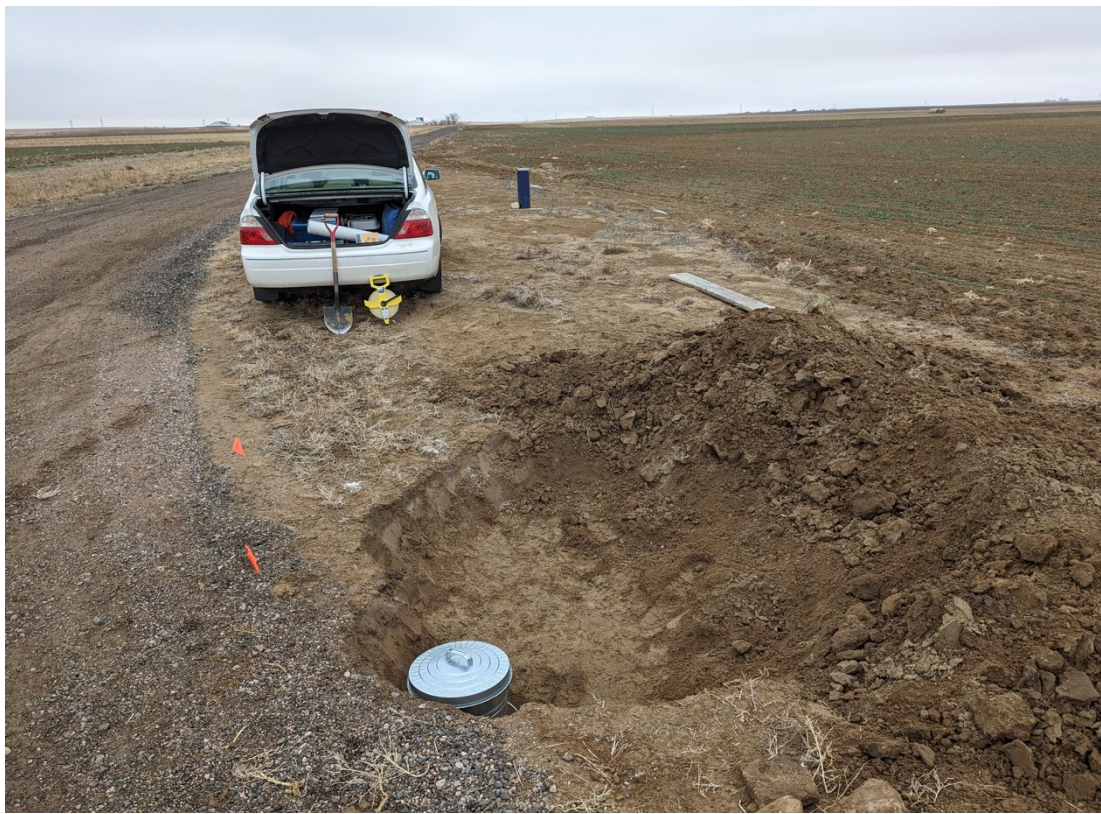
Temporary extension and cover installed:

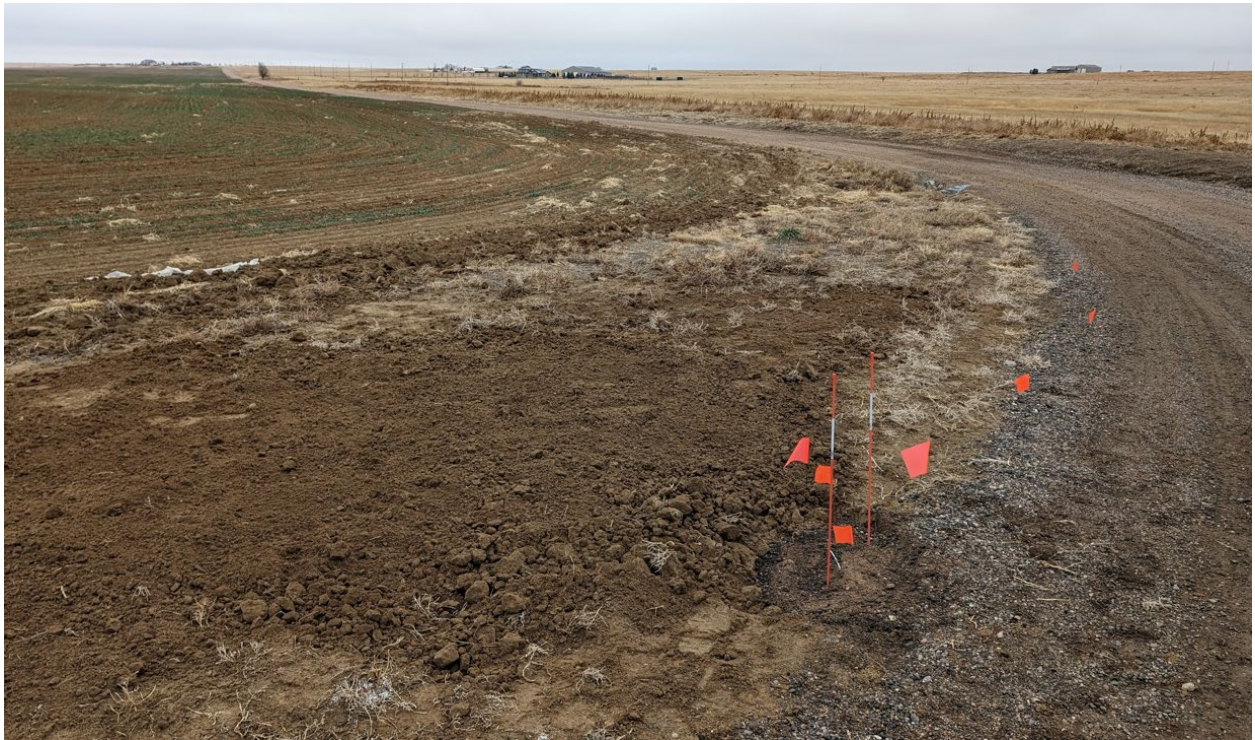
BH-836 after well cover installed and excavation filled back in:
