MINERALS PROGRAM INSPECTION REPORT
PHONE: (303) 866-3567

MINE NAME: Jones Pit East	MINE/PROSPECTING ID#: M-1987-009	MINERAL: Sand and gravel	COUNTY: Prowers
INSPECTION TYPE: Monitoring	WEATHER: Clear	INSP. DATE: February 14, 2024	INSP. TIME: 13:00
OPERATOR: Prowers County	OPERATOR REPRESENTATIVE: None	TYPE OF OPERATION: 112c - Construction Regular Operation	
REASON FOR INSPECTION: Normal I&E Program	BOND CALCULATION TYPE: None	BOND AMOUNT: \$0.00	
DATE OF COMPLAINT: NA	POST INSP. CONTACTS: None	JOINT INSP. AGENCY: None	
INSPECTOR(S): Zach Trujillo	INSPECTOR'S SIGNATURE:

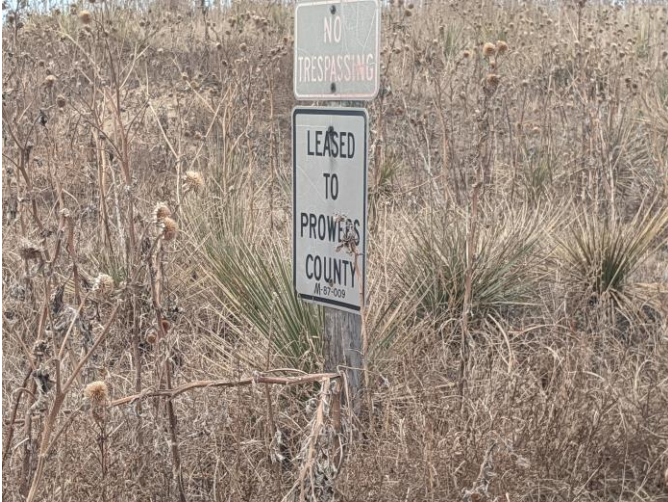
Mine identification sign.

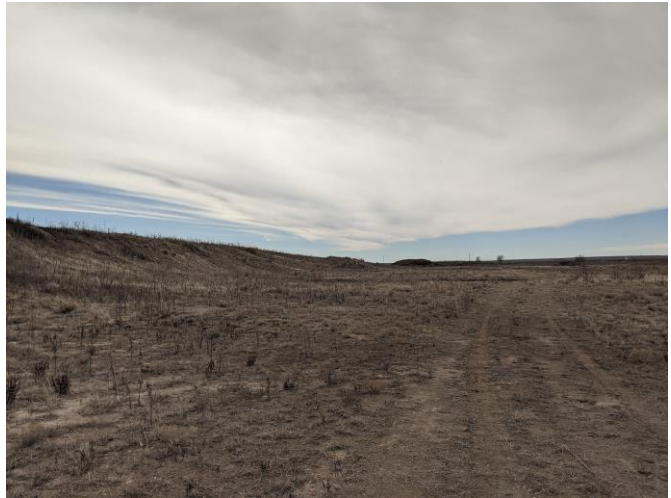
Pit area looking south.

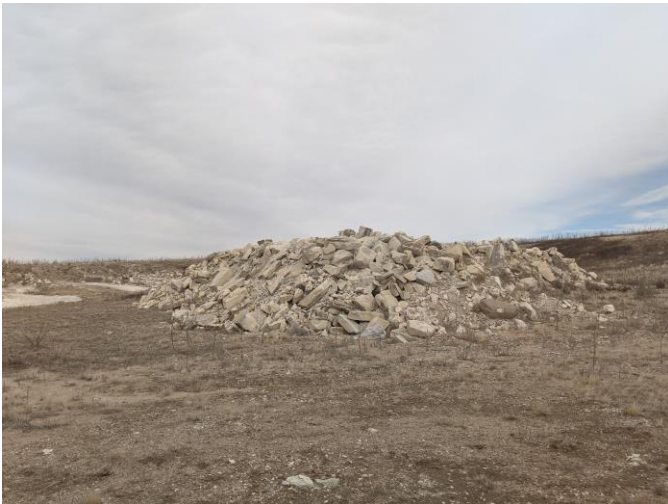
Material stockpile on site.
