## Additional Information Required, 4Q2023 GW/SW Monitoring Report, Cresson Project, M1980-244

**Photographic Log - GV06 021224.pdf**

## PHOTOGRAPHIC LOG

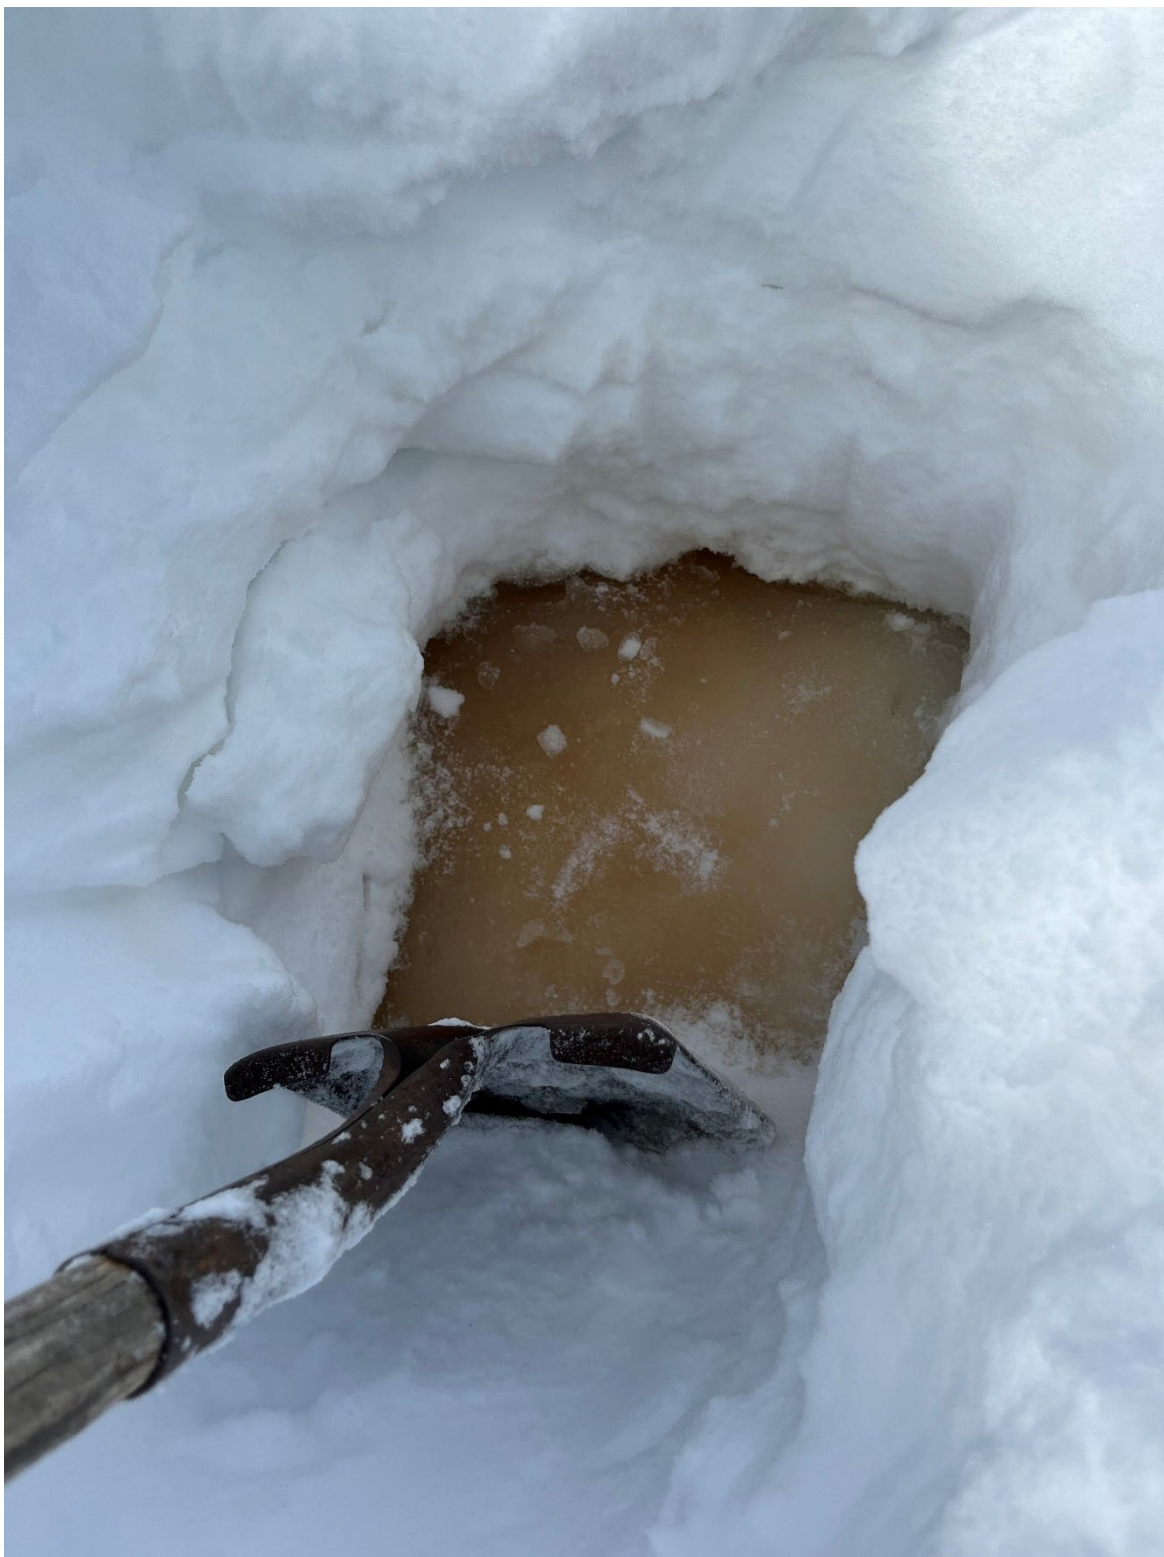
Photograph 1: View of the GV-06 surface water monitoring location, showing the frozen water in the drainage

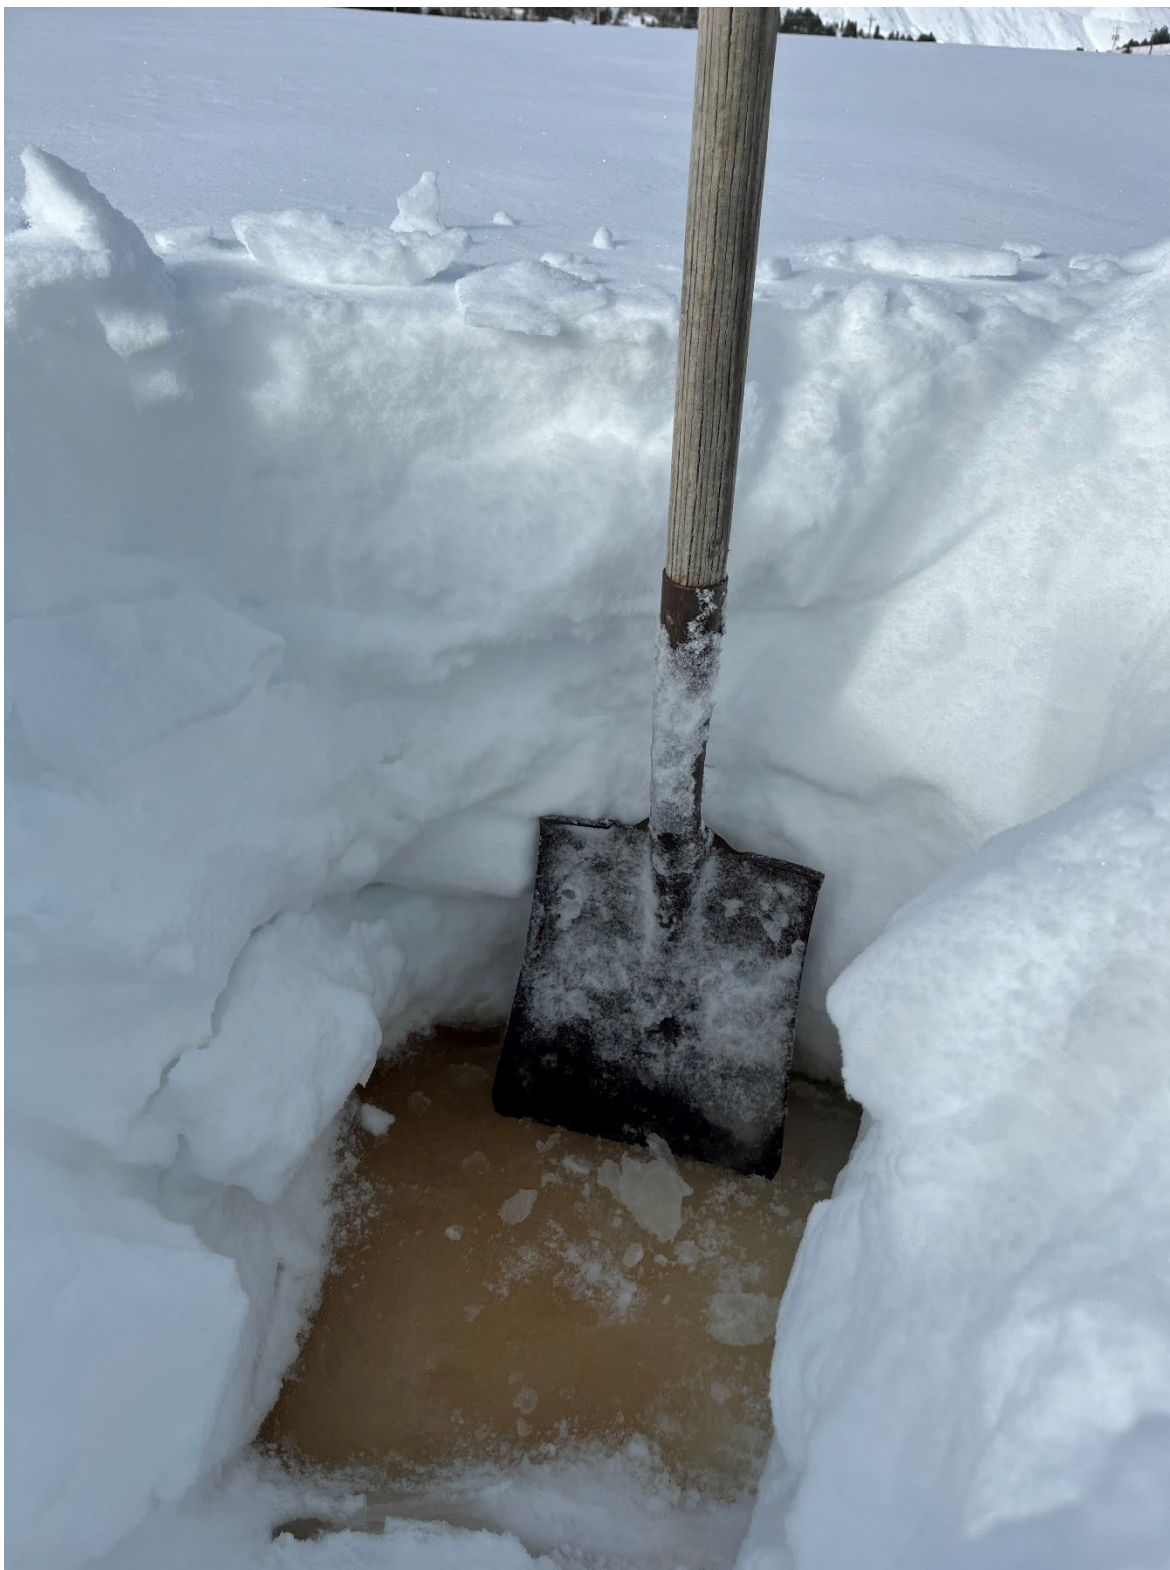
Photograph 2: View of the GV-06 surface water monitoring location, showing the accumulation of snow compared to a standard shovel

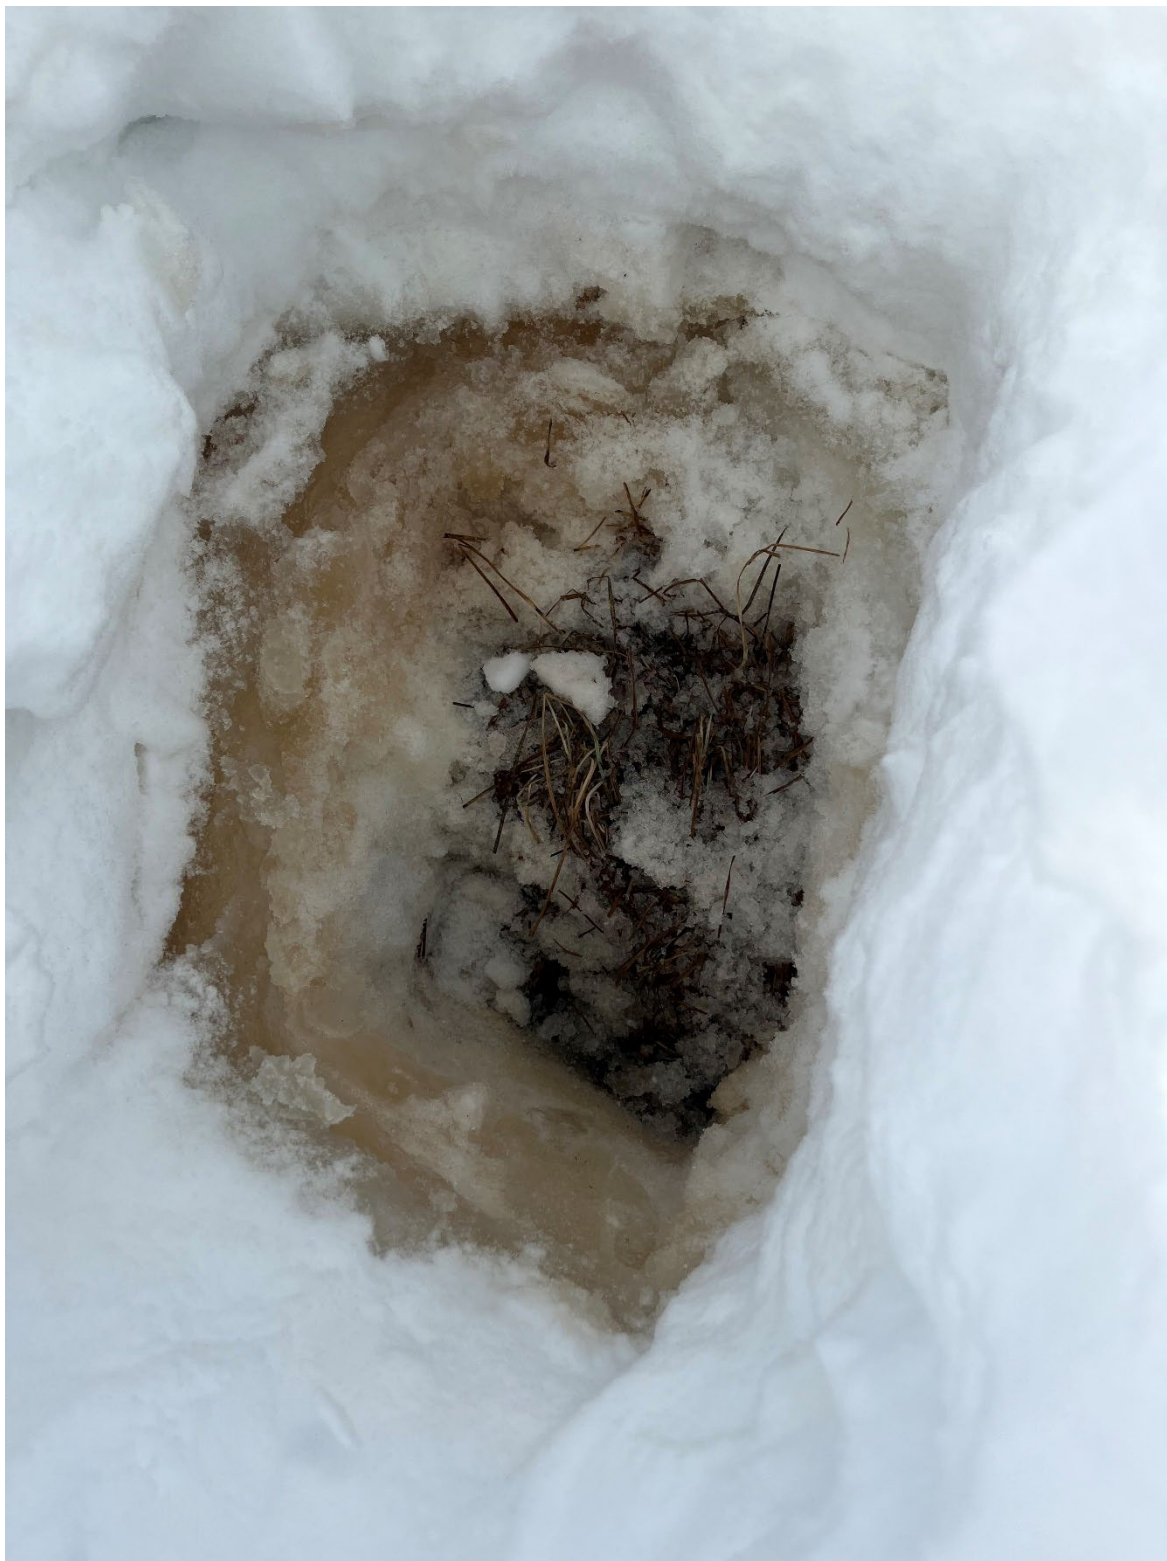
We investigated GV-06 today, as requested in item #10. The drainage is frozen and covered in ~3 feet of snow. We dug down to the ground level and broke through the ice, but no flow was observed. We will continue to monitor the location weekly until a sample can be collected. Attached is a photographic log from today's investigation. I'll keep you updated on our findings in the coming weeks at the GV-06 monitoring location. Additionally, we will include a formal response to item #10 in the follow up submittal for the additional information request. Let me know if you have questions. Thank you!

Photograph 3: View of the GV-06 surface water monitoring location after layer of ice was removed. No flowing water was observed at the location.
