Additional Information Required, 4Q2023 GW/SW Monitoring Report, Cresson Project, M1980-244

Attached is photo documentation of our inspection of the GV-06 location today. No flowing water was observed. We will plan on inspecting the location on Mondays moving forward; I will let you know if the schedule changes. Let me know if you have questions and thank you.

**Photographic Log - GV06 021924.pdf**
1229K

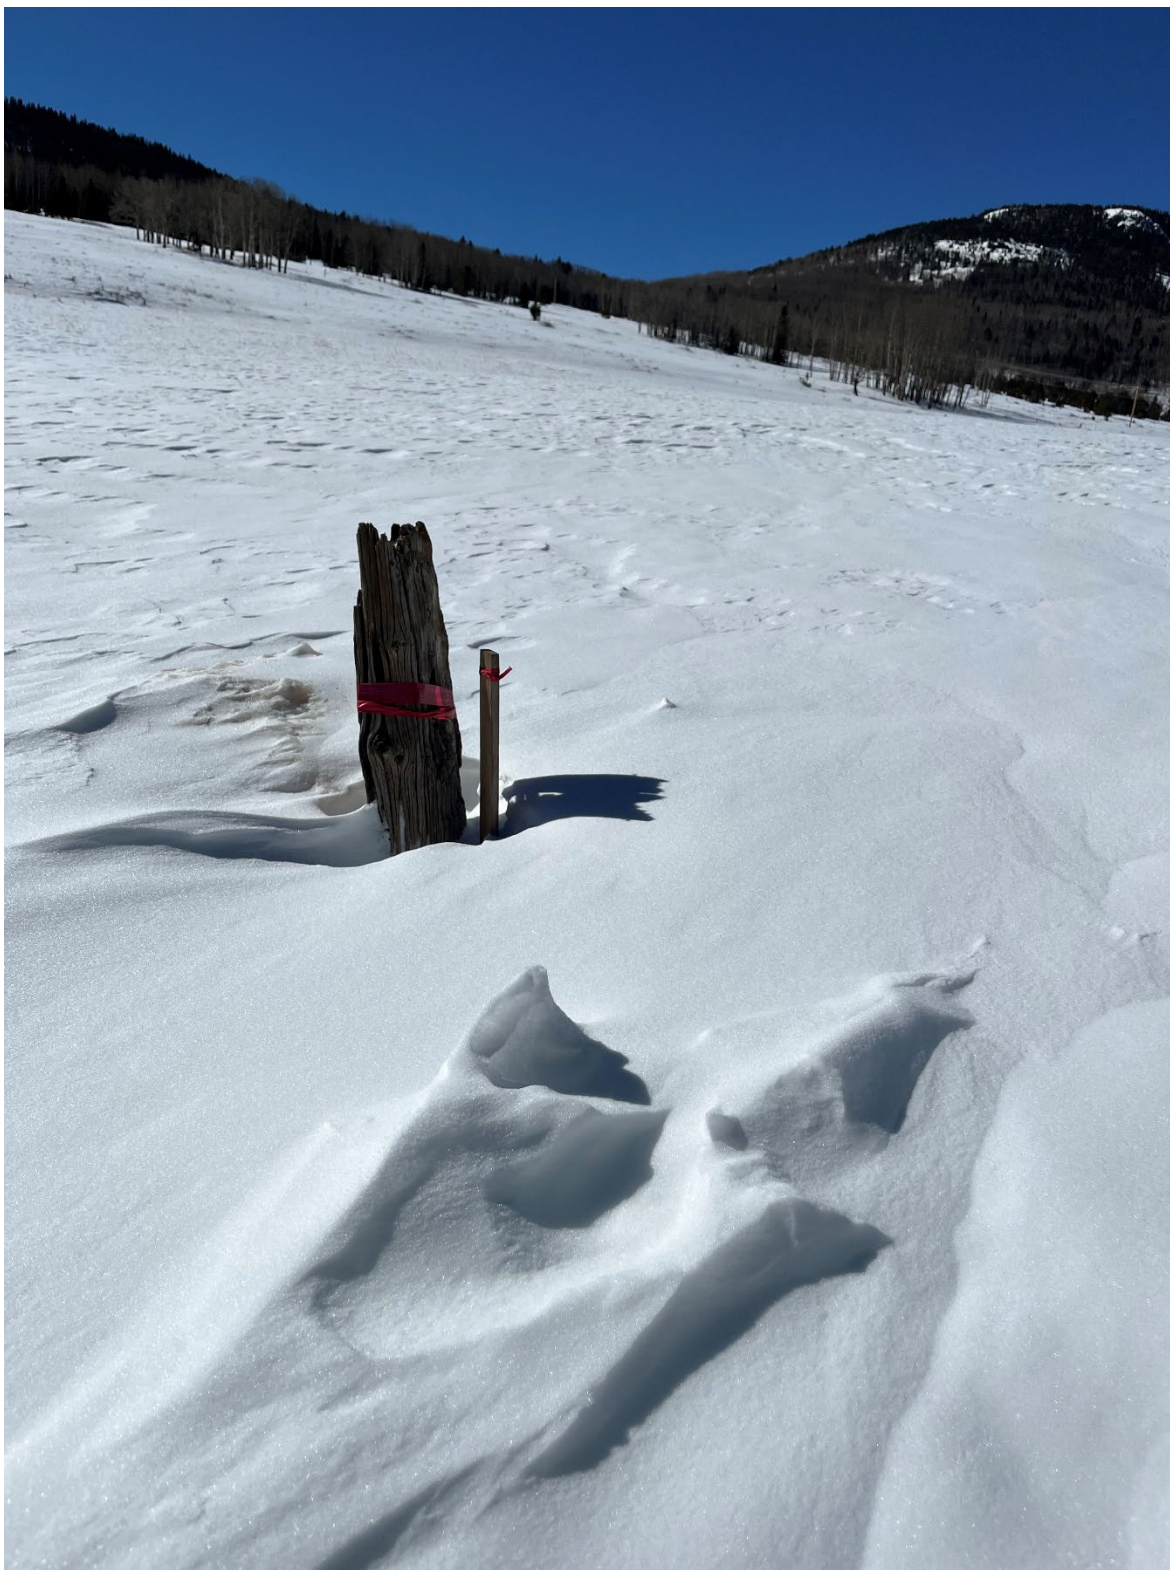
Photograph 2: View of the GV-06 surface water monitoring location, looking southwest

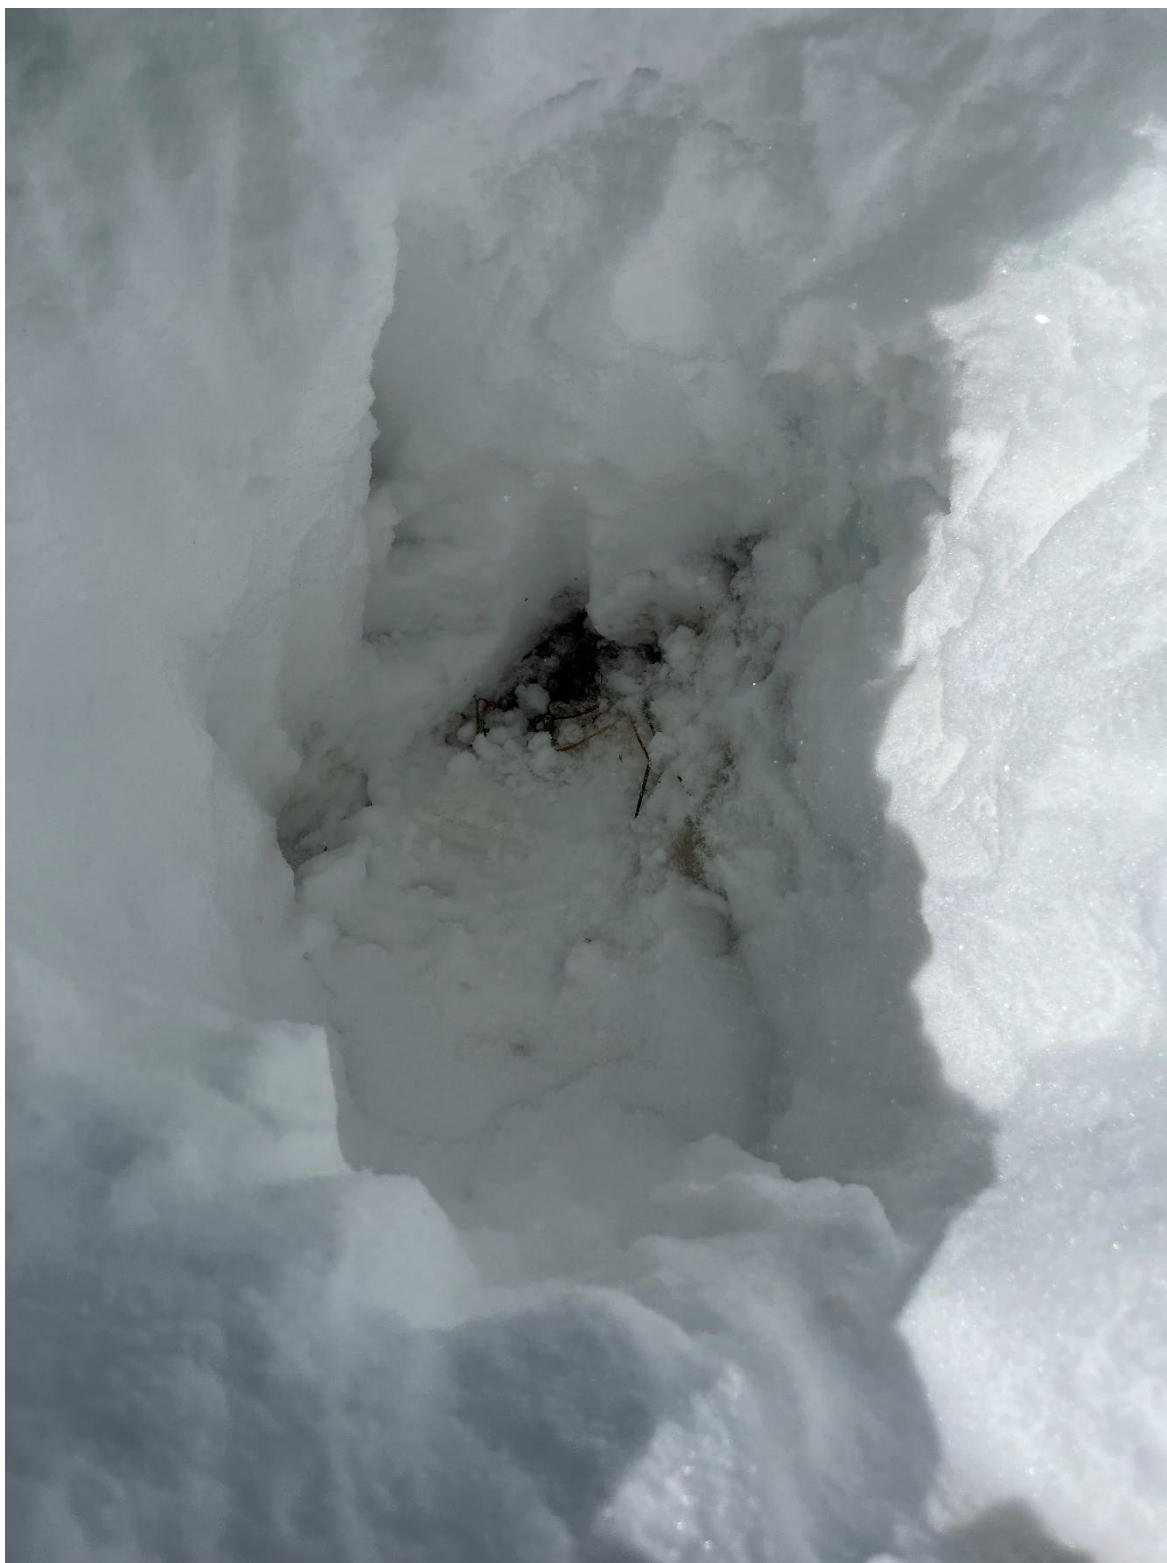
Photograph 3: View of the GV-06 surface water monitoring location after layer of ice was removed. No flowing water was observed at the location.

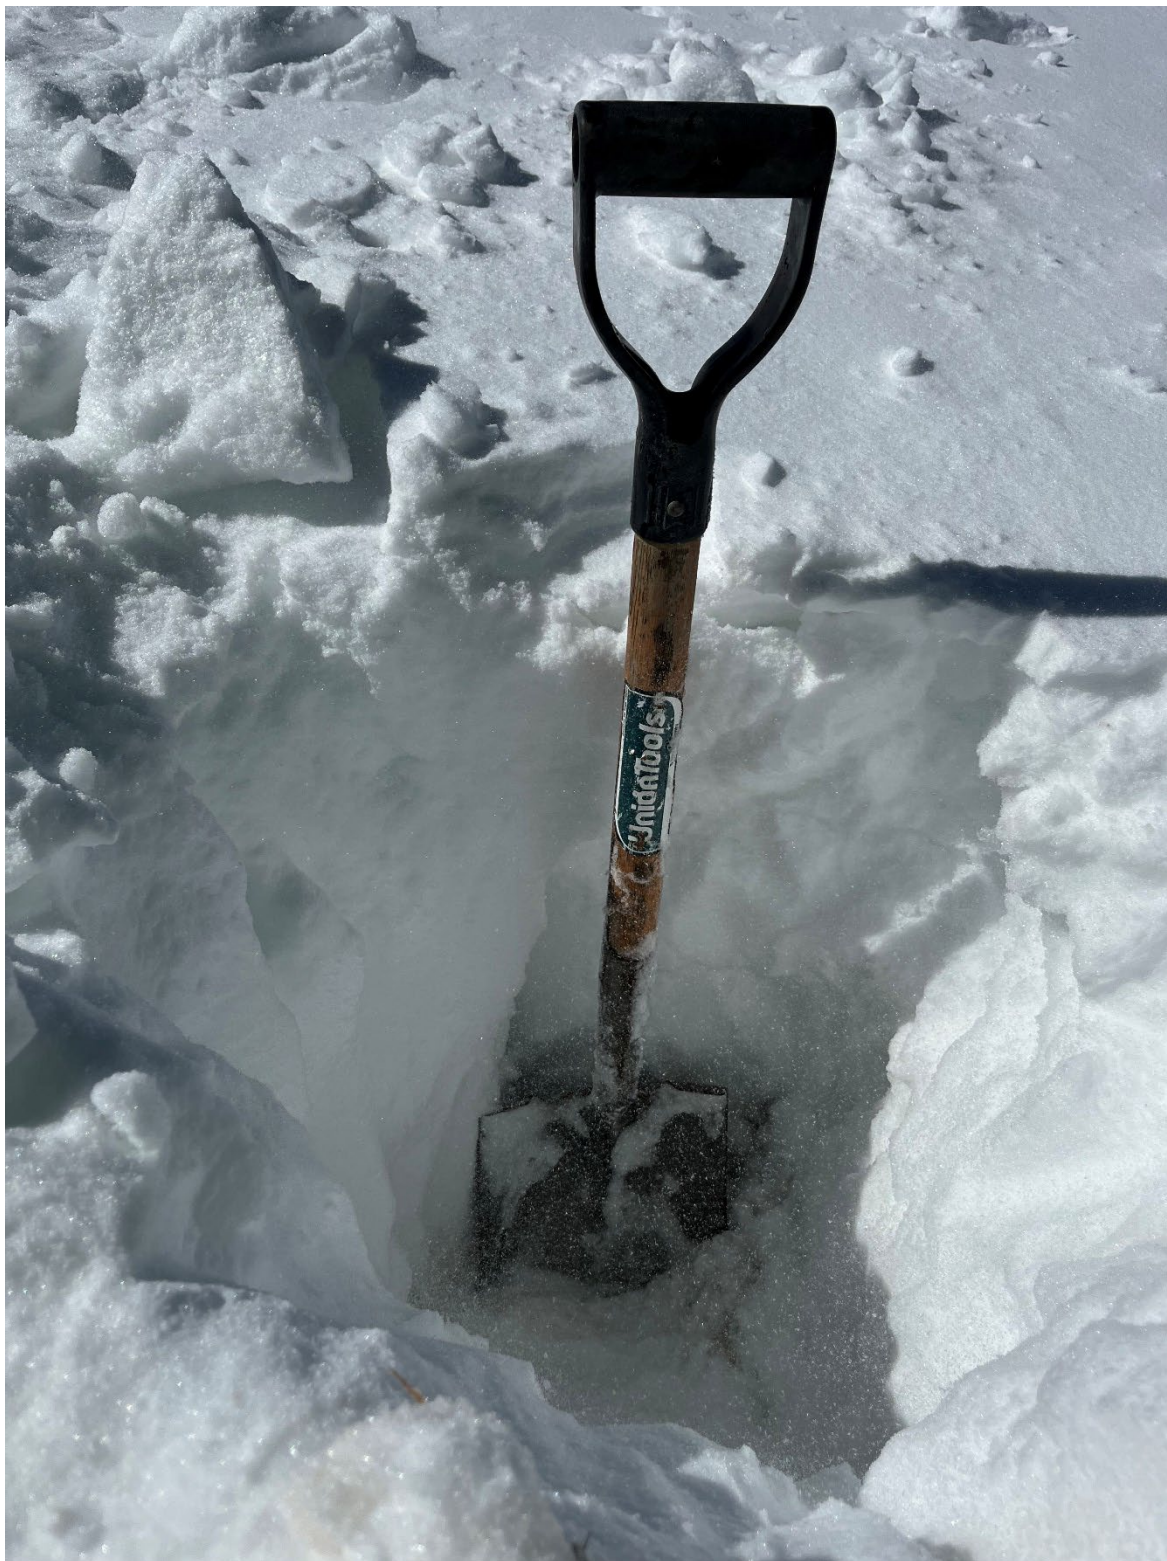
Photograph 3: View of the GV-06 surface water monitoring location showing the depth of the snow.

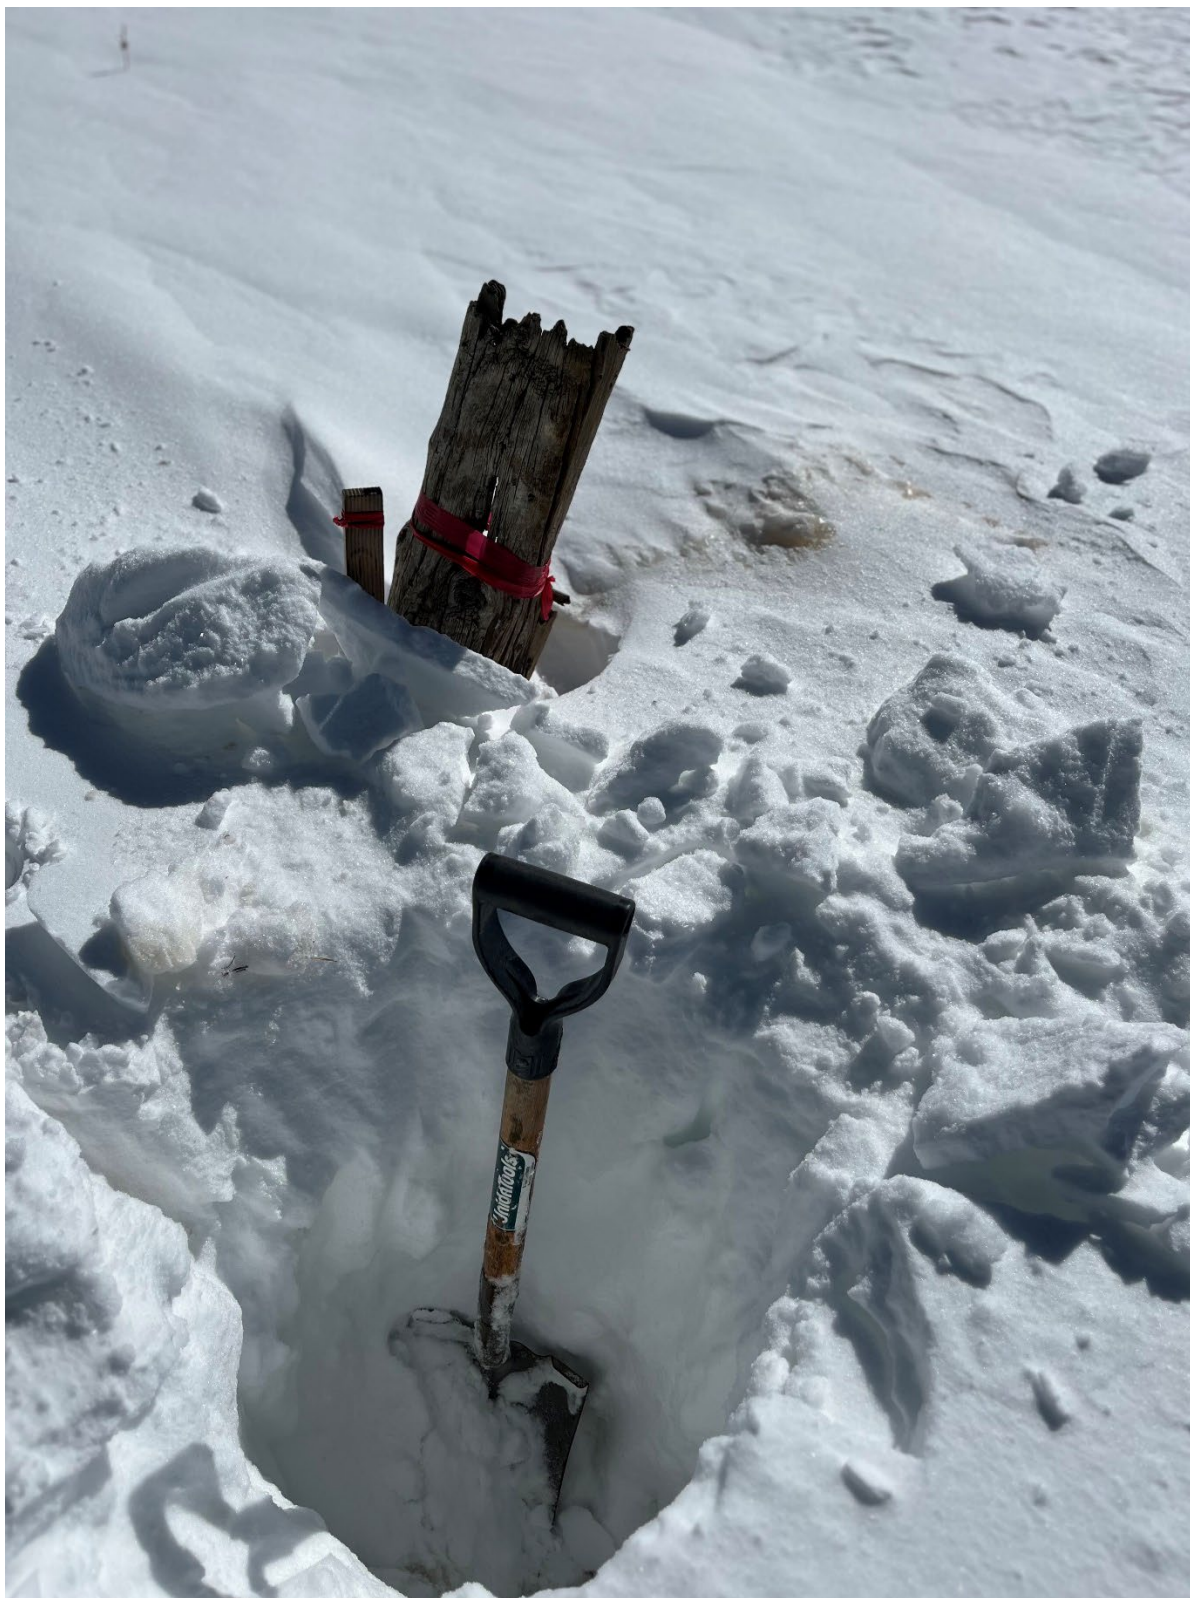
Photograph 3: View of the GV-06 surface water monitoring location. No flowing water was observed at the location.
