**RE: North of Douglas Pass, Permit No. M-1981-043, Unresolved Problem(s) Noted in a Past Inspection Report -2**

**MINERALS PROGRAM INSPECTION REPORT**  
**PHONE: (303) 866-3567**

<b>MINE NAME:</b> N Of Douglas Pass	<b>MINE/PROSPECTING ID#:</b> M-1981-043	<b>MINERAL:</b> Shale	<b>COUNTY:</b> Rio Blanco
<b>INSPECTION TYPE:</b> Monitoring	<b>WEATHER:</b> Clear	<b>INSP. DATE:</b> October 24, 2023	<b>INSP. TIME:</b> 12:40
<b>OPERATOR:</b> Colorado Department of Transportation	<b>OPERATOR REPRESENTATIVE:</b> None	<b>TYPE OF OPERATION:</b> 110c - Construction Limited Impact	
<b>REASON FOR INSPECTION:</b> Normal I&E Program	<b>BOND CALCULATION TYPE:</b> None	<b>BOND AMOUNT:</b> \$0.00	
<b>DATE OF COMPLAINT:</b> NA	<b>POST INSP. CONTACTS:</b> DRMS	<b>JOINT INSP. AGENCY:</b> U.S.BLM	
<b>INSPECTOR(S):</b> Amy Yeldell	<b>INSPECTOR'S SIGNATURE:</b>

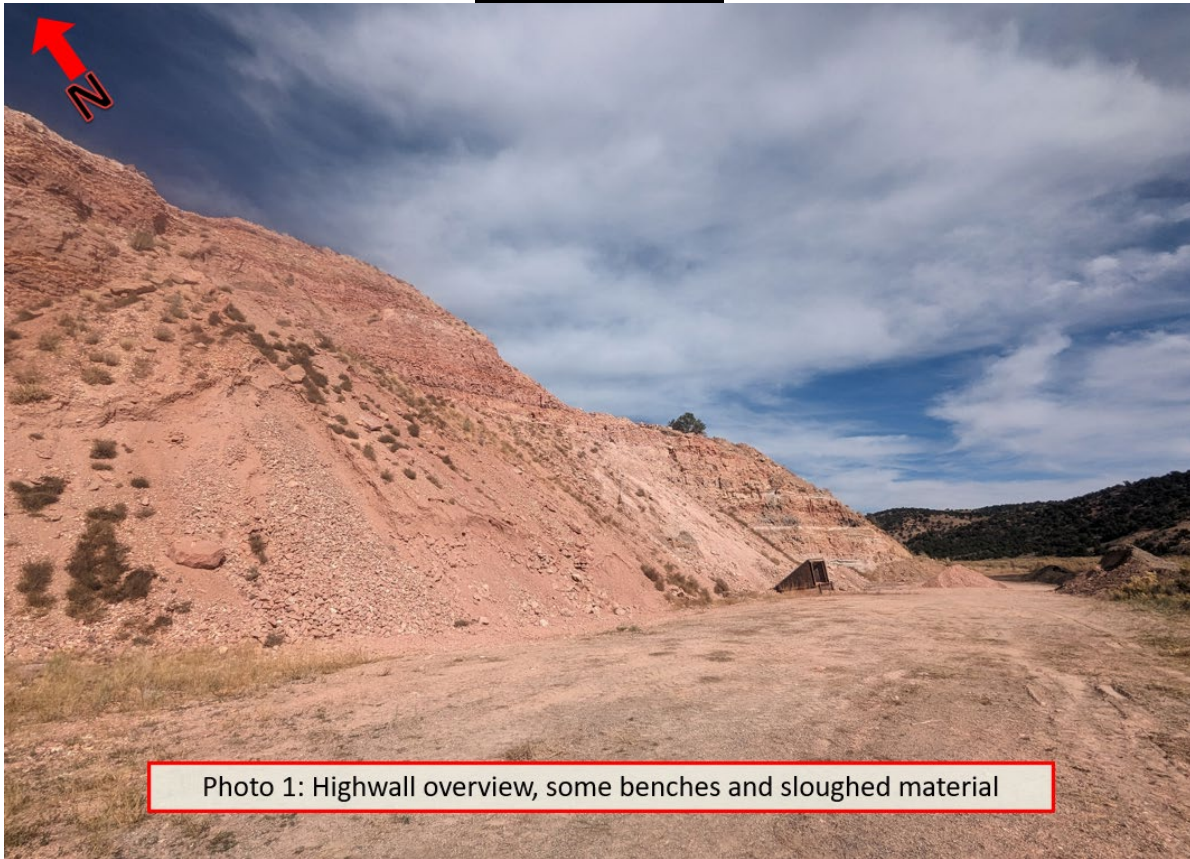
Near vertical highwalls have been excavated (Photo One). There is some small interstitial benching of the highwall and one main bench on the eastern side (Photo Three). There is a road on the east side to access the top of the highwall. The main bench serves as a switch back on the access road.

Photo 1: Highwall overview, some benches and sloughed material

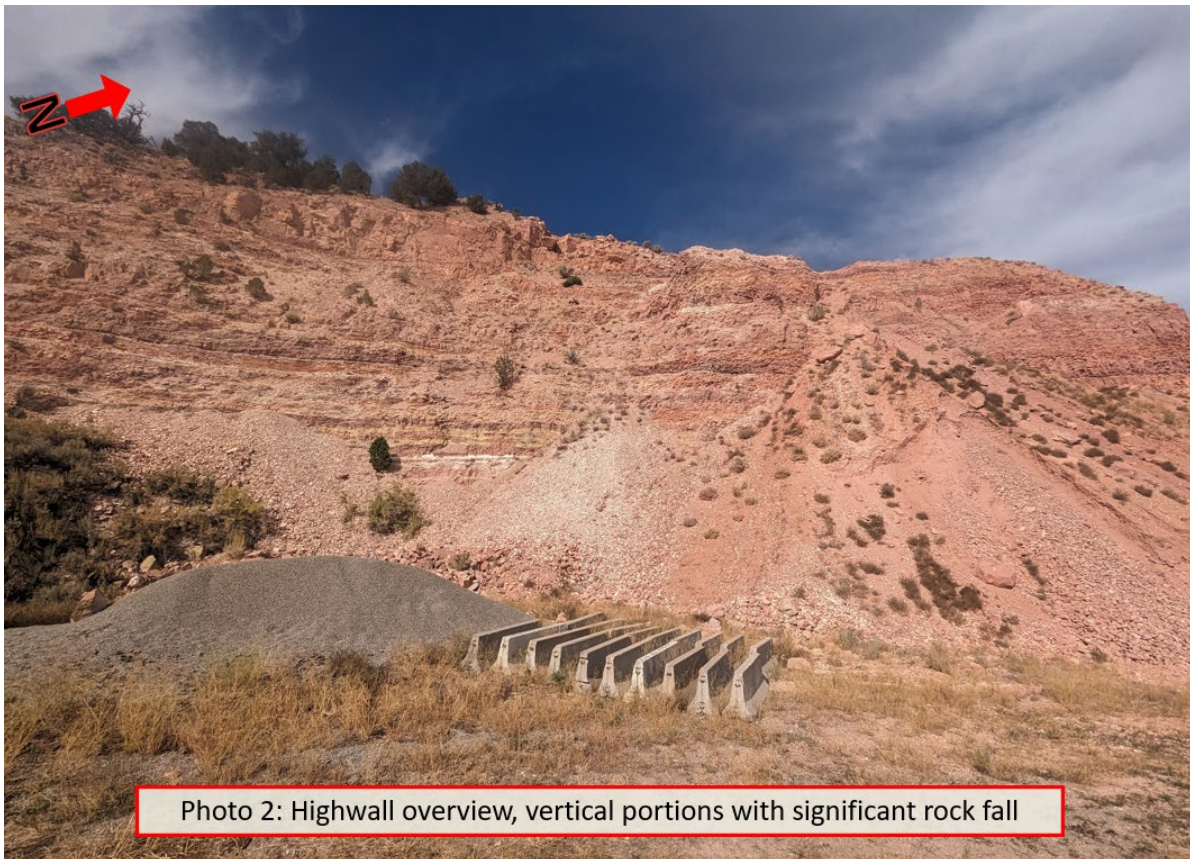
In several areas rocks and loose soils were observed falling and sloughing off throughout the inspection. A large amount of rockfall material is located at the base of the highwalls (Photo Two). It is unclear if this was by design or sloughing over time. While the site is approved to leave slopes at 1.5H: 1V they must be stable. If rock slopes are not stable catch benches may be necessary.

Photo 2: Highwall overview, vertical portions with significant rock fall

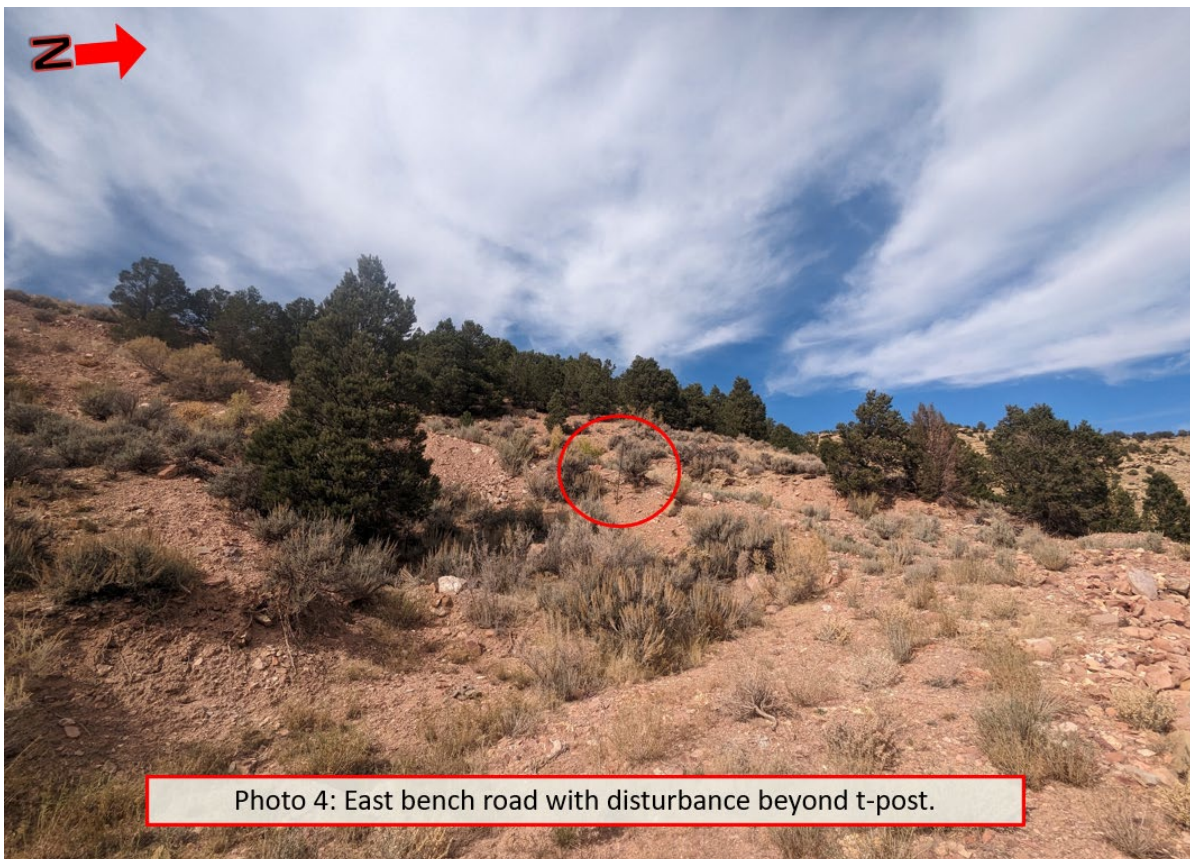
There may be off site damage. The Division was unable to fully delineate the permit boundary. However several t-posts that appeared to be boundary markers were observed. Disturbances were observed beyond those markers (Photo Four). In order to conduct reclamation activities additional land may be necessary where mining extends up to permit boundary. See additional comment under Signs and Markers section.

The permit boundary of the affected land was not sufficiently delineated as required by Rule 3.1.12(2). This is cited as an inspection problem. Only a few markers were observed. Along the west side of the highwall access road several t-post were observed on both sides of the road cut. And most notable there was a t-post on the edge of the highwall with additional disturbances to the north (behind it). In several instances disturbances were observed on both sides of the t-post markers indicating a potential for offsite impacts (Photos Four – Seven).

**CORRECTIVE ACTIONS:** The operator shall 1) conduct a survey and replace the boundary markers in the correct location(s). 2) Provide a map which correlates to the photographic documentation of location points. 3) And include a cover letter declaring if all disturbance were contained within the permit boundary OR if land has been affected outside of the approved permit boundary. The operator shall provide this corrective action documentation to the Division by the corrective action deadline.

Please field delineate the approved 7.8 ac permit boundary (AM-1 in 1999 revised). Provide the Division with photo documentation that all boundary markers have been replaced by the corrective action deadline on page 2 of this report. Provide a map which correlates to the photographic documentation of location points. Additionally include a cover letter declaring if all disturbance were contained within the permit boundary OR if land has been affected outside of the approved permit boundary. Affected lands is defined by Rule 1.1(3)

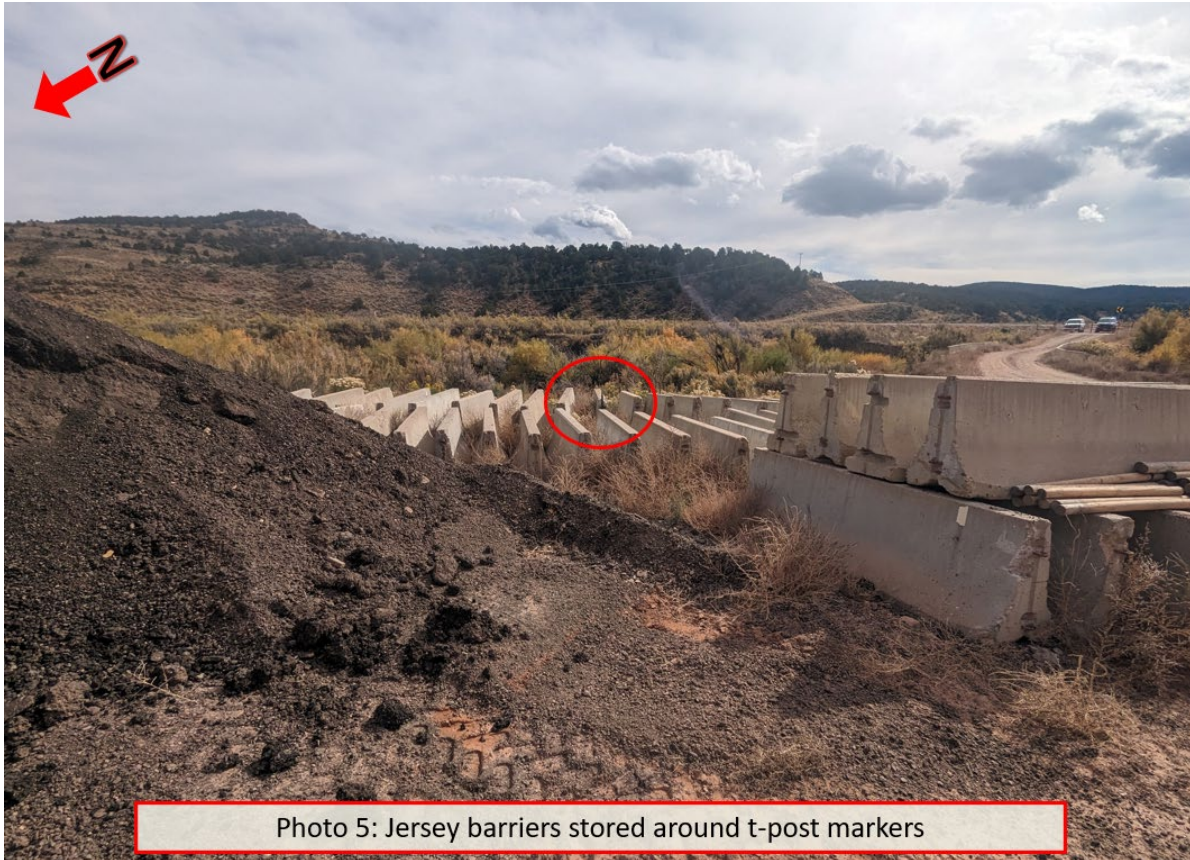
Several jersey barriers are being stored on the pit floor. All materials must remain within the affected lands footprint pursuant to Rule 1.1(3). Several of the barrier appeared to be stored around and outside of the affected lands boundary (Photo Five).

Photo 5: Jersey barriers stored around t-post markers

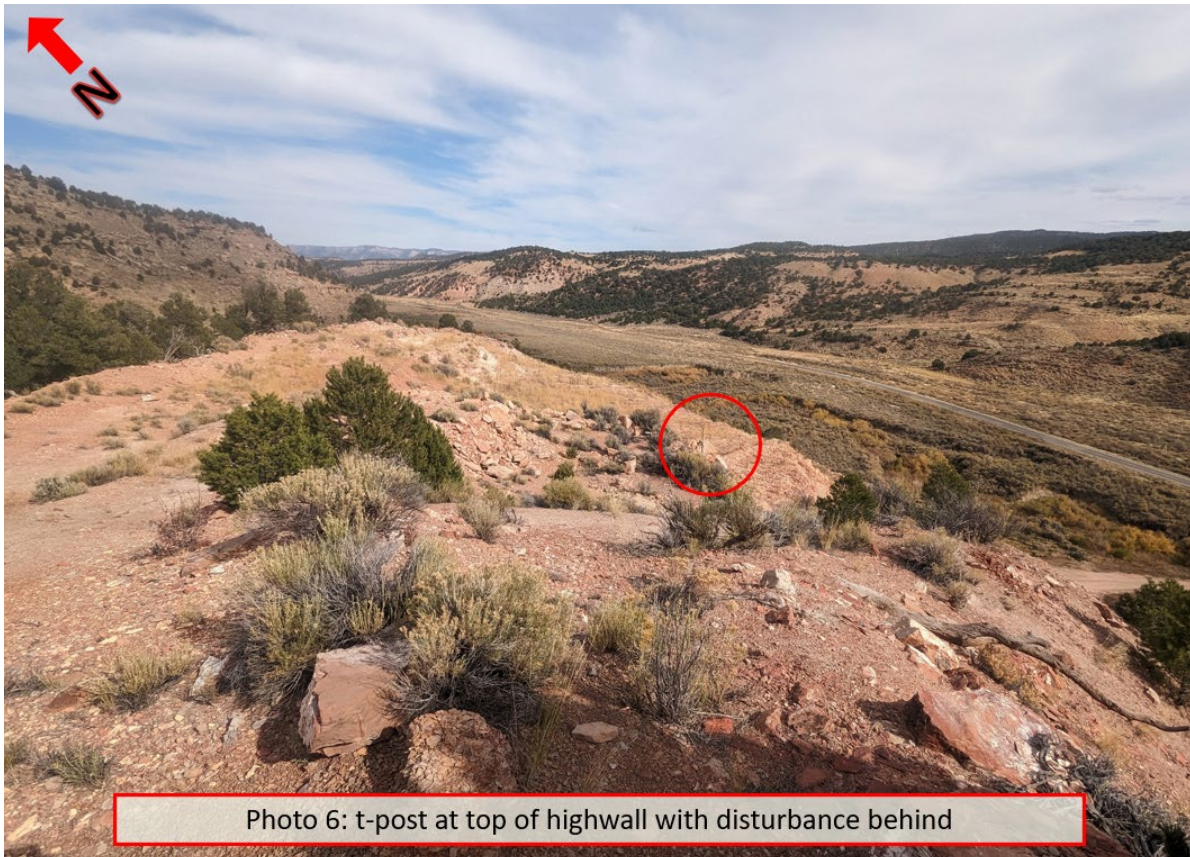
Photo 6: t-post at top of highwall with disturbance behind
