MINERALS PROGRAM INSPECTION REPORT
PHONE: (303) 866-3567

MINE NAME: Monument View Gravel Pit	MINE/PROSPECTING ID#: M-2000-032	MINERAL: Sand and gravel	COUNTY: Mesa
INSPECTION TYPE: Monitoring	WEATHER: Clear	INSP. DATE: February 13, 2024	INSP. TIME: 12:20
OPERATOR: M.A. Concrete Construction, Inc.	OPERATOR REPRESENTATIVE: Andy Azacarraga	TYPE OF OPERATION: 112c - Construction Regular Operation	
REASON FOR INSPECTION: Normal I&E Program	BOND CALCULATION TYPE: None	BOND AMOUNT: \$686,663.00	
DATE OF COMPLAINT: NA	POST INSP. CONTACTS: DRMS	JOINT INSP. AGENCY: None	
INSPECTOR(S): Amy Yeldell	INSPECTOR'S SIGNATURE:

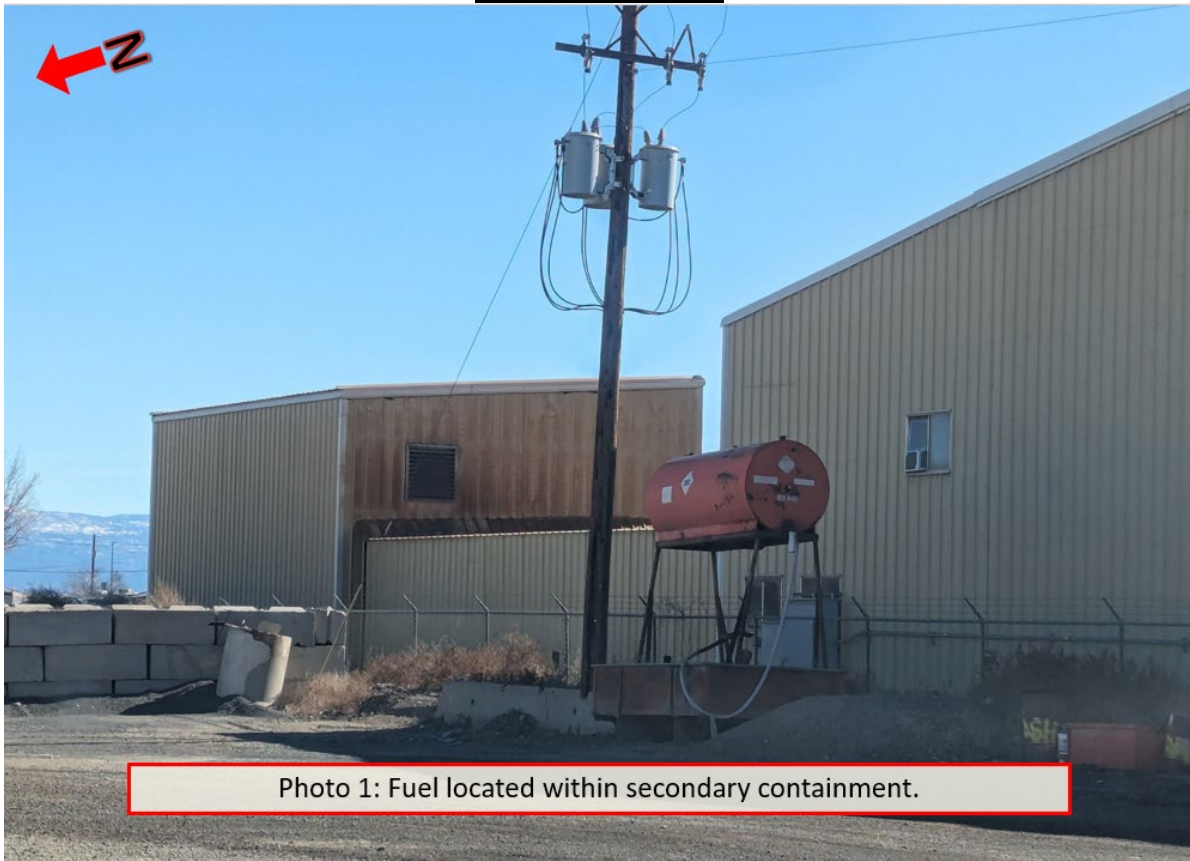
All fuel and other hazardous materials are stored within secondary containment. The primary fuel storage is located along the southern permit boundary (Photo One). Another tank for the crusher is located adjacent to the plant. A third tank is next to the water horse for the pump (Photo Two).

Photo 1: Fuel located within secondary containment.

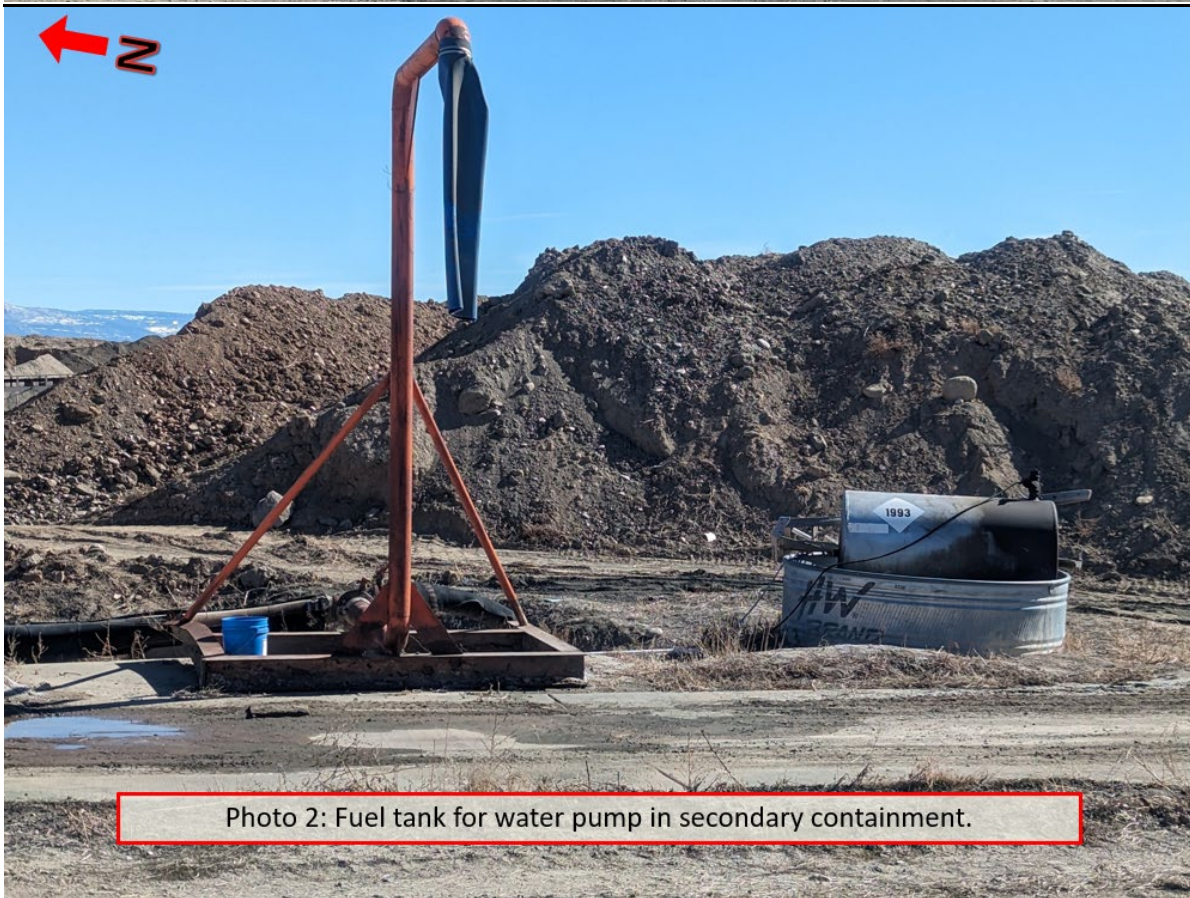
No exposed groundwater was observed. The entire pit is a bowl, so a few small stormwater structures had standing water. On the eastern side of the pit is a water-horse (Photo Two) to provide water for on-site dust suppression.

Photo 2: Fuel tank for water pump in secondary containment.

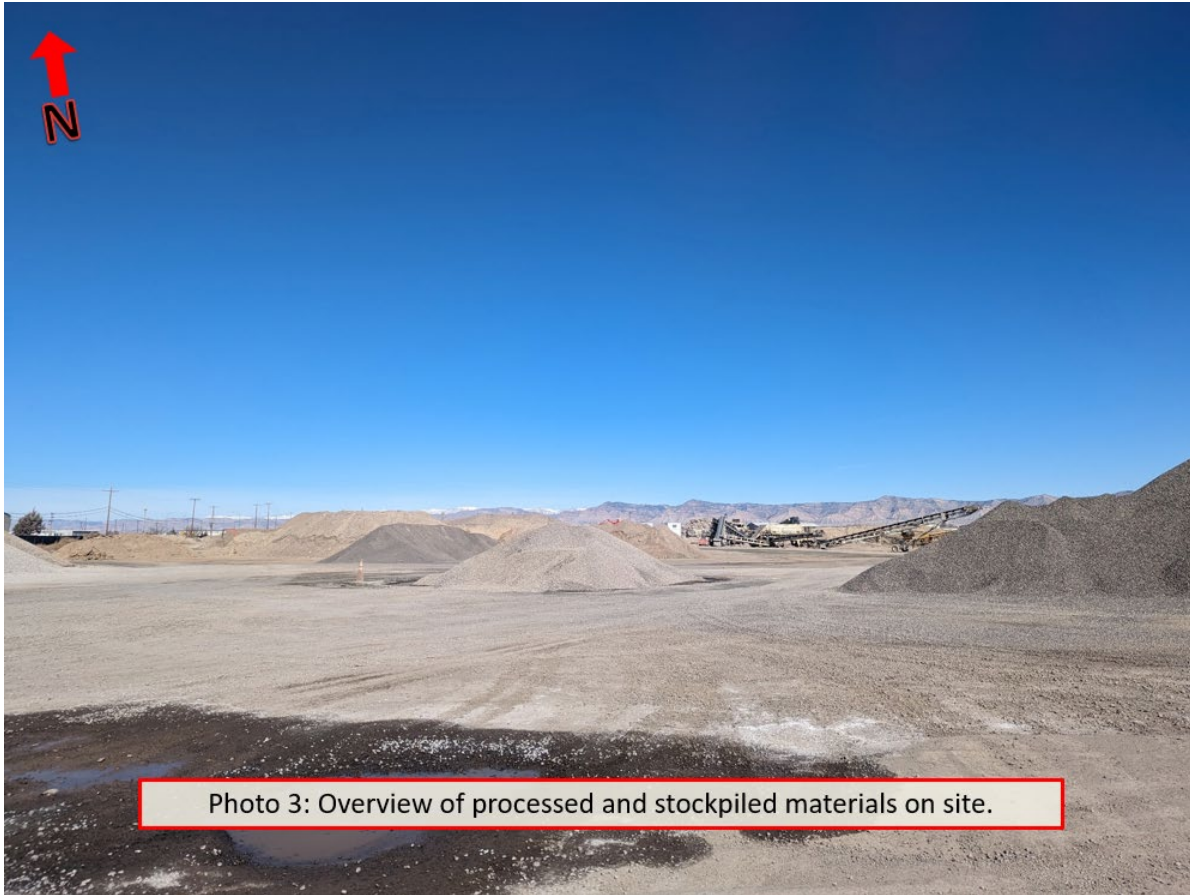
Mining/excavations at this site have concluded. Currently the site is primarily being used to crush/process material (Photos three – Six). Gravel is being imported from the Operators other sites as well as inert materials that are being processed (Photo Seven).

Photo 3: Overview of processed and stockpiled materials on site.

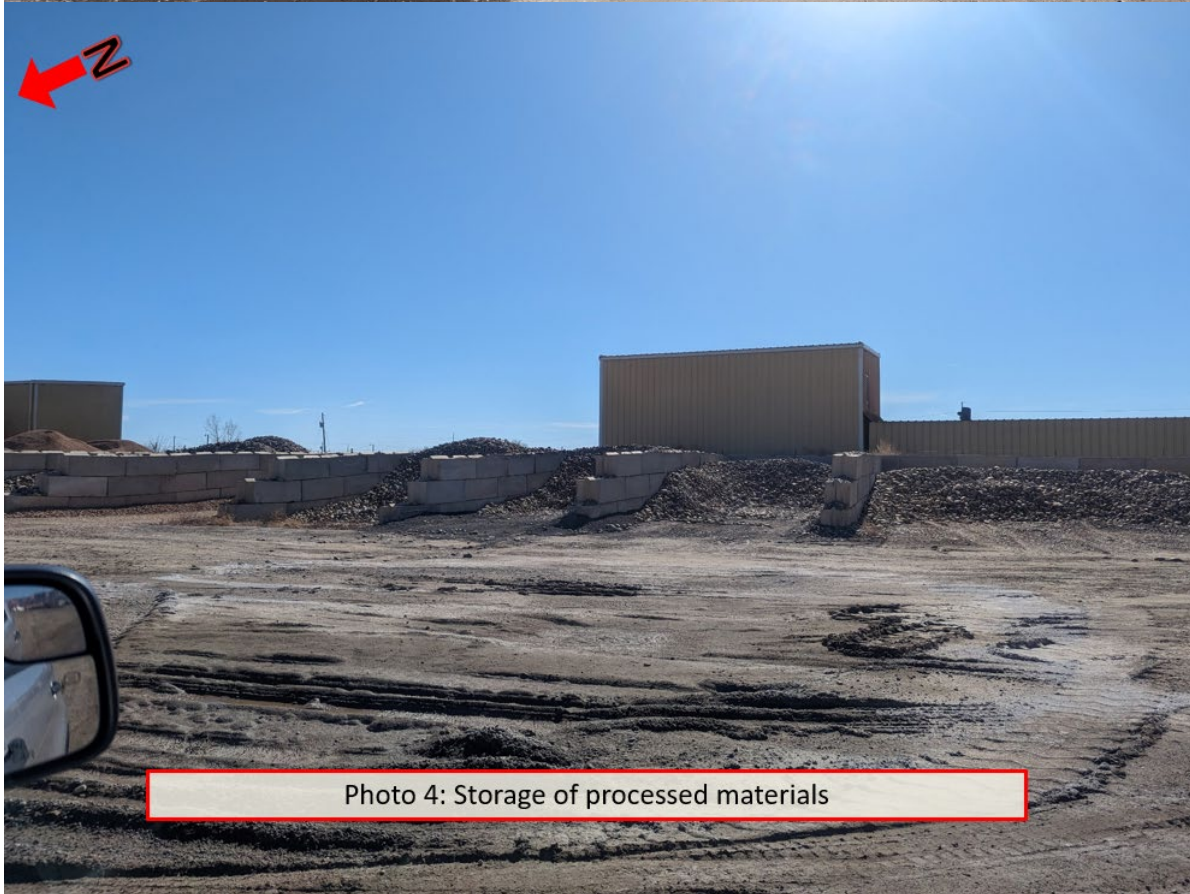
Photo 4: Storage of processed materials

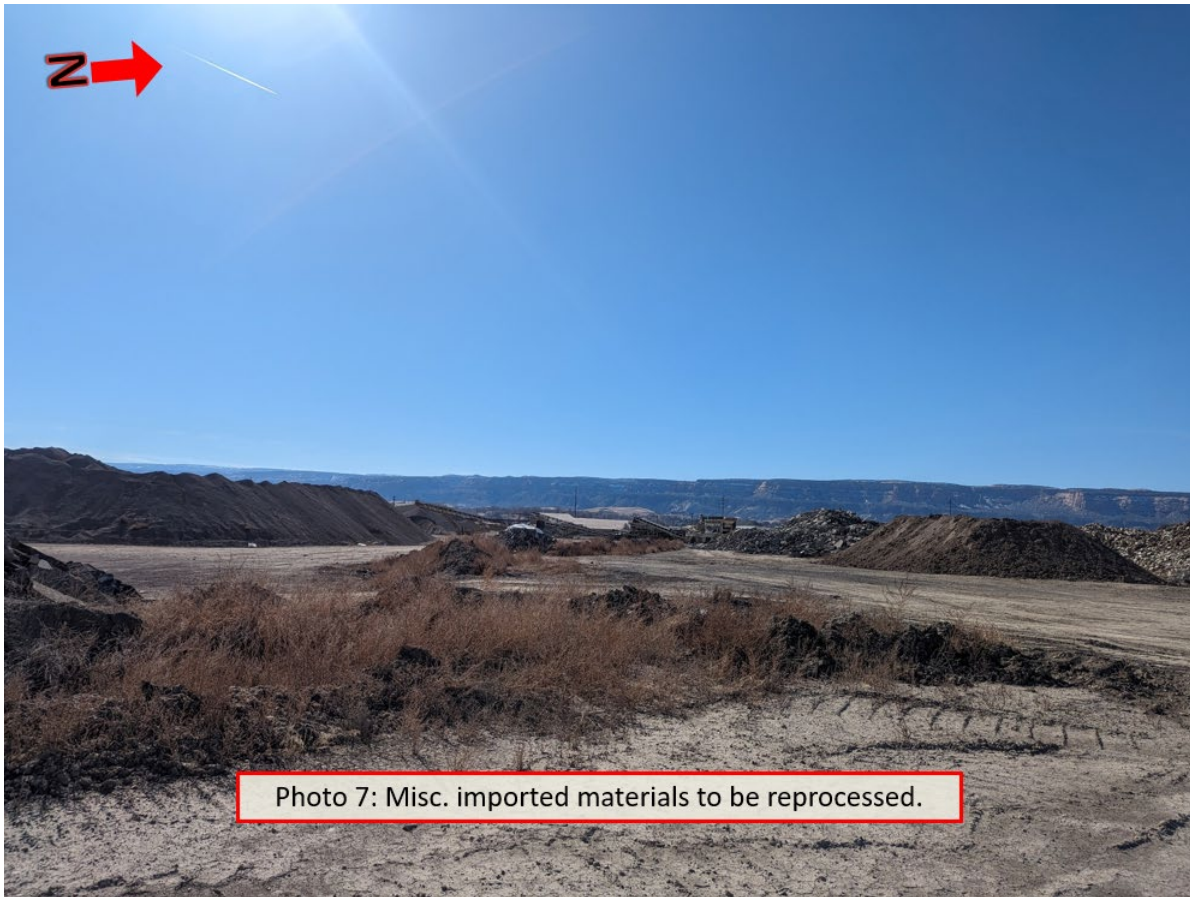
Photo 7: Misc. imported materials to be reprocessed.

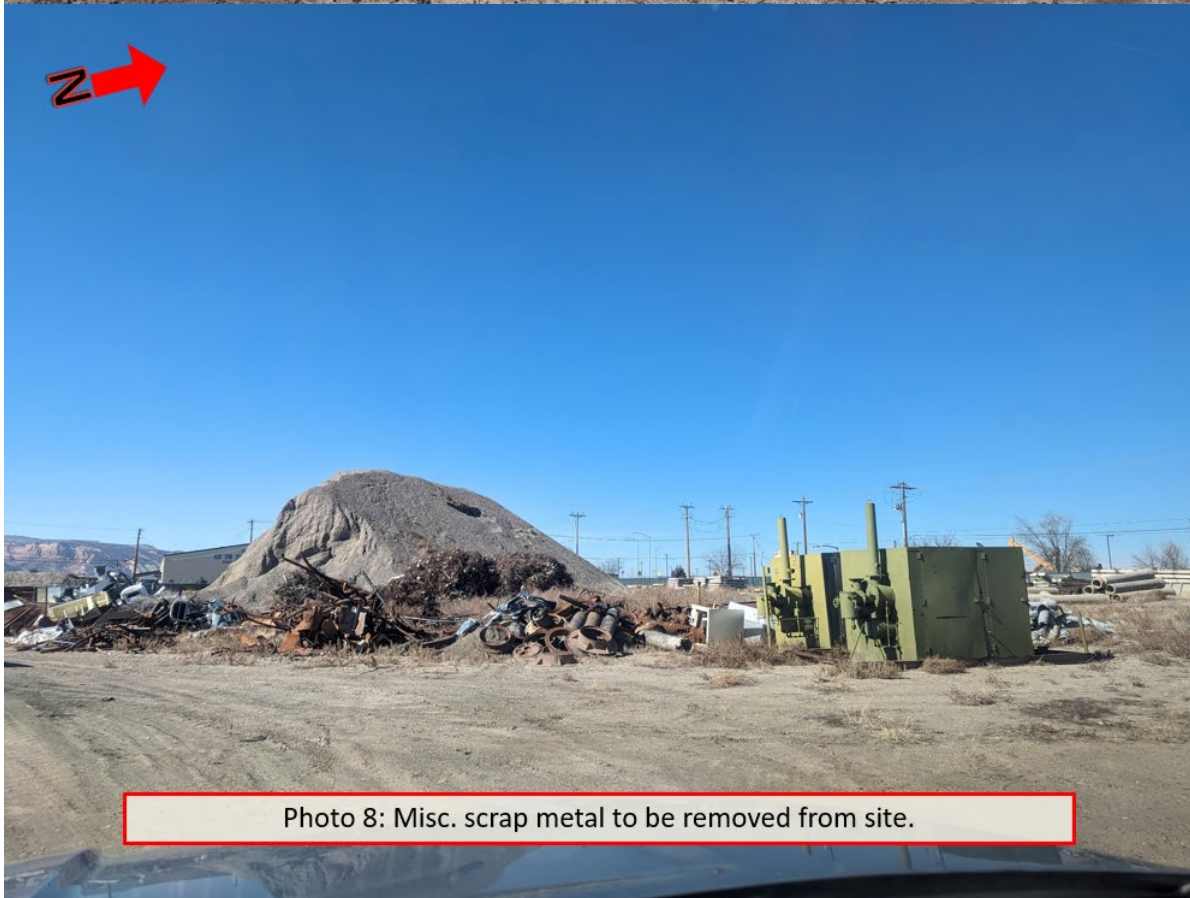
Misc scrap metal is located on site (Photo Eight). This material should be removed from site periodically to avoid excessive stockpiling.

Photo 8: Misc. scrap metal to be removed from site.

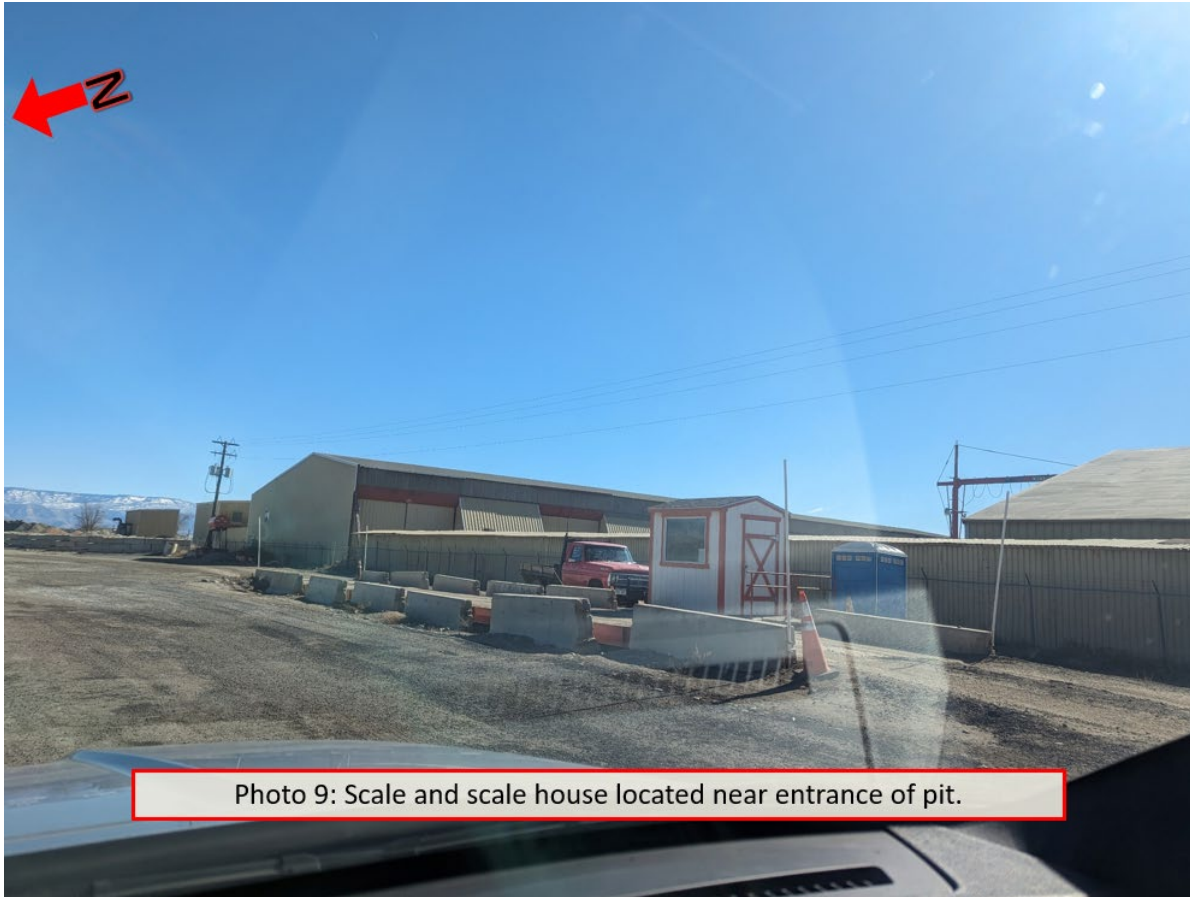
A scale and scale house are located near the pit entrance (Photo Nine). Several processing plants are located throughout the pit. No other permanent structures exist. There is a small temporary wooden shed on the north east side of the pit.

Photo 9: Scale and scale house located near entrance of pit.

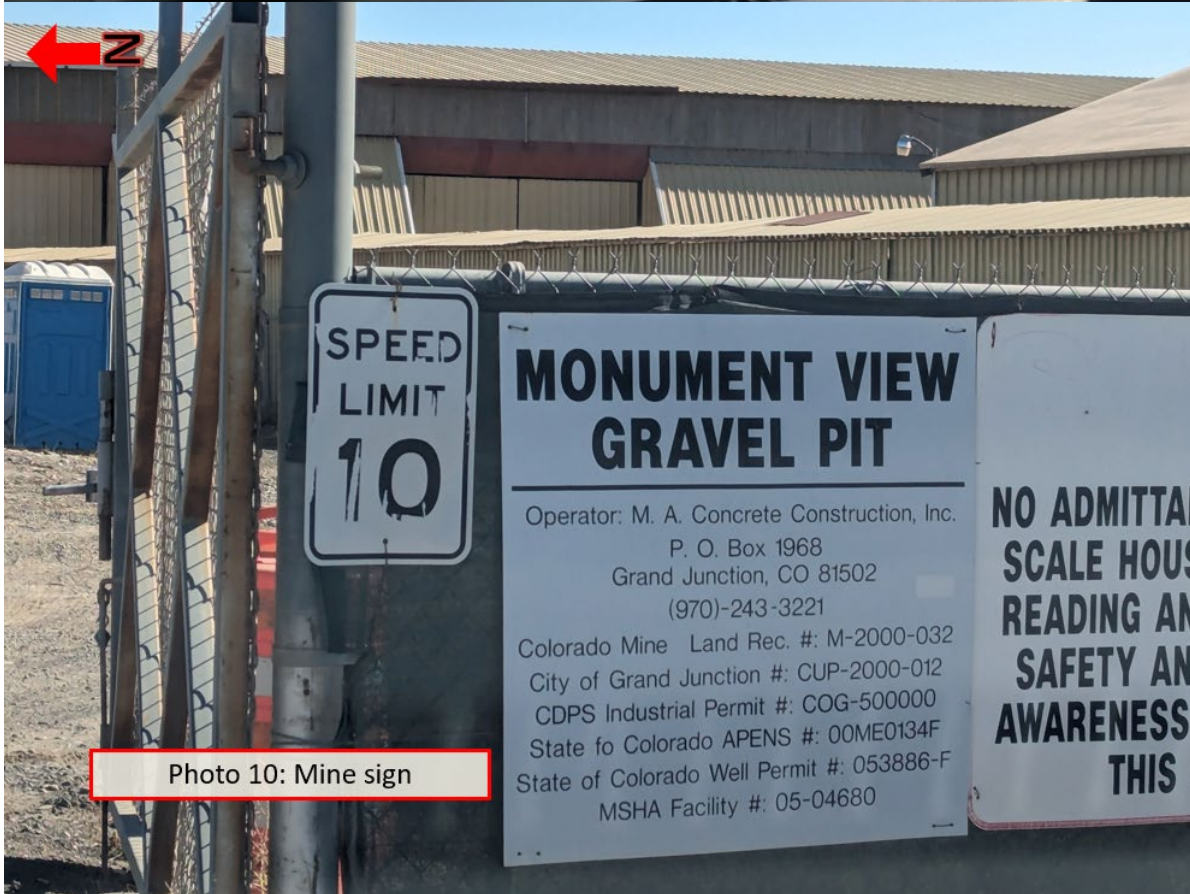
Photo 10: Mine sign

A mine sign was posted at the entrance to the mine site as required by Rule 3.1.12(1). The information depicted was correct/ up to date and the sign was of sufficient size (Photo Ten). The permit boundary of the affected land was clearly delineated primarily by a fence pursuant to Rule 3.1.12(2).
