RE: Piceance Pit, Permit No. M-2001-077, Unresolved Problem(s) Noted in a Past Inspection Report

MINERALS PROGRAM INSPECTION REPORT
PHONE: (303) 866-3567

MINE NAME: Piceance Pit	MINE/PROSPECTING ID#: M-2001-077	MINERAL: Sand and gravel	COUNTY: Rio Blanco
INSPECTION TYPE: Monitoring	WEATHER: Snowing	INSP. DATE: November 30, 2023	INSP. TIME: 09:55
OPERATOR: IHC Scott, Inc.	OPERATOR REPRESENTATIVE: Chris Adrian	TYPE OF OPERATION: 112c - Construction Regular Operation	
REASON FOR INSPECTION: Normal I&E Program	BOND CALCULATION TYPE: Complete Bond	BOND AMOUNT: \$40,408.00	
DATE OF COMPLAINT: NA	POST INSP. CONTACTS: DRMS	JOINT INSP. AGENCY: None	
INSPECTOR(S): Amy Yeldell	INSPECTOR'S SIGNATURE:

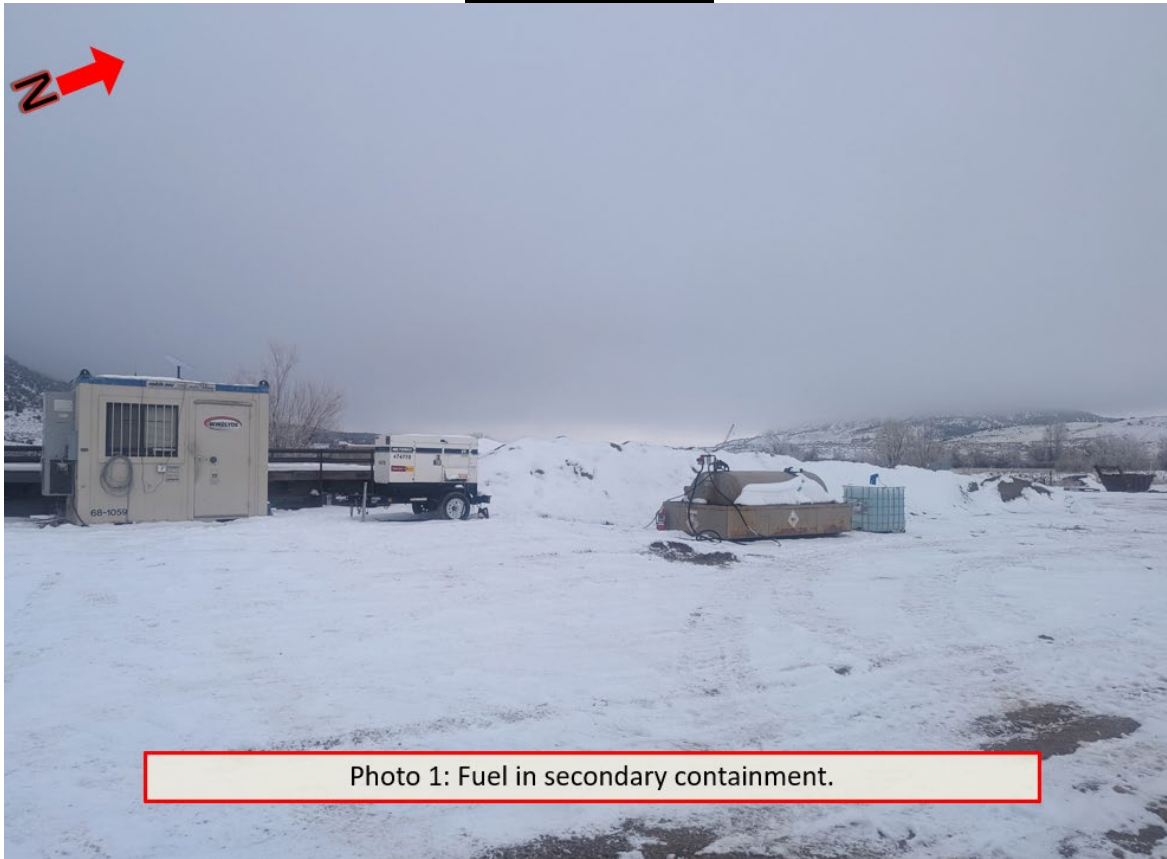
Fuel is stored on site near the scale house (Photo One). It is properly stored in secondary containment. No other fuels or hazardous materials were observed.

Photo 1: Fuel in secondary containment.

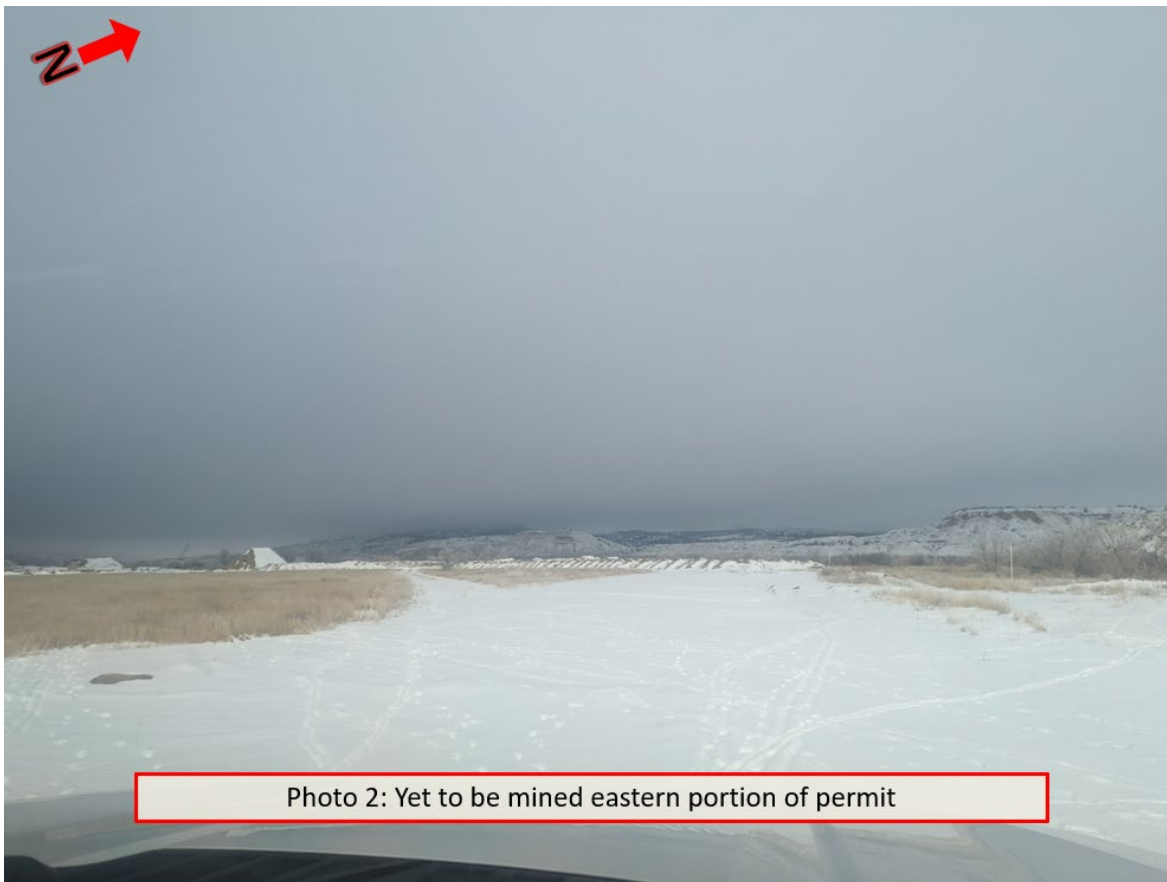
The majority of the site has been affected by mining. Only approximately 4.5 acres on the eastern side of the pit has yet to be stripped and mined (Photo Two). The west side of the pit remains a stockpile area and is approx. 5.56 ac (Photo Three). The excavated pit has progressed to the east and is approximately 12 acres (Photos Four and Five). The remaining land is occupied by overburden stockpiles and berms.

Photo 2: Yet to be mined eastern portion of permit

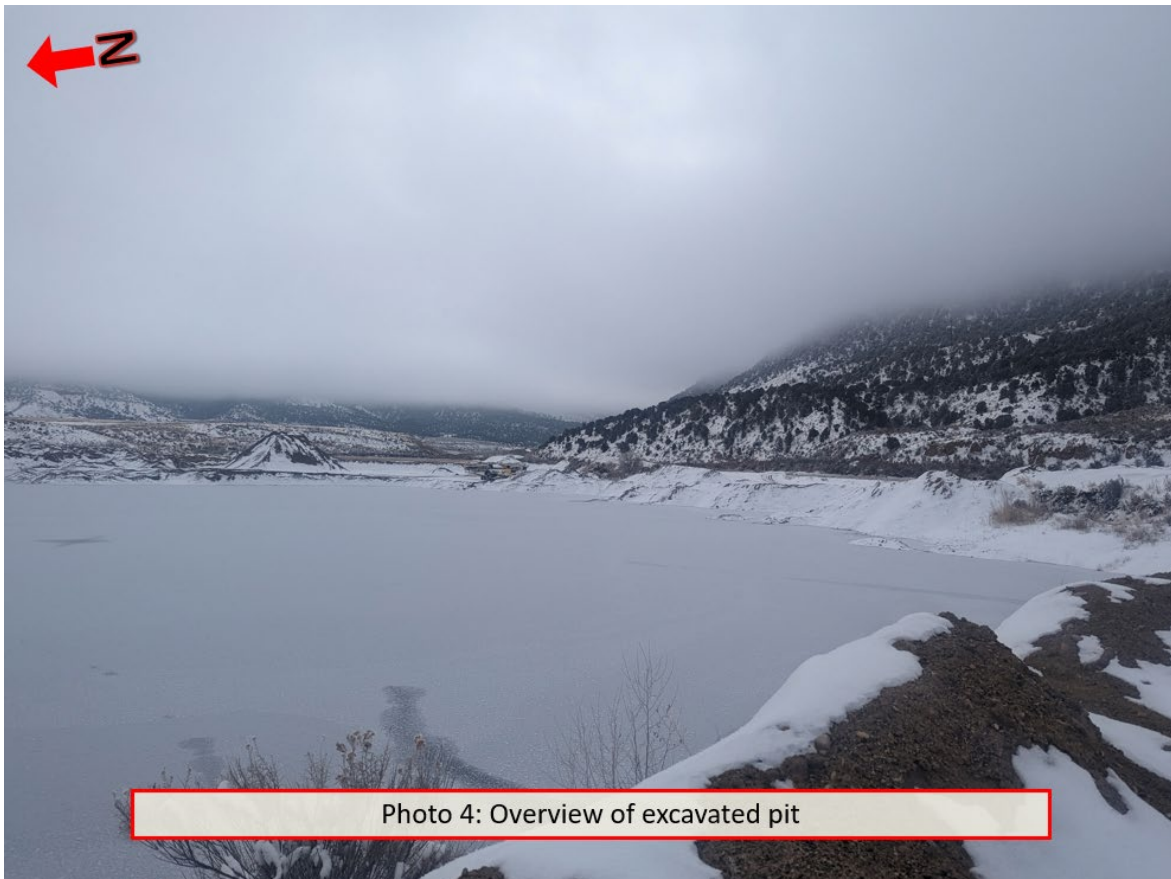
Photo 4: Overview of excavated pit

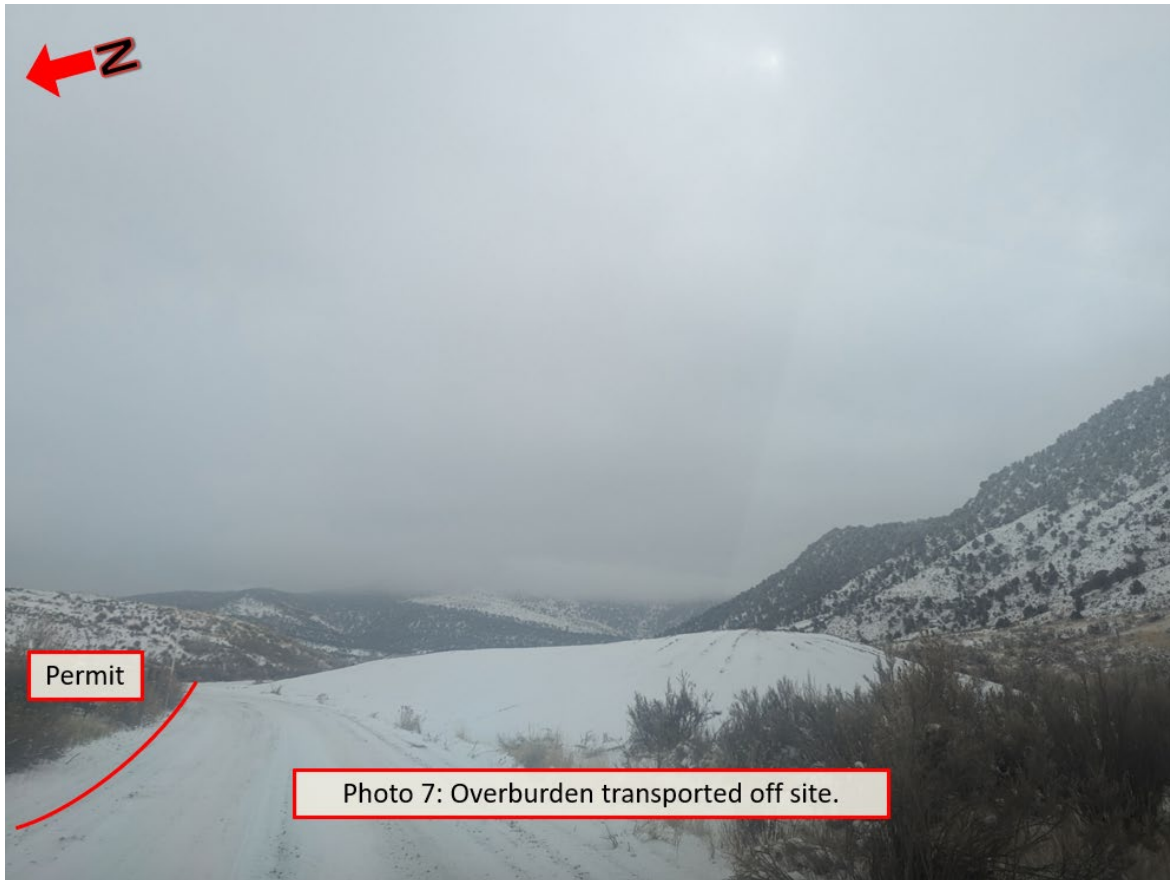
Per the landowners request excess overburden was transported out of the permit area to be used at a later date. The material is being stored south of the southeast corner of the pit outside of the permit boundary

(Photo Seven). The stockpile occupies approximately one acre. The stockpile is sloped and appears stable. The Division will consider this material 'sold' and may no longer be used for reclamation purposes on site.

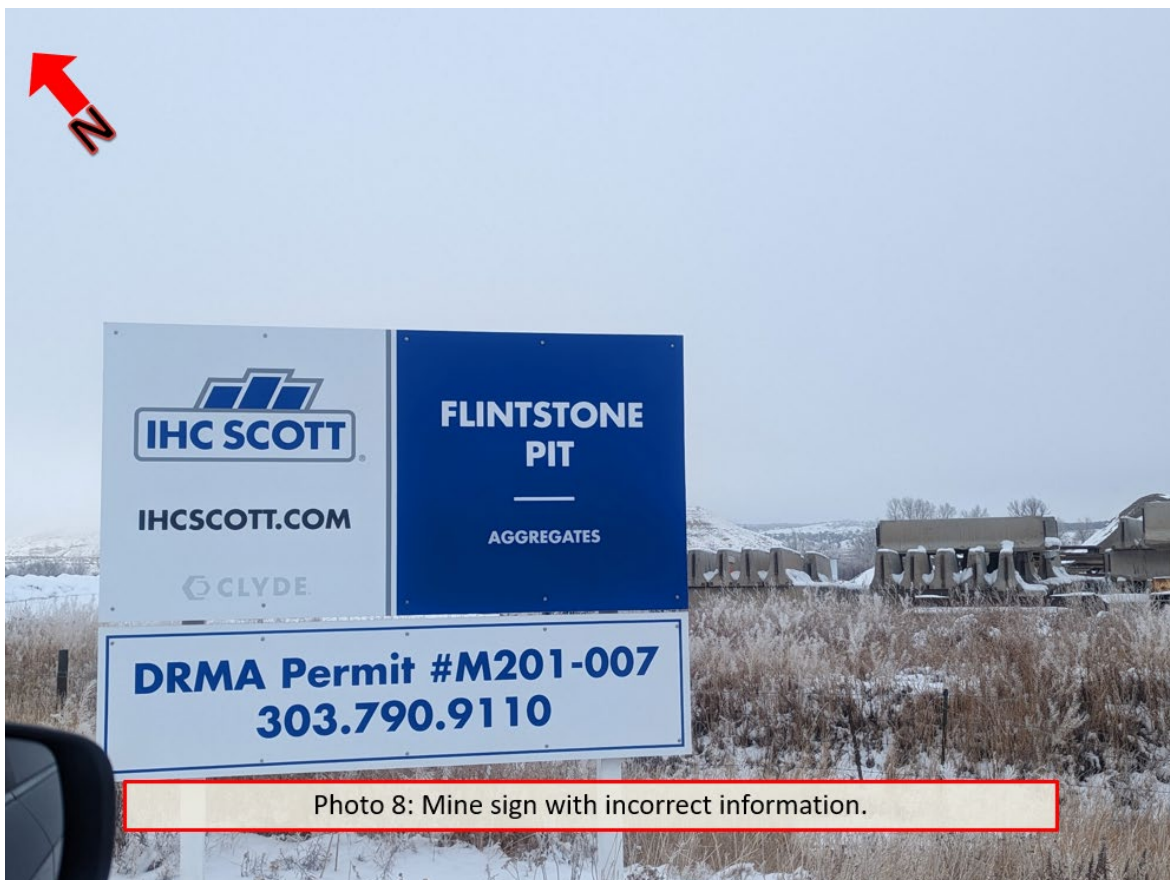
PROBLEM: The mine identification sign posted at the entrance of the mine site did not meet the requirements of Rule 3.1.12(1) of the rule. The Operator shall, at the entrance of the mine site post a sign, which shall be clearly visible from the access road, with a minimum size equaling one hundred and eighty-seven (187) square inches, such as eleven (11) inches in height and seventeen (17) inches in width, with appropriate font size, with the following: the name of the Operator, a statement that a reclamation permit for the operation has been issued by the Colorado Mined Land Reclamation Board; and the permit number.

A sign was posted at the entrance to the mine however the information on the sign was incorrect (Photo Eight). The sign listed the operation name as the "Flintstone Pit", while it is permitted with DRMS as the "Piceance Pit". Additionally, the Divisions acronym DRMS is mis-spelled. And the wrong permit number is listed, it should be M-2001-077, not M201-007. The sign does not meet the requirements of Rule 3.1.12(1). This is cited as an inspection problem. Please post a new mine sign (or correct the existing) at the permit entrance by the corrective action date. The permit boundary of the affected land was clearly delineated primarily by white PVC markers pursuant to Rule 3.1.12(2).

CORRECTIVE ACTIONS: The operator shall, at the entrance of the mine site, post a sign which shall be clearly visible from the access road with the following: the name of the operator, a statement that a reclamation permit for the operation has been issued by the Colorado Mined Land Reclamation Board; and the permit number. The operator shall submit photo documentation that a proper sign has been posted by the corrective action date.
