**MINERALS PROGRAM INSPECTION REPORT**  
**PHONE: (303) 866-3567**

<b>MINE NAME:</b> Climax Mine	<b>MINE/PROSPECTING ID#:</b> M-1977-493	<b>MINERAL:</b> Molybdenum	<b>COUNTY:</b> Lake, Summit
<b>INSPECTION TYPE:</b> Aerial Inspection	<b>INSPECTOR(S):</b> Dustin Czapla / Brock Bowles	<b>INSP. DATE:</b> February 13, 2024	<b>INSP. TIME:</b> 12:45
<b>OPERATOR:</b> Climax Molybdenum Company	<b>OPERATOR REPRESENTATIVE:</b> NA	<b>TYPE OF OPERATION:</b> 112d-3 - Designated Mining Operation	
<b>REASON FOR INSPECTION:</b> Normal I&E Program	<b>BOND CALCULATION TYPE:</b> None	<b>BOND AMOUNT:</b> \$91,011,850.00	
<b>DATE OF COMPLAINT:</b> NA	<b>POST INSP. CONTACTS:</b> None	<b>JOINT INSP. AGENCY:</b> None	
<b>WEATHER:</b> Clear	<b>INSPECTOR'S SIGNATURE:</b>

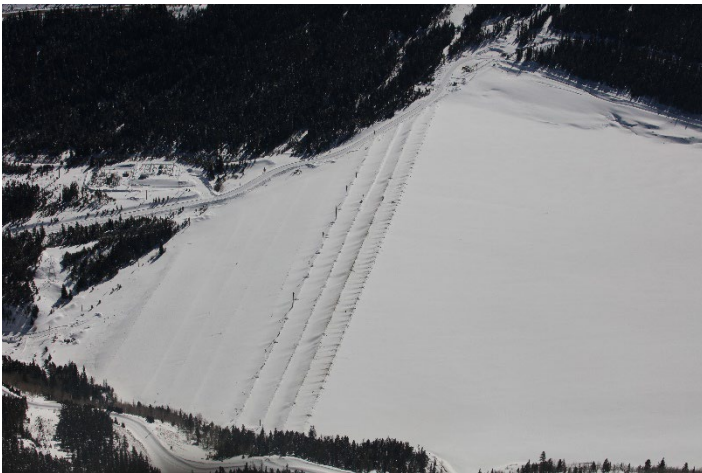
5 Dam

The Mayflower TSF and 5 Dam, Tenmile TSF and 3 Dam, Robinson TSF and 1 and 2 Dams, Robinson Lake, Eagle Park Reservoir and 4 Dam were observed. No abnormal conditions were noted. TSF's appear to be functioning within the established design criteria.

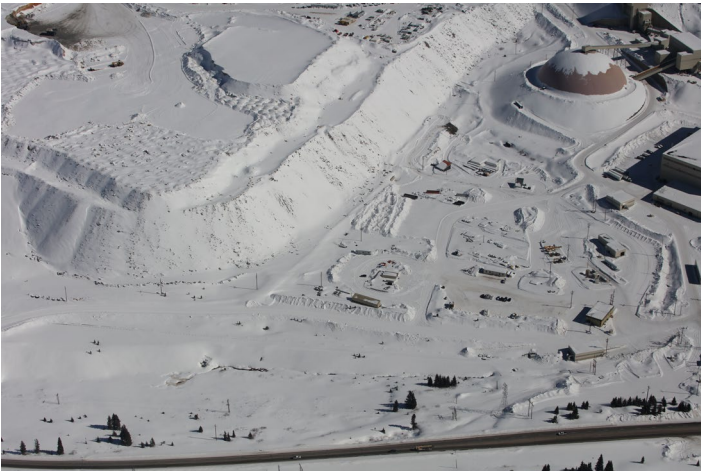
North 40 OSF

The McNulty and North 40 OSF's were observed. No abnormal conditions were noted. OSF's appear to be functioning within the established design criteria.
