MINERALS PROGRAM INSPECTION REPORT
PHONE: (303) 866-3567

MINE NAME: Climax Mine	MINE/PROSPECTING ID#: M-1977-493	MINERAL: Molybdenum	COUNTY: Lake, Summit
INSPECTION TYPE: Aerial Inspection	INSPECTOR(S): Dustin Czapla	INSP. DATE: February 22, 2024	INSP. TIME: 11:30
OPERATOR: Climax Molybdenum Company	OPERATOR REPRESENTATIVE: Alex Unger	TYPE OF OPERATION: 112d-3 - Designated Mining Operation	
REASON FOR INSPECTION: Normal I&E Program	BOND CALCULATION TYPE: None	BOND AMOUNT: \$91,011,850.00	
DATE OF COMPLAINT: NA	POST INSP. CONTACTS: None	JOINT INSP. AGENCY: None	
WEATHER: Clear	INSPECTOR'S SIGNATURE:

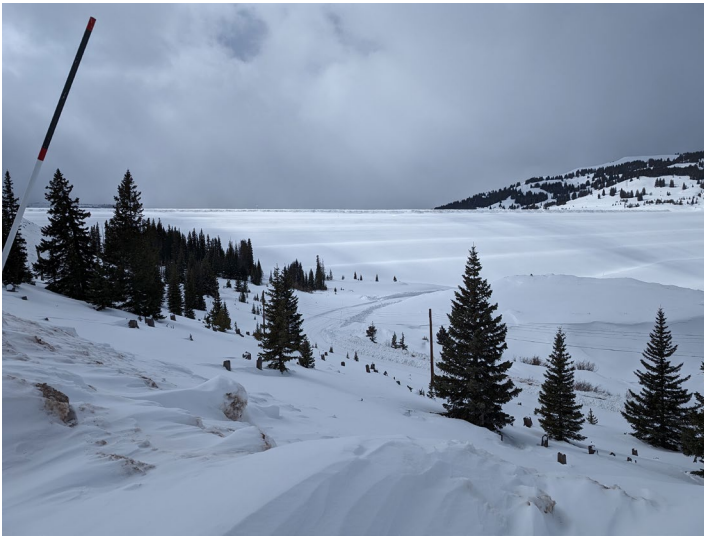
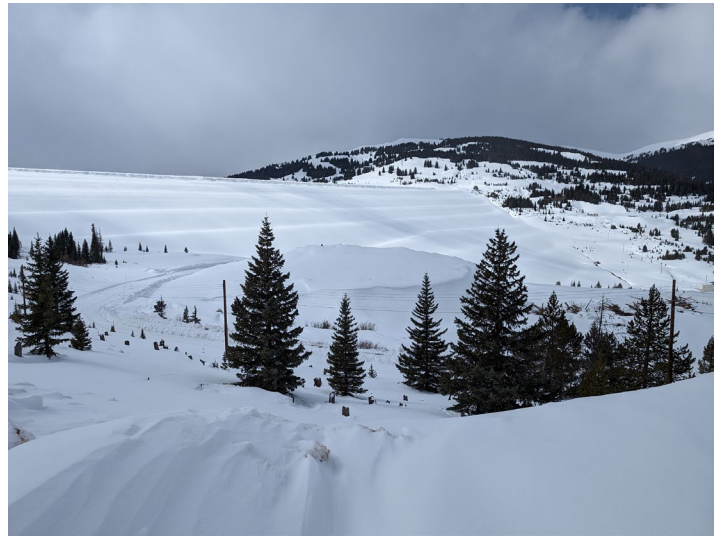
3 Dam

The Tenmile TSF and 3 Dam, and Mayflower TSF and 5 Dam were observed. No abnormal conditions were noted. TSF's appear to be functioning within the established design criteria.

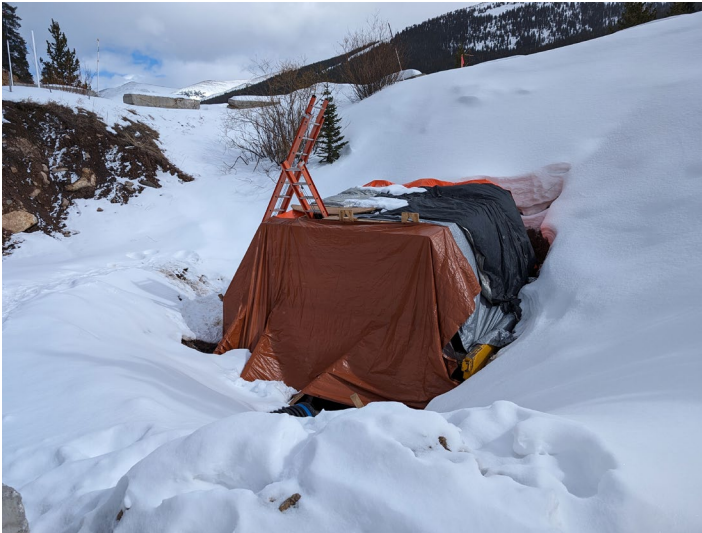
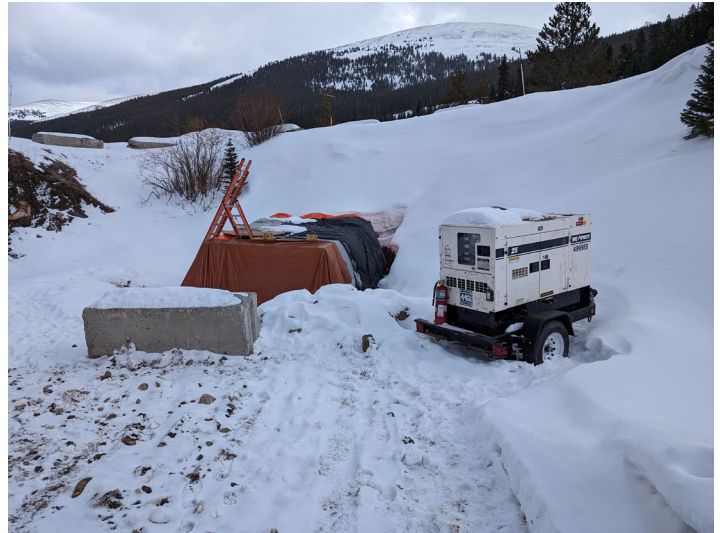
Construction of the 5-Dam Seepwater Collection Area - Secondary Containment System that was approved through TR36 has been halted due to winter conditions and materials availability. Construction is anticipated to resume in May.
