New Horizon 2 Mine February Inspection Report

Permit Number: C-1981-008 Mine Name: New Horizon Mine Operator: Elk Ridge Mining and Reclamation, LLC Operator Address: Mr. Tony Tennyson P.O. Box 628 27646 West 5th Avenue Nucla, CO 81424	County: Montrose Operation Type: Surface Permit Status: Active Ownership: Private
	Operator Representative Present: Mindy Sickles
Operator Representative Signature: (Field Issuance Only)

Inspection Start Date: February 14, 2024 Inspection Start Time: 12:25 Inspection End Date: February 14, 2024 Inspection End Time: 13:35		Inspection Type: Coal Complete Inspection Inspection Reason: Normal I&E Program Weather: Clear	
Joint Inspection Agency: None		Joint Inspection Contacts: None	
Post Inspection Agency: None		Post Inspection Contacts: None	
Inspector(s): Clayton Wein	Inspector's Signature: <i>Clayton Wein</i> Signature Date: 2/26/2024

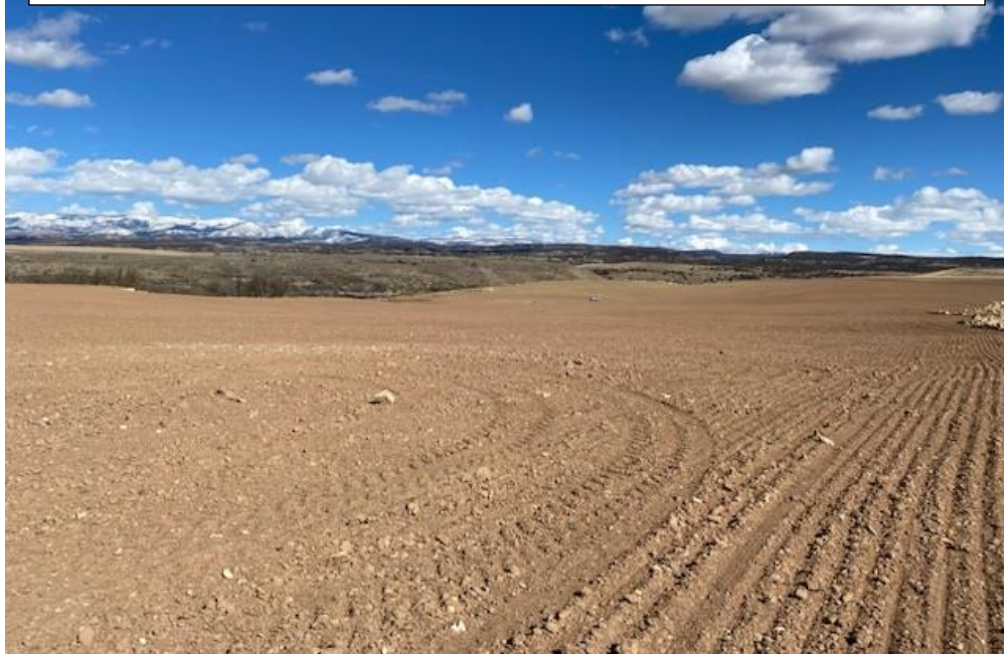
ERMR completed backfilling and grading, as well as, topsoil replacement and seeding of 85.5 acres at the end of 2023. The land is located in the southern portion of section 36 on the north side of BB Road. There are two parcels of reclamation divided in the middle by the Johnson Access Road. The reclamation on the western side of the Johnson Access Road gently sloped up to the west and south (Photo 1). The reclamation was stable and there were no erosional features observed. No indications of differential settling were identified. The second parcel of reclamation is east of the Johnson Access Road (Photo 2). The reclamation slopes gently to the east and a small portion slopes up to the north. This portion of the reclamation was also stable and had no indications of erosional features. No signs of differential settling were observed.

Photo 1: The western portion of the reclamation in Section 36. The photo was taken looking to the northeast.

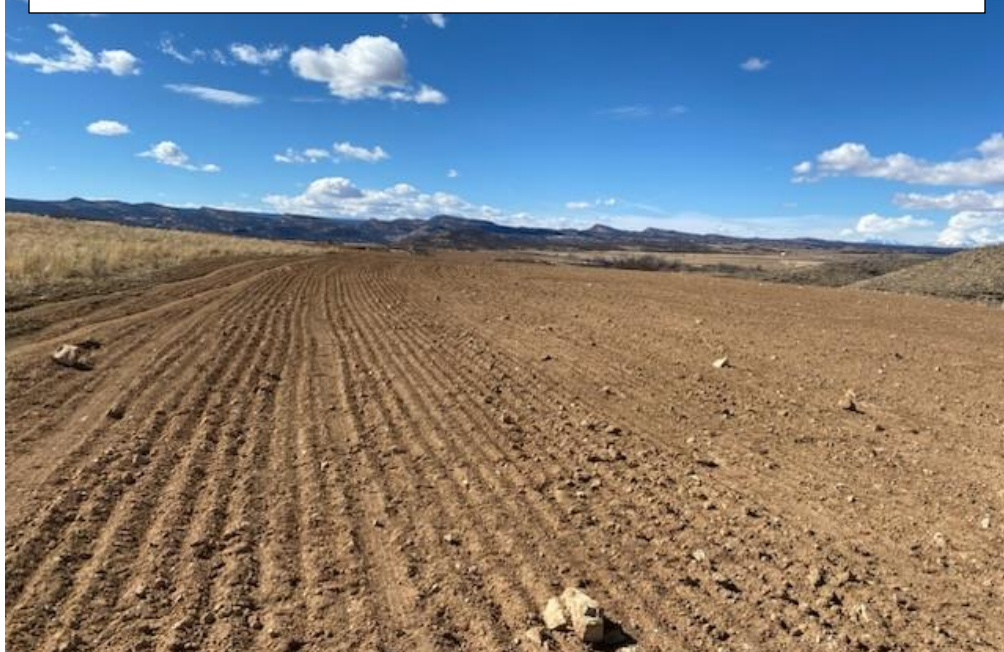
Photo 2: The eastern Reclamation of Section 36. The photo was taken looking to west.

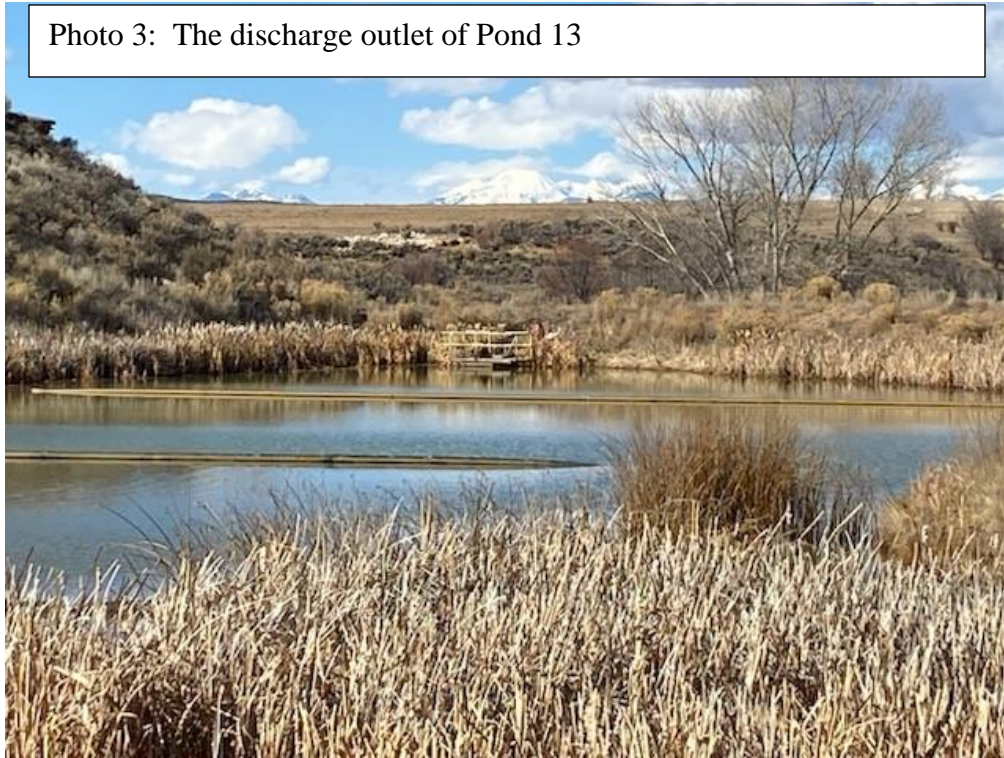
Pond 13 was impounding water during the inspection. Discharge from the pond was occurring. The outlet for the pond was clear of obstructions (Photo 3). The embankment for pond 13 was vegetated and stable. No erosional concerns were noted. The inlet pipes for the pond were also clear of debris.

Photo 3: The discharge outlet of Pond 13

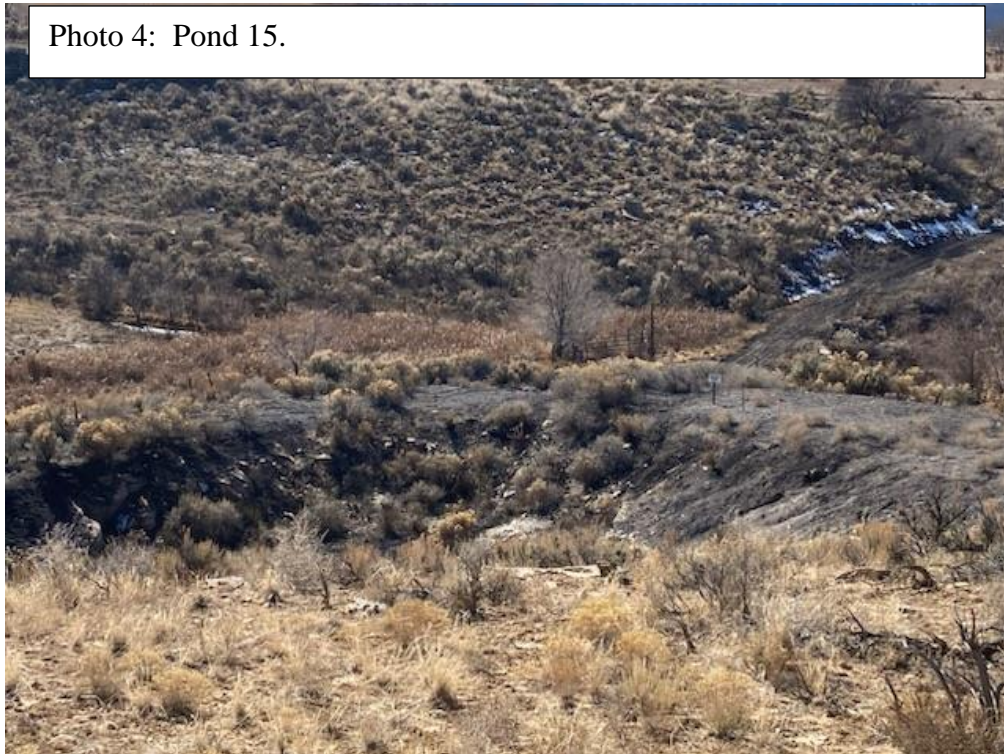
Pond 15 was observed to be dry (Photo 4). The embankments for the pond were stable with minor rills. These rills have been noted on the interior of the embankments of the pond in previous Division inspections. The rills had not enlarged. The outlet for the pond was observed to be unobstructed.

Photo 4: Pond 15.

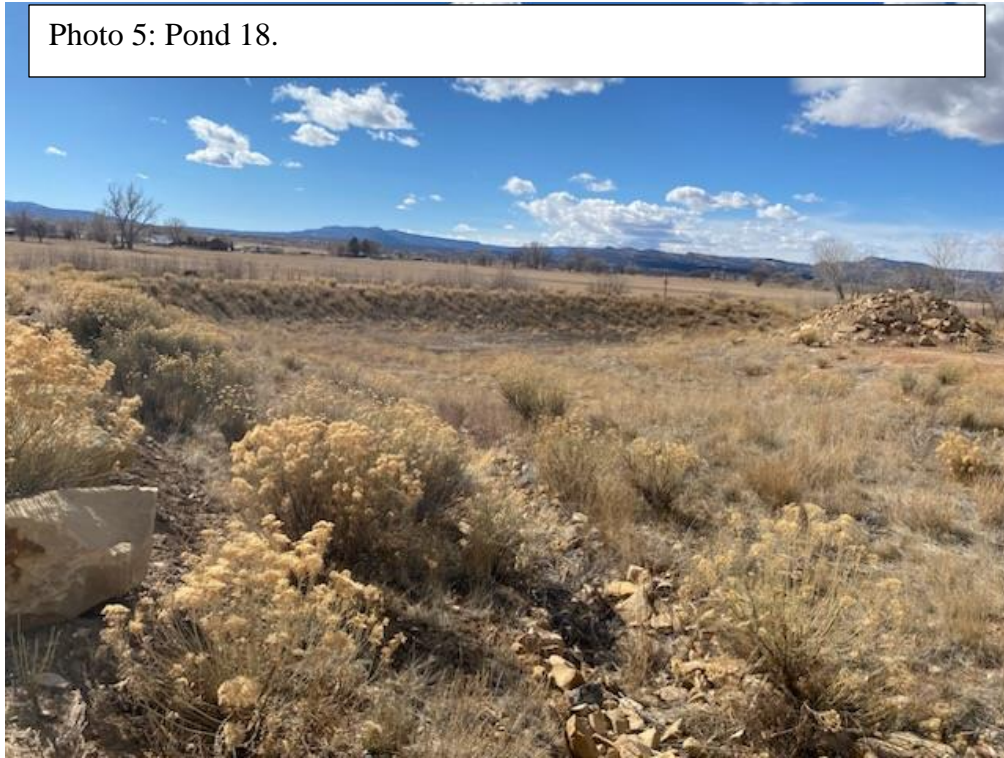
Pond 18 was not holding any water during the inspection (Photo 5). The inlet and outlet for the pond were clear. The pond's embankment was vegetated and stable. No erosional features were observed.

Photo 5: Pond 18.

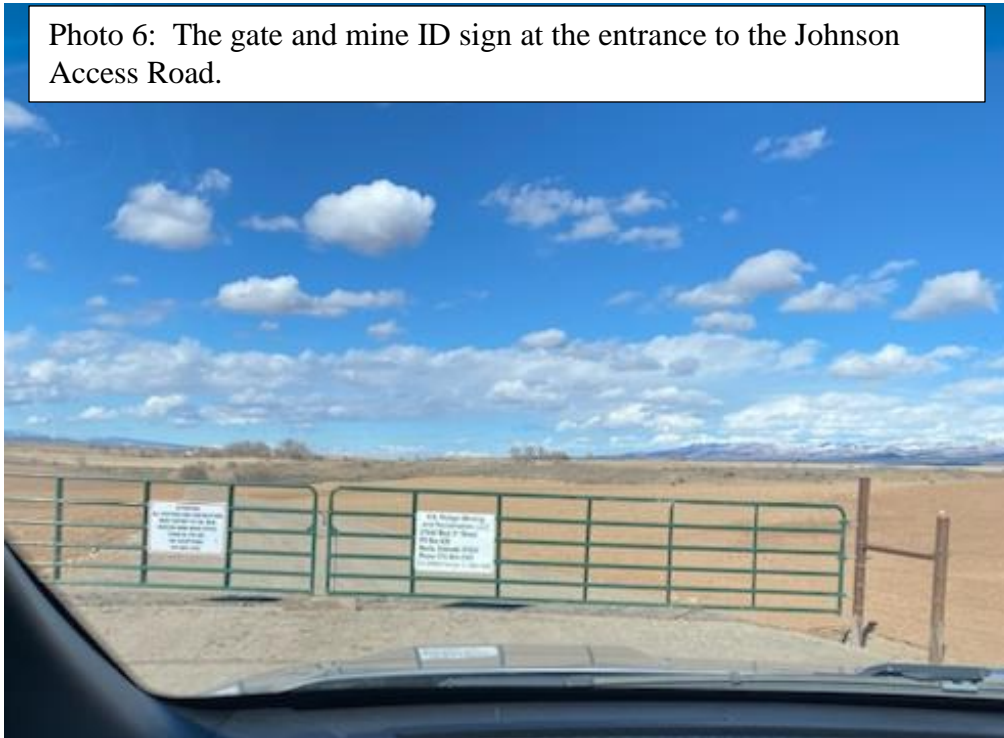
Mine identification markers were observed posted on all entrances to the permit area. The signs displayed the permit number and contact information for both the permittee and the Division. Several other permit boundary markers were seen posted on the fences that mark the current permit boundary. All signs were observed to be posted in easily viewed areas. The entrance to the northwest permit area at the intersection of the Johnson Access Road and BB Road had a gate installed (Photo 6). Fencing along the southern portion of the Section 36 reclamation was also observed to be new.

Photo 6: The gate and mine ID sign at the entrance to the Johnson Access Road.

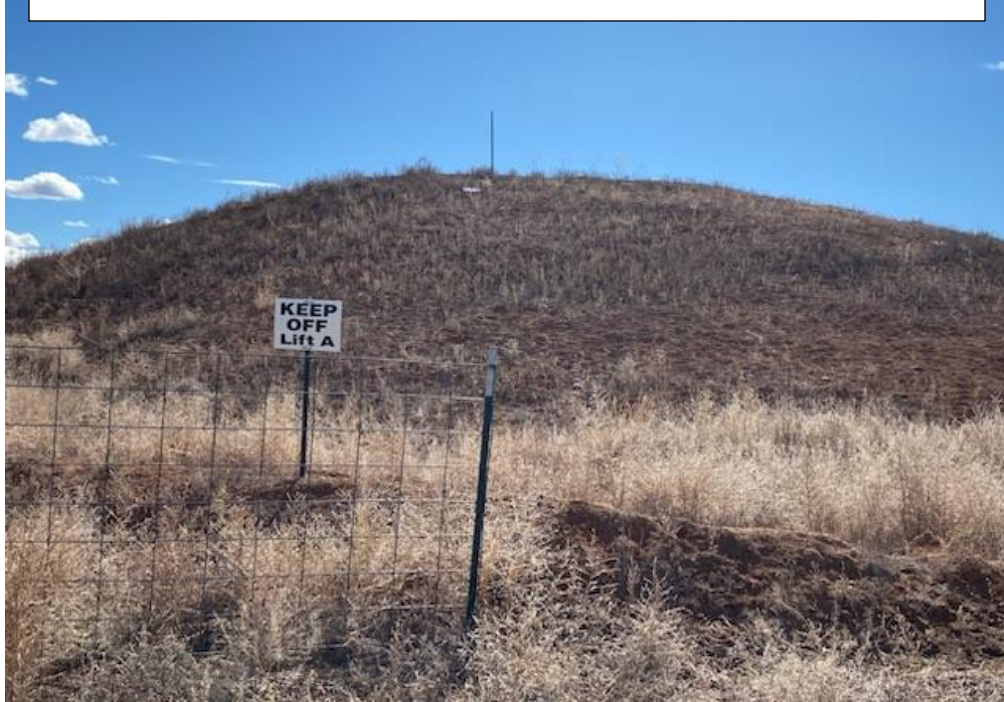
Topsoil Piles 11A (Photo 7) and 11B are located to the south of IC-1. The topsoil piles were observed to be stable and covered with vegetation. No erosional concerns were identified. The perimeter berms were stable and vegetated. No loss of topsoil resource was observed.

Photo 7: The 11 A topsoil Pile

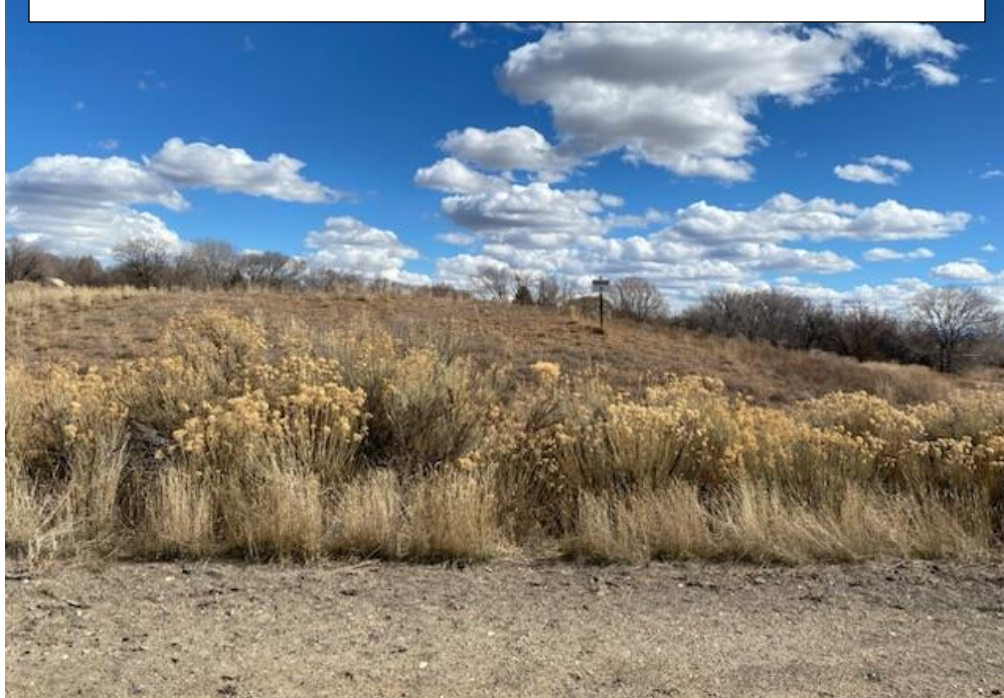
The Topsoil piles C (Photo 12), D and H are located south of the Mine Office. These piles were covered with vegetation and stable. There were no erosional features observed. The perimeter berms were noted to be intact. No loss of topsoil resource was observed.

Photo 8: The C Topsoil pile south of the mine office.
