MINERALS PROGRAM INSPECTION REPORT
PHONE: (303) 866-3567

MINE NAME: 20 Road Gravel Pit	MINE/PROSPECTING ID#: M-2005-061	MINERAL: Sand and gravel	COUNTY: Mesa
INSPECTION TYPE: Monitoring	WEATHER: Clear	INSP. DATE: February 13, 2024	INSP. TIME: 11:30
OPERATOR: M.A. Concrete Construction, Inc.	OPERATOR REPRESENTATIVE: Any Azacarraga	TYPE OF OPERATION: 112c - Construction Regular Operation	
REASON FOR INSPECTION: Normal I&E Program	BOND CALCULATION TYPE: Complete Bond	BOND AMOUNT: \$120,584.00	
DATE OF COMPLAINT: NA	POST INSP. CONTACTS: DRMS	JOINT INSP. AGENCY: None	
INSPECTOR(S): Amy Yeldell	INSPECTOR'S SIGNATURE:

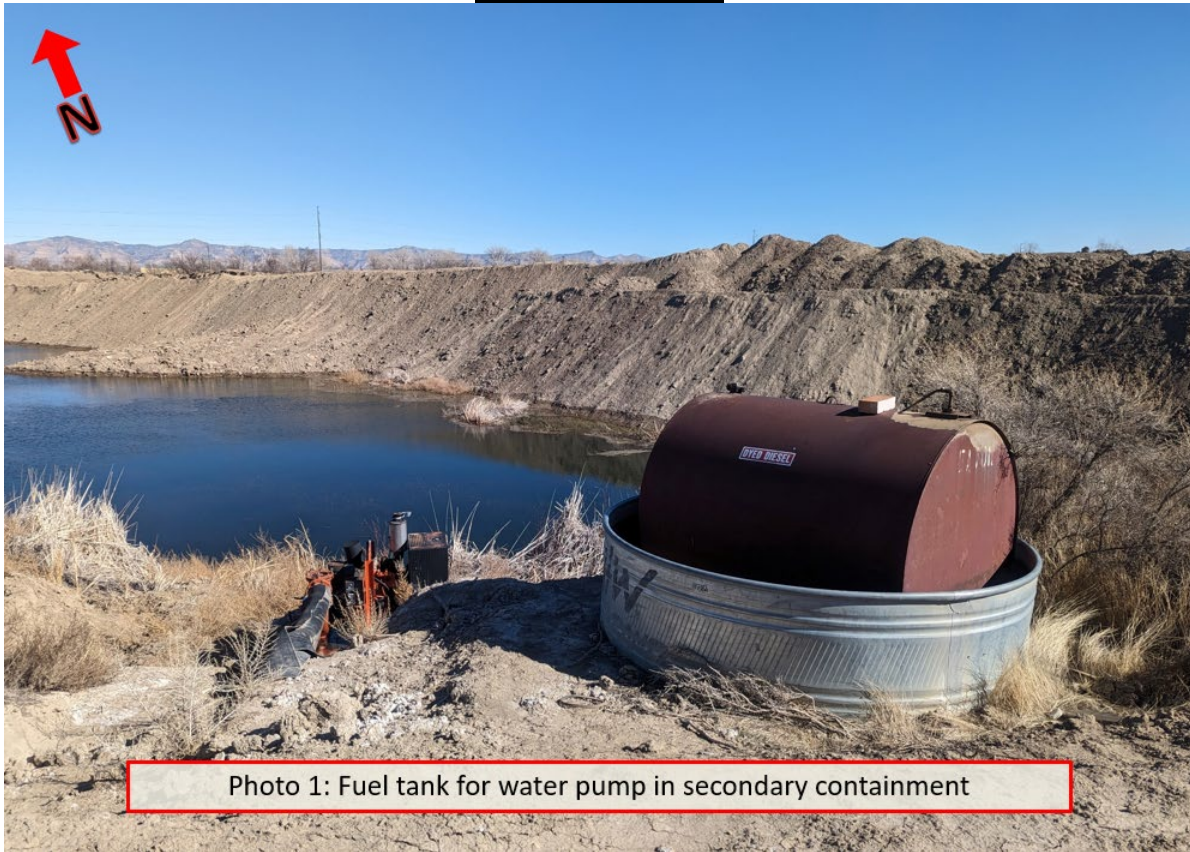
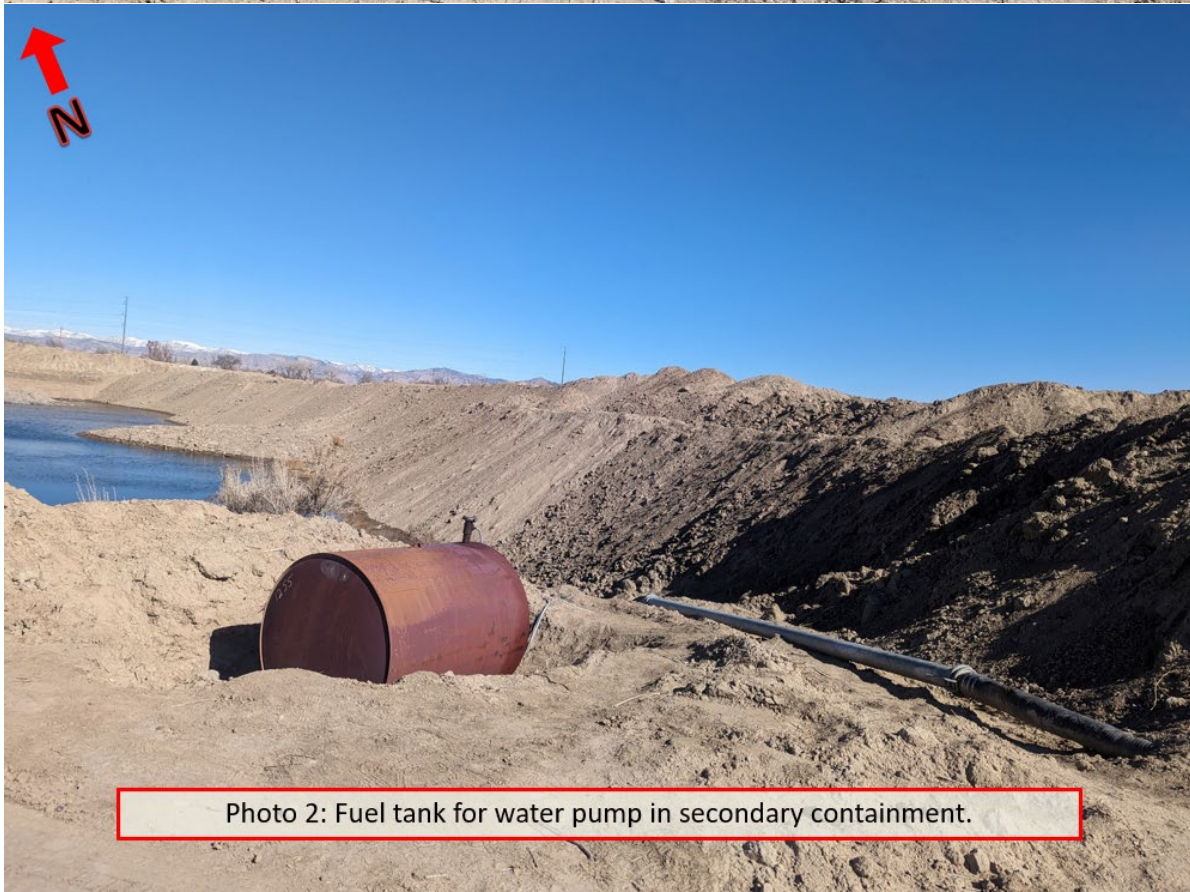
One fuel tank for equipment is located on the south side of the permit adjacent to the open pit. Two other smaller fuel tanks are located on the south side of the pit to feed the dewatering pumps. All fuel and other hazardous materials are stored within an earthen secondary containment (Photos One – Three).

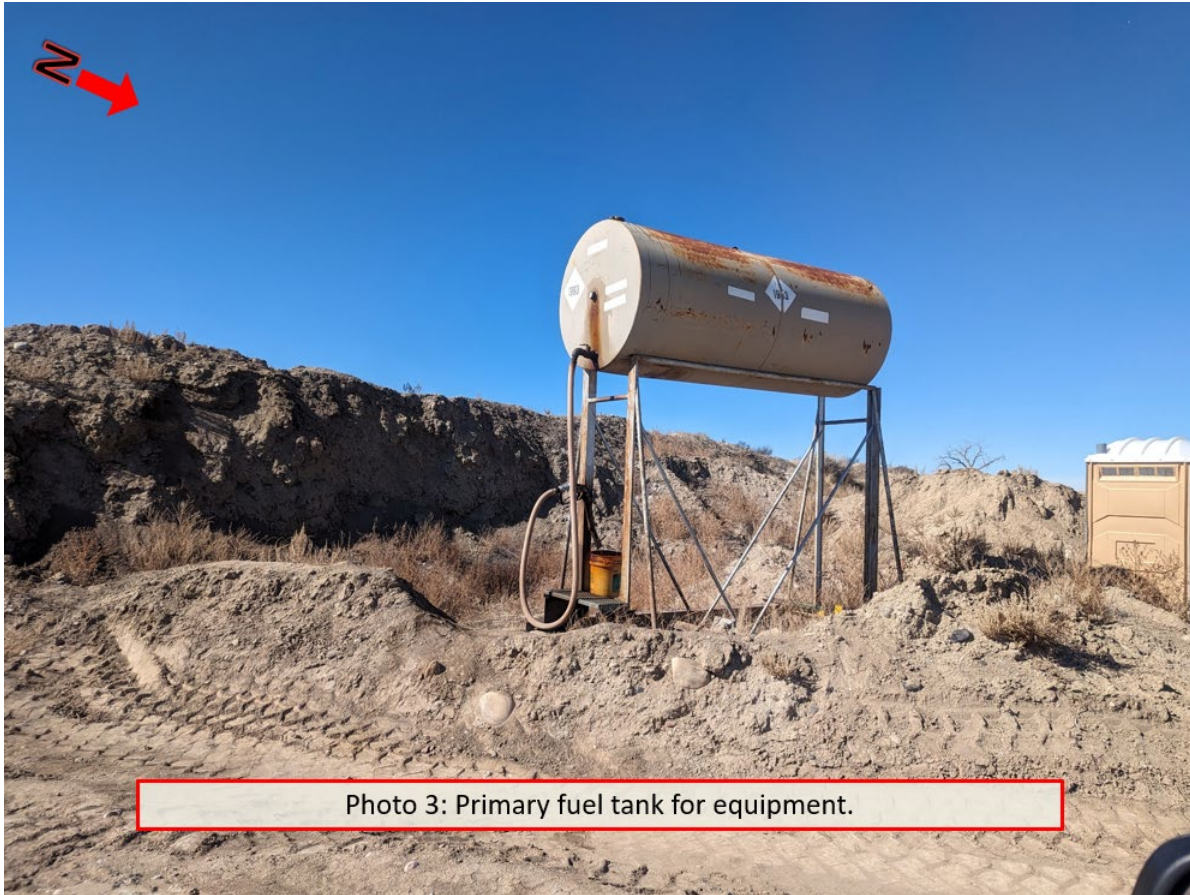
Photo 3: Primary fuel tank for equipment.

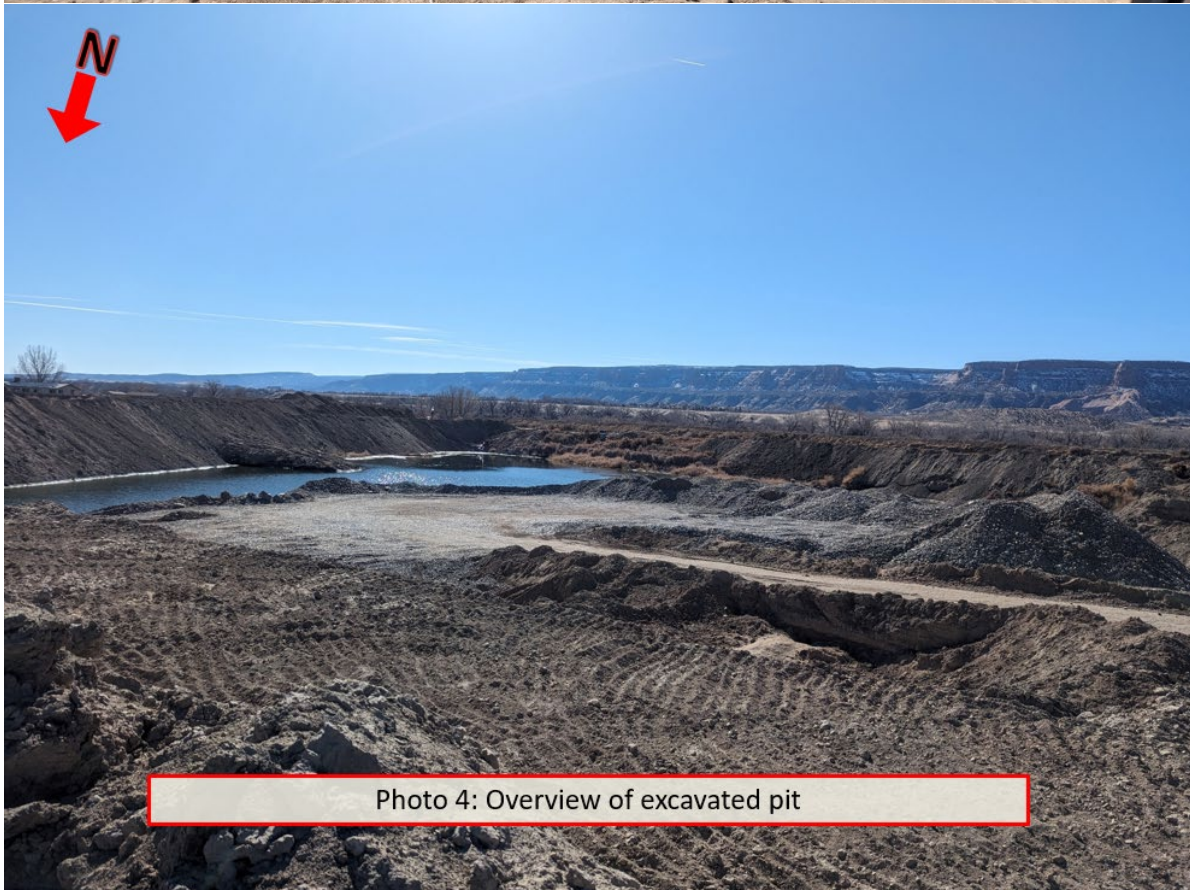
(Photos Four – Seven) The pit has approximately 10-15 feet of overburden and gravel is up to 25 feet for maximum total excavated pit depth of 40 feet. Stripped overburden is being directly replaced on the far eastern side. Where mining is advancing slopes are near vertical. Previously mined slopes (east) that have been partially backfilled and are graded to a 1.5H: 1V. All slopes are cut/fill.

Photo 4: Overview of excavated pit

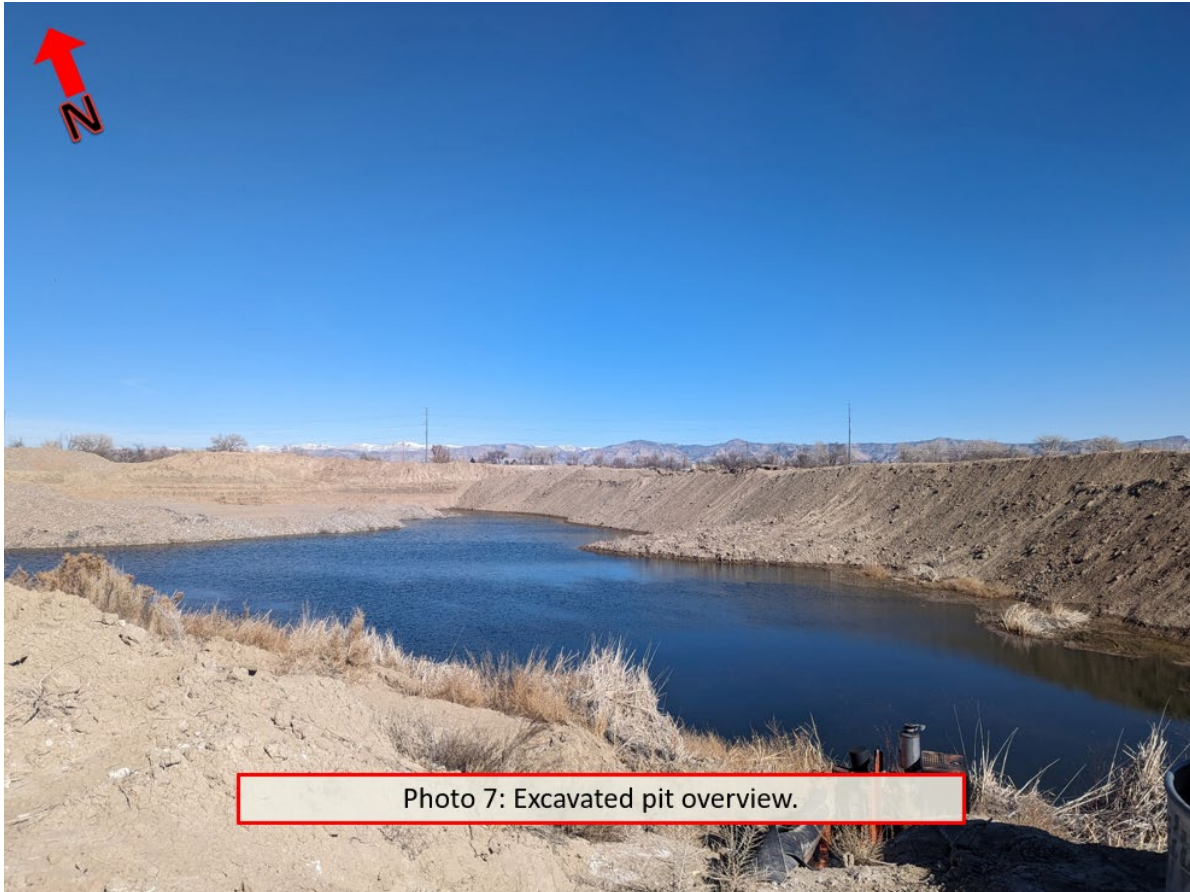
Photo 7: Excavated pit overview.

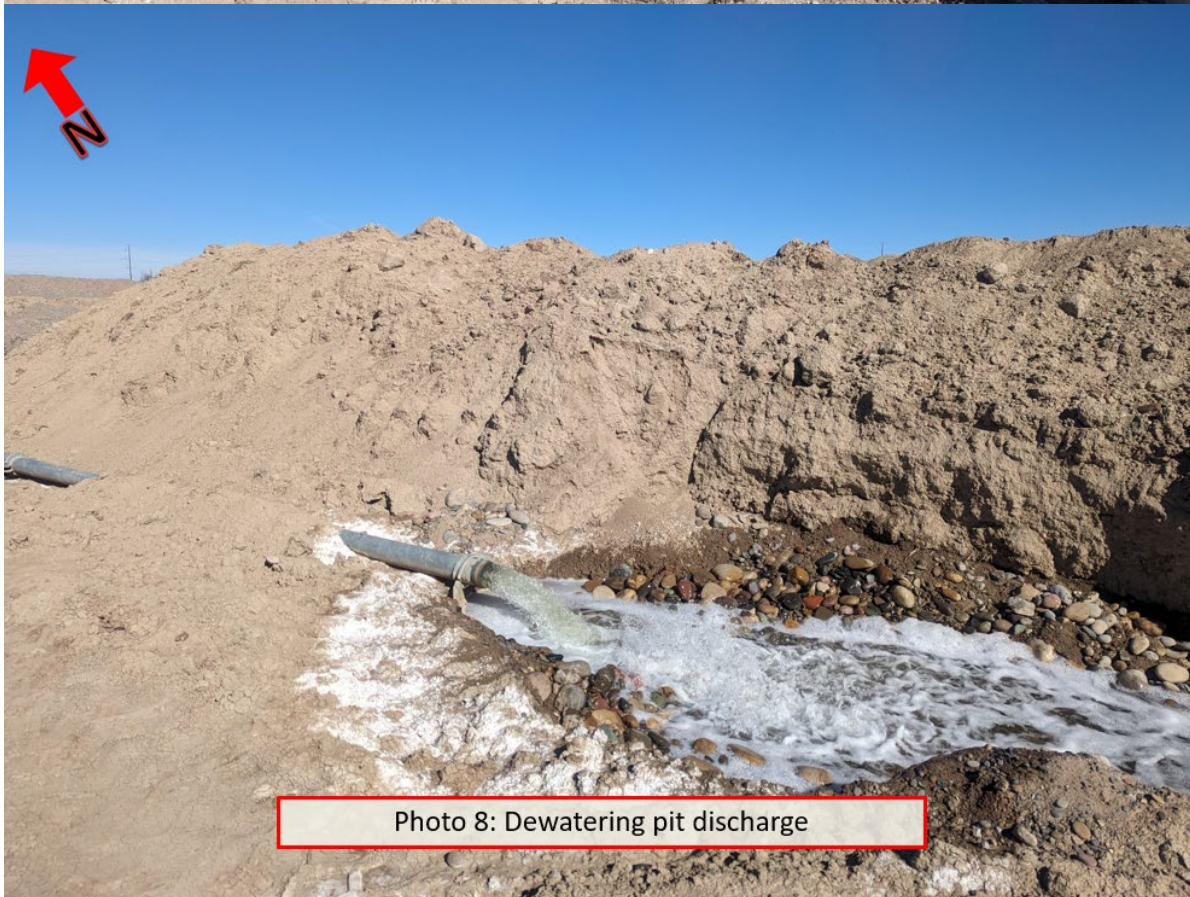
The excavated pit is currently being dewatered for mining and is estimated to be 7 acres. Water is being pumped into a ditch along the south of the permit which runs to the east into a ditch which reports to the Colorado River (Photo Eight).

Photo 8: Dewatering pit discharge

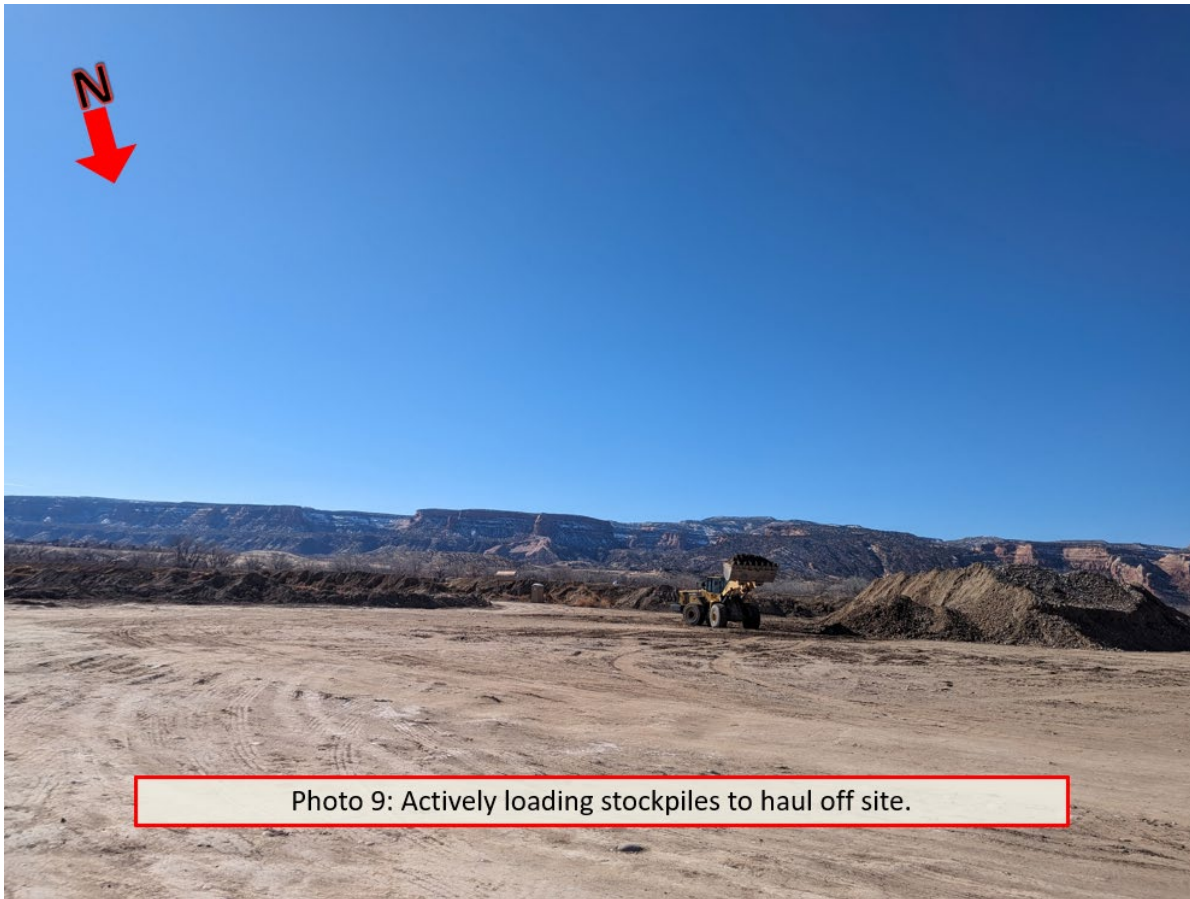
The site was active at the time of the inspection (Photo Nine). Previously excavated material was being loaded

Photo 9: Actively loading stockpiles to haul off site.

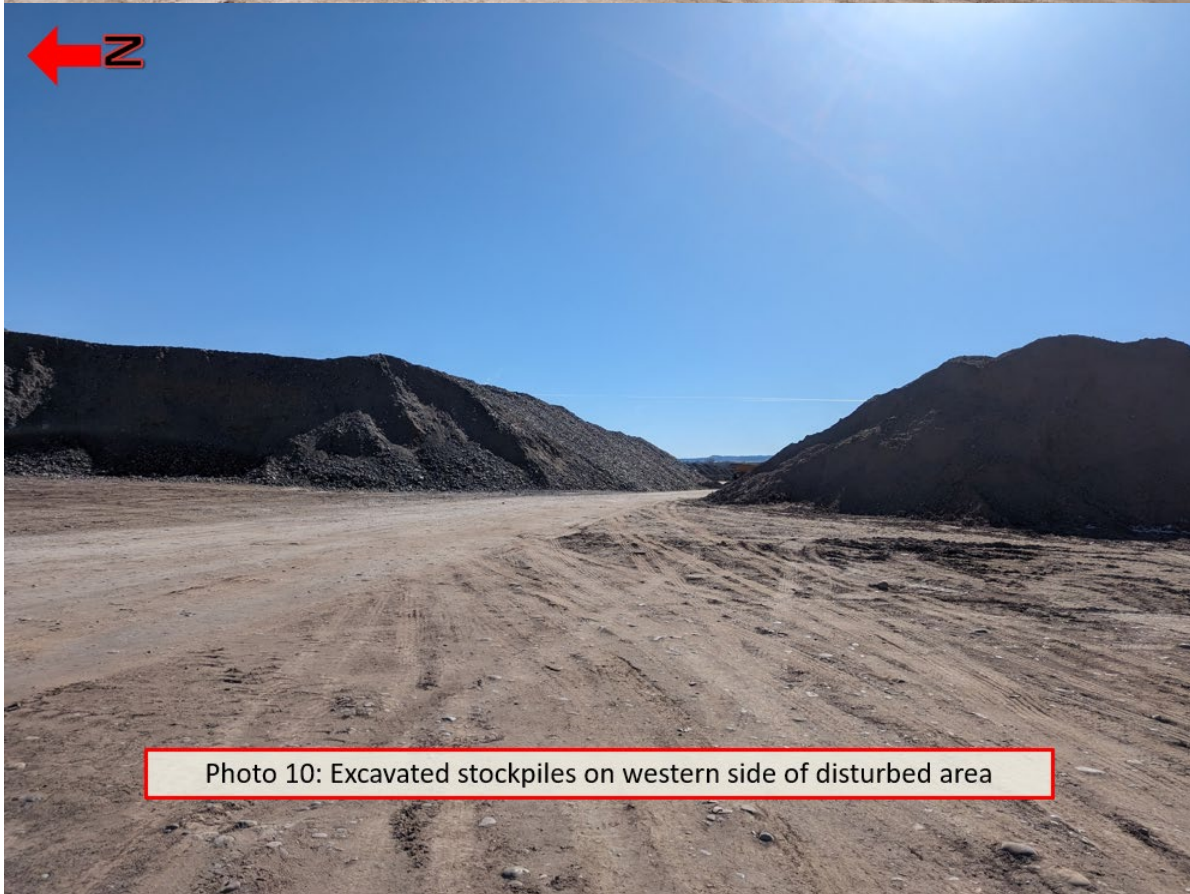
into haul trucks and transported off site. No other mining support equipment was located on site at this time. Several stockpiles of excavated material are neatly stored on the western side of the affected lands (Photo Ten).

Photo 10: Excavated stockpiles on western side of disturbed area

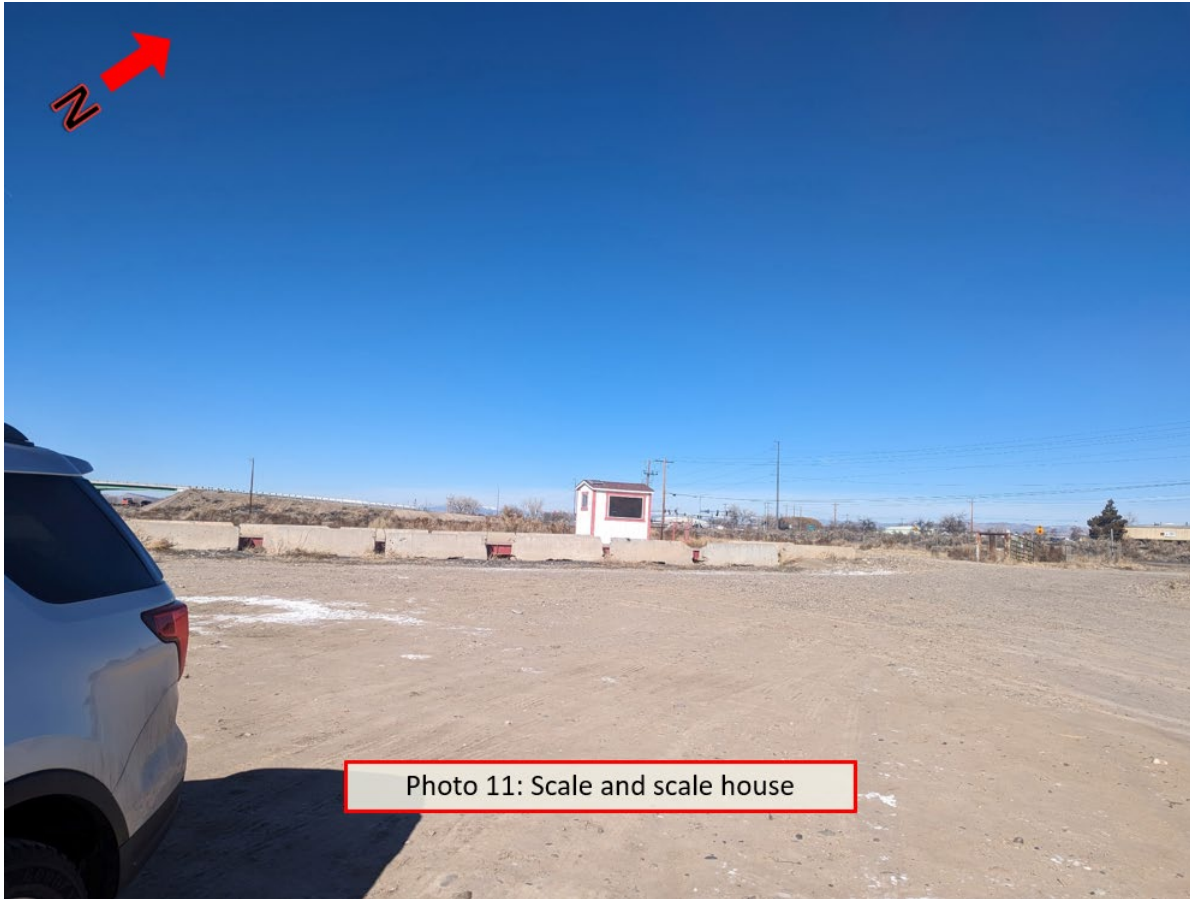
A scale and scale house are located near the pit entrance (Photo Eleven). No other permanent structures exist.

Photo 11: Scale and scale house

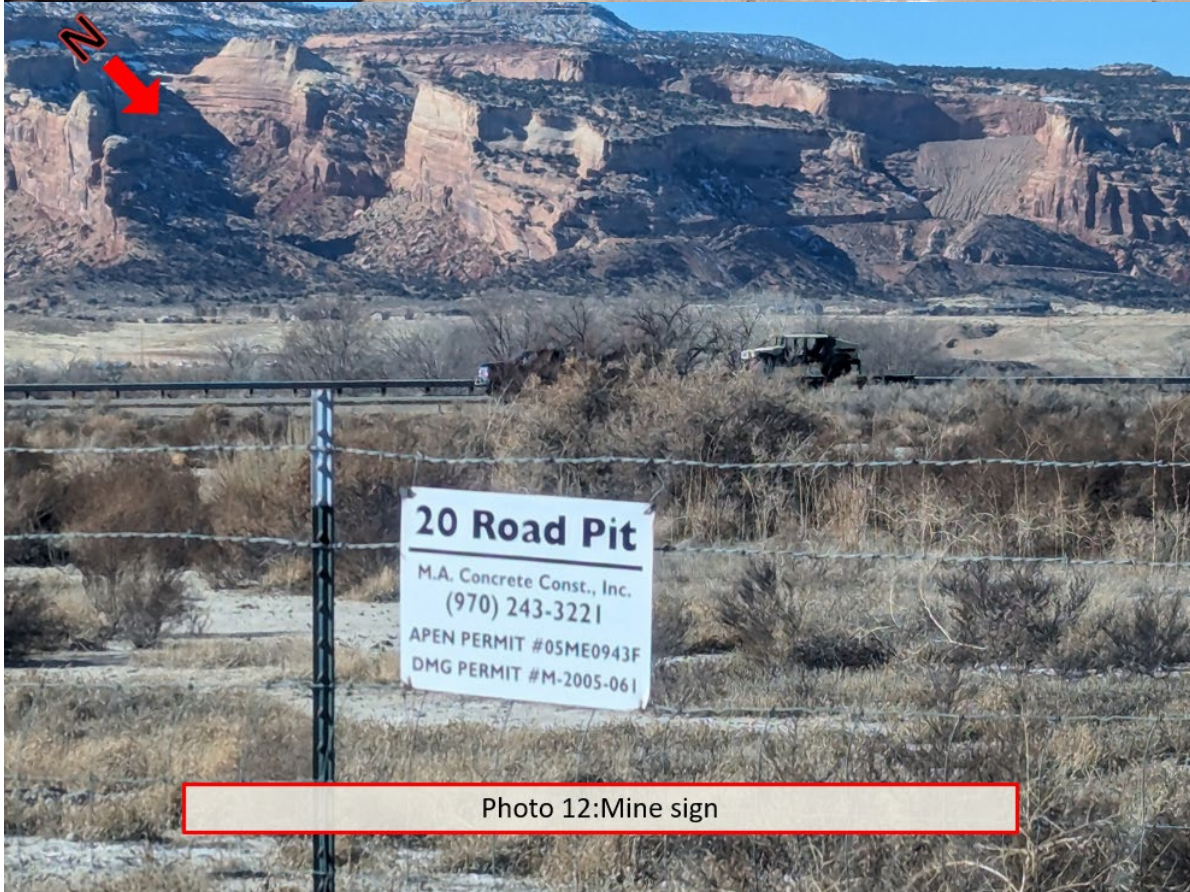
A mine sign was posted at the entrance to the mine site as required by Rule 3.1.12(1). The information depicted was correct/ up to date and the sign was of sufficient size (Photo Twelve). The permit boundary of the affected land was clearly delineated primarily by a fence pursuant to Rule 3.1.12(2).

Photo 12: Mine sign
