King Mine February Inspection Report

King Mine, C-1981-035, February 2024 Complete Inspection Report_CCW.pdf

PERMIT INFORMATION

INSPECTION INFORMATION

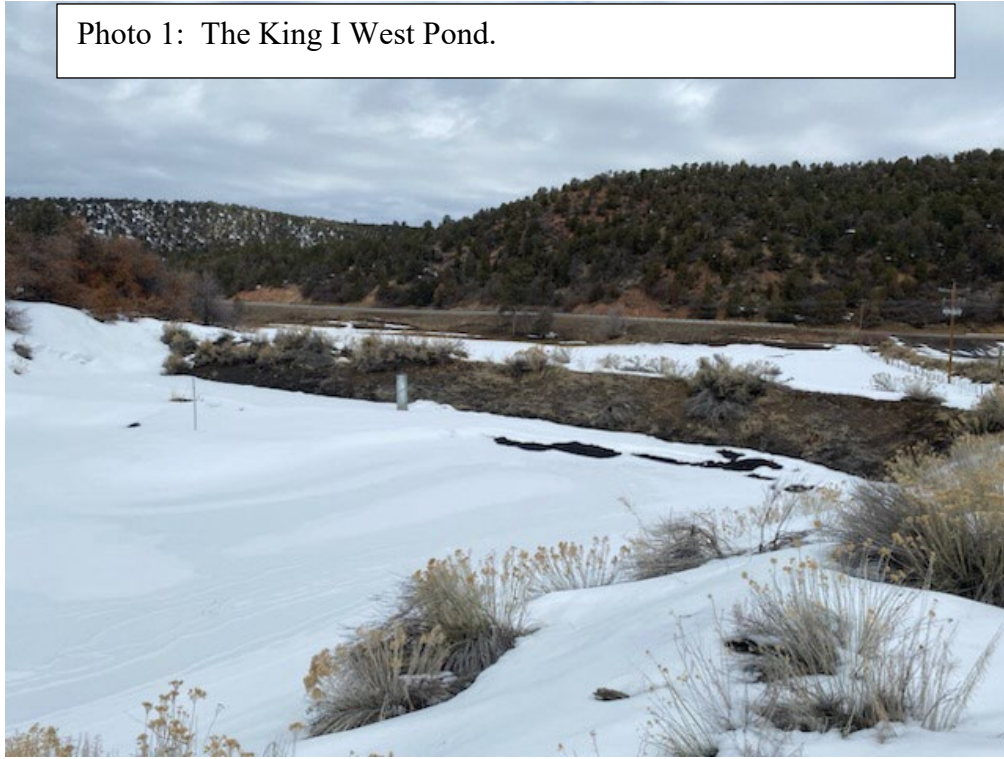
Two sediment ponds are located at the King I Mining Area, the west pond (Photo 1) and the east pond (Photo 2). Both ponds were covered with snow at the time of the inspection. The embankments for the ponds were stable with no indications of erosional features. The outlets for the ponds were observed to be clear of debris. Inlets to the ponds were clear of blockages.

Photo 1: The King I West Pond.

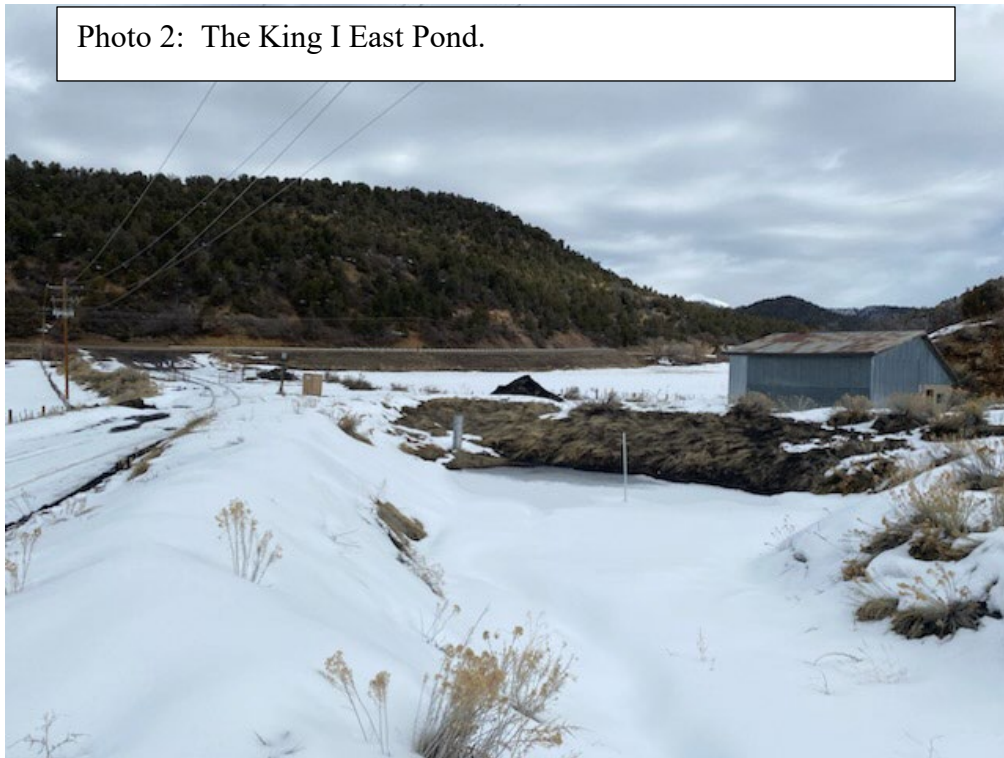
Photo 2: The King I East Pond.

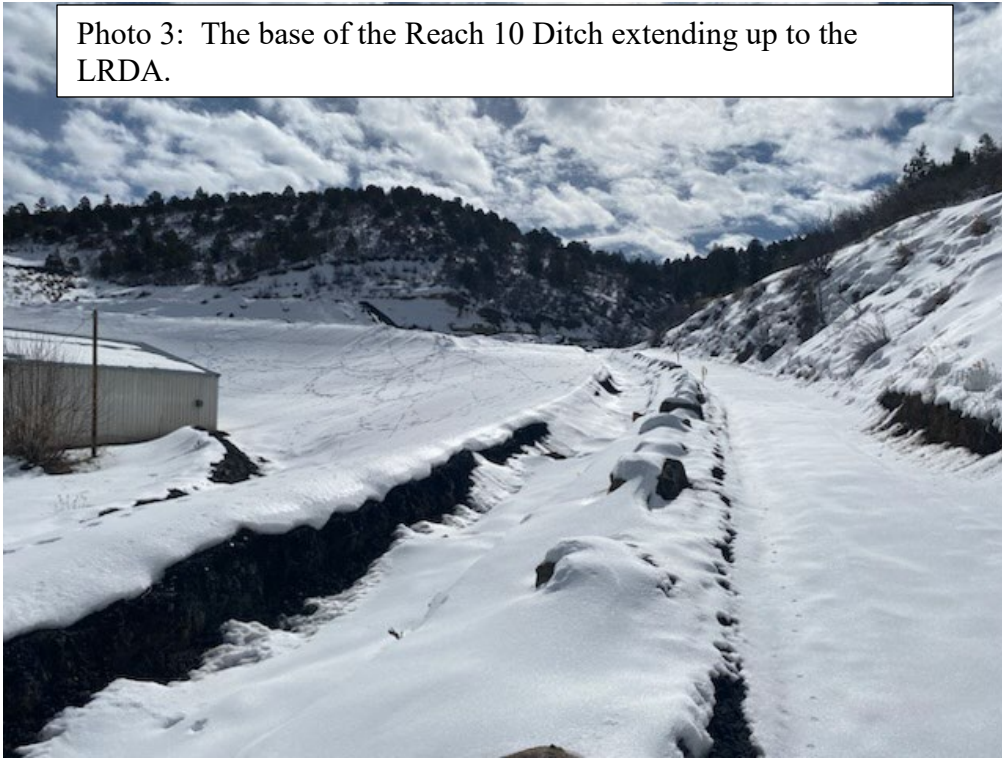
Ditches throughout the facilities area and on the refuse disposal area were covered with snow. There were no indications of erosional issues or blockages. The Ditches appeared to be stable, including Reach 15 and Reach 10 (Photo 3). These ditches were reconstructed in the fall of 2023.

Photo 3: The base of the Reach 10 Ditch extending up to the LRDA.

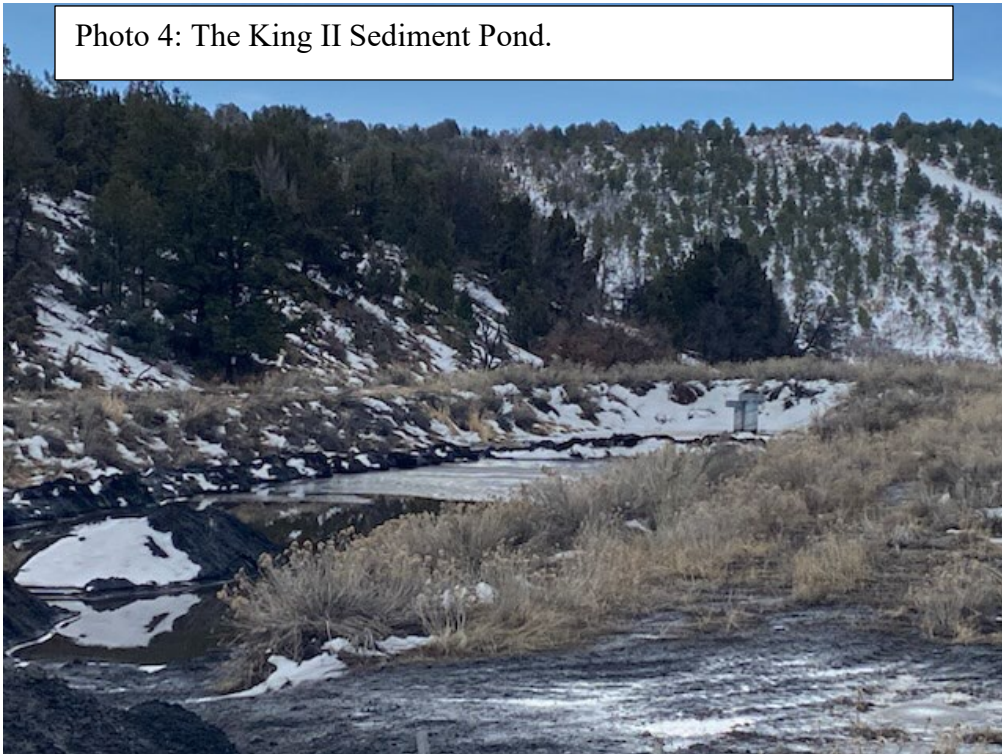
The sediment pond for the King II Area is located at the southern end of the facilities pad. The pond was holding a small amount of frozen water in it (Photo 4). There was no discharge from the pond. The discharge outlet was observed to be free of debris. Sediment located in the pond's northern portion of the bottom was stockpiled for cleanout. Pond cleaning operations are conducted when ground conditions allow. The sediment pond has sufficient storage capacity in its current state to handle runoff from the King II Mining Area.

Photo 4: The King II Sediment Pond.

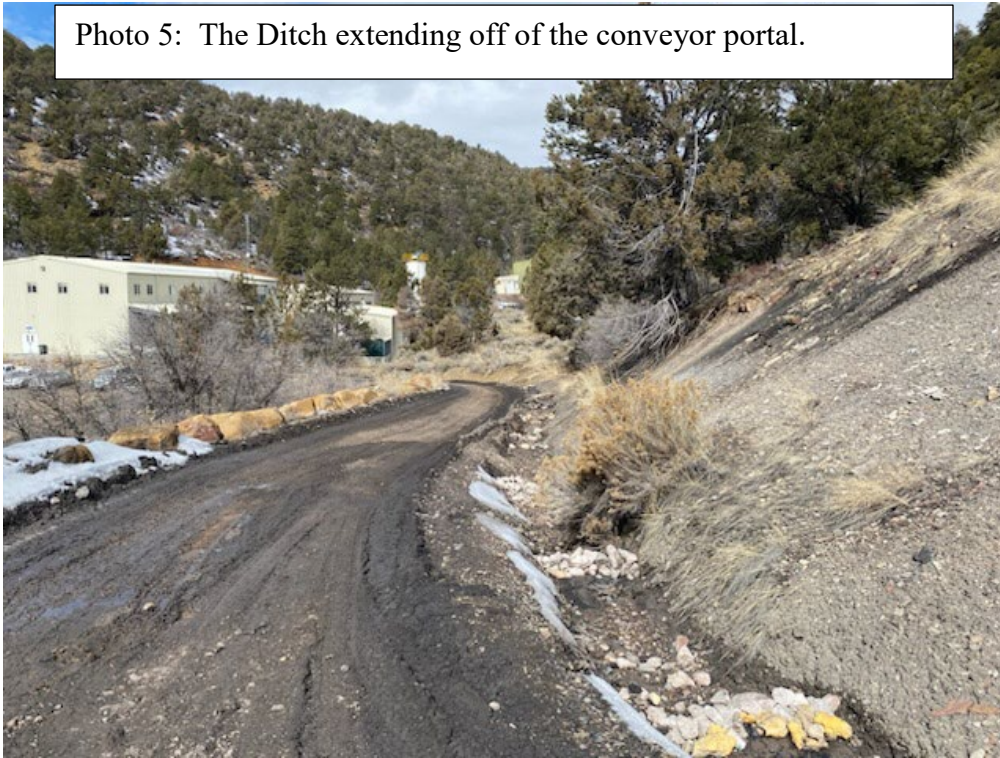
Ditches throughout the King II Mining Area were clear of debris and functioning as designed (Photo 5). There were no indications of erosional features or channel escapement.

Photo 5: The Ditch extending off of the conveyor portal.

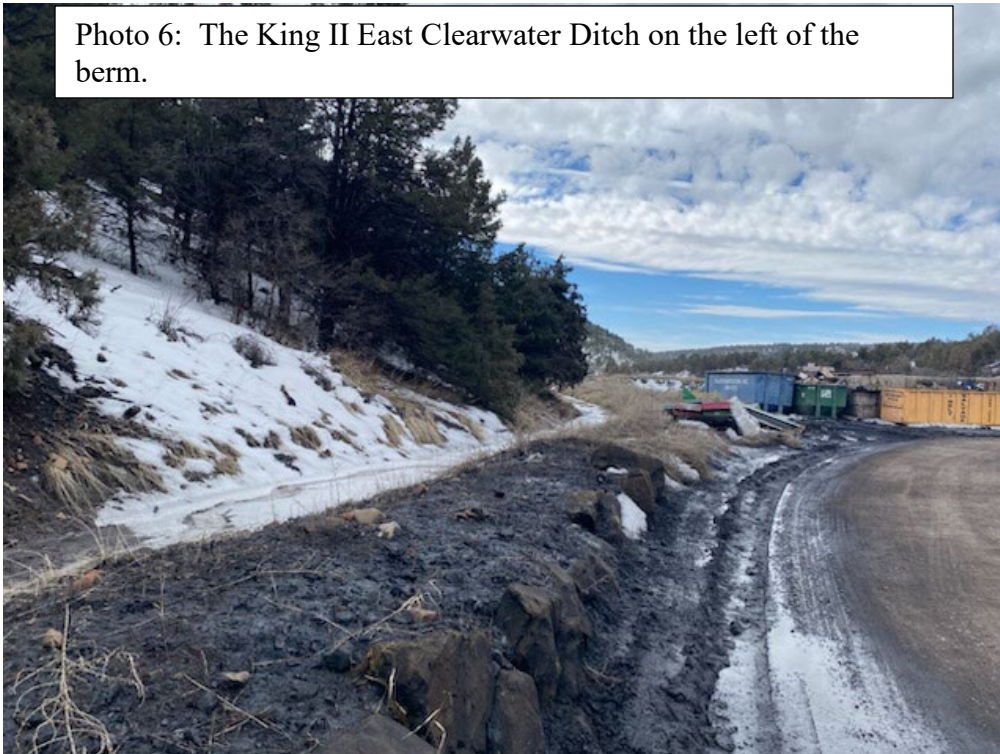
The East (Photo 6) and West Clearwater ditches were muddy during the inspection. There were no blockages or debris identified in the channels. The channels were stable with no indications of erosion.

Photo 6: The King II East Clearwater Ditch on the left of the berm.

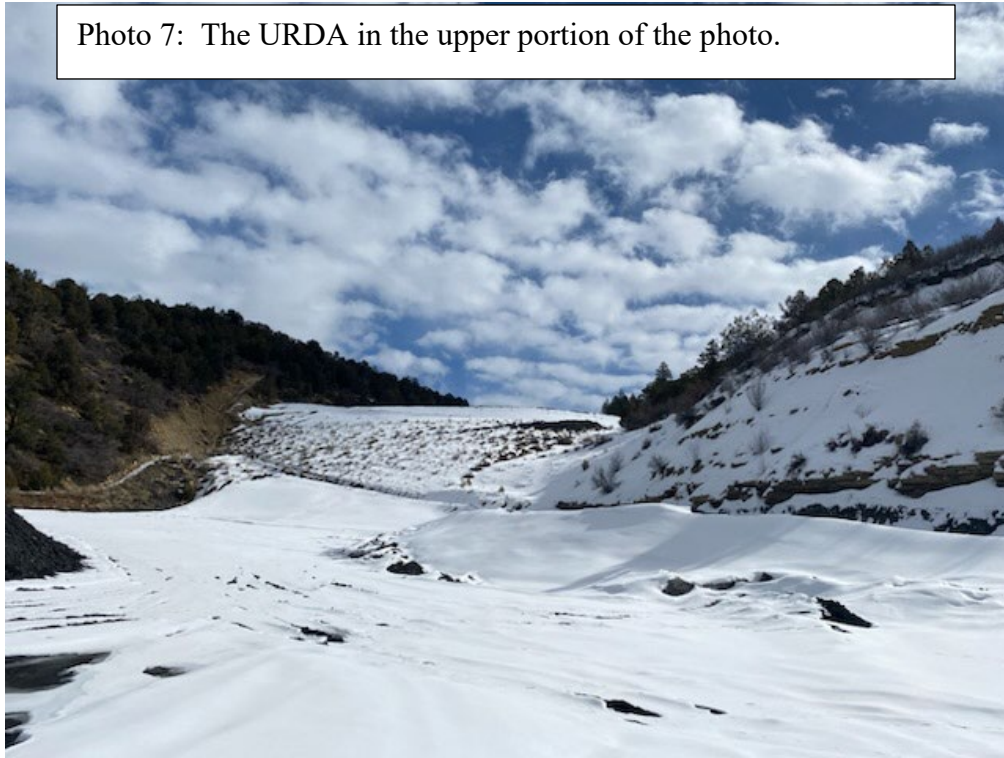
The coal refuse for the King Mine is placed in a refuse disposal area at the King I Mining Area. There is an upper refuse disposal area (URDA Photo 7) and a lower refuse disposal area (LRDA Photo 8). The URDA was covered with snow during the inspection. The access road to the URDA was covered over with snow preventing the placement of refuse material on the pile. The slope of the URDA was stable with no erosional features. The LRDA was being used to store refuse material in a stockpile. The remaining portion of the top of the pile was graded to prevent ponding of water. The refuse material placed on the top of the LRDA was stable and contained to the LRDA. The face of the LRDA was covered with snow. The face appeared to be stable and had no erosional issues.

Photo 7: The URDA in the upper portion of the photo.

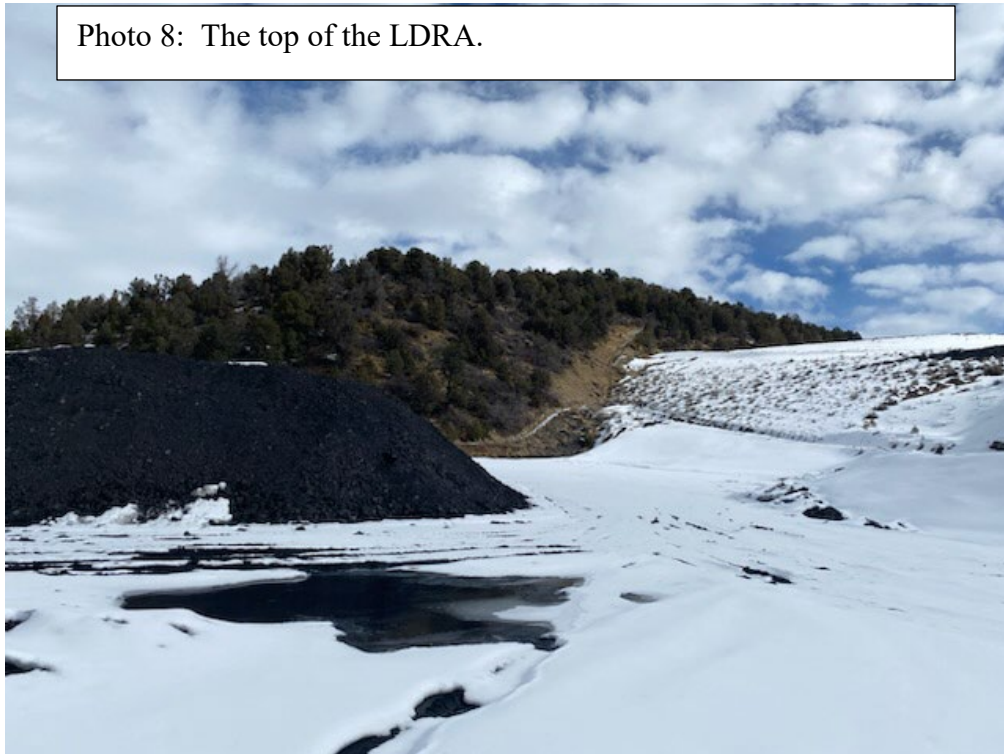
Photo 8: The top of the LDRA.

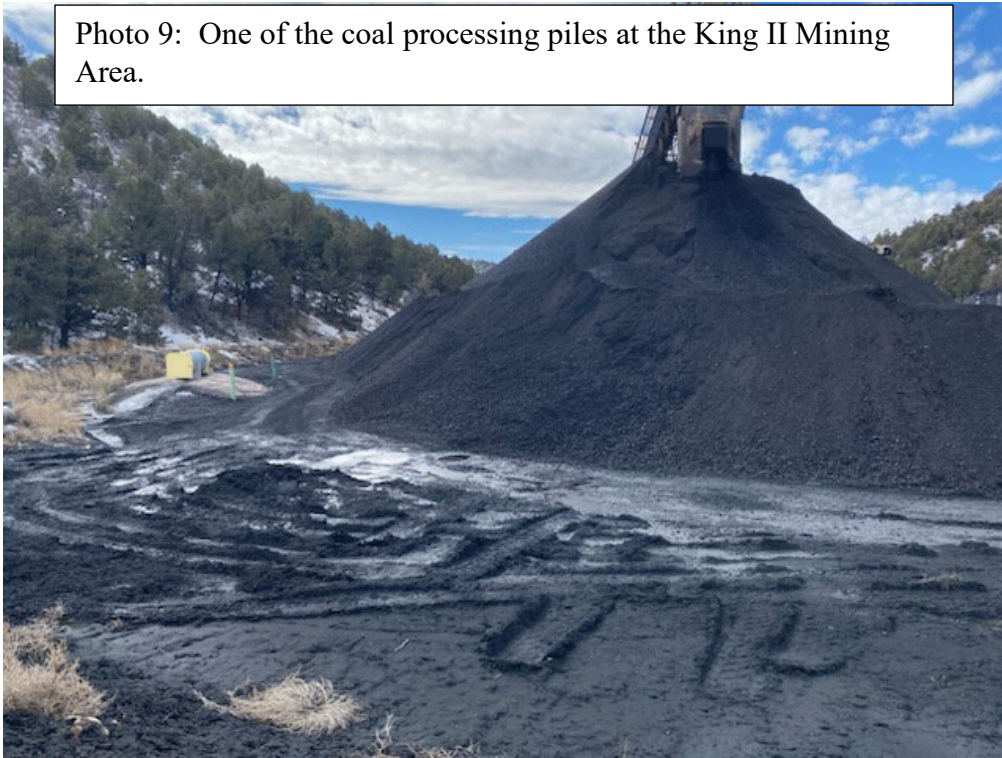
The coal processing and loading facilities are located on the King II facilities pad. Coal stockpiles placed within the processing area were stable and kept within their designated areas (Photo 9).

Photo 9: One of the coal processing piles at the King II Mining Area.

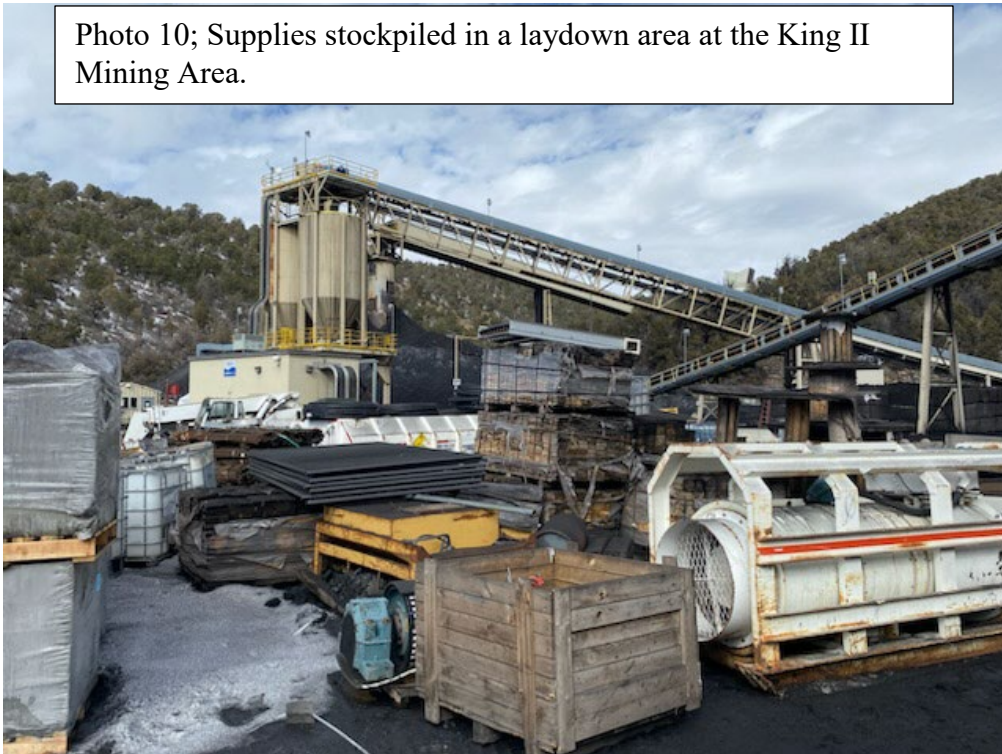
Materials and supplies were stockpiled neatly in their respective laydown areas (Photo 10).

Photo 10; Supplies stockpiled in a laydown area at the King II Mining Area.

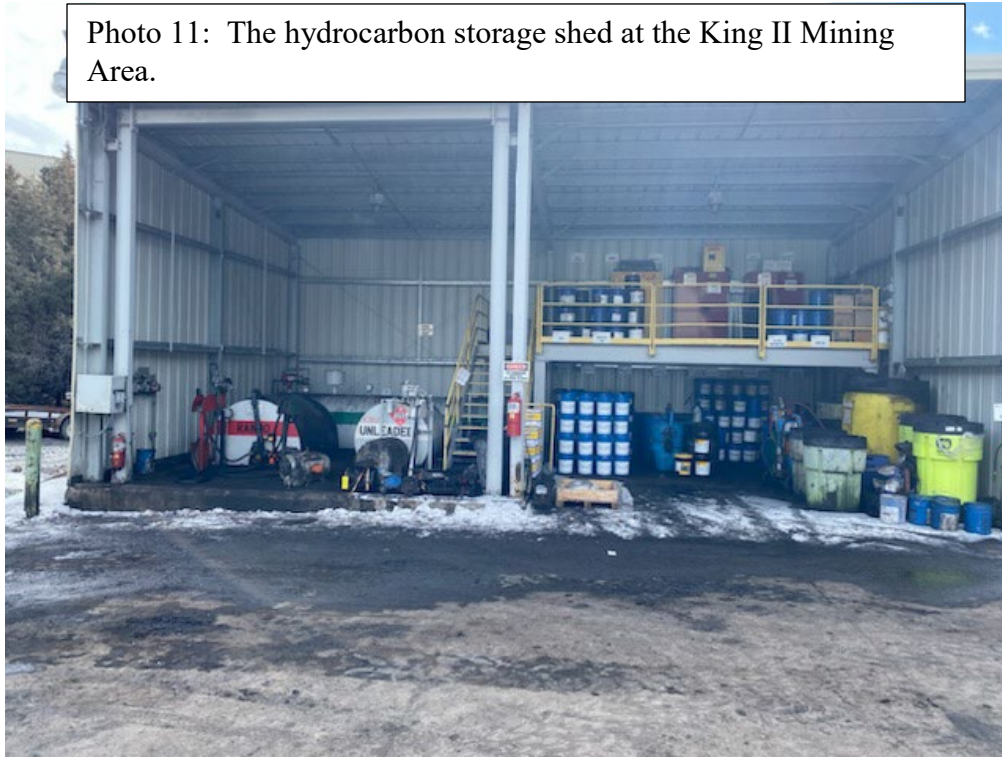
Fuels and Hydrocarbons were stored properly in a designated area with secondary containment (Photo 11). No spills were observed during the inspection.

Photo 11: The hydrocarbon storage shed at the King II Mining Area.
