February 29, 2024

**Re: Lorencito Canyon Mine (Permit No. C-1996-084)  
Review of Permit Renewal Application No. 5 (RN-5)  
Third Adequacy Review**

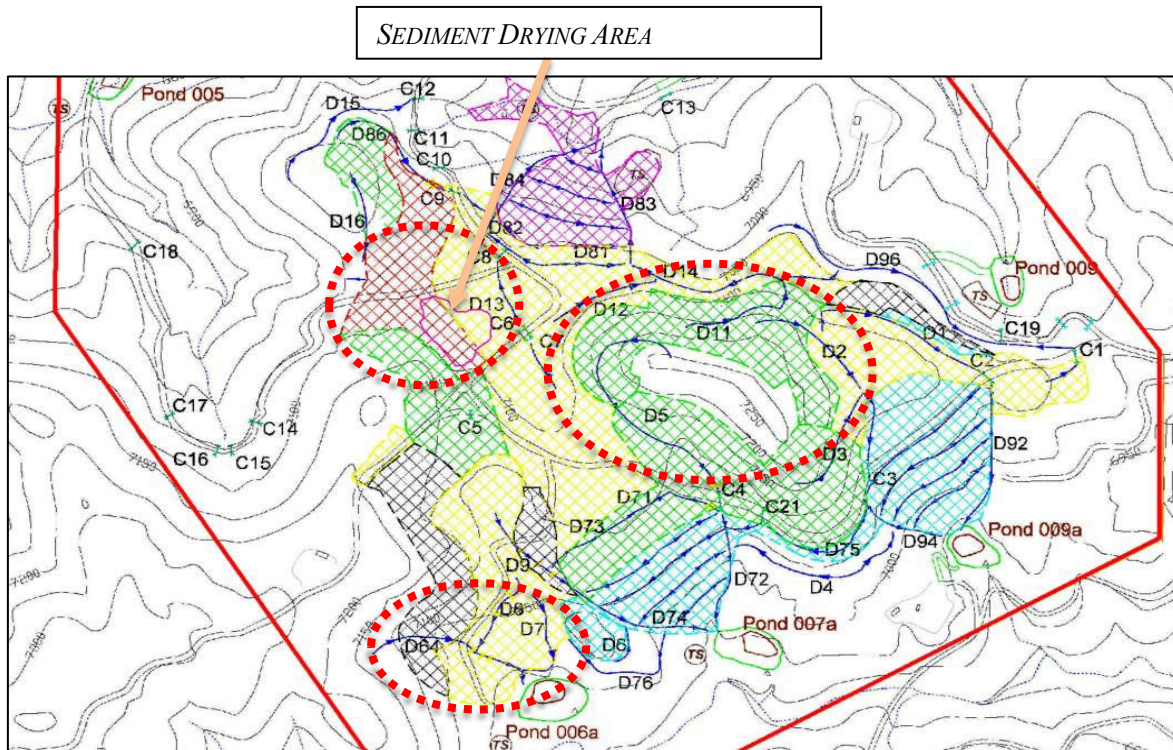
11. Significant rills, gullies, and areas with sparse vegetation have been noted in the reclaimed areas around the “Knob”, areas reported to have been reclaimed in 2006 and 2005 located above the area where pond and ditch cleanings are being stored, and areas reported to have been revegetated in 2007/2004 above Pond 006a. These areas are shown in the figures below. NECC has utilized several erosion control methods including the placement of straw waddles perpendicular to some of the eroded slopes, and the placement of brush within rills and gullies. The brush does seem to help prevent the rills from growing, and the brush seems to catch and hold soil and growth medium. Given the age of the reclamation of these areas in question, NECC will need to evaluate these areas to determine the best methods to fill, regraded, or otherwise stabilized these areas from erosion in accordance with Rule 4.14.6. Also, it is likely these areas will need to be reseeded in places given the sparse nature of the vegetation that has established. Please update the rill and gully plan to address how these areas will be stabilized in accordance with Rule 2.05.4(2)(c).

FIGURE 1. AREAS WHERE RILLS, GULLIES AND SPARSE VEGETATION HAS BEEN FOUND TO BE A PERSISTENT PROBLEM AT THE SITE ARE WITHIN THE DOTTED CIRCLE AREAS. BACKGROUND IMAGE IS THE 2020 ANNUAL REPORT MAP.

- *DRMS — “NECC states that NECC plans on addressing the rills and gullies by regrading or reseeding actions, and that this is planned to be addressed in 2023. NECC has a limited rill and gully plan included in the current page 2.05-69 of the PAP. In accordance with Rules 2.05.4(2)(c) and 4.14.6, please expand on this plan to include a proposal for addressing the specific areas highlighted in Figure 1. Be sure to identify these areas in the PAP as needing to be treated during this permit term. The Division requires NECC to create and submit a formal plan for addressing these issues at this time. This plan needs to be created and reviewed prior to approval of the permit renewal RN-5.”*
