## Inspection Report, Partial Inspection, Lorencito C-1996-084, February 16, 2024

**PERMIT INFORMATION**

<b>Permit Number:</b> C-1996-084 <b>Mine Name:</b> Lorencito Canyon Mine <b>Operator:</b> New Elk Coal Company, LLC <b>Operator Address:</b> Mr. John Terry 12250 Highway 12 Weston, CO 81091	<b>County:</b> Las Animas <b>Operation Type:</b> Surface <b>Permit Status:</b> Permanent Cessation <b>Ownership:</b> Private  <b>Operator Representative Present:</b>  John Terry
<b>Operator Representative Signature: (Field Issuance Only)</b>

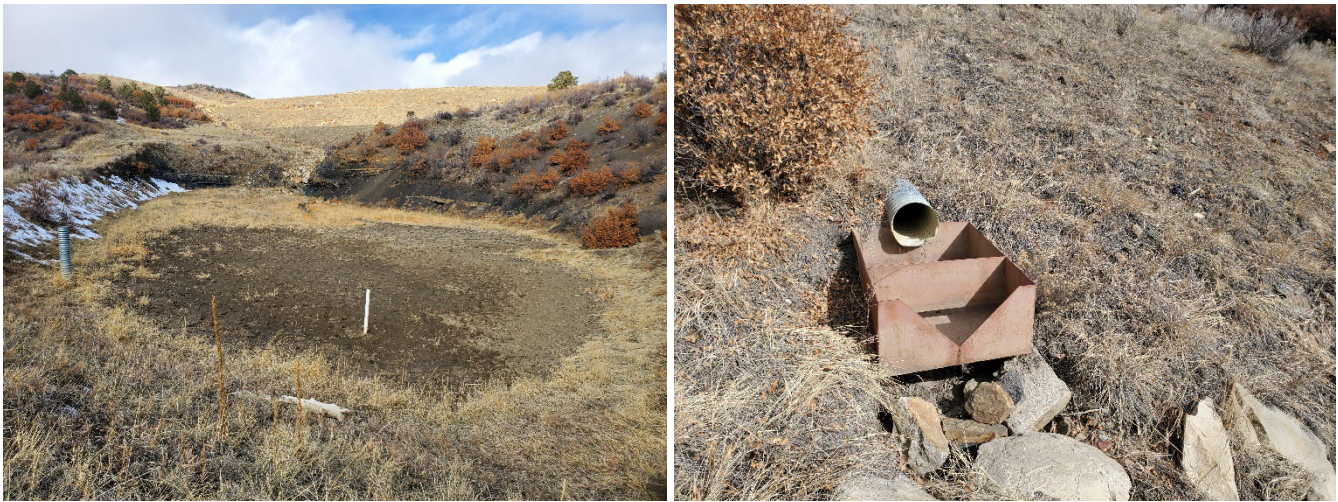
- Pond 007a was observed (Photo 1). The primary and emergency spillways were clear and functional. The pond was dry and was not discharging. The pond embankment was stable and vegetated.

**Photo 1:** (Left) Pond 007a. (Right) Dry flume for Pond 007a.

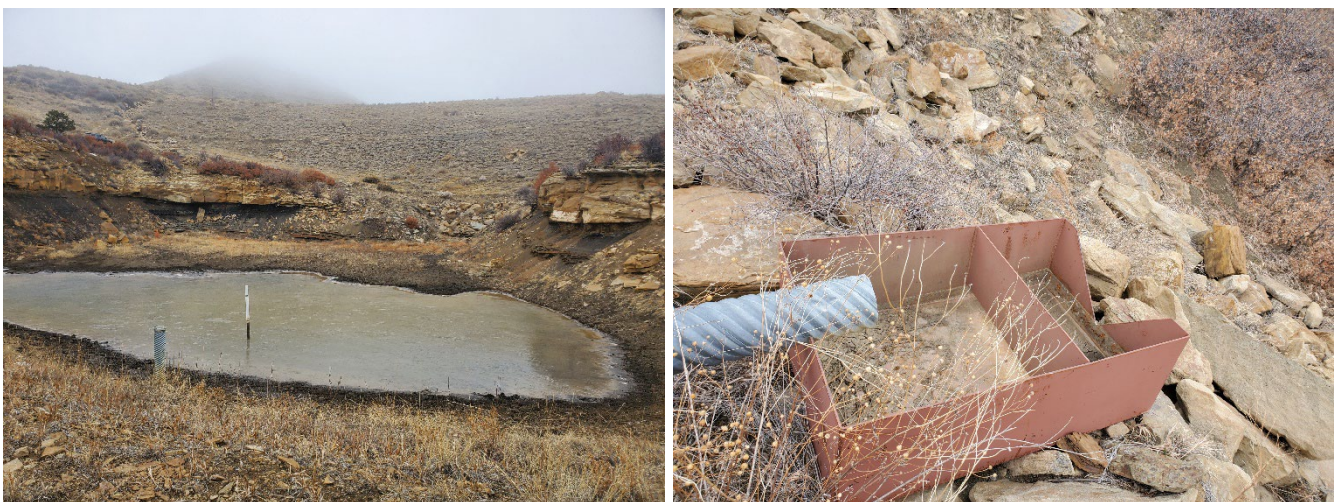
- Pond 009 was observed (Photo 2). The primary and emergency spillways were clear and functional. The pond contained partially frozen water and was not discharging. The pond embankment was stable and vegetated.

**Photo 2:** (Left) Pond 009a. (Right) Dry flume for Pond 009a.

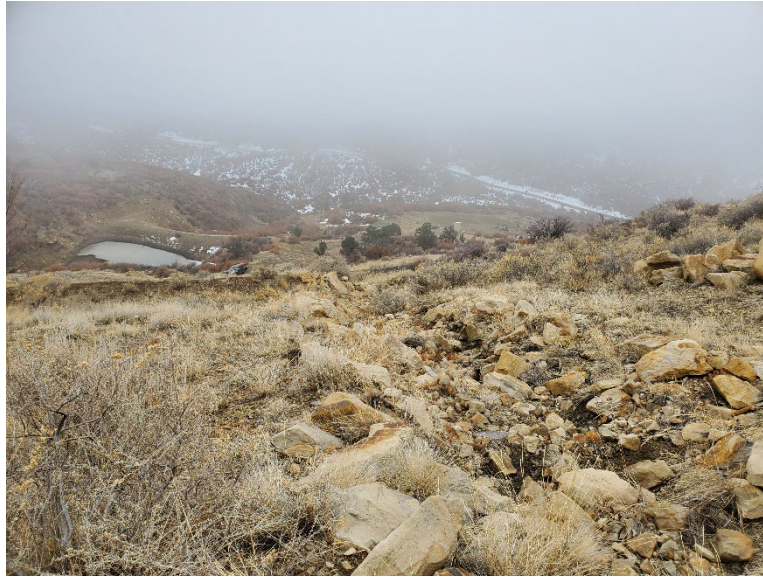
- Fill 007 was observed. Fill 007 was well vegetated and appeared stable.
- The Division and the Operator walked Fill 009, starting at the bottom south-west corner. Fill 009 was well vegetated and appeared stable. The armored channels along the sides of the fill were clear of obstructions (Photo 3).

**Photo 3:** West channel along the side of Fill 009.

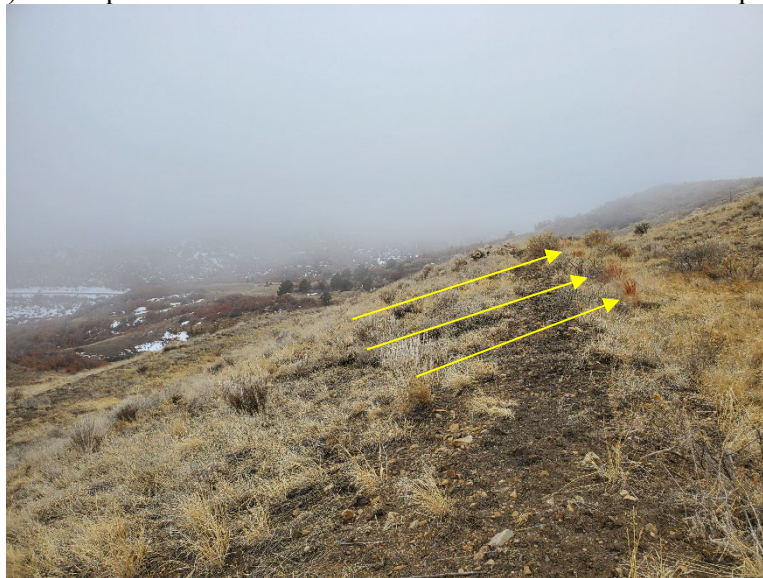
- The Operator stated that much of the vegetation on the fill is native and has volunteered onto the slopes. The Operator also stated that most of what was planted in the seed mix is limited to the tough areas along the benches (Photo 4). The Operator intends to submit a revision to revise the seed plan at this site.

**Photo 4:** Looking west along bench on Fill 009. Arrows point to grasses from seed mix.

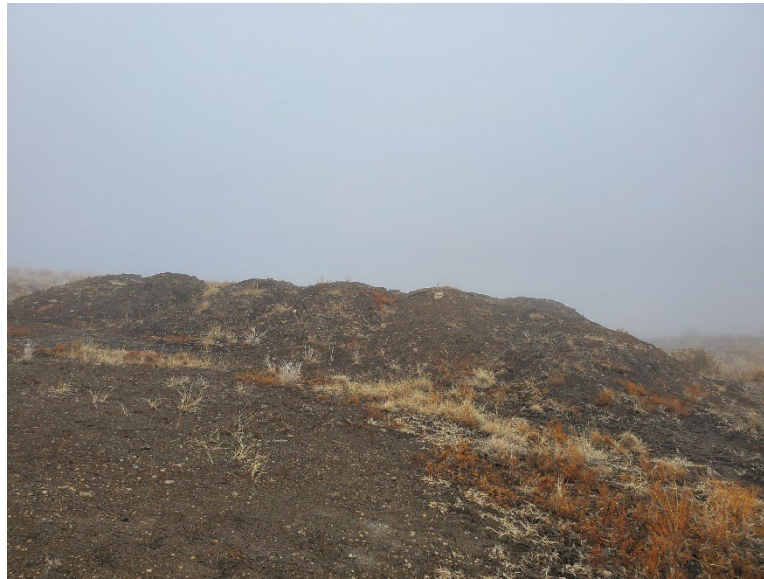
- NECC has placed pond and ditch cleanings to the west of ditch D13 in an area reported to have been reclaimed in 2004 and 2005. During the Division's March 15, 2022 inspection, this area was measured using ArcCollector and found to be about 1.68 acres in size. This area has been re-affected by the operation at the site, will need to be reclaimed and revegetated, and is no longer be considered in a state of reclamation. The Operator stated during the current inspection that the last time that pond cleanings have been placed in this Sediment Drying Area was 2021. However, when the maintenance issues for Pond 006a and Pond 008 are addressed within the next month, the Operator intends to put the cleaned material in this area. The piles have not been seeded, but do have volunteer vegetation growing on them (Photo 5).

**Photo 5:** Pond cleaning piles in the Sediment Drying Area.

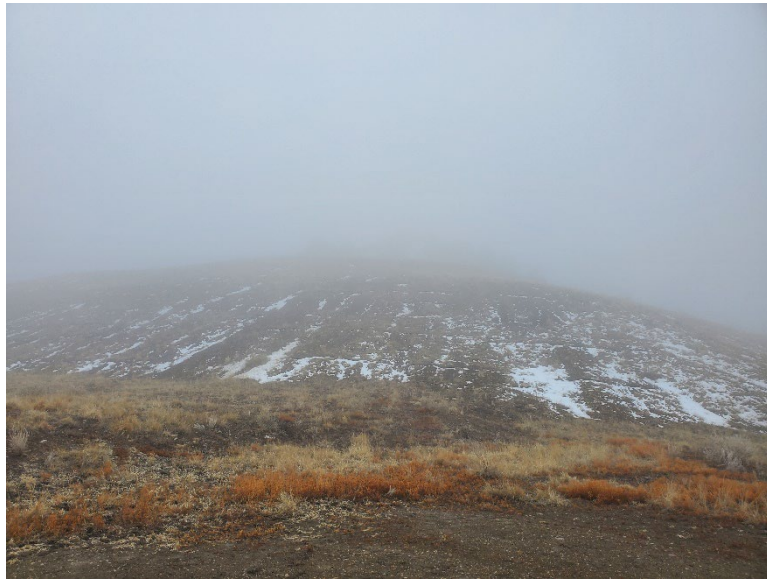
- The area above where NECC stores pond and ditch cleanings consists of a steep slope (Photo 6). This slope was observed. Erosion rills and gullies were observed. The vegetation on this slope appears better established this year than previously observed by DRMS. NECC is encouraged to continue to monitor this area and conduct maintenance as needed.

**Photo 6:** Reclaimed area above the sediment cleaning storage area.

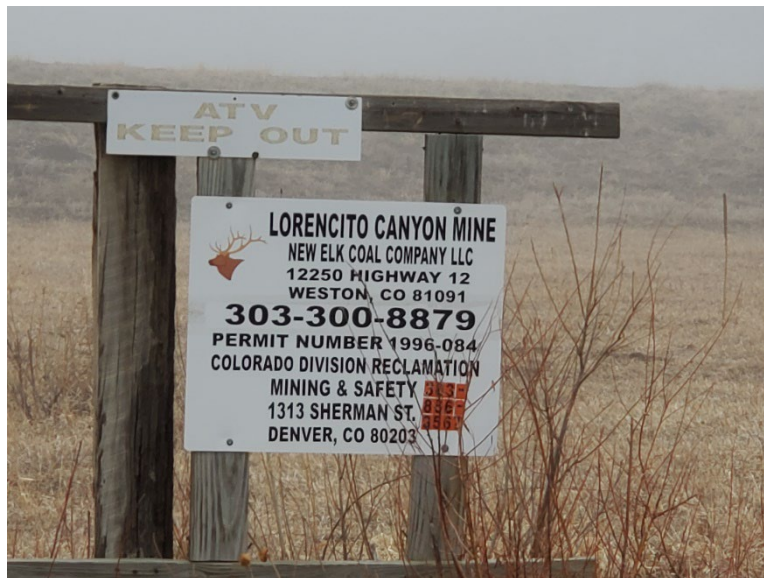
- Mine signs were posted at road entrances (Photo 7) and at the entrance to permit boundary in compliance with Rule 4.02.

**Photo 7:** Permit sign.
