File: January 2024 Monitoring Summary

Date: February 29, 2024

Reference: January 2024 Geotechnical Monitoring Summary Pikeview Quarry

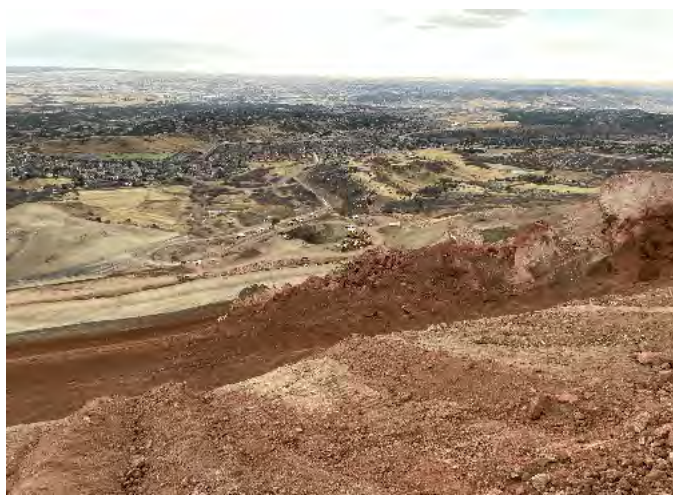
6. VIEW SOUTHEAST.

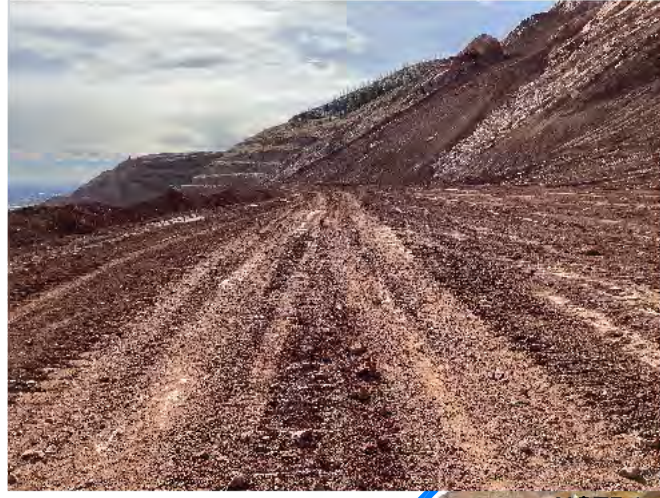
- Operators placed compacted material in the buttress zone. Material was primarily excavated from the Upper Borrow Area. The material was hauled down ramps to the buttress floor and placed in lifts and compacted.

5. VIEW NORTH OF BUTTRESS FLOOR.

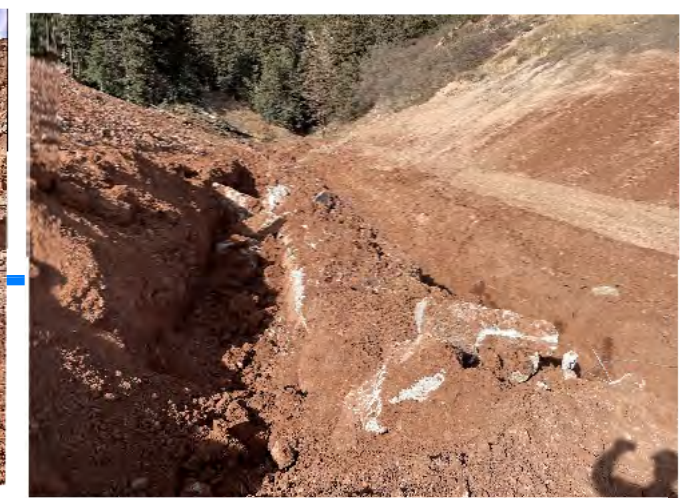
- The contractor began removal of the culvert. Castle Aggregate has procured a pump and will begin pumping operations if any water collects behind the culvert.

3. CULVERT PARTIALLY EXCAVATED.

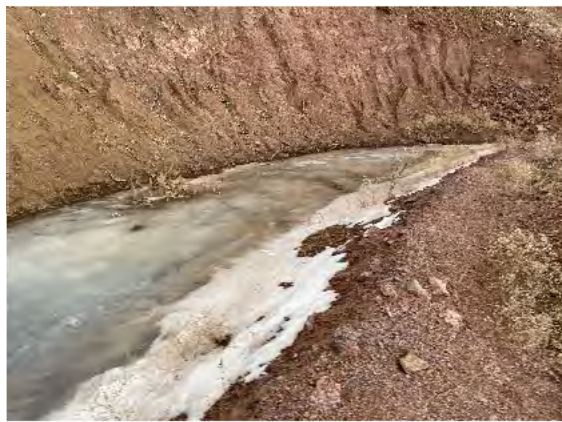
7. WILDLIFE POND ALONG HAUL ROAD

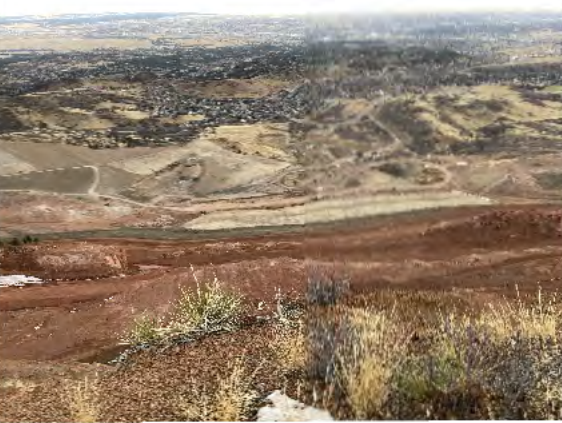
8. VIEW TO EAST FROM P33 LOCATION.

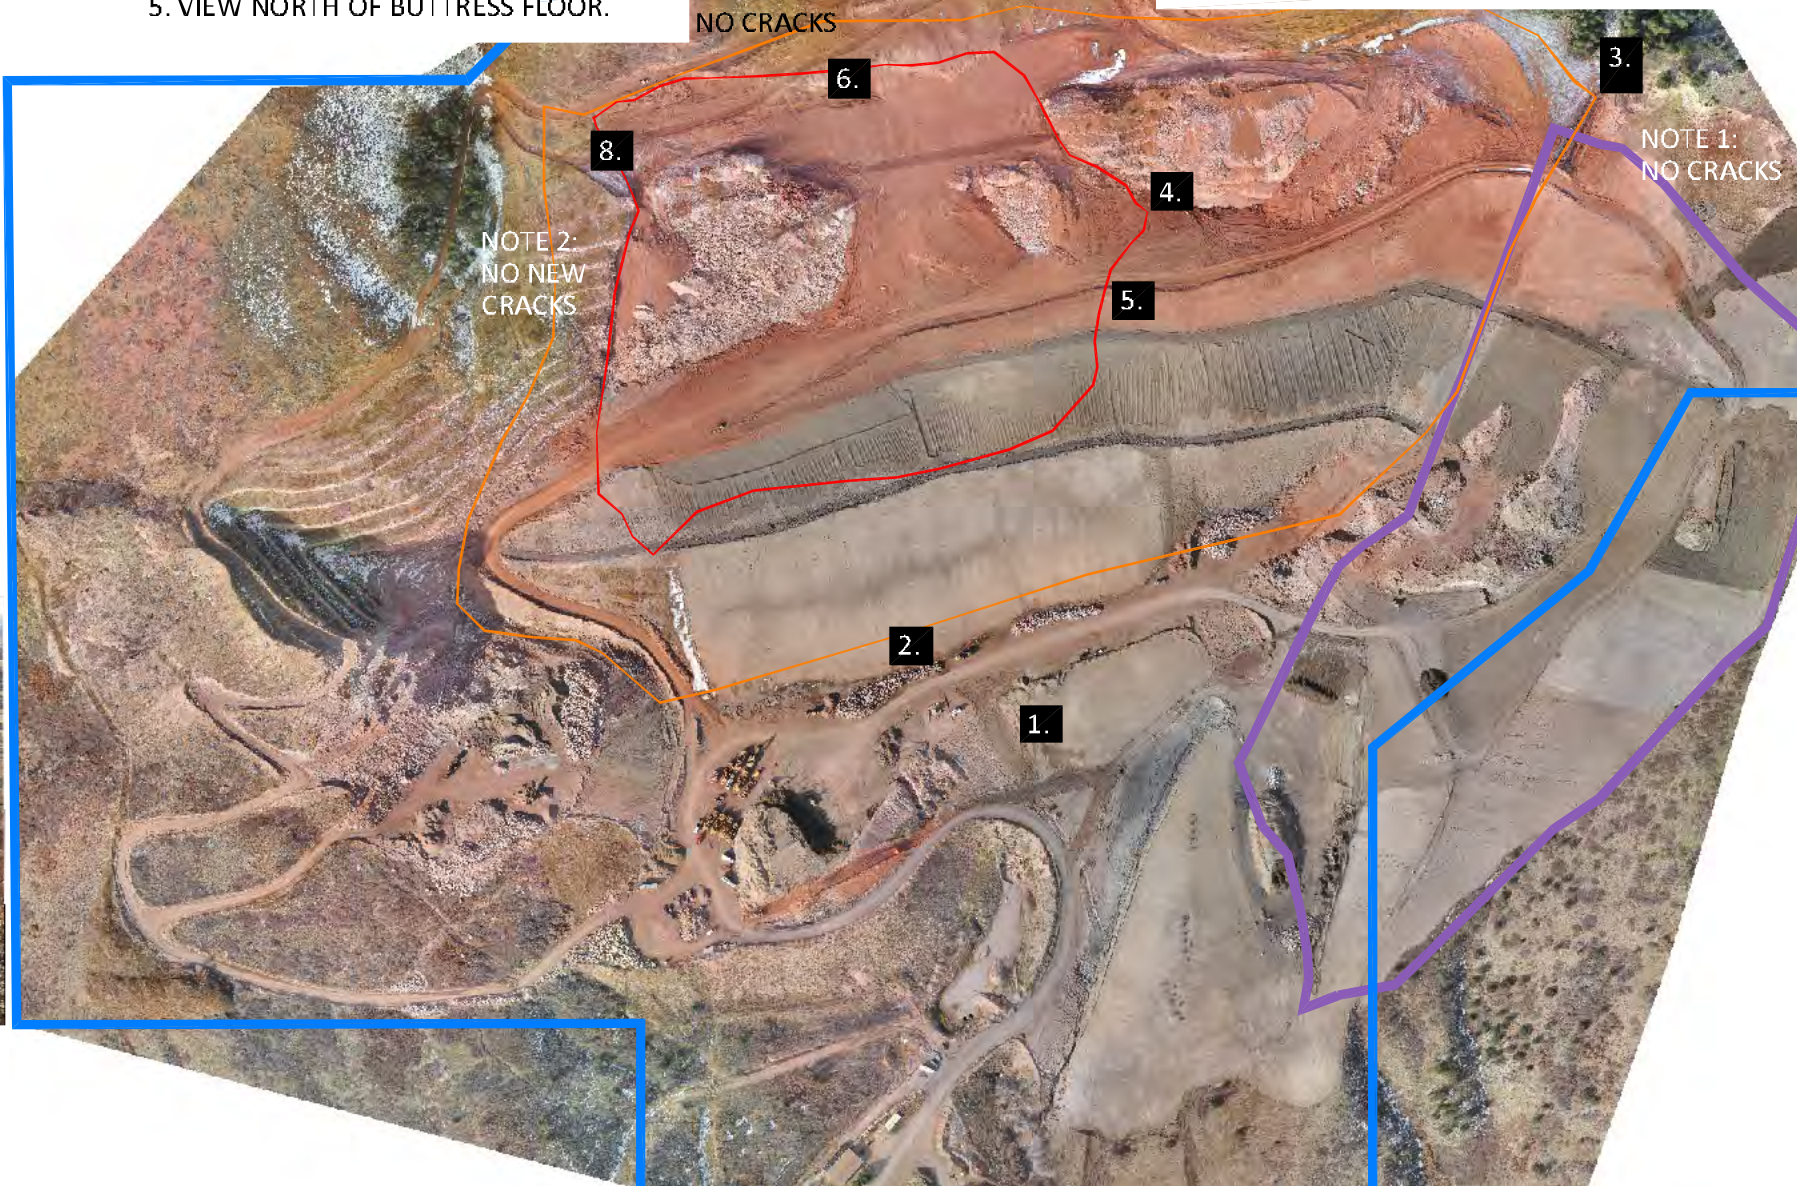
OBSERVATIONS FROM
JANUARY INSPECTION

Stantec conducted visual inspections of the Pikeview Quarry slopes on January 3 and 22, 2024. The engineering inspections were conducted by traversing each area of the mine and observing the uphill slope and the downhill slope for signs of instability, and areas in need of maintenance. Slopes that have been graded and are 2 horizontal (H):1 vertical (V) or shallower are also traversed on foot. The findings are listed below, and photographs of notable observations are included on Figure 2 in Appendix A.

- Visual inspections of the Pikeview Quarry did not reveal any evidence of large-scale instability outside of the landslide areas previously identified. No bulging, rippling, over-steepening, depressions, slumps, or dry slip-offs were observed in areas that have been graded and/or reclaimed.

1. NO CRACKS OBSERVED IN THIS AREA.
2. NO NEW CRACKS OBSERVED IN THIS AREA.
3. PHOTOS TAKEN ON JANUARY 22, 2024.

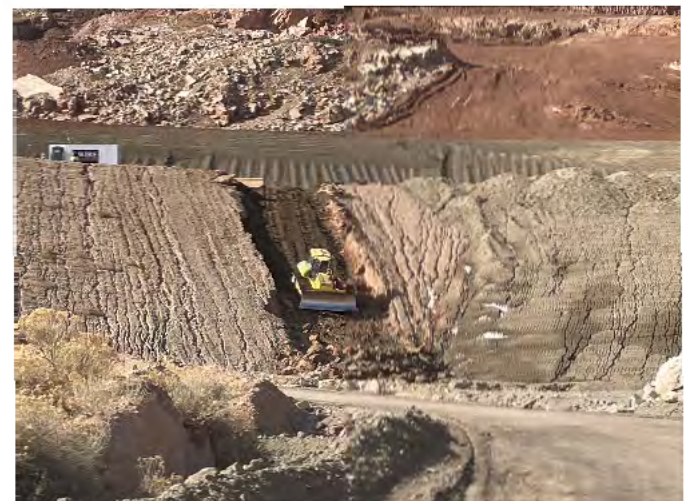
1. DOZER REPAIRING EROSION GULLY.

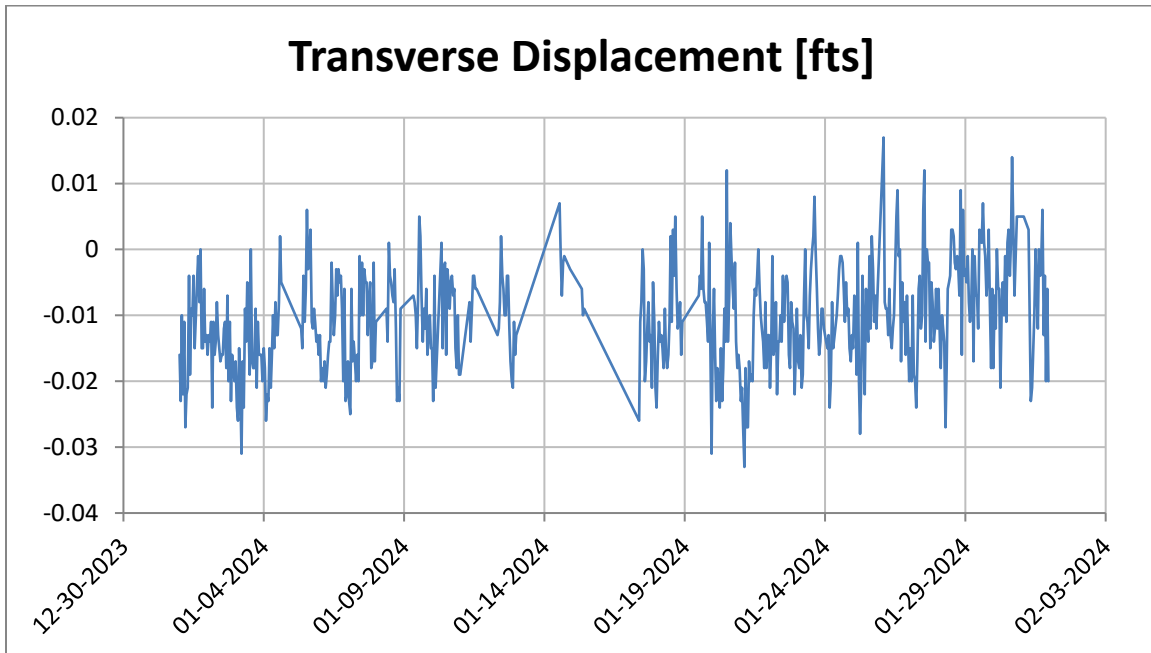
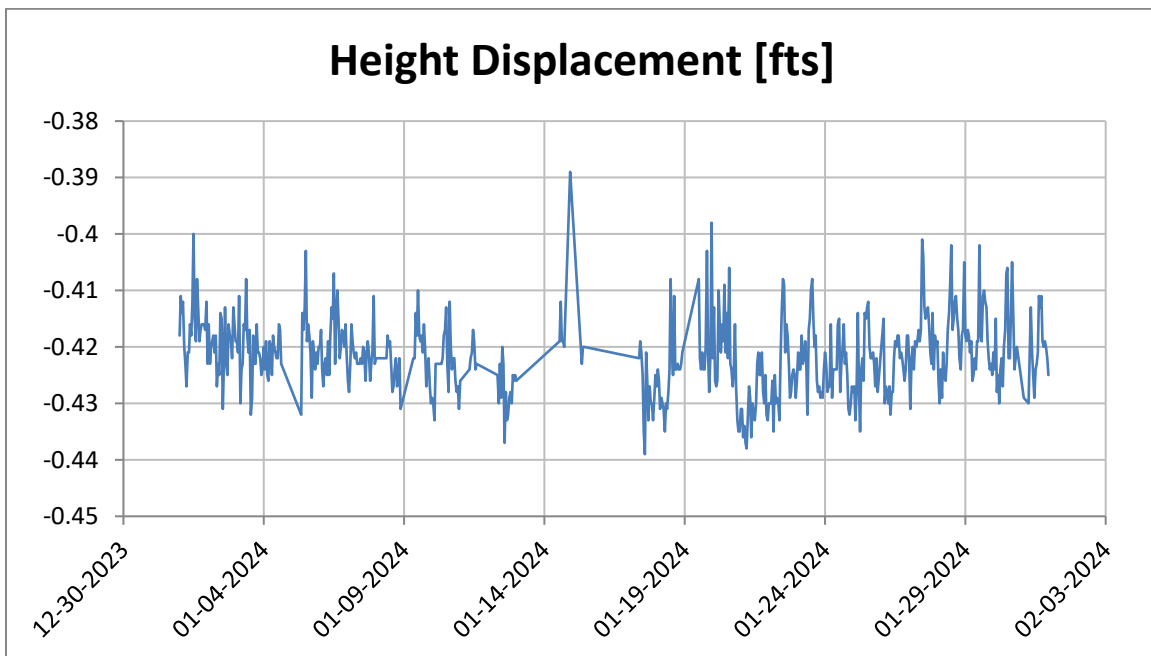
Prism BR1

The data show stable conditions with no movements at the 24 prisms with recorded displacements limited to data scatter and not actual movements. Prisms BR1 and BR3 are located above the landslide, and these prisms previously recorded slope creep movements at slow velocity. This settlement was likely related to loose fill or landslide material consolidating under its own weight. The continued rise of the buttress fill elevation may have halted these slope creep movements. The prisms placed on the buttress slope continue to show signs of settlement. A small amount of settlement is common for newly placed compacted fill. Plots of the transverse and height displacements for each prism are included in Appendix B.
