## OSMRE oversight Inspection Report, Partial Inspection, New Elk Mine C-1981-012

Attached for your records is a copy of the Division's Inspection Report for the OSMRE oversight-Partial Inspection of the New Elk Mine (C-1981-012) conducted on February 15, 2024.

<b>Permit Number:</b> C-1981-012 <b>Mine Name:</b> New Elk Mine <b>Operator:</b> New Elk Coal Company, LLC <b>Operator Address:</b> Mr. John Terry 12250 Highway 12 Weston, CO 81091	<b>County:</b> Las Animas <b>Operation Type:</b> Underground <b>Permit Status:</b> Active <b>Ownership:</b> Private
	<b>Operator Representative Present:</b>
<b>Operator Representative Signature: (Field Issuance Only)</b>

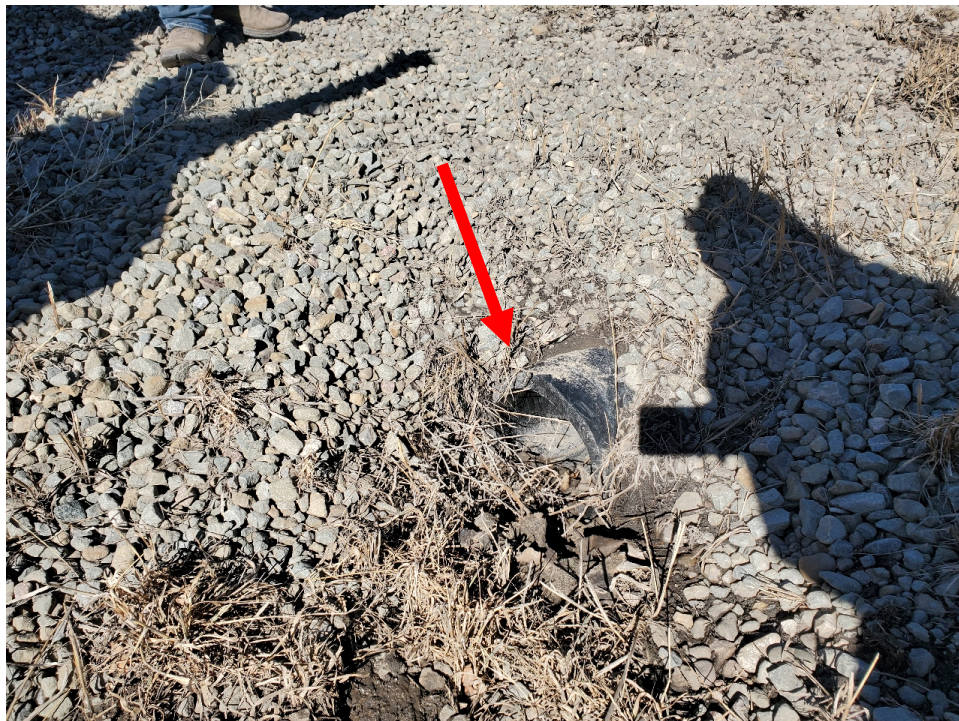
**Photo 1:** C12 almost buried by road.

- The measurements for the culverts leading up to, within, and around the RDA were not collected during this inspection.
- After the inspection concluded, it was discovered that culvert C11 was missed on accident, therefore no field measurement has been obtained at this time (see Figure 1).
- **The items in red on Table 1 identify maintenance items for culverts C12, C14, C16D, C61, and C65.** See Photos 1-3 and 6. Also, see Figure 1 for approximate locations of these issues.

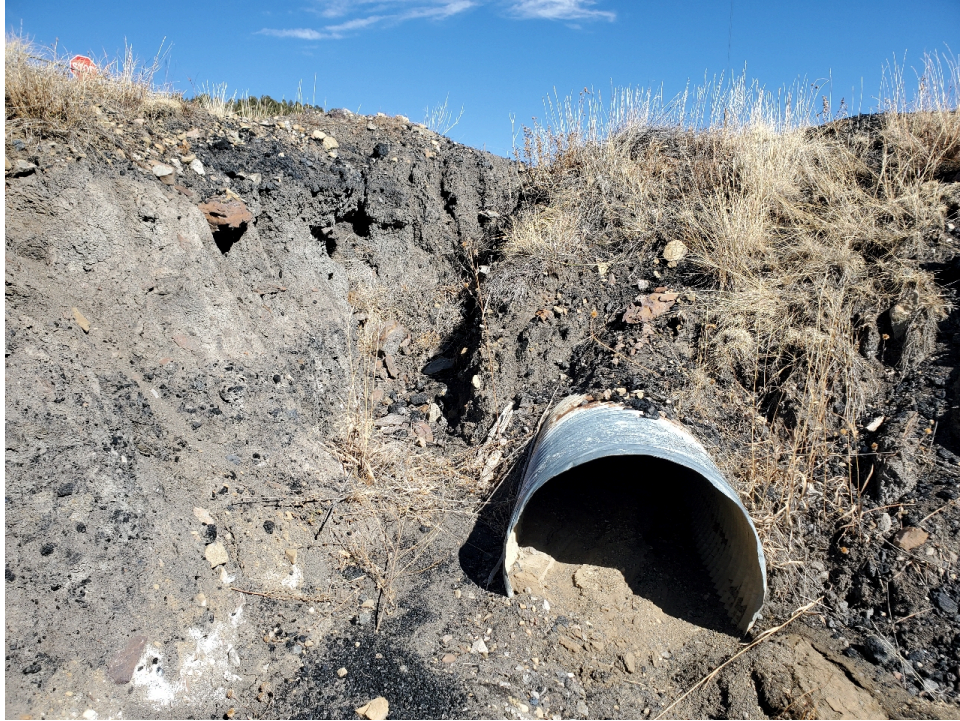
**Photo 2:** Erosion leading down from north side, near the highway at culvert C14. The sediment also needs to be cleaned out of C14.

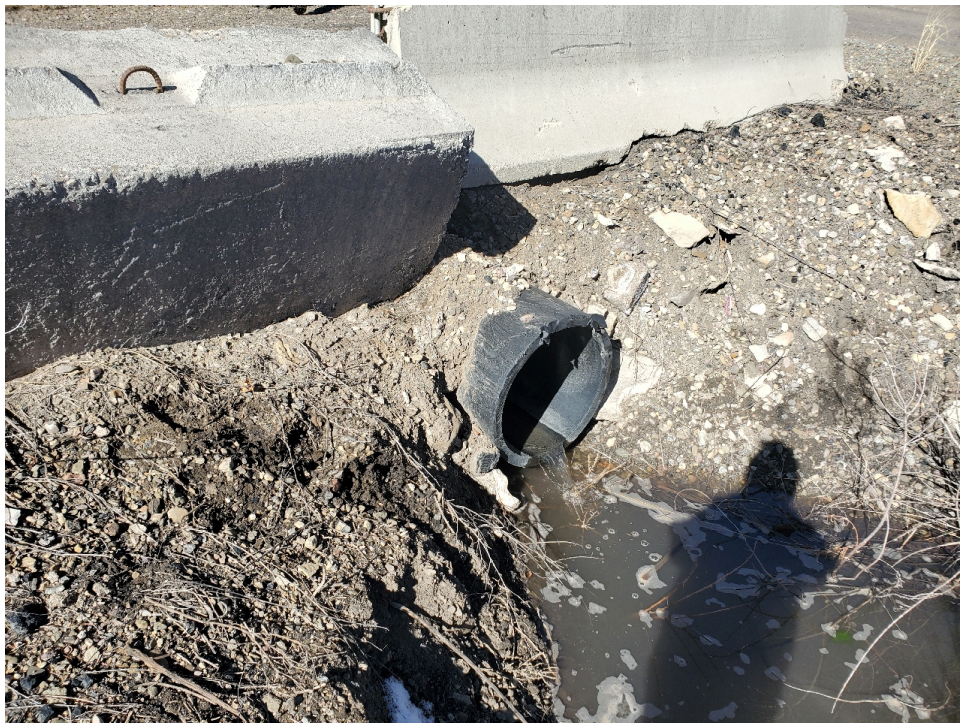
**Photo 3:** Erosion cutting down the side of culvert C16D.

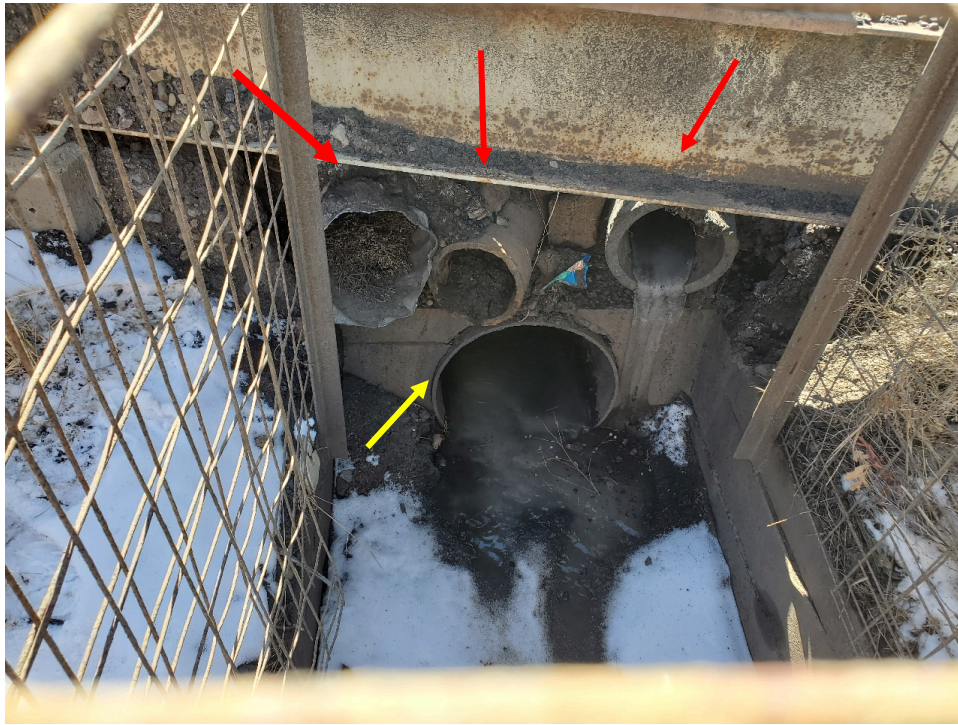
28	<i>Missing</i>	Never constructed?
28A	<i>Missing</i>	Never constructed?
29	<i>Missing</i>	Never constructed?
30	48	
[?] Below other three in the cage (C31, C33, C61)	24	Map looks like there should only be 3 culverts here, but there are 4 in a cage (Photo 4).
31	8	
31A	6	Broken, no longer seems functional, PVC pipe (Photo 5).
32	36	
33	12	
34	24	
36	18 or 19	Bent, difficult to get accurate measurement.
37	<i>Removed</i>	Removed since at least 2010.
39		RDA culvert
40		RDA culvert
41		RDA culvert
45		RDA culvert
46	24	
48	24	
49	44	
52	<i>Missing</i>	Duplicate number on Map 14, both missing.
52	<i>Missing</i>	Duplicate number on Map 14, both missing.
53	24	
54	<i>Missing</i>	Removed?
60	<i>Missing</i>	Removed?
61	12	Outlet side, into the 'drop inlet' labled on Map 13 needs to be cleaned out.
64	25	Inlet side measured.
65	24	Starting to scour underneath west bank of pond 006A, rock was put in because it was starting to wash out (Photos 6-7).

**Photo 4:** Culverts with red arrows from left to right in the photo: C61, C31, and C33. The culvert with the yellow arrow is unlisted and unnamed on Map 13.

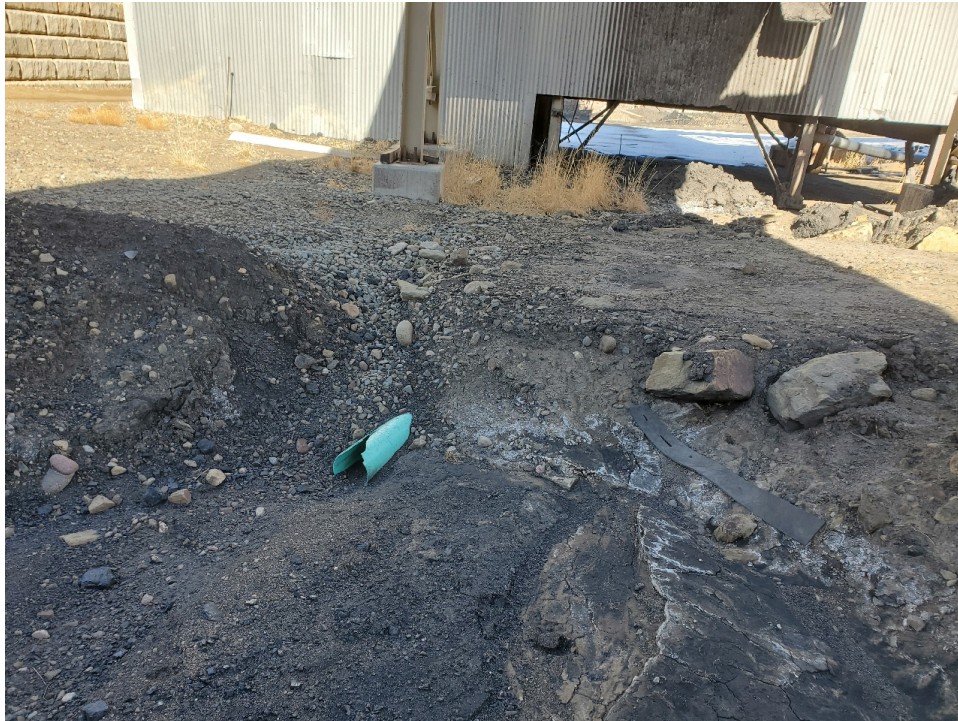
**Photo 5:** The broken green PVC pipe is in the location of culvert C31A on Map 13. It appears that this culvert is no longer functional or functioning as intended.

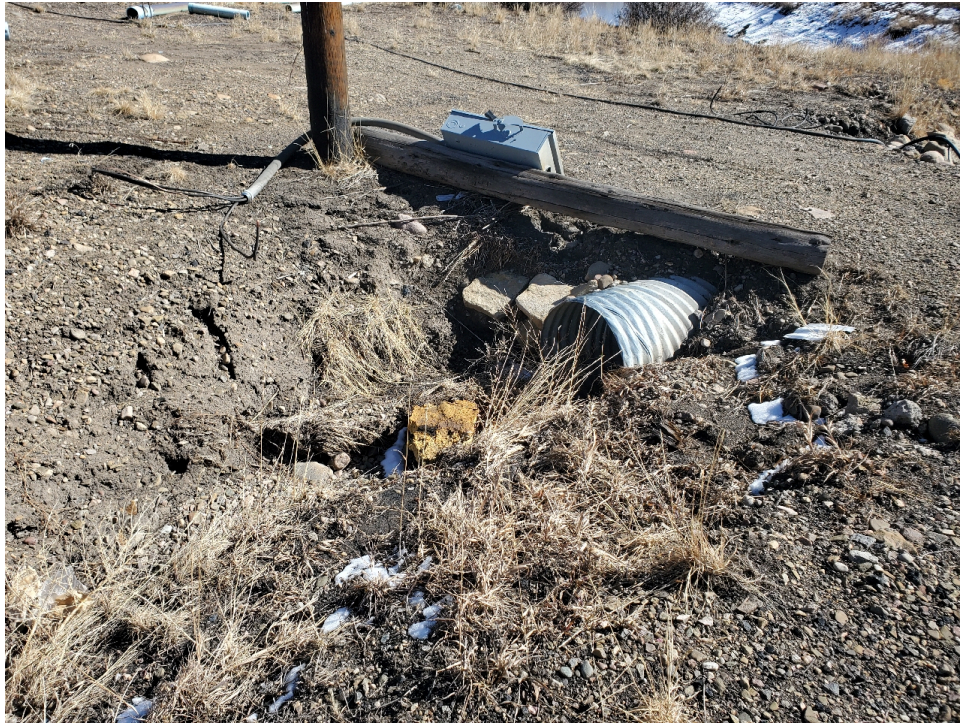
**Photo 6:** Scouring around inlet of C65

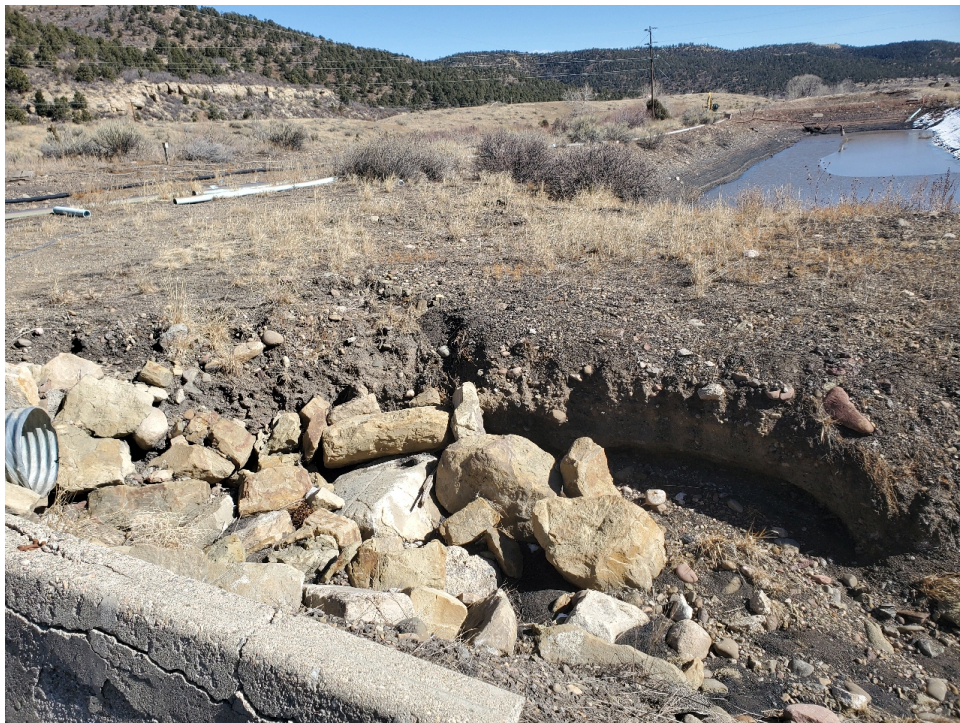
**Photo 7:** Scouring around outlet of C65.

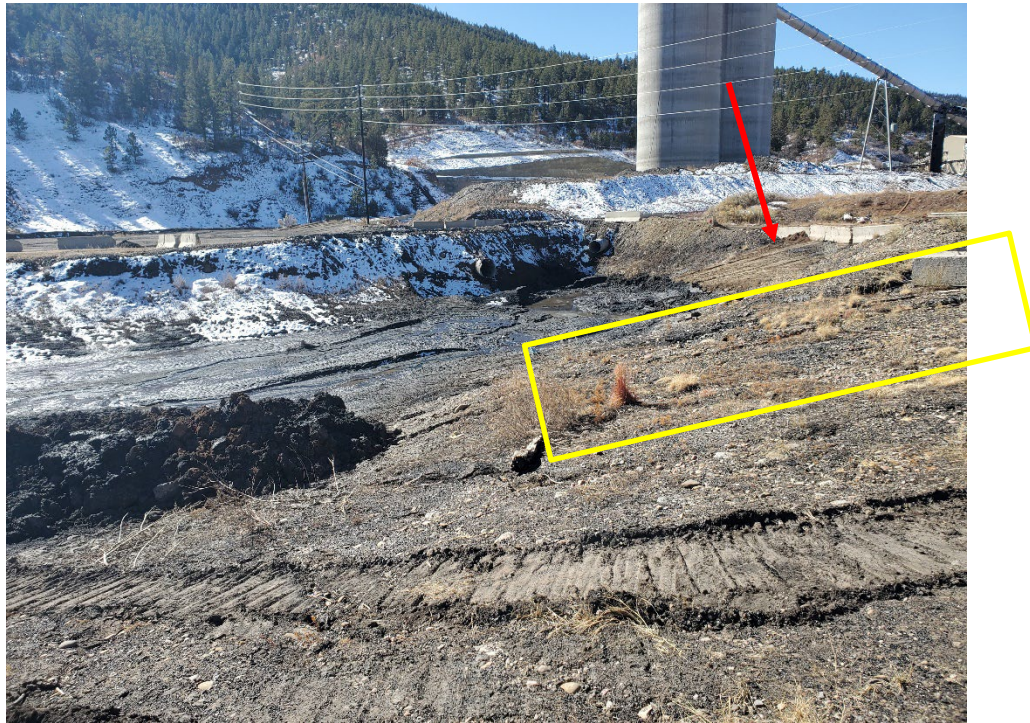
- **The silt fences along the SAE near Pond 007A that were damaged as a result of recent snowfalls, mentioned in the January 2024 report, still need to be repaired.**
- The erosion along the western bank of Pond 007A, leading down from the road, has been partially repaired (Photo 8). The erosion along the north-west portion of Pond 007A's bank **still requires stabilization.**

**Photo 8:** Arrow indicates where erosion leading under the concrete berms next to the road has been repaired and Pond 007A's western bank. The portion of the bank (within the rectangle) still requires some repairs.

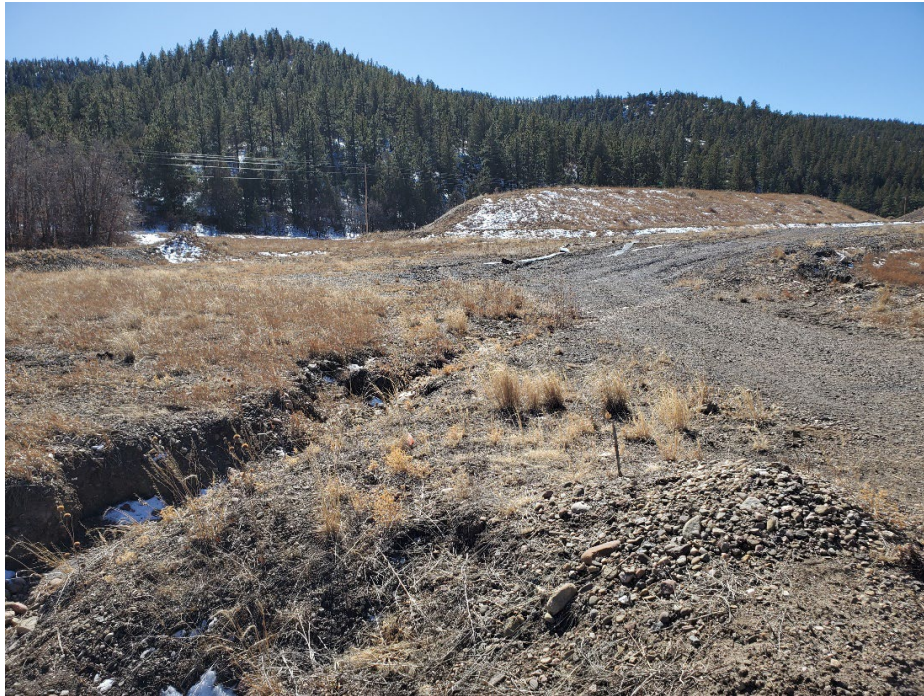
- The Division observed erosion gullies leading off to the north and north-west of the Stockpile Storage Area, located to the south of culvert C9A and east of the Train Yard (Photos 9-10). The Operator has tried to minimize and address the erosion with the use of branches placed in the gully and the installation of check dams; however, the check dams are in disrepair and erosion is continuing. **The Operators shall repair the erosion gullies and install any necessary BMPS to stabilize the area and reduce its susceptibility to erosion.**

**Photo 9:** Erosion from surface water run-off flowing to the north-east from the flat-road-area of the Stockpile Storage Area (to the east of the Train Yard).

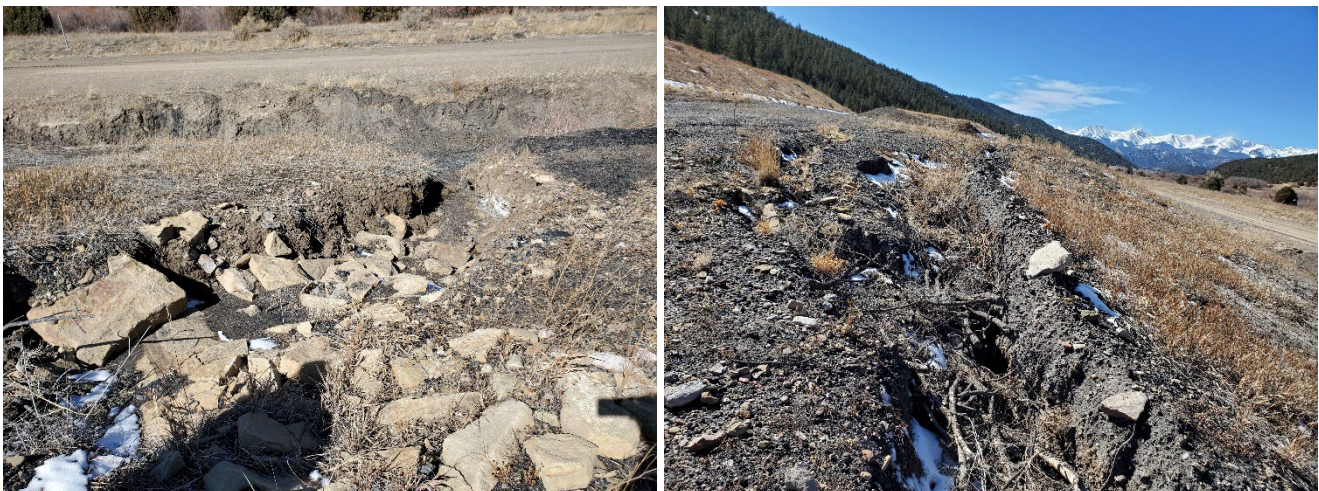
**Photo 10 (A and B):** Erosion from surface water run-off flowing to the north from the flat-road-area of the Stockpile Storage Area (to the east of the Train Yard). The Operator stated that they had tried to armor the gully with check dams (A) and branches (B) but they have since failed.

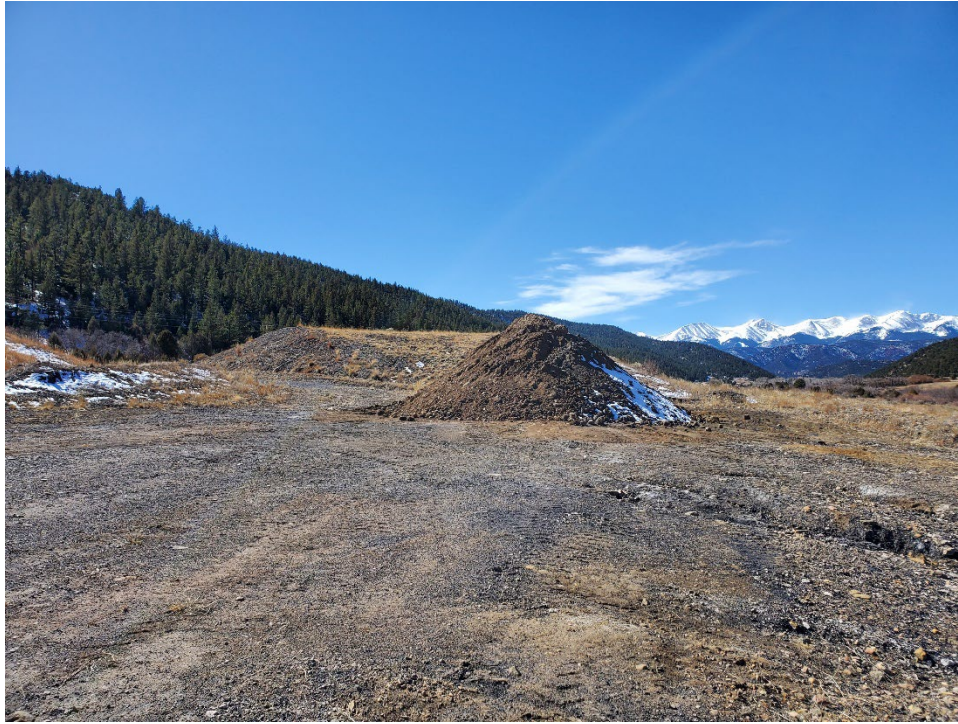
- In the Stockpile Storage Area, there is a new pile of soil (Photo 11). The Operator stated that the soil was salvaged during the debris clean-up work conducted during the past year in the Train Yard Area. The Operator believes that the pile contains topsoil quality soil. **If the Operator intends to salvage this material as topsoil, the topsoil pile must be stabilized with a vegetative cover (Rule 4.06.3(2)(a)(i) and identified by signage (Rule 4.02.7).**

**Photo 11:** New stockpile created from soil sifted from the cleaning up the debris in the Train Yard area.

- **The Operator shall submit a Minor Revision (MR) to update *Map 11-Sheet 3: East Portal Facilities* and pages 37-41 of section 2.05 of the PAP to account for the location, source, and volume of the new topsoil pile pictured in Photo 10.**
- The 'Topsoil' sign for Topsoil Pile #2 (located within the SAE south of Highway 12 and southwest of Pond 08) has fallen over and the post is broken. **The Operator shall replace the sign post and erect the sign on Topsoil Pile #2.**
