STATE OF
COLORADO

February Partial Inspection Report

Permit Number: C-1981-018 Mine Name: Deserado Mine Operator: Blue Mountain Energy, Inc Operator Address: Mr Kurtis Blunt 3607 County Road 65 Rangely, CO, 81648	County: Moffat, Rio Blanco Operation Type: Underground Permit Status: Active Ownership: Private
	Operator Representative Present: Kurtis Blunt
Operator Representative Signature: (Field Issuance Only)

Inspection Start Date: February 21, 2024 Inspection Start Time: 10:45 Inspection End Date: February 21, 2024 Inspection End Time: 13:00	Inspection Type: Coal Partial Inspection Inspection Reason: Normal I&E Program Weather: Cloudy
Joint Inspection Agency: None	Joint Inspection Contacts: NA
Post Inspection Agency: None	Post Inspection Contacts: NA
Inspector(s): Todd Jesse	Inspector's Signature:

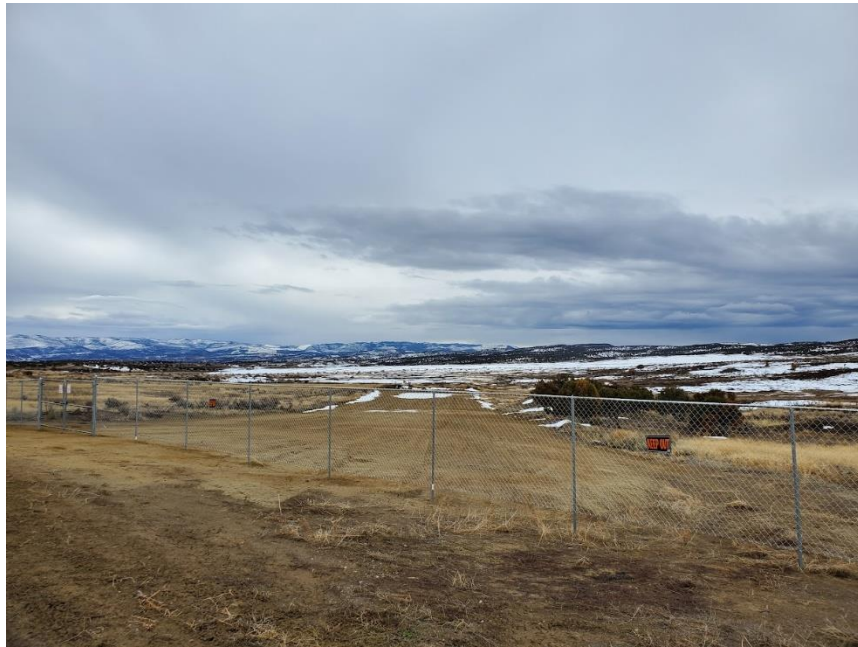
Backfilling and grading of the Halandras Landfill (with the exception of the adjacent sump) has been completed. The grading has returned the area to the approximate original contour of the area (Photo 1). A fence was installed to prevent the general public from entering the area. Topsoil needs to be replaced and the area also needs to be seeded.

Photo 1 – Grading of the Halandras Landfill with fence to prevent unauthorized entry.

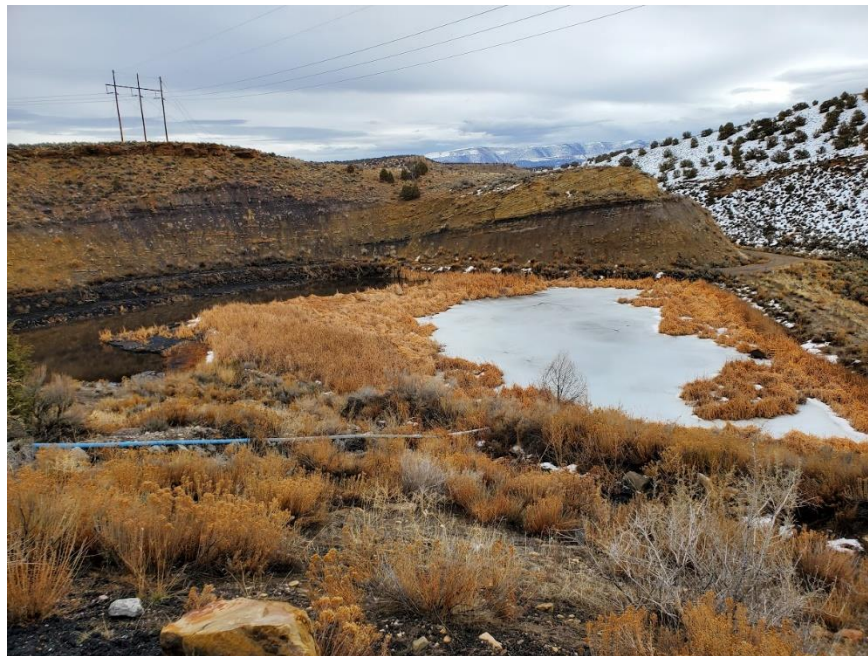
Photo 2 – View from middle bench of Pond DP-1. No signs of instability.

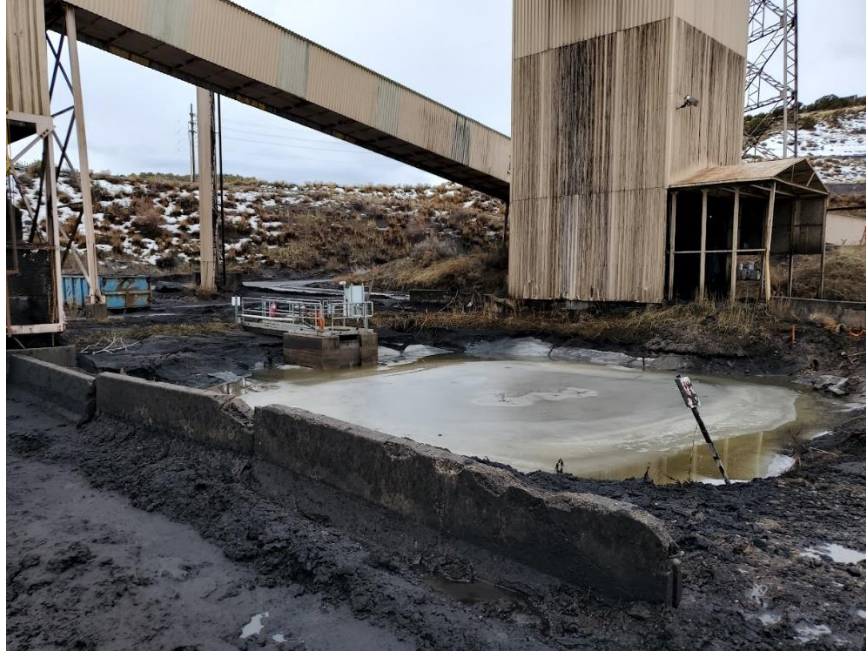
partially frozen at the time of the inspection. No signs of instability or erosion were noted (Photo 3). Pond PP-1 was not observed to be discharging. The PP-2 pond is located on the upper facilities bench. This pond was also partially frozen. There were no indications of instability or erosion on the pond's embankment (Photo 4).

Photo 3 – Pond PP-1 near the prep plant. No signs of erosion or instability. Water level lower than previous inspection.

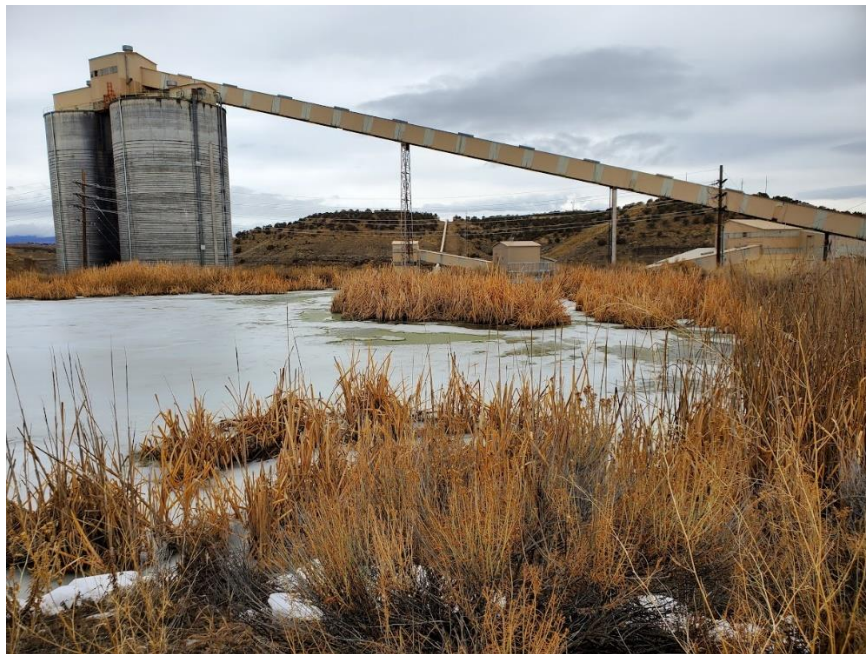
Photo 4 – Pond PP-2 on the top bench of the facility area. No signs of erosion or instability.

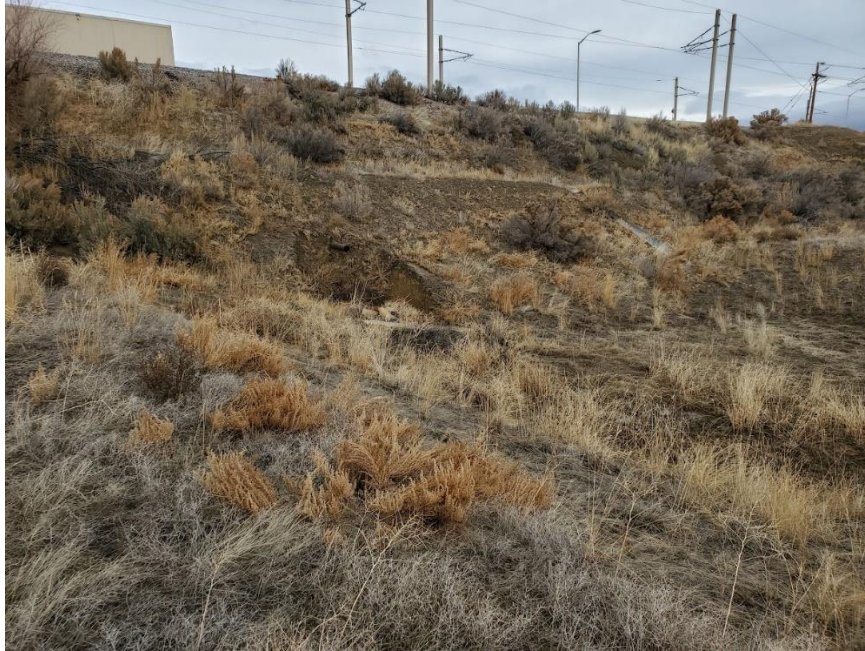
The RS-1 Sump and the RR-1 Pond are located on the south side of the rail loadout. The RS-1 Sump was not impounding water at the time of the inspection. The sump's embankments were stable and there were no erosional features identified. No water was observed in the RR-1 Pond. The inlets to the pond were stable and the erosional cutting on the idle inlet had not enlarged since the Division's previous inspection (Photo 5). The embankments of the pond were stable with no signs of erosion.

Photo 5 – Erosion scar in pond RR-1. There appears to be no change from previous inspections.

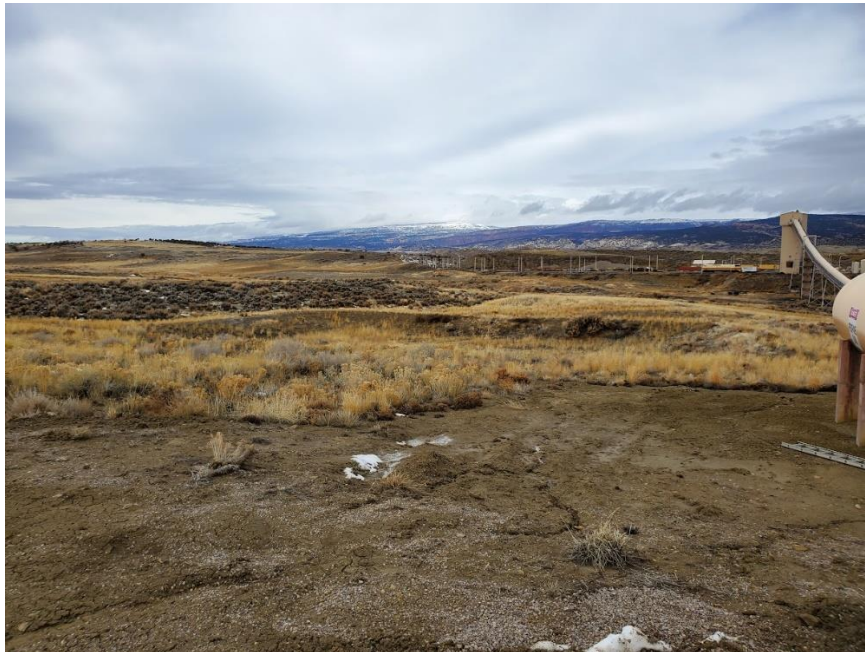
The SS-1 and SS-2 Ponds are located north of the Slot Storage Facility. The SS-1 Pond was holding some minor amounts of water that was mostly frozen. The pond was not discharging water. The pond's embankments were stable with no indications of erosion. The SS-2 Pond was not holding water at the time of the inspection. The embankment of the pond was stable with no signs of erosion (Photo 6).

Photo 6 – Pond SS-2 near the slot storage. Embankments are vegetated and stable. No water present.

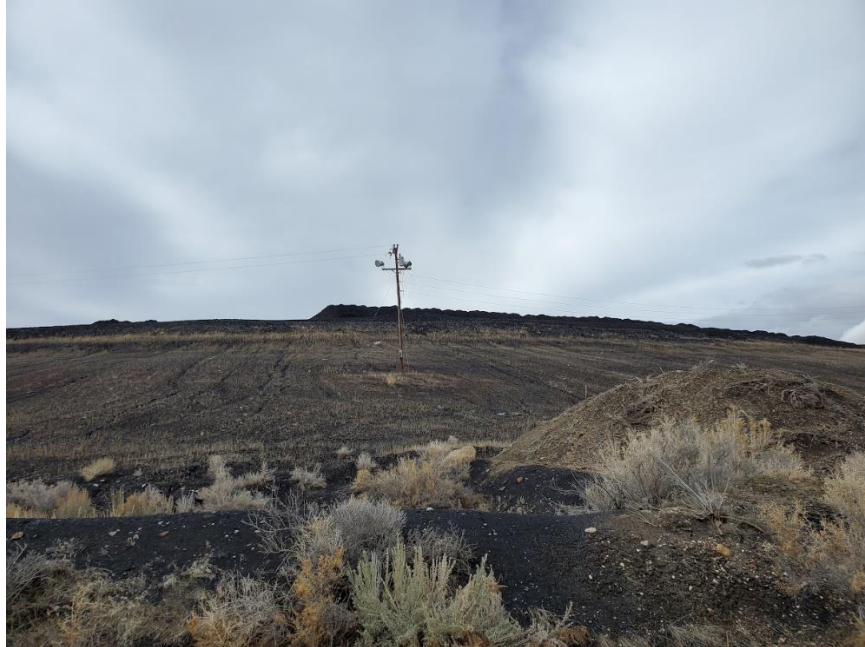
Three refuse piles are active at the Deserado Mine. The RP-2/3/4, RD-5a and RP-A piles. Minor rills were observed on the slopes of RP-2/3/4 and RP-5a. The rills have not yet reached the size of gullies and do not appear to affect the stability of the refuse piles (Photo 7). The rills are typically graded and patched as part of the spring maintenance that occurs at the mine. No other erosional features or displacement were observed on RP-2/3/4 or RP-5a. No indication of displacement, slumping, or other instability was observed in the waste piles. Currently windrows of material are being stacked on the RP-2/3/4 pile.

Photo 7 – Waste Pile RP-2/3/4 with minor rills on the slope face. Windrows can be seen on top of the pile.

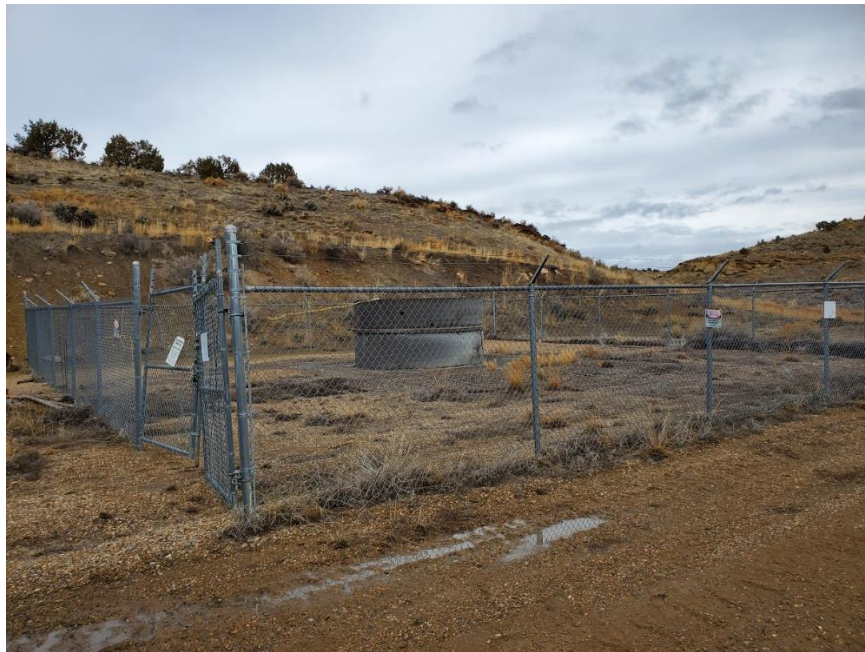
The B Seam Vent Shaft #1 is located north of the main facilities off of the haul road. The pad was stable with no erosional features. The fencing around the shaft to prevent unauthorized entry was in good condition (Photo 8).

Photo 8 – B Seam Vent #1. Fence prohibits unauthorized entry and pad shows no signs of instability.

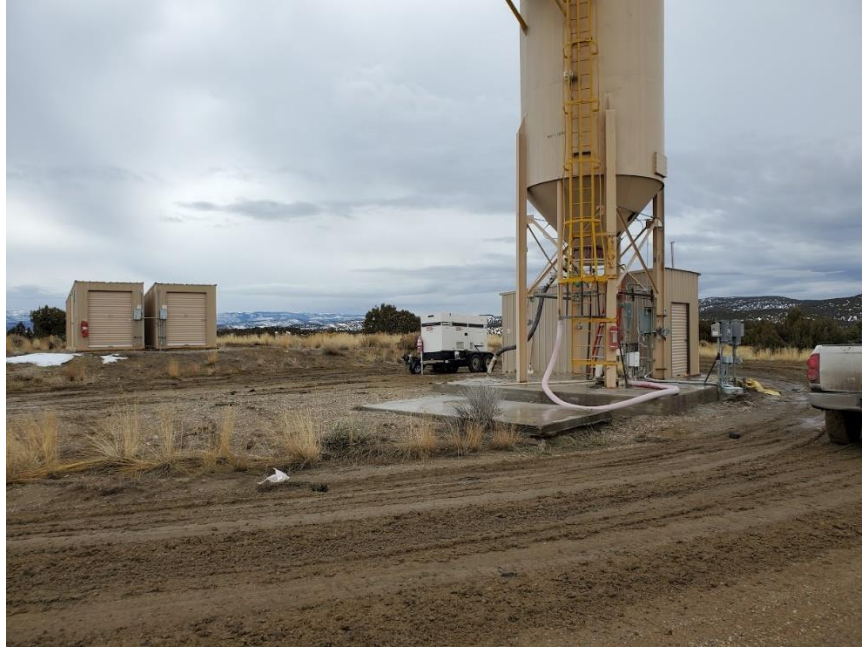
The pad for RDH-2 rock dust tank is located to the east of the B Seam Vent Shaft #1. The pad is stable with no erosional features (Photo 9).

Photo 9 – RDH-2 pad and rock dust tank. Pad shows no signs of instability.

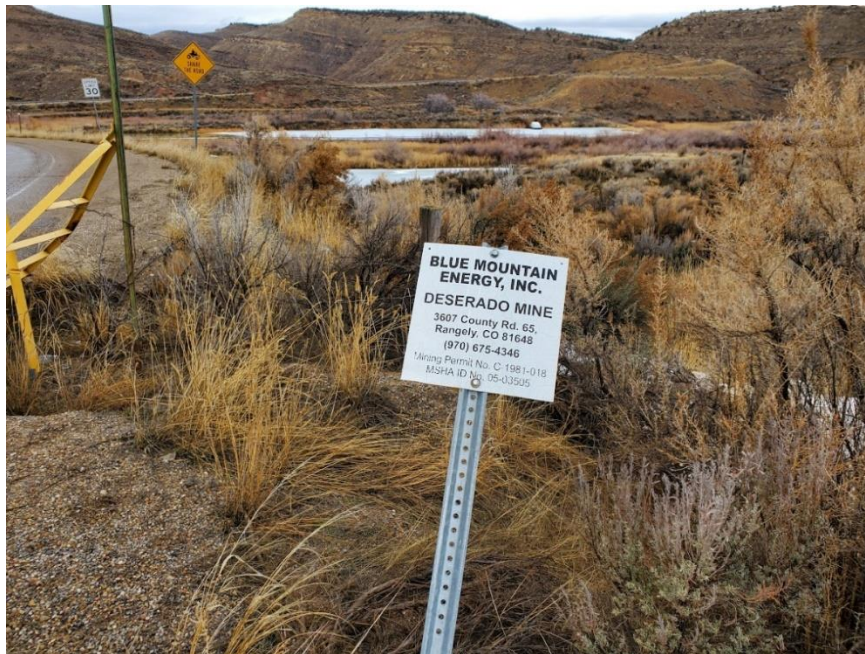
The mine identification signs are posted on the entrance to the permit boundary on CR-65. The signs displayed the current contact information for the permittee. The signs also include the assigned DRMS permit number. The ID signs were placed in unobstructed location and the text was clearly legible (Photo 10).

Photo 10 – Mine Identification Sign placed at the permit boundary along CR-65.

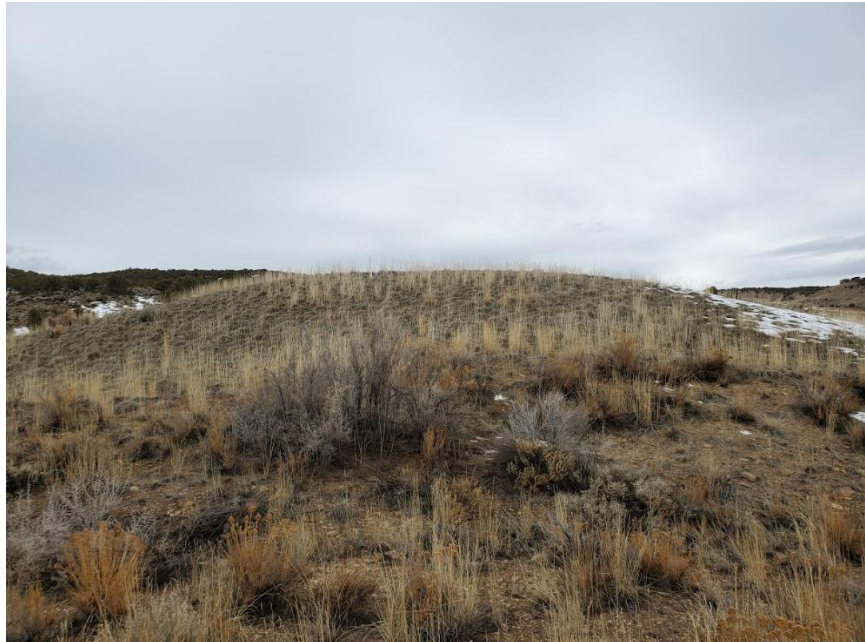
Topsoil stockpiles are located throughout the mine site. Topsoil stockpiles observed during this inspection include the B-Vent Raise (Photo 11), rail loop, RDH-2 and RDH-4 stockpiles. The stockpiles were protected by vegetation and showed no indications of erosion or instability. Each topsoil pile that was observed had topsoil markers at the top of the pile. The markers are T-posts covered with pieces of white PVC. The markers were placed in visible locations and easy to spot.

Photo 11 – Topsoil pile along the road to the B-Vent Raise. Marker can be seen on top of the pile.
