March 1, 2024

Re: Lorencito Canyon Mine, Permit No. C-1996-084; 2023 Annual Reclamation Report Review

COLORADO
Division of Reclamation,
Mining and Safety
Department of Natural Resources

Inspection Start Date: March 15, 2022 Inspection Start Time: 12:30 Inspection End Date: March 22, 2022 Inspection End Time: 14:30		Inspection Type: Coal Partial Inspection Inspection Reason: Normal I&E Program Weather: Clear	
Joint Inspection Agency: None		Joint Inspection Contacts: None	
Post Inspection Agency: None		Post Inspection Contacts: None	
Inspector(s): Jared Ebert	Inspector's Signature:

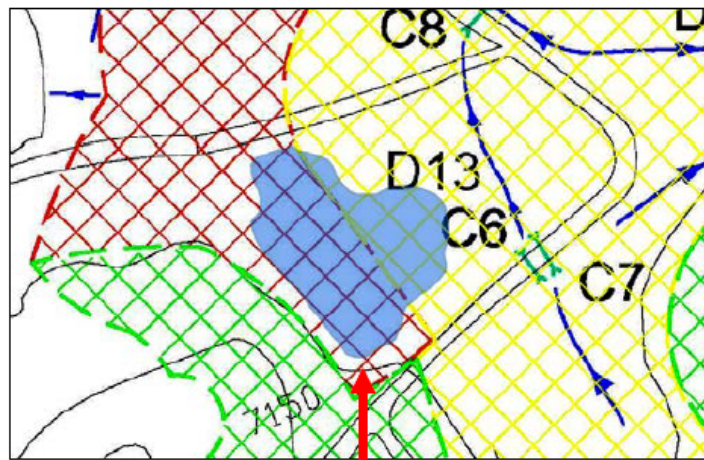
- Update the Annual Reclamation Report Form to reflect the 2023 calendar year.
4. In the March 15, 2022 inspection report, the Division measured the area that had been re-affected by pond and ditch cleanings (referred to the re-disturbed area in item #3 above). During that inspection, the Division determined that **1.68 acres** have been re-disturbed, which is **1.58 acres more** than what is reported on the 2022 and 2023 Annual Reclamation Reports, and on the 2022 and 2023 Annual Reclamation Report maps. Please:

Figure 9. Area re-affected by pond and ditch cleanings.

- Update the 2023 annual report map to reflect a 1.68 acre area of un-reclaimed disturbance for the sediment drying area (see figure below from the Division's March 15, 2022 inspection report).

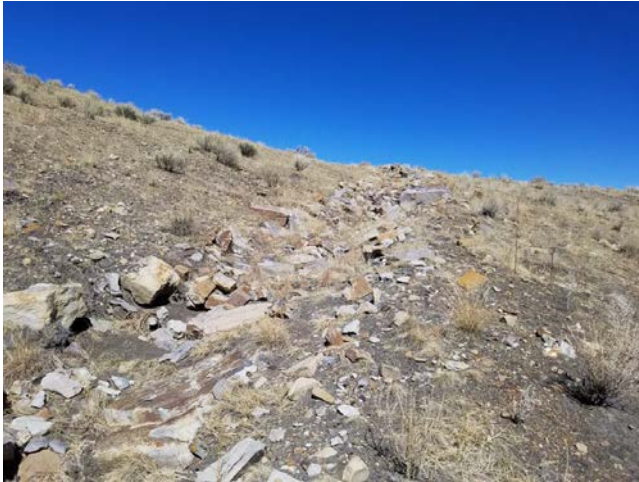
The reclaimed area around the Knob was observed. The areas above ditches D2, D14, D11 and D5 have sparse vegetation established in some areas and these areas have a number of rills and gullies that have developed. The area reported to have been reclaimed in 2006 and 2005 above the area where pond and ditch cleanings are being stored was observed as well. This area has sparse vegetation established and the area has a significant number of rills and gullies that have formed. NECC has placed straw waddles on this slope and have placed brush in most of the rills. It appears elk and wildlife have heavily used this area and have damaged the waddles. The brush does seem to help prevent the rills from growing, and the brush seems to catch and hold soil and growth medium. These areas were discussed with Vince Massarotti and NECC is exploring options in addressing similar rills and gullies that have formed in the reclaimed area above Pond 006a. **Given the age of the reclamation of these areas in question, NECC will need to evaluate these areas around the Knob, above the pond cleanings and above Pond 006a to determine the best methods to fill, regraded, or otherwise stabilized these areas from erosion.**

Figure 1. Ditch D2

Also, it is likely these areas will need to be reseeded in places given the sparse nature of the vegetation that has established.

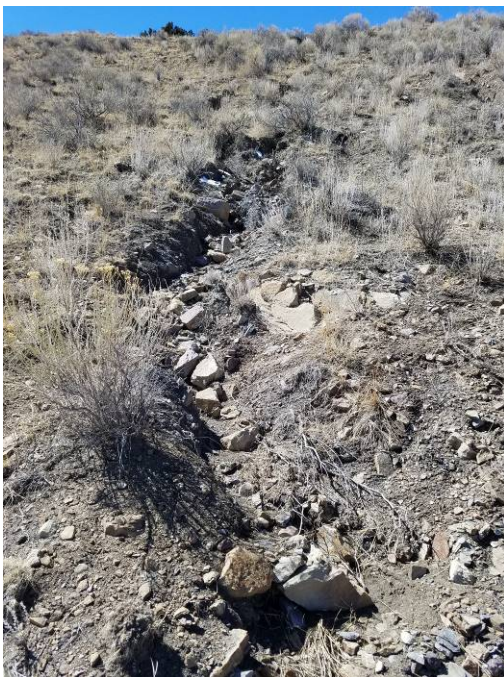
Figure 2. Rill above ditch D2

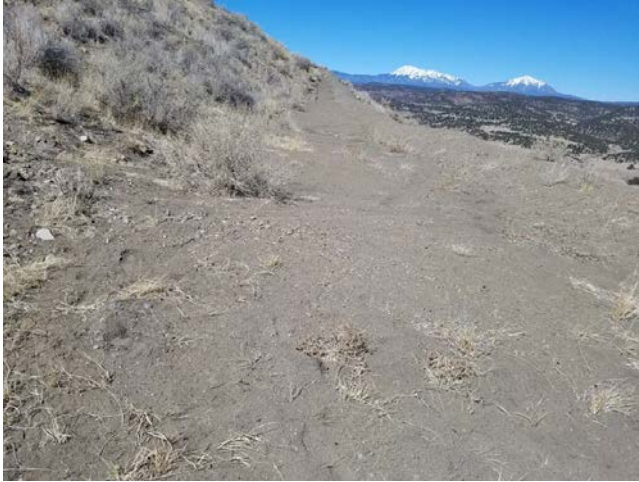
Figure 3. Sediment deposited below rills formed above ditch D2

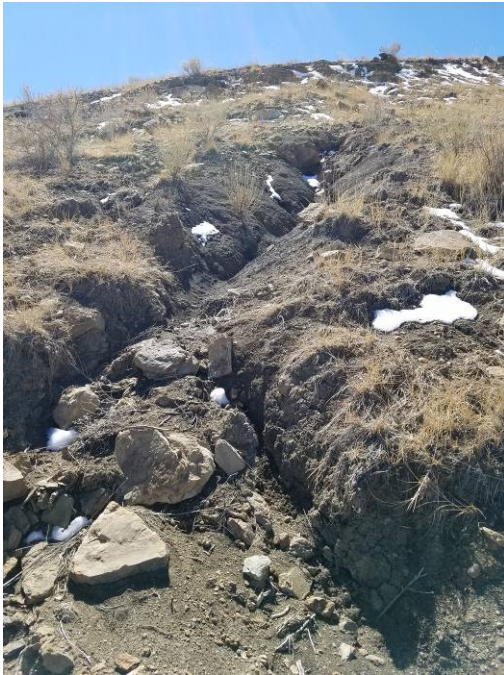
Figure 4. Rill above ditch D11.

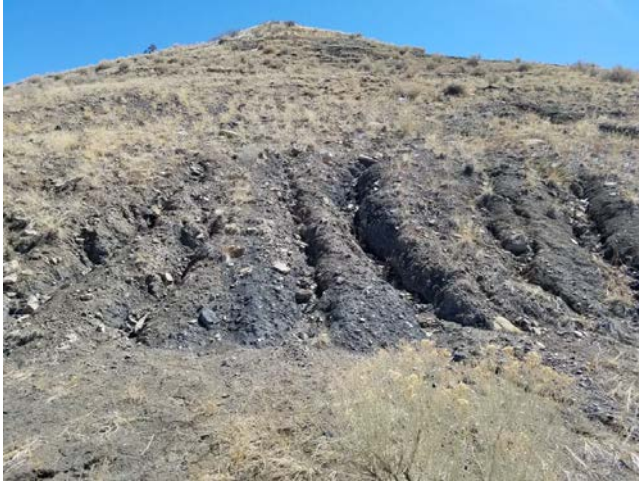
Figure 5. Rills on the Knob

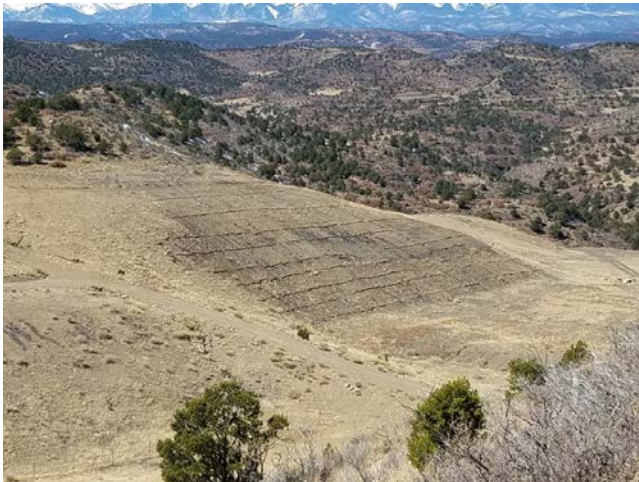
Figure 6. Area above pond/ditch cleanings where rills and gullies have formed.

The areas to be repaired for rills and gullies where sparse vegetation has established discussed above will likely need to be revegetated.

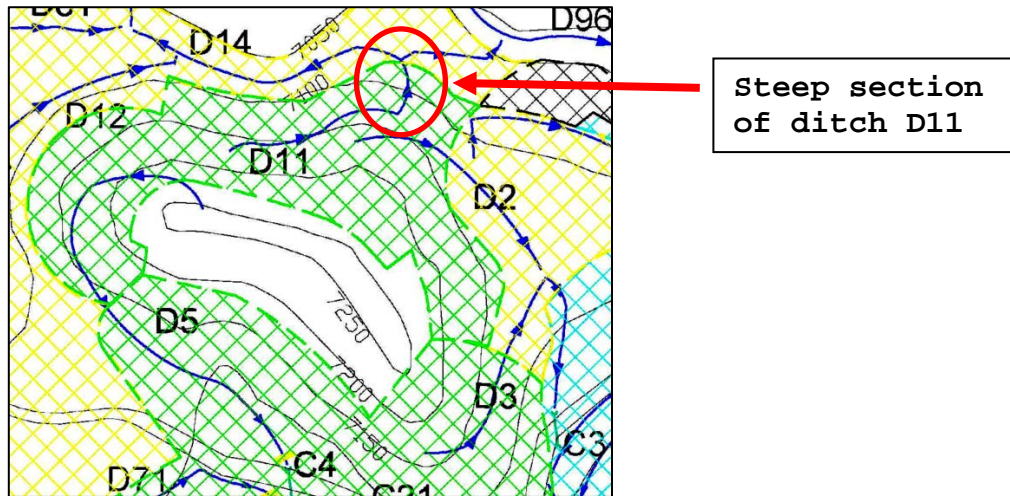
Figure 7. The Knob

The water collection drainages or ditches around the area known as “The Knob” was inspected. This included ditches D3, D2, D11, D14, and D5. The affected land around the Knob was reclaimed in 2006 and 2004 according to the 2020 annual reclamation report map submitted by NECC. Overall, these ditches were maintained and appeared functional. There is a steep stretch of ditch D11 as it bends and drains due north into ditch D14. The center of the ditch is rock lined but the side of the channel has sparse vegetation established and is partially eroding. **NECC should evaluate this ditch and stabilize the side slopes.**

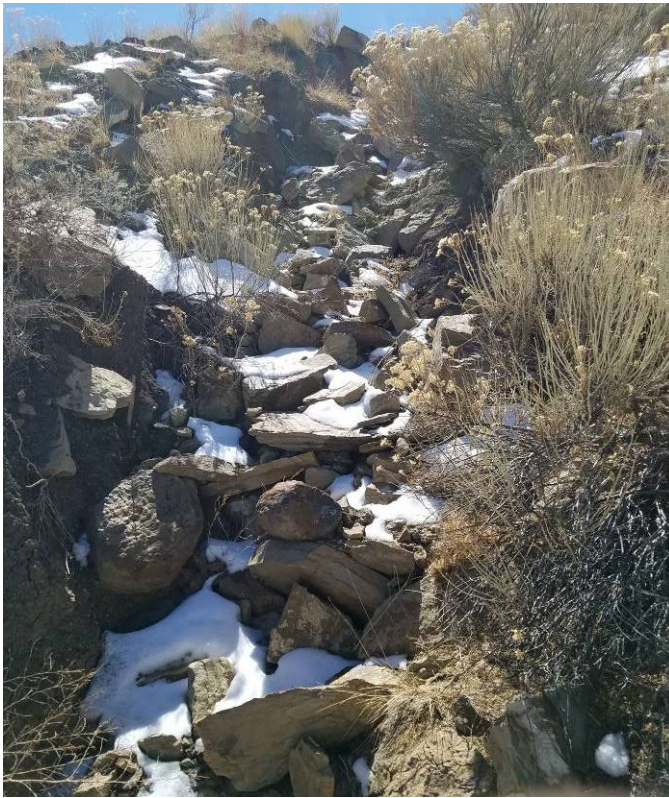
Figure 8. Steep section of D11

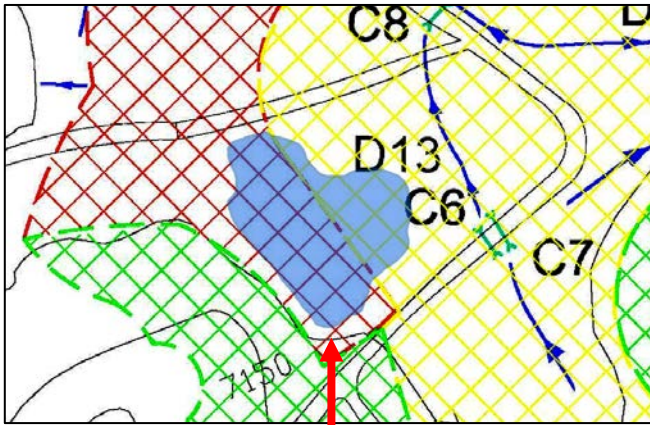
NECC has placed pond and ditch cleanings in an area west of ditch D13 in an area reported to have been reclaimed in 2004 and 2005. This area was measured using ArcCollector and found to be about 1.68 acres in size. This area has been re-affected by the operation at the site and will need to be reclaimed and revegetated and can no longer be considered in a state of reclamation.

Figure 9. Area re-affected by pond and ditch cleanings.
