**MINERALS PROGRAM INSPECTION REPORT**  
**PHONE: (303) 866-3567**

<b>MINE NAME:</b> North R-34 Pit	<b>MINE/PROSPECTING ID#:</b> M-1996-008	<b>MINERAL:</b> Sand and gravel	<b>COUNTY:</b> Montrose
<b>INSPECTION TYPE:</b> Monitoring	<b>WEATHER:</b> Clear	<b>INSP. DATE:</b> February 28, 2024	<b>INSP. TIME:</b> 12:00
<b>OPERATOR:</b> Western Gravel, Inc.	<b>OPERATOR REPRESENTATIVE:</b>	<b>TYPE OF OPERATION:</b> 112c - Construction Regular Operation	
<b>REASON FOR INSPECTION:</b> Normal I&E Program	<b>BOND CALCULATION TYPE:</b> Complete Bond	<b>BOND AMOUNT:</b> \$23,380.00	
<b>DATE OF COMPLAINT:</b> NA	<b>POST INSP. CONTACTS:</b> None	<b>JOINT INSP. AGENCY:</b> None	
<b>INSPECTOR(S):</b> Dustin Czapla	<b>INSPECTOR'S SIGNATURE:</b>

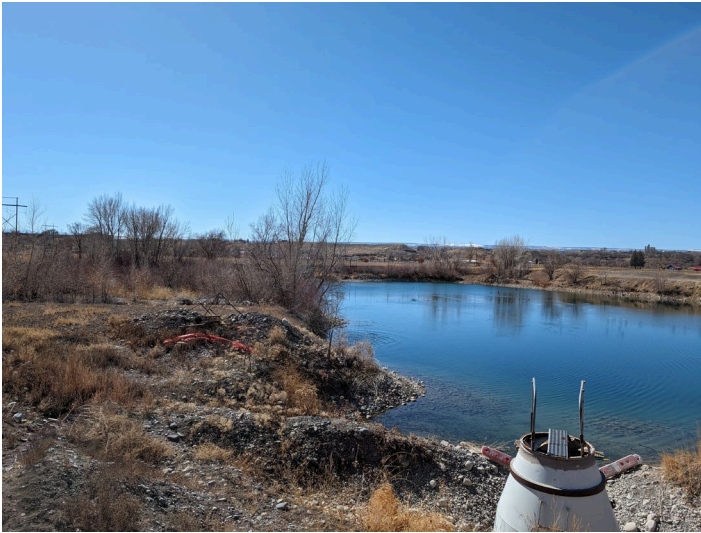
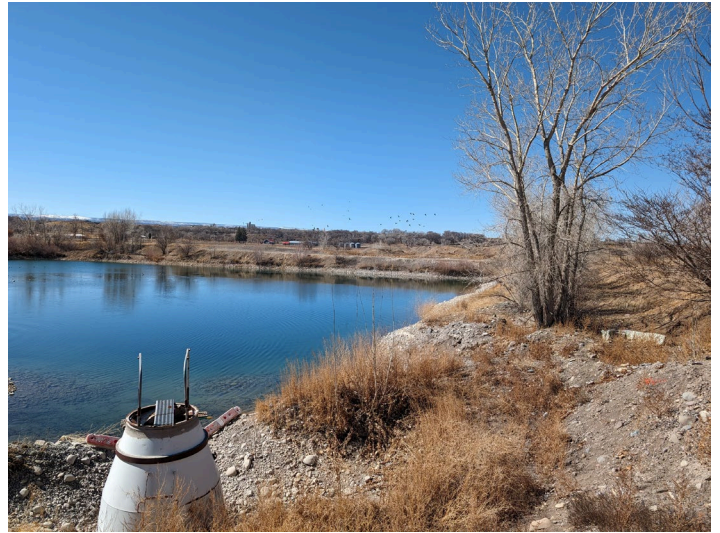
There has been no additional mining since the Division's last inspection. Mining disturbance is still contained within the Phase 1 area. The pond includes approximately 2.5 acres. The pond slopes have been mined at approximately 2H:1V. The area on the east side of the pond, approximately one acre, has been graded level and appeared to be a stockpile/staging area. Topsoil is stockpiled in the northwest corner of the Phase 1 area. The Phase 2 area is not yet disturbed.
