MINERALS PROGRAM INSPECTION REPORT
PHONE: (303) 866-3567

MINE NAME: Haldorson Sand and Gravel Mine	MINE/PROSPECTING ID#: M-2003-037	MINERAL: Sand and gravel	COUNTY: Montrose
INSPECTION TYPE: Monitoring	WEATHER: Clear	INSP. DATE: February 28, 2024	INSP. TIME: 11:00
OPERATOR: Oldcastle SW Group, Inc. dba United Companies of Mesa County	OPERATOR REPRESENTATIVE: None	TYPE OF OPERATION: 112c - Construction Regular Operation	
REASON FOR INSPECTION: Normal I&E Program	BOND CALCULATION TYPE: Complete Bond	BOND AMOUNT: \$306,730.00	
DATE OF COMPLAINT: NA	POST INSP. CONTACTS: None	JOINT INSP. AGENCY: None	
INSPECTOR(S): Dustin Czapla	INSPECTOR'S SIGNATURE:

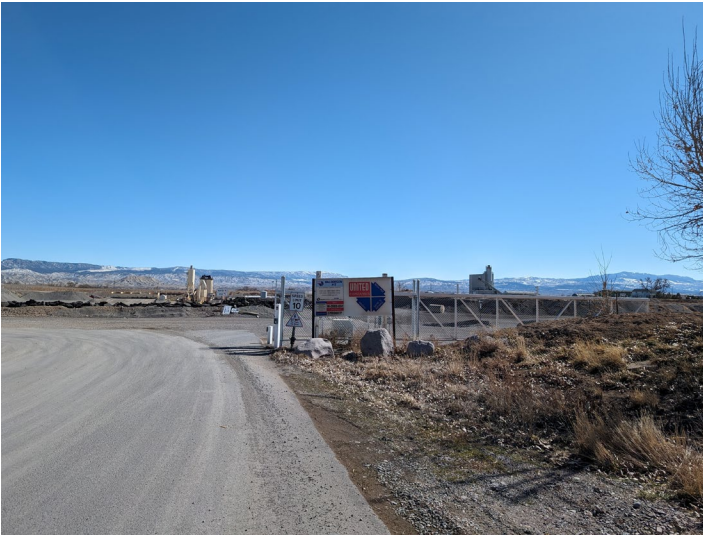
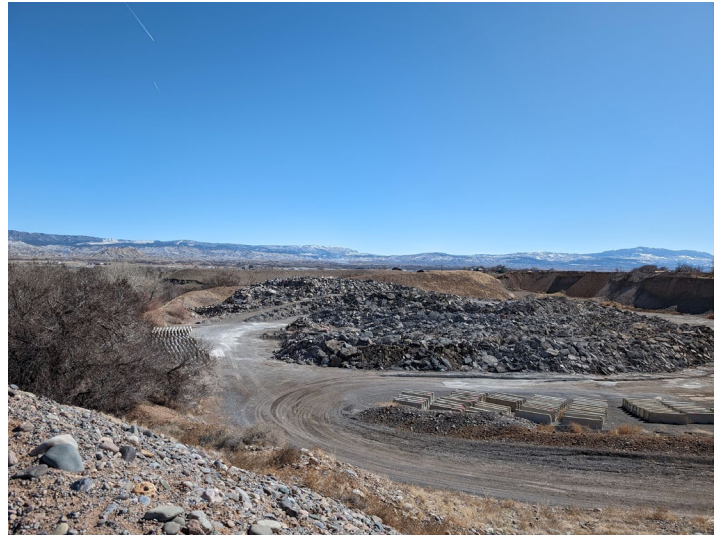
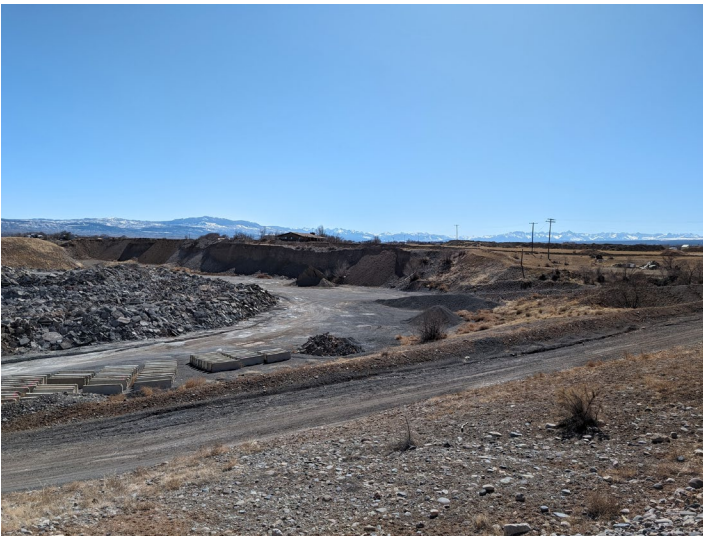
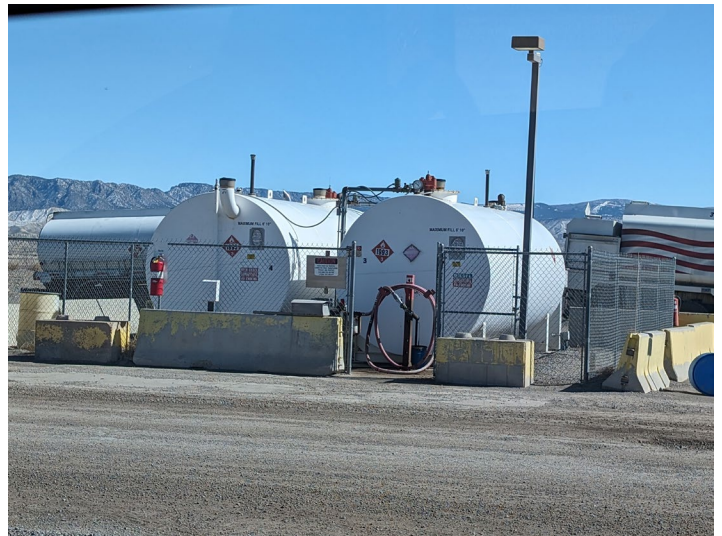
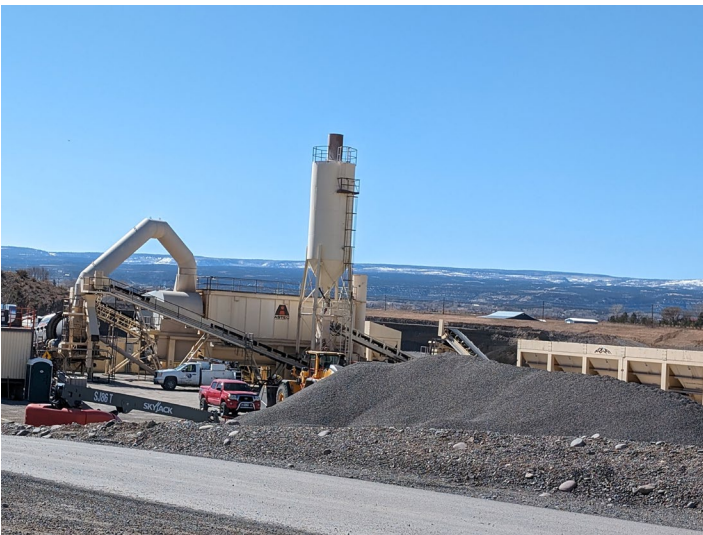
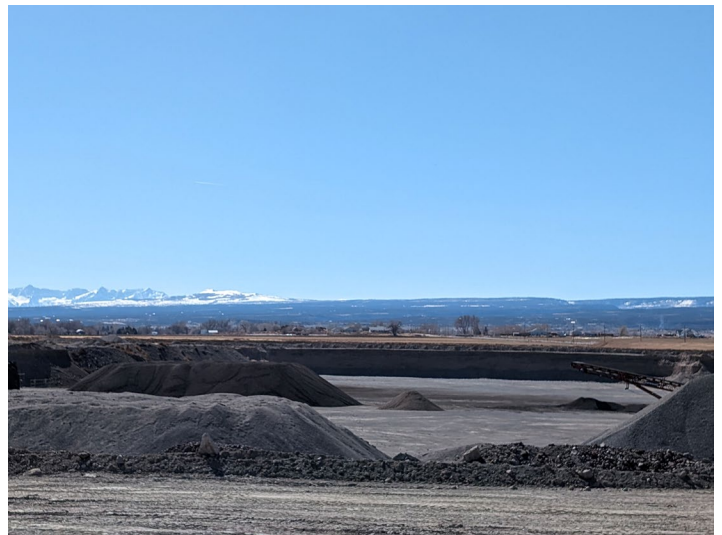
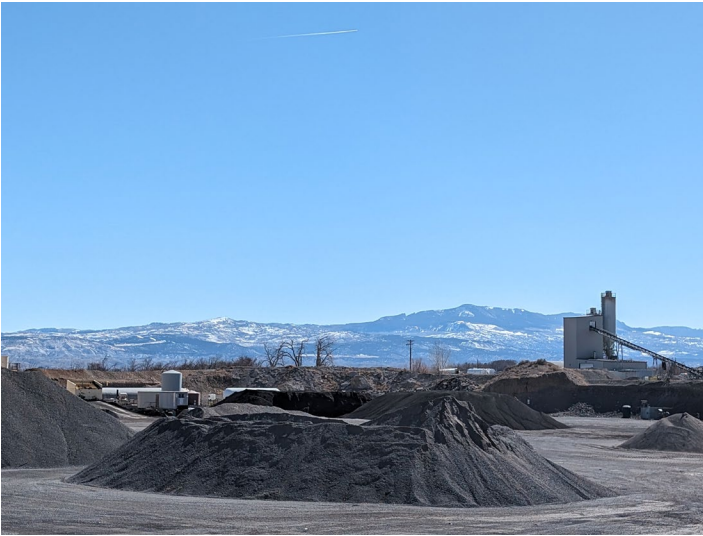
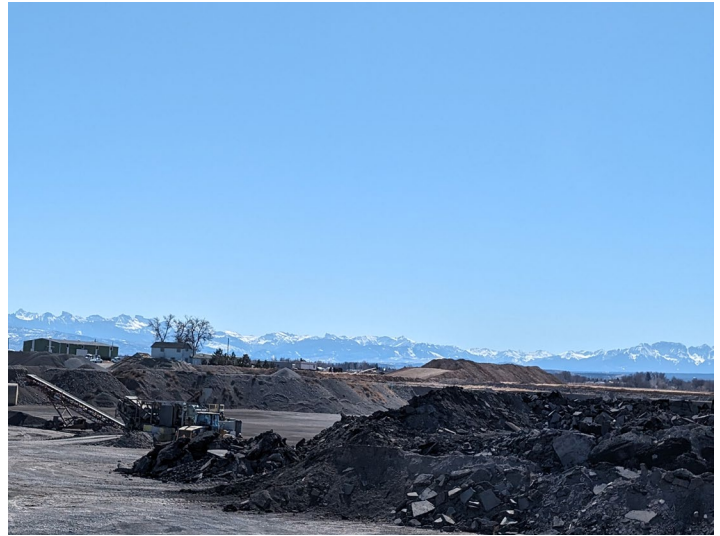
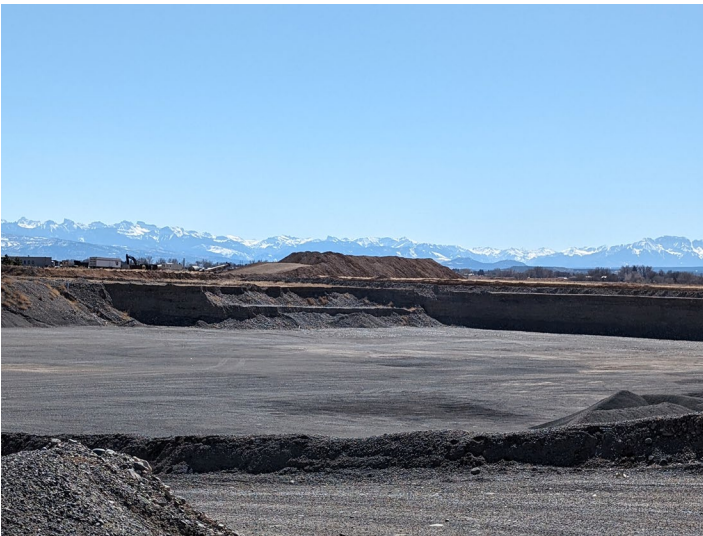
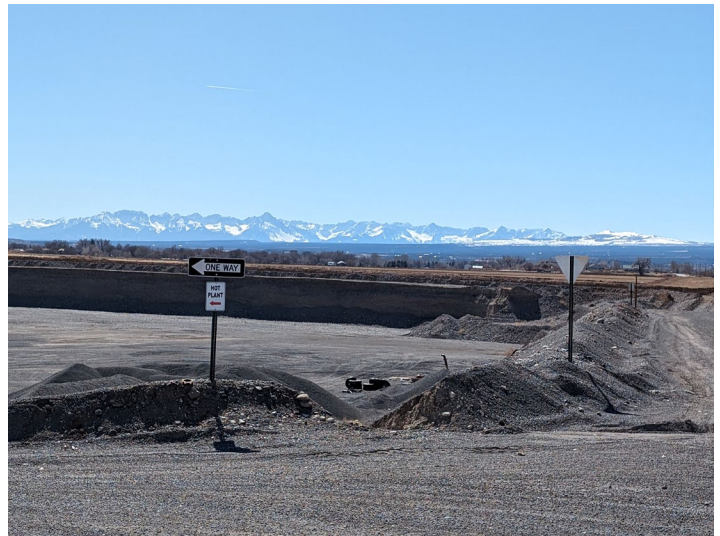
Adequate mine identification signage was noted at the entrance to the site.

The affected area was marked by fencing that was clearly visible and adequate to delineate the affected area boundary.

Topsoil is stockpiled in a visual berm around the perimeter of the site on the north and west sides. The topsoil piles are vegetated and appear adequately stabilized.

The asphalt and concrete plants are located in the east side of the pit. Fuel stored in these areas is adequately contained. No problems were noted related to these areas.

Slopes around the pit range from approximately 1H:1V to 2H:1V and appear stable. A section of near vertical highwall, approximately 400 lf, exists at the south end of the pit where mining is progressing southward.
