**MINERALS PROGRAM INSPECTION REPORT**  
**PHONE: (303) 866-3567**

<b>MINE NAME:</b> Pikeview Quarry	<b>MINE/PROSPECTING ID#:</b> M-1977-211	<b>MINERAL:</b> Limestone (general), granite gneiss and do	<b>COUNTY:</b> El Paso
<b>INSPECTION TYPE:</b> Monitoring	<b>WEATHER:</b> Clear	<b>INSP. DATE:</b> February 28, 2024	<b>INSP. TIME:</b> 10:00
<b>OPERATOR:</b> Riverbend Industries Inc.	<b>OPERATOR REPRESENTATIVE:</b> Jerry Schnabel	<b>TYPE OF OPERATION:</b> 112c - Construction Regular Operation	
<b>REASON FOR INSPECTION:</b> Normal I&E Program	<b>BOND CALCULATION TYPE:</b> None	<b>BOND AMOUNT:</b> \$13,389,784.00	
<b>DATE OF COMPLAINT:</b> NA	<b>POST INSP. CONTACTS:</b> None	<b>JOINT INSP. AGENCY:</b> None	
<b>INSPECTOR(S):</b> Hunter Ridley Timothy Cazier, P.E.	<b>INSPECTOR'S SIGNATURE:</b>

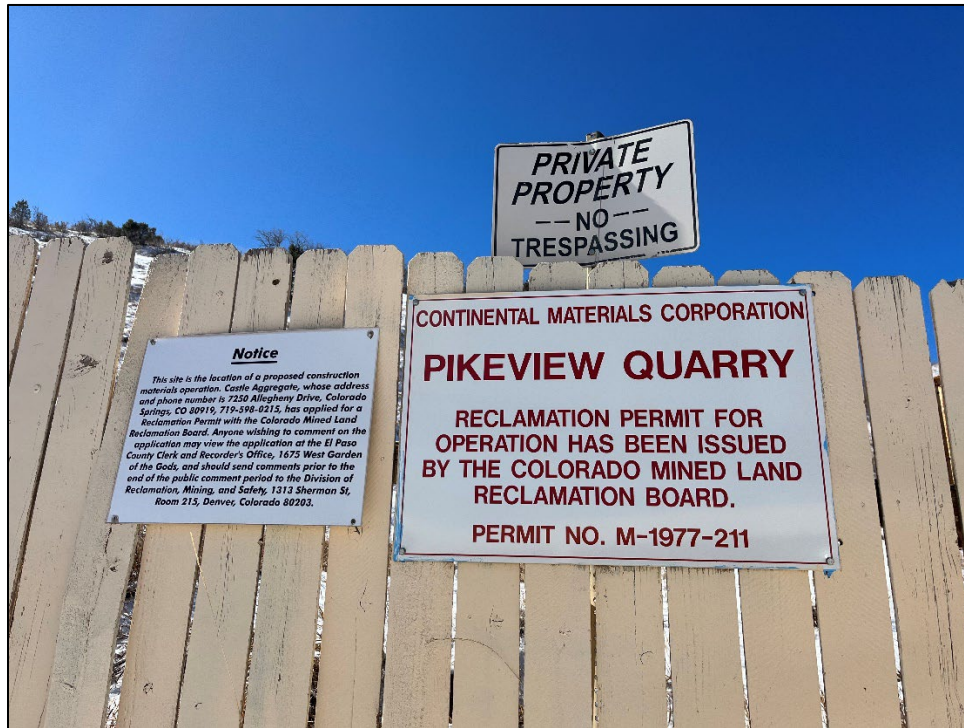
Photo 1: A mine sign is located at the site entrance and in compliance with Rule 3.1.12.

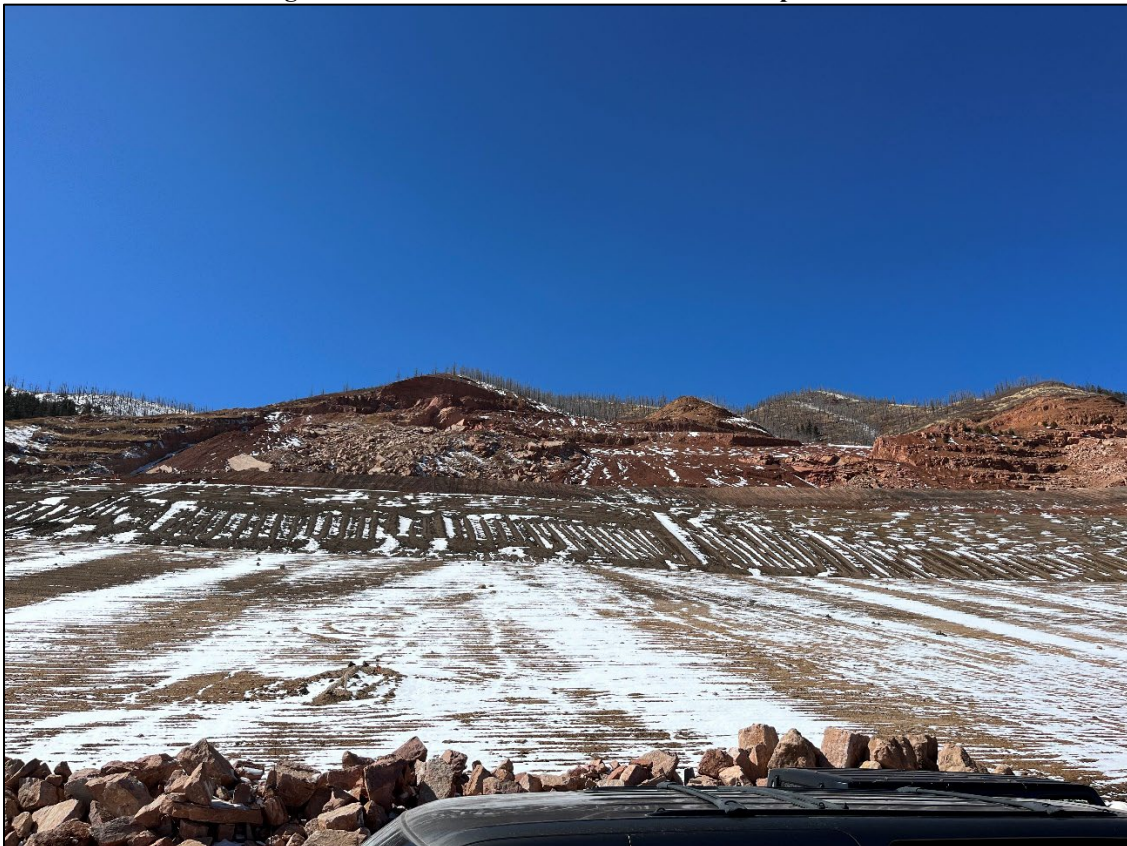
**Revegetation & Topsoil:** The first bench of the buttress has been fully topsoiled and seeded. Topsoil has been placed on the middle bench but not yet trimmed to final grade. Topsoil is initially placed vertically on slopes, creating a pattern of windrows (Photo 2), before being trimmed to final elevation and reworked horizontally to achieve final grade. Revegetation in the northern portion continues to be monitored throughout the off season. This includes the irrigated tree-planting system.

Photo 2: View west of the benches, each in various stages of backfill and topsoiling.

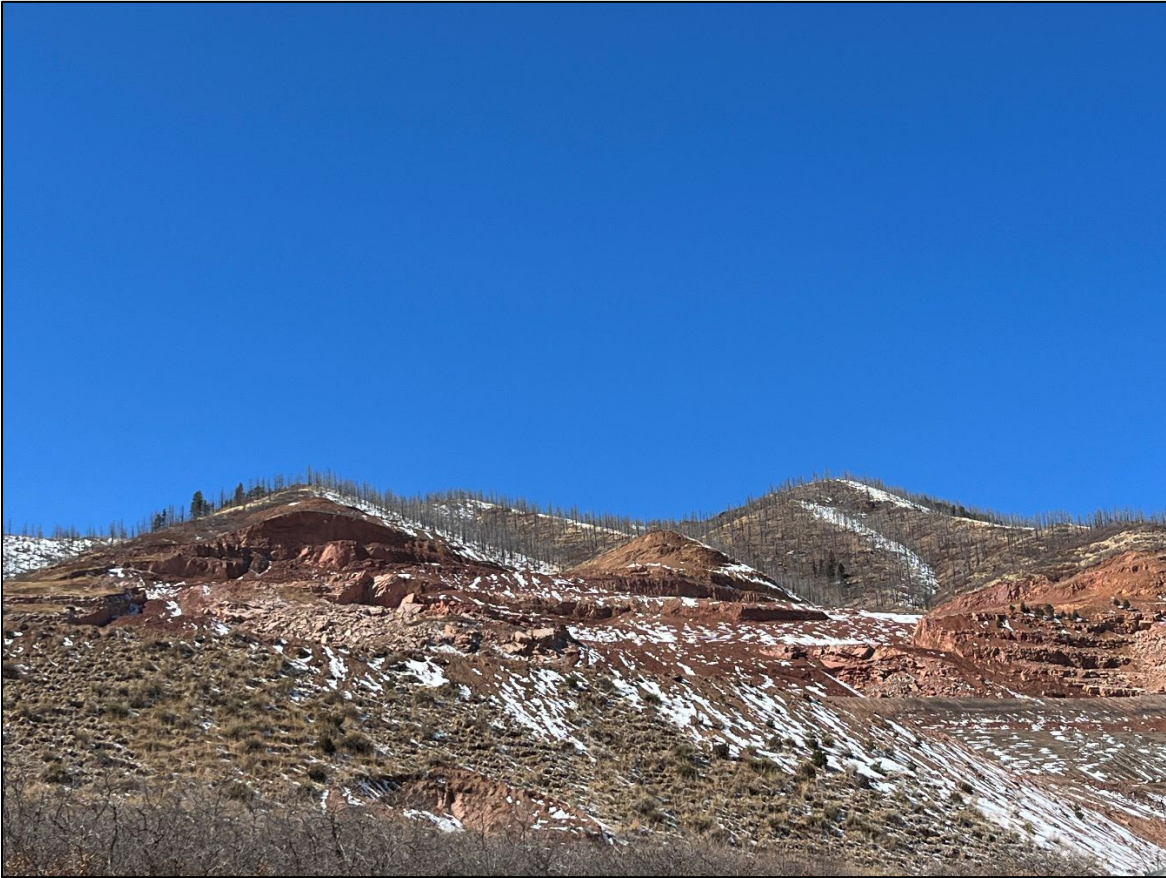
**Roads:** A slice of the uppermost road located at the South Peak had fallen out one day prior to the inspection. Stantec representative Paul Kos noted that this was likely due to rapid freeze and thaw of an abundance of moisture received at the site recently (Photos 3 and 6). There were no injuries or damages as a result of this road failure. The South Peak area is planned to be blasted at the start of March. In the interim, berms will be placed on both sides of the road to block any traffic from getting near the slope.

**Photo 3: View west of the south peak area (far left), a slice of the road just beneath the horizontal cliff has recently fallen out.**

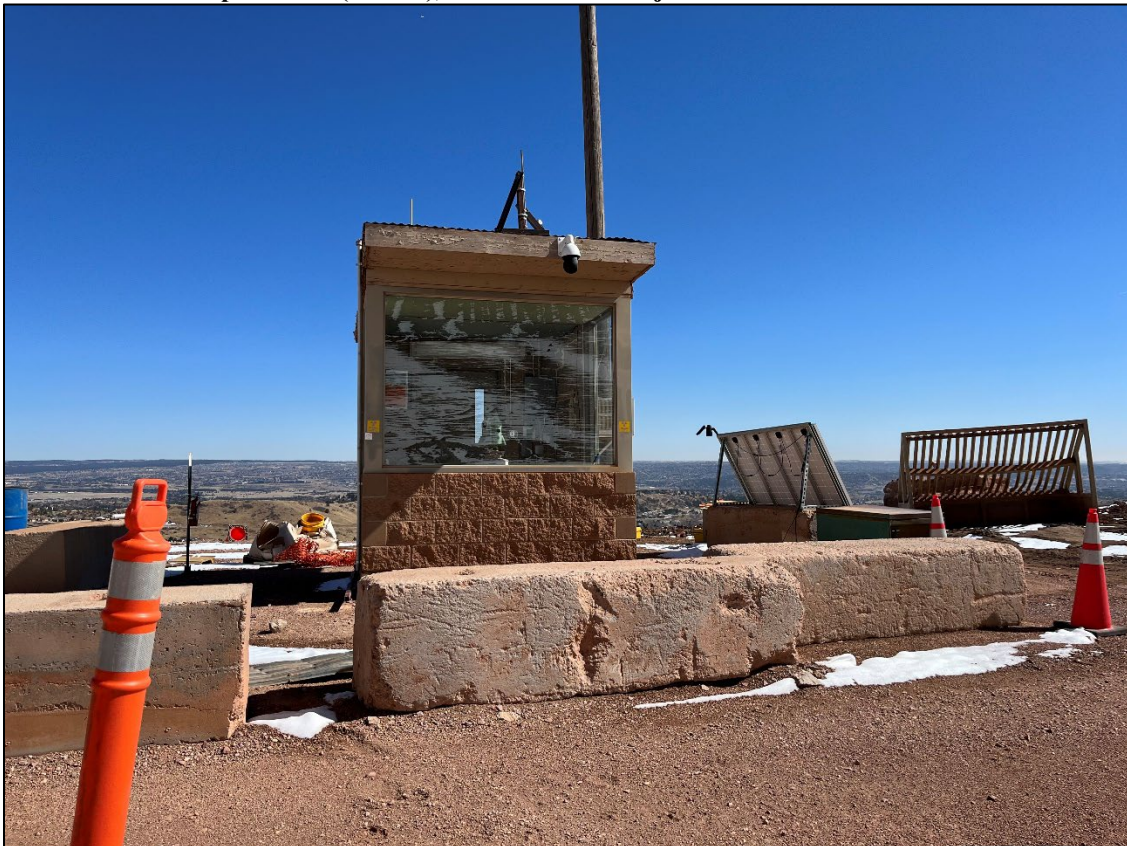
**Photo 4: Leica station, batteries for the system were recently replaced.**

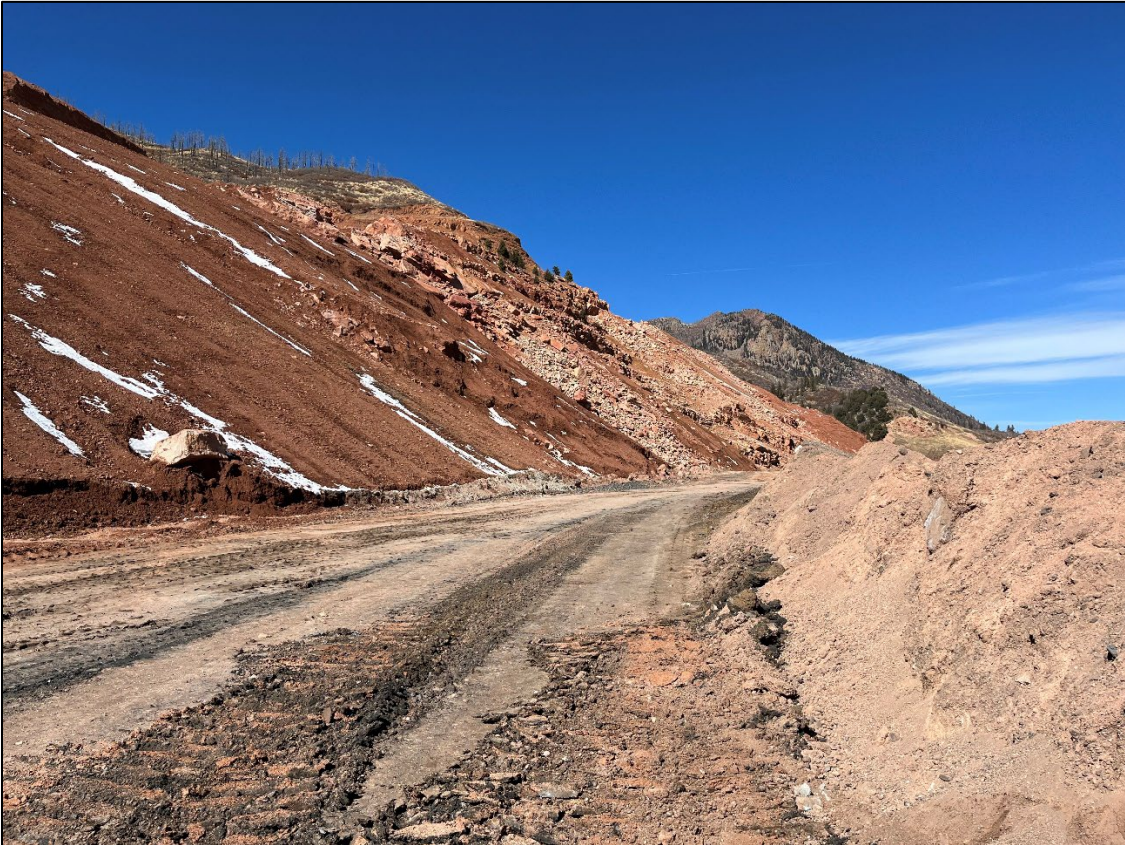
**Explosives:** The highwall on the “South Peak” area (Photo 5) has been approved to be blasted to achieve a stable final slope. DRMS approved the blasting plan technical revision (TR-23) request on December 19<sup>th</sup>, 2023. Drilling equipment was stationed at a staging area just north of the South Peak (Photo 7). Mr. Schnabel stated that drilling would begin in early March and that unlike other areas of the quarry, pre-split would not be used for this slope. By avoiding pre-split blasting, the final slope design will have a more irregular and natural looking face.

**Photo 5: View north of the middle bench and 'Kiewit Cliffs' area, the drainage channel for the mountain seep is planned to run down to this bench and out of the site to the northeast.**

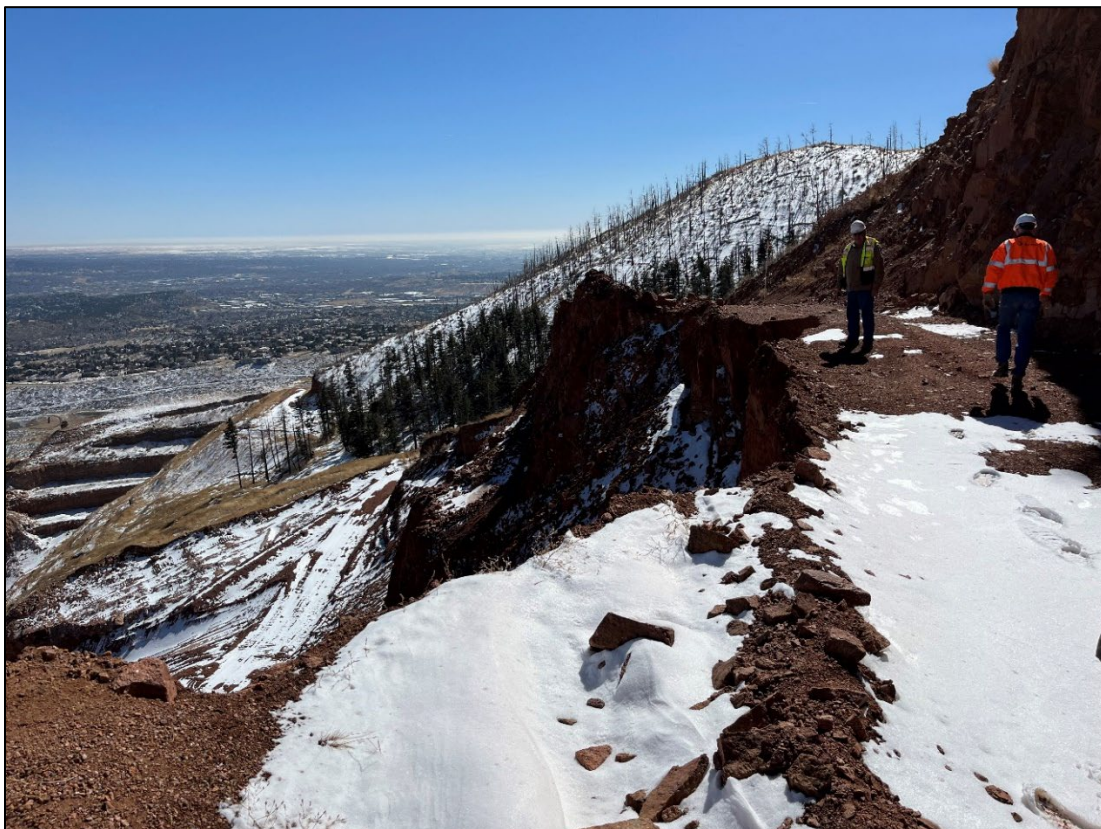
**Photo 6: View southeast of the area of road which fell out at the South Peak.**

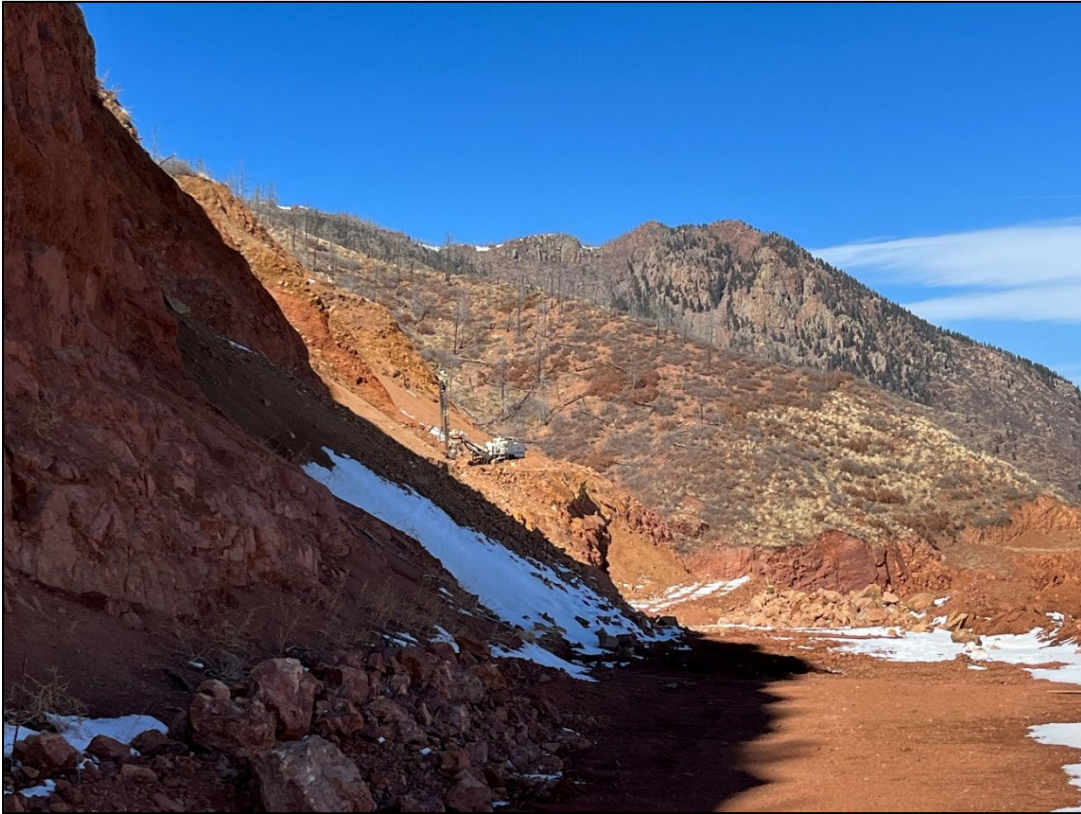
**Photo 7: View northwest of drilling equipment stored in the staging area, drilling for the blasting of South Peak are scheduled to begin early March.**

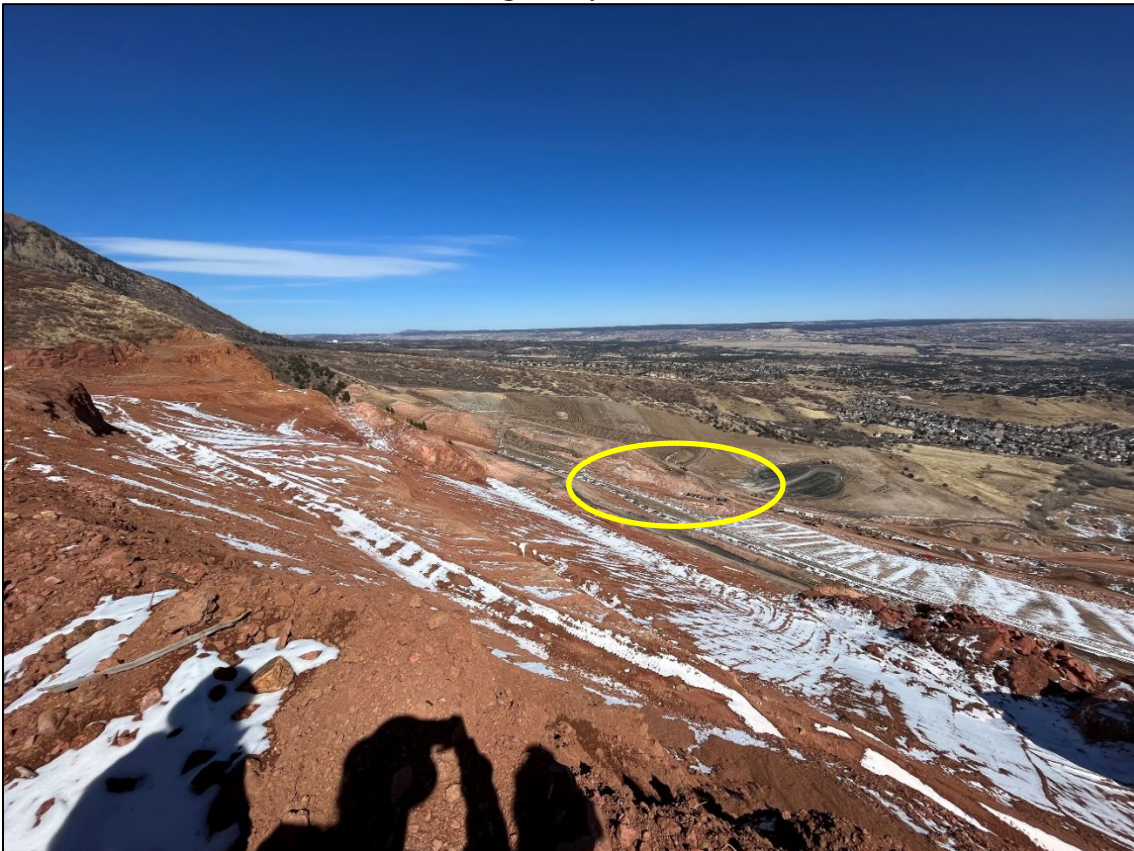
As discussed in last month's inspection report, the current design of the North Ditch will need to be amended to work around the exposed large bedrock feature (named the “Dragon's Back”) (Photo 8). Upper ditches are also planned to be redesigned to allow for mountain seep to fall in with surface runoff, travel around the ‘Kiewit Cliffs’ area and towards the North Ditch (Photo 5). The Operator is reminded that this will require the submission of a Technical Revision for review by the Division before the new channels are constructed.

**Photo 8: View northeast of the benches in progress, a channel will cut through this area to drain water from the mountain seep away from the benched area, the 'Dragons Back' is visible to the east (circled).**

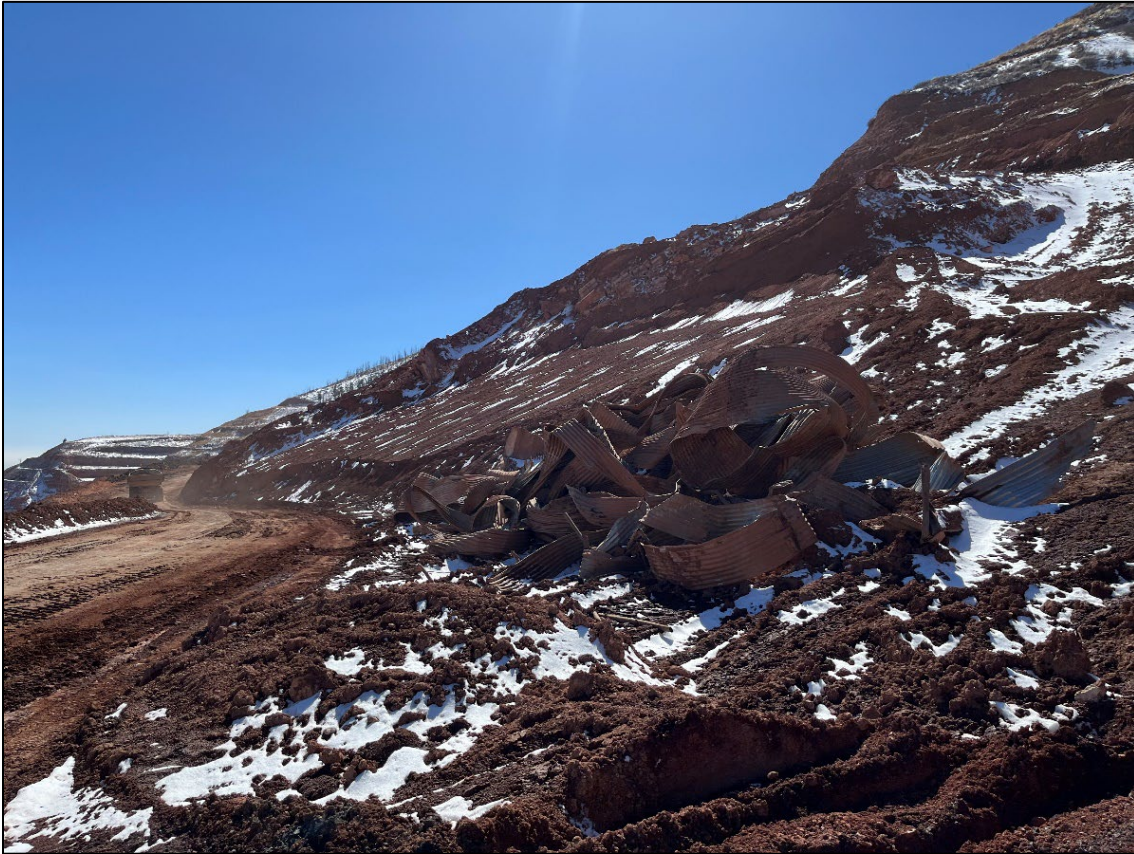
The remaining culvert that used to take the upper drainage flow below the upper access road to the North Ditch has been completely dugout. The culvert is to be removed and disposed of off-site (Photo 9).

**Photo 9: View south of the remains of the culvert which was recently removed.**

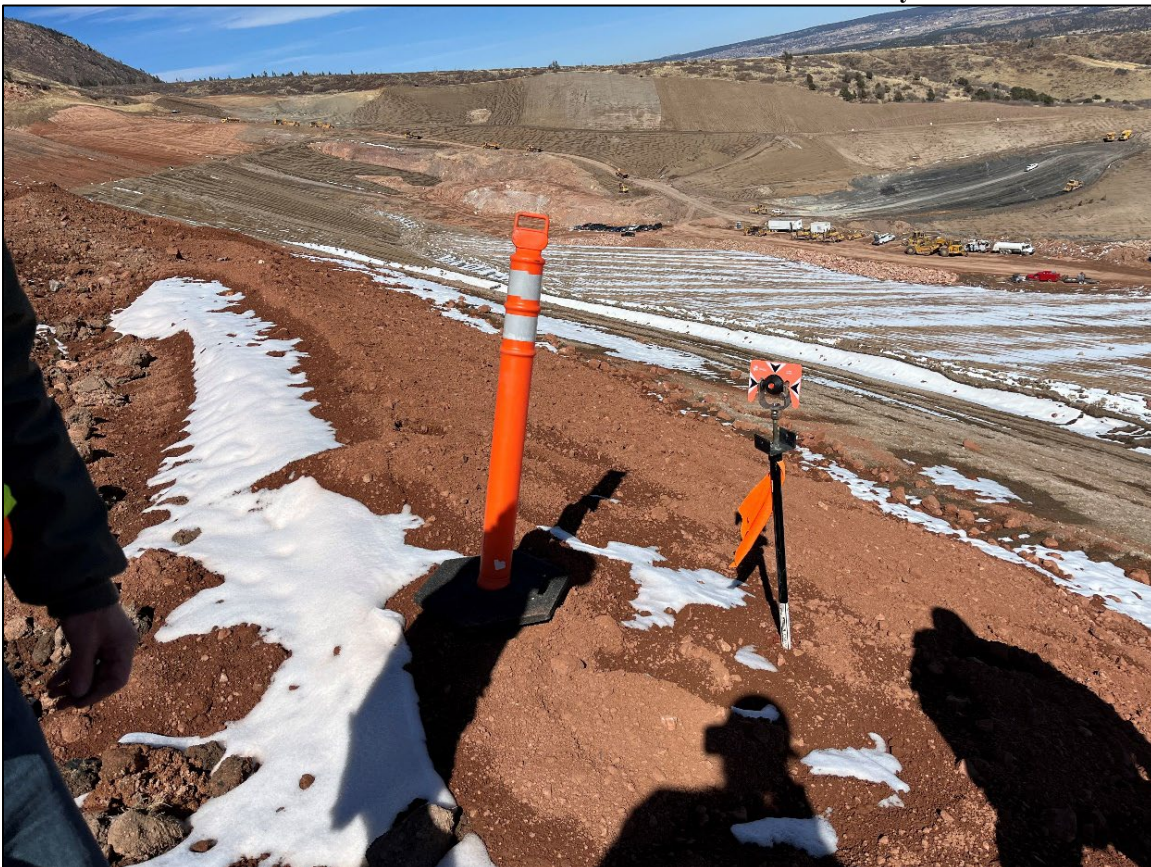
**Records:** Compaction testing records were reviewed back to January 22nd, the last date not available during the previous inspection. All test results reviewed in this period (January 22<sup>nd</sup> to February 24th) demonstrated at least 90 percent compaction in compliance with the approved specification. No tests were performed on several of the days as no work was performed due to weather conditions. Mr. Schnabel presented the Leica prism system data and trends for January. Three of the 7400 series of prisms (7400-1, 7400-2, and 7400-3) were showing above average movement with ~2in of vertical, downward movement. However, longitudinal movement was steady for these prisms. Mr. Schnabel explained that, unlike series 7200 and 7300 prisms, the 7400 series were placed *before* final dozer compaction of the bench. In contrast, the 7200 and 7300 series were placed months after the final dozer compaction of their associated benches. Therefore, any natural settling of material on these slopes would have been missed by the readings of 7200 and 7300 series. The slight movement of the 7400 series is most likely to natural settling of material has slopes above are reworked. The Division conducted a visual inspection of the 7400 series prisms and confirmed that the material in which the prisms were placed is looser material than other benches but appears easily compactable (Photo 10). No tension cracks or signs of potential slide activity were evident. Stantec will continue to monitor this prism series closely over the next month as the last of material is placed on the slopes. Stantec also stated they will continue to conduct visual inspections at least weekly, but often daily, for this area. Should the movement of these prisms flatten out over time, the Division has no major concern for slope stability.

**Photo 10: View north of prism 7400-2, material around is loose and easily compacted.**

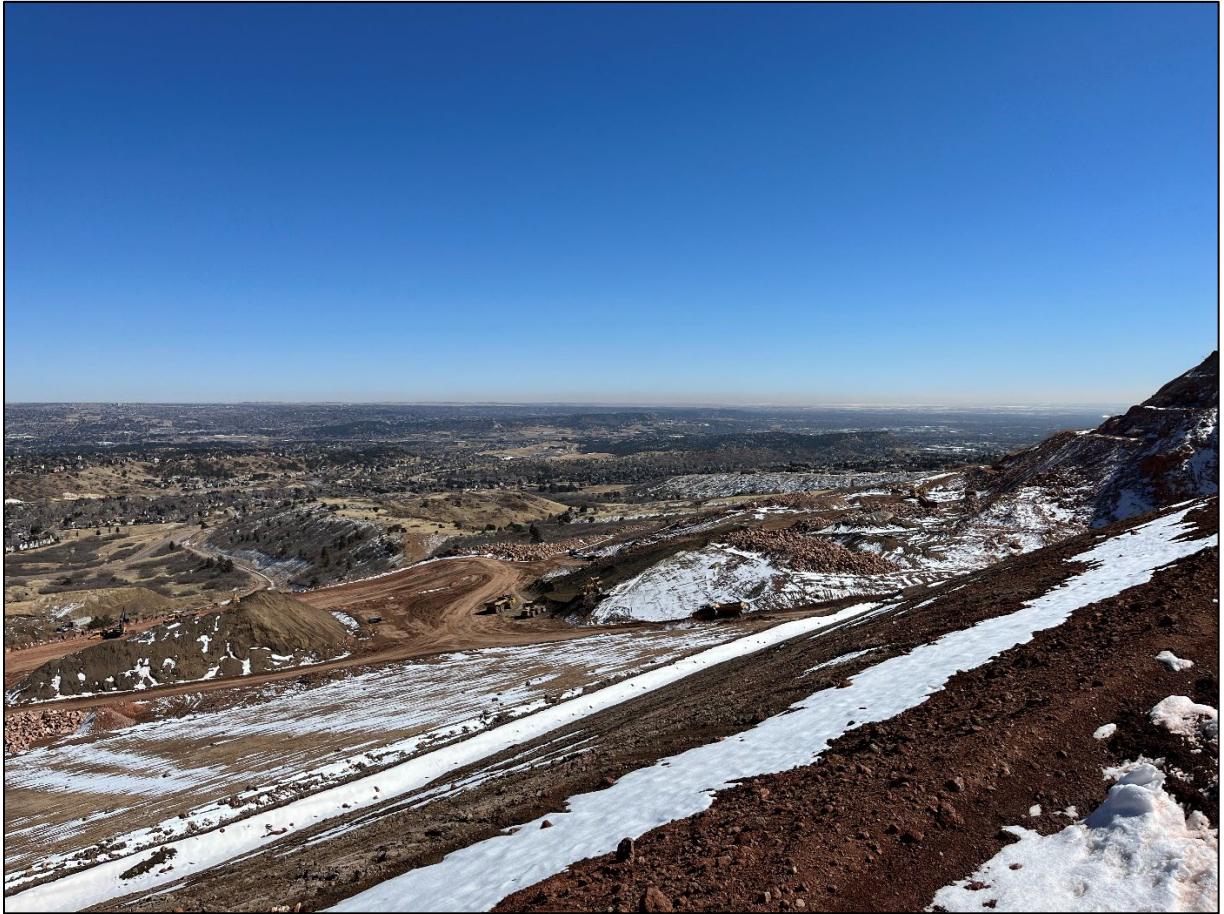
**Backfilling and Grading:** Mr. Schnabel indicated that placement of material from the south borrow area was nearly complete (Photo 11). Scrapers were seen removing material from the shop area as well. Material from the various borrow areas is placed in an alternating pattern and mixed before grading. This ensures that compaction is optimal on benches. There are currently about 10-12 trucks and 3-4 scrapers working on site to move ~ 15,000 CY per day of material. Water trucks are still onsite to combat any issues with dust. There have been slight adjustments made to traffic patterns to improve safety at the site. Equipment now follows one-way, circular traffic, no roads have a grade > 25%, and roadable vehicles now fuel up near the office to reduce foot traffic in the active areas. Subgrade contouring is complete on the lower bench and middle benches and growth media has been placed. All placed backfill continues to be tested for compaction in accordance with the approved specifications.

**Photo 11: View southeast of the south borrow area.**
