Roadside Mine, C-1981-041, February Partial Inspection Report

PERMIT INFORMATION

Permit Number: C-1981-041 Mine Name: Roadside Portals Operator: Snowcap Coal Company, Inc. Operator Address: MS Tonya Hammond 743 Horizon Court, Suite 334 Grand Junction, CO 81506	County: Mesa Operation Type: Underground Permit Status: Active Ownership: Private
	Operator Representative Present: Tonya Hammond
Operator Representative Signature: (Field Issuance Only)

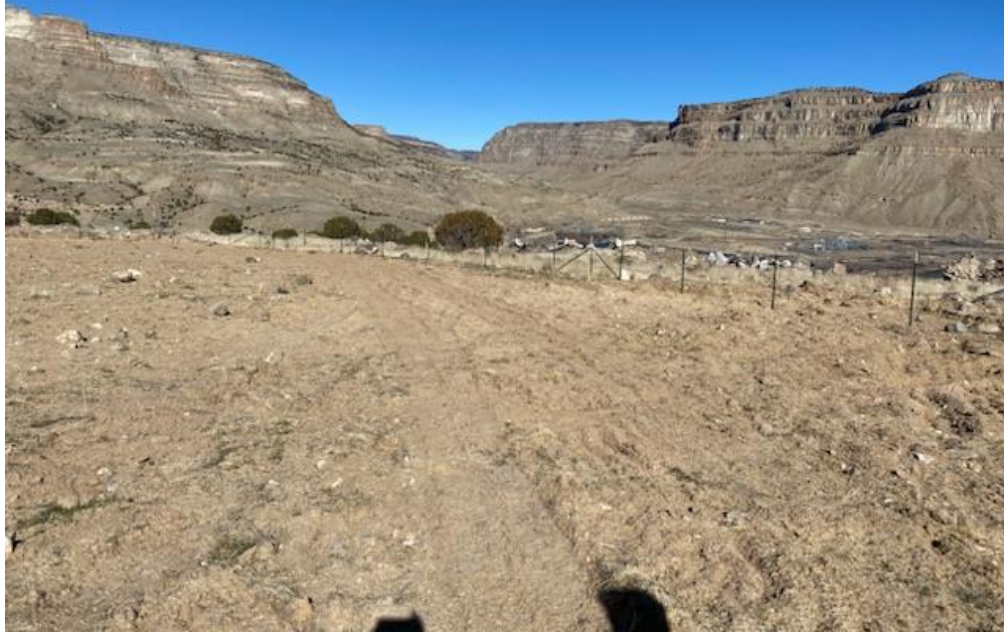
During the inspection, the TR-69 Repair Area was stable and had no indications of erosional features (Photos 1, 2 and 3). There was no observed signs of differential settling observed. The straw waddles located at the down-gradient portions of the reclamation were in good condition. No off-site impacts were observed. Vegetation on the site has not yet begun to sprout from the seeding that occurred in the fall of 2023.

Photo 1: The northern portion of the TR-69 Repair Area. The photo was taken looking to the west.

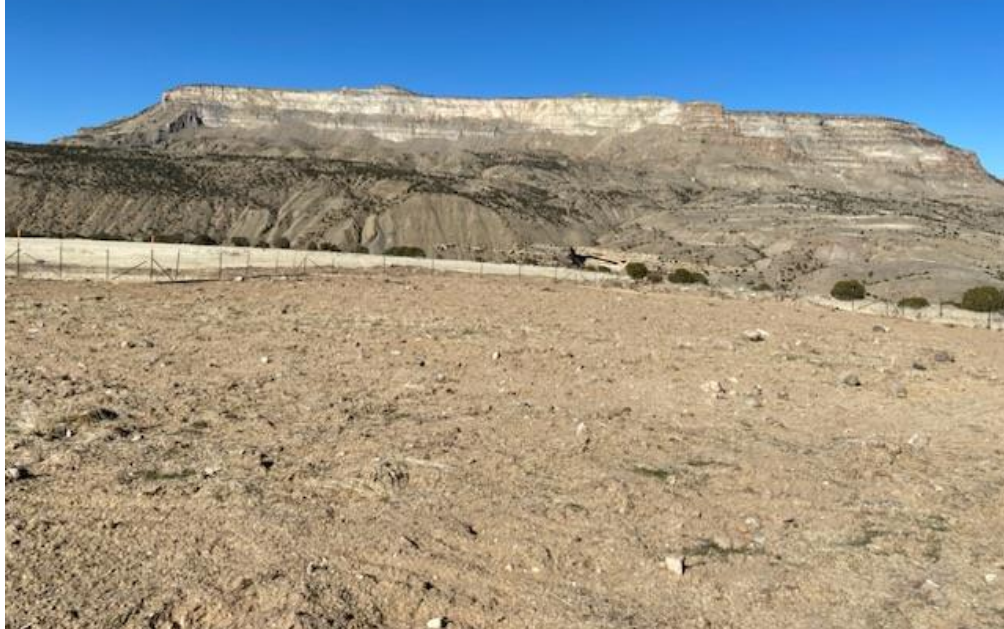
Photo 2: The middle portion of the TR-69 Repair Area. The photo was taken looking to the west.

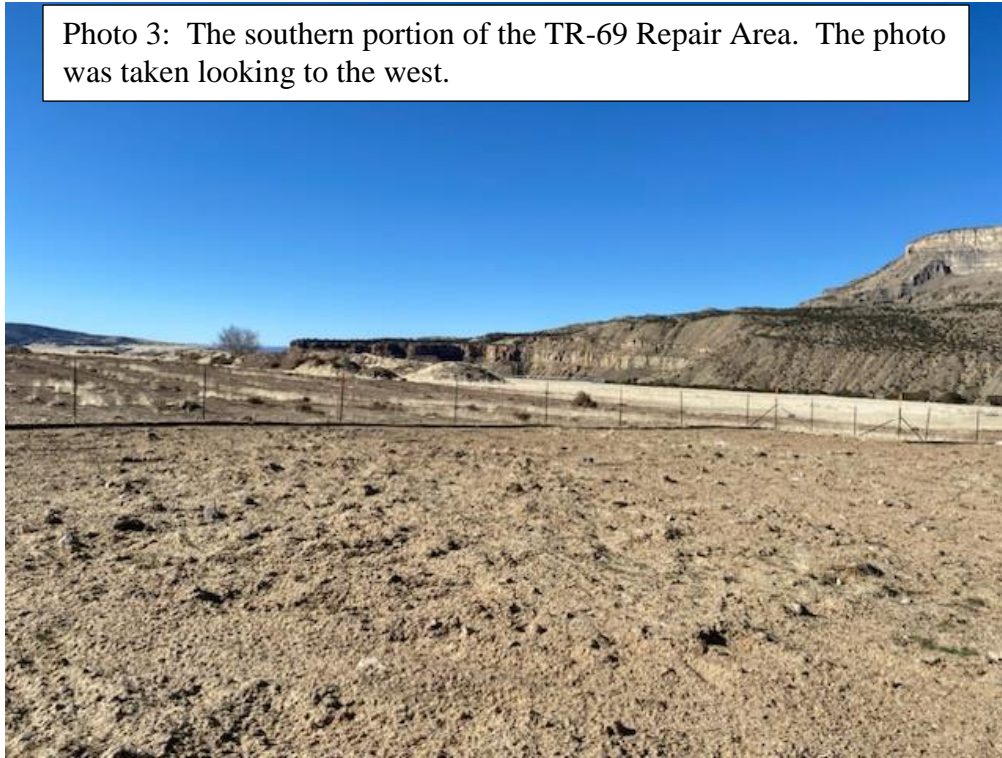
Photo 3: The southern portion of the TR-69 Repair Area. The photo was taken looking to the west.
