## Additional Information Required, 4Q2023 GW/SW Monitoring Report, Cresson Project, M1980-244

**Photographic Log - GV06 022624.pdf**

## PHOTOGRAPHIC LOG

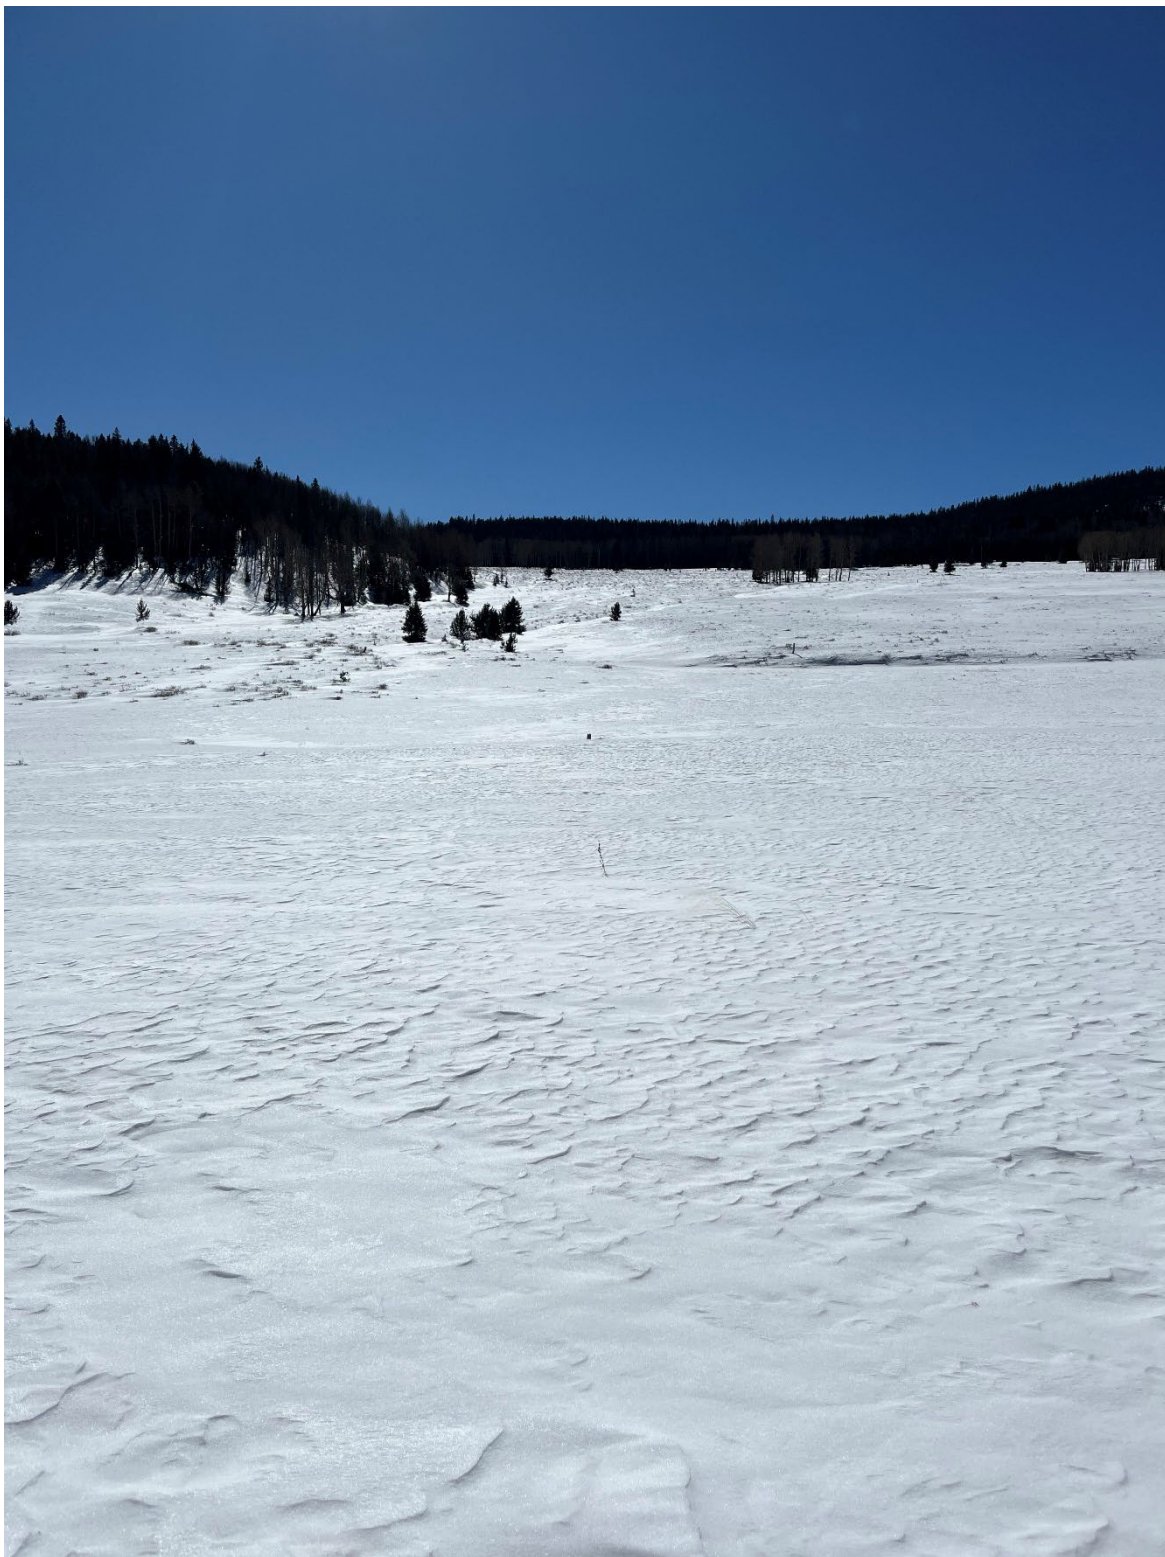
Photograph 1: View of the GV-06 surface water monitoring location, looking south. Photo taken 2/19/2024.

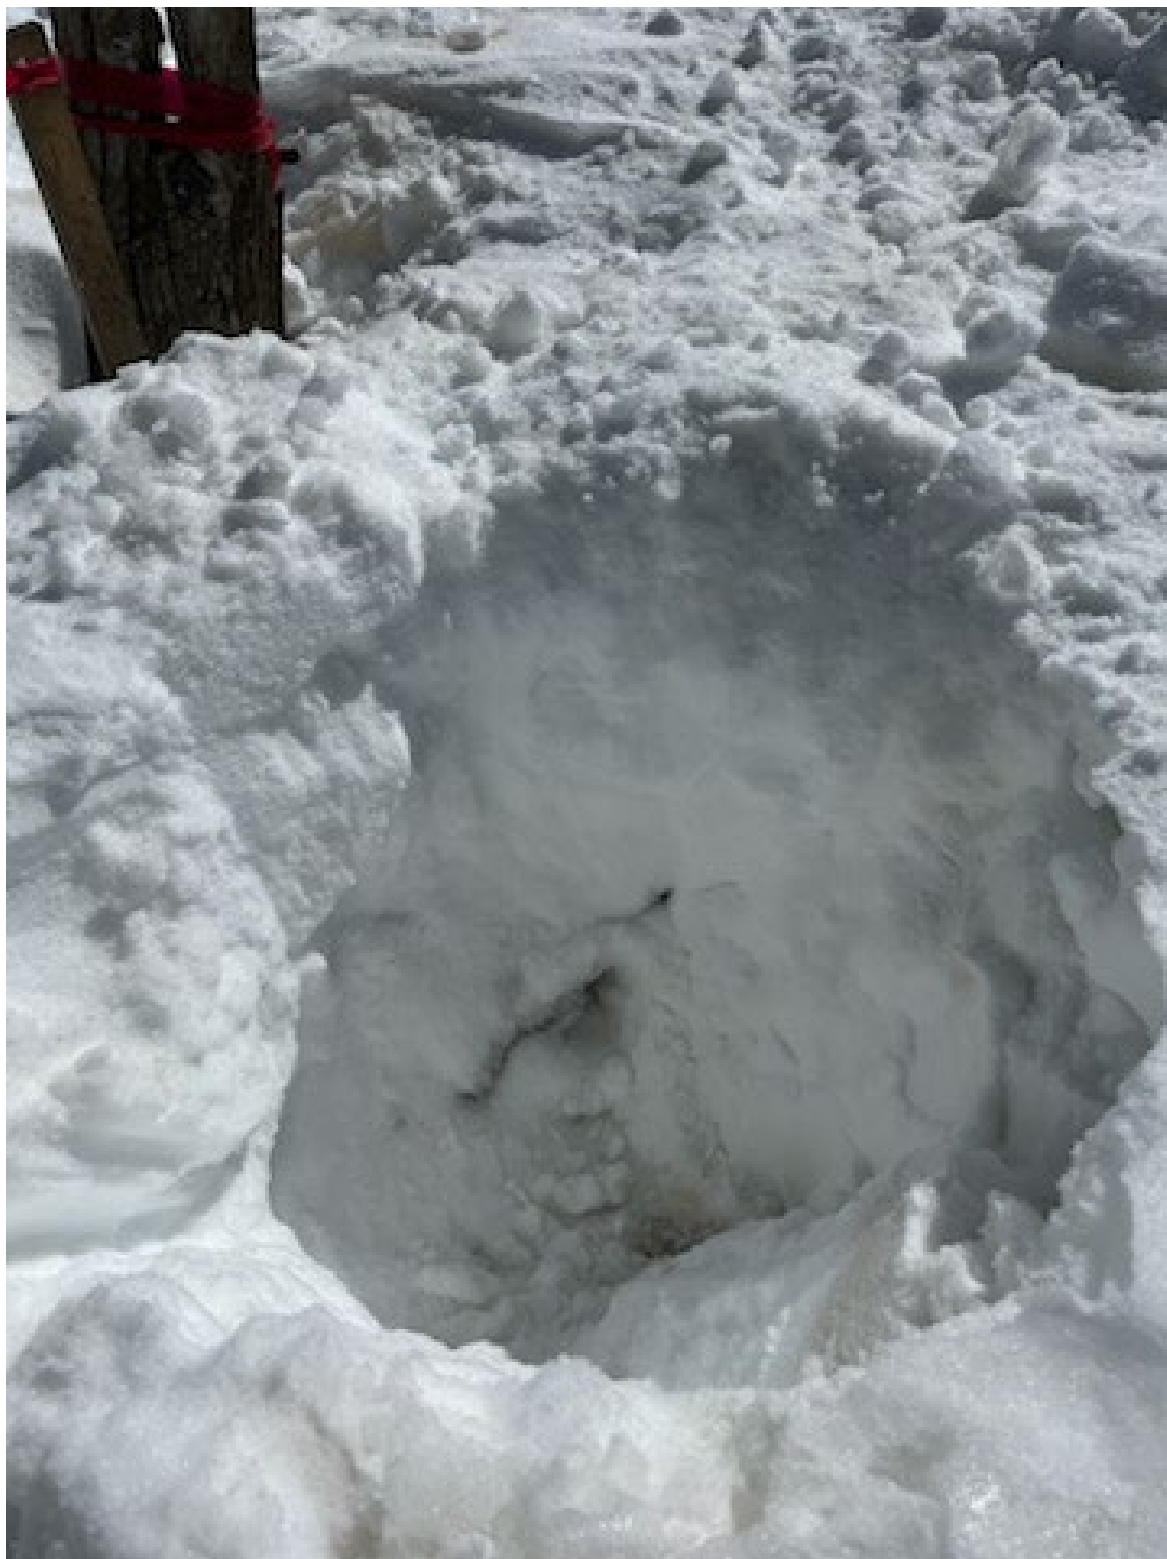
Photograph 2: View of the GV-06 surface water monitoring location, looking southeast. Photo taken 2/26/2024 at approximately 13:20 MST.

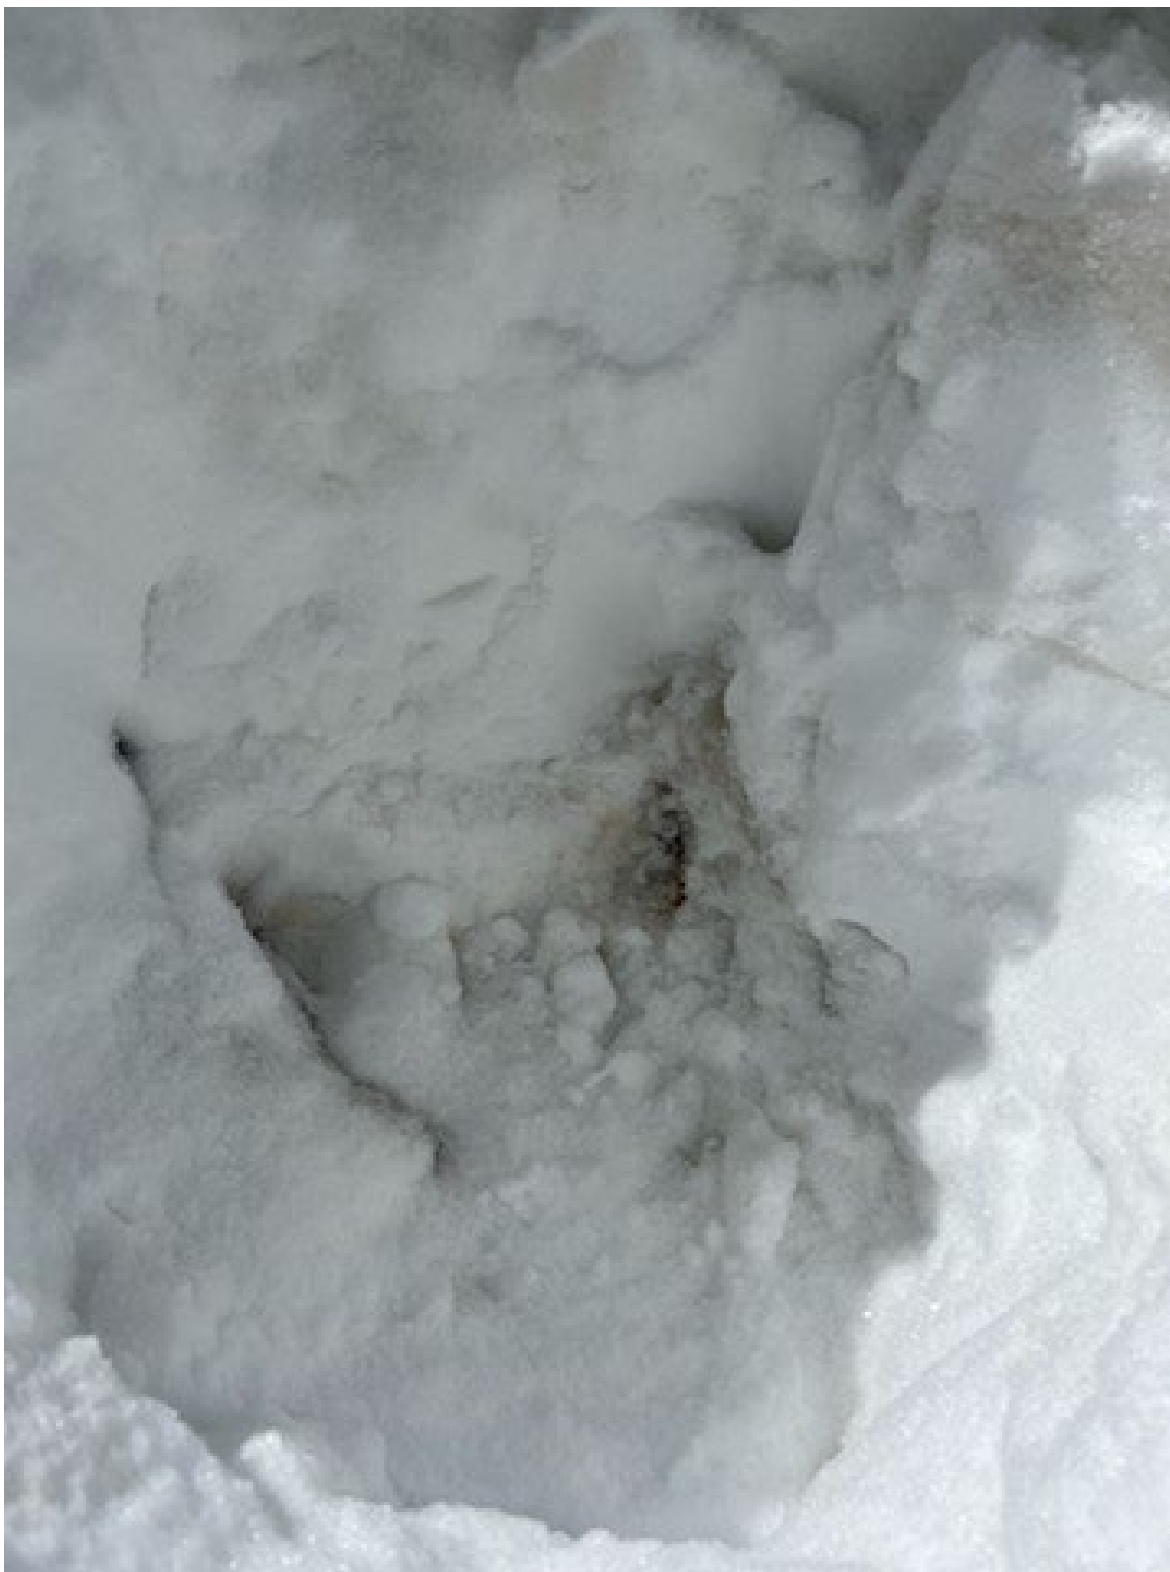
Photograph 3: View of the GV-06 surface water monitoring location after layer of ice was removed. No flowing water was observed at the location. Photo taken 2/26/2024 at approximately 13:20 MST.

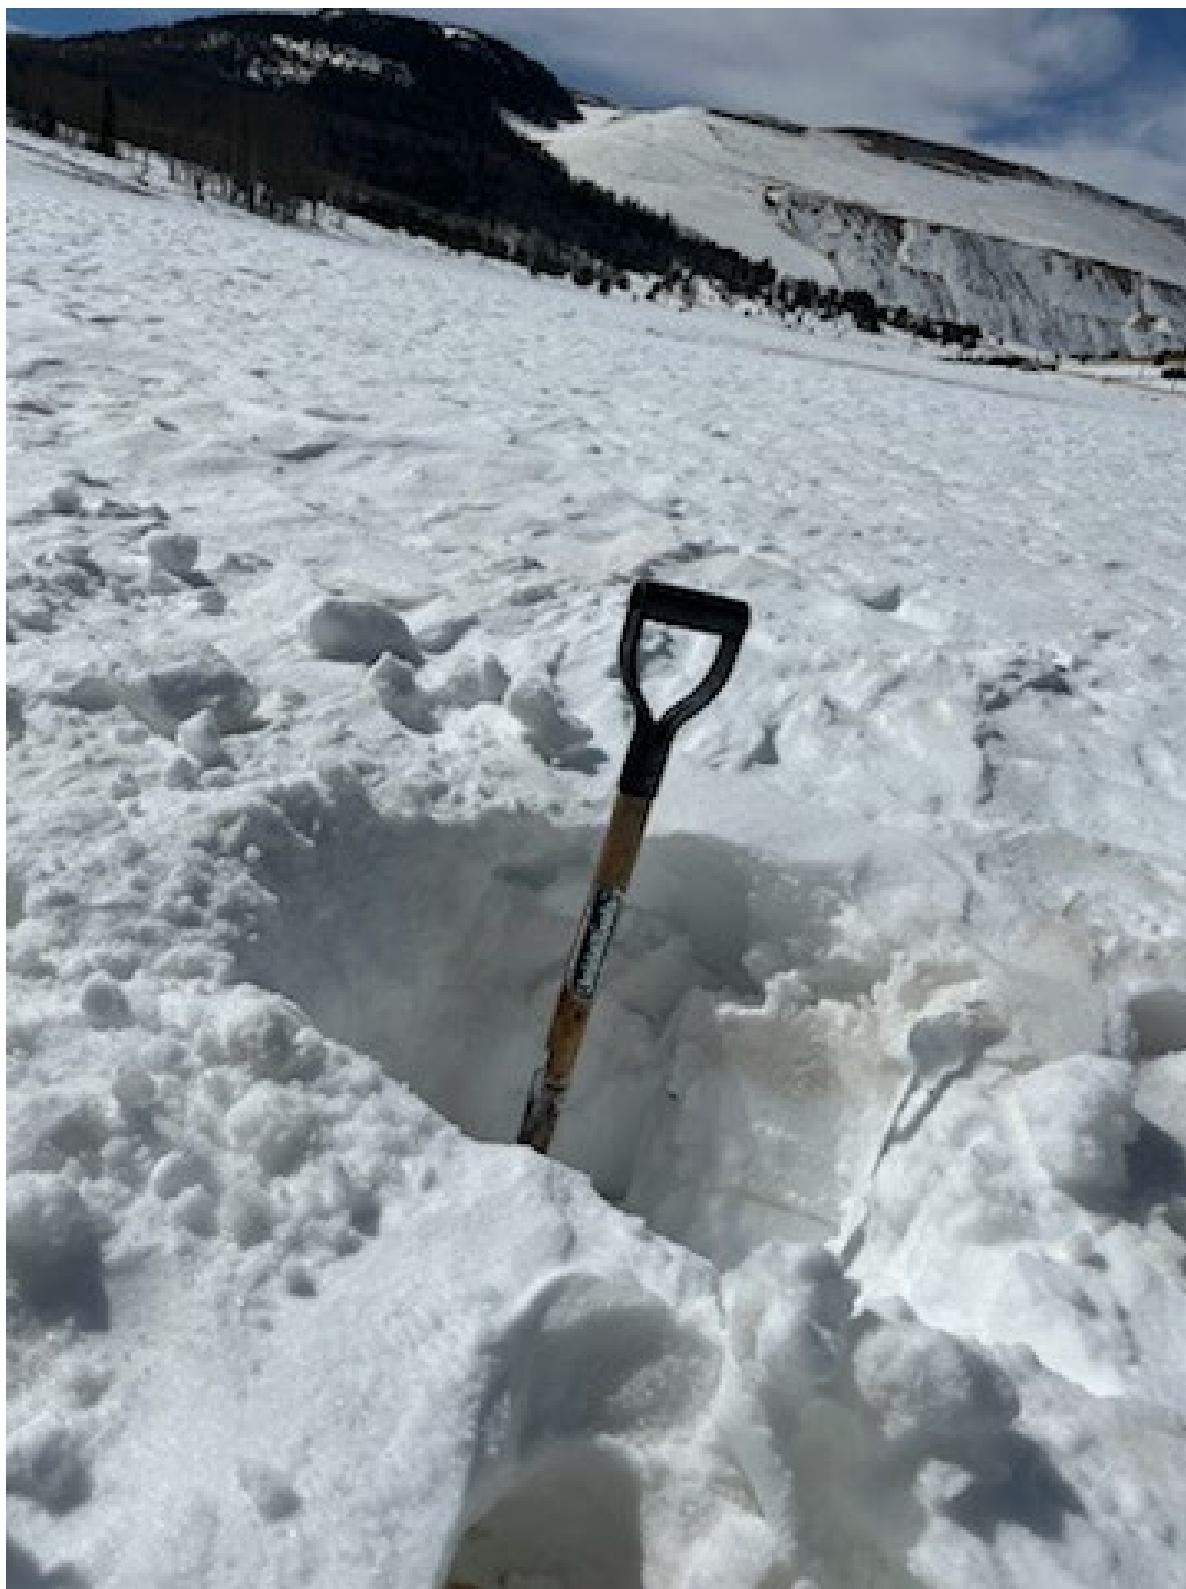
Photograph 4: View of the GV-06 surface water monitoring location showing the depth of the snow, looking west. Photo taken 2/26/2024 at approximately 13:20 MST.
