Additional Information Required, 4Q2023 GW/SW Monitoring Report, Cresson Project, M1980-244

**Photographic Log - GV06 030424.pdf**
1074K

PHOTOGRAPHIC LOG

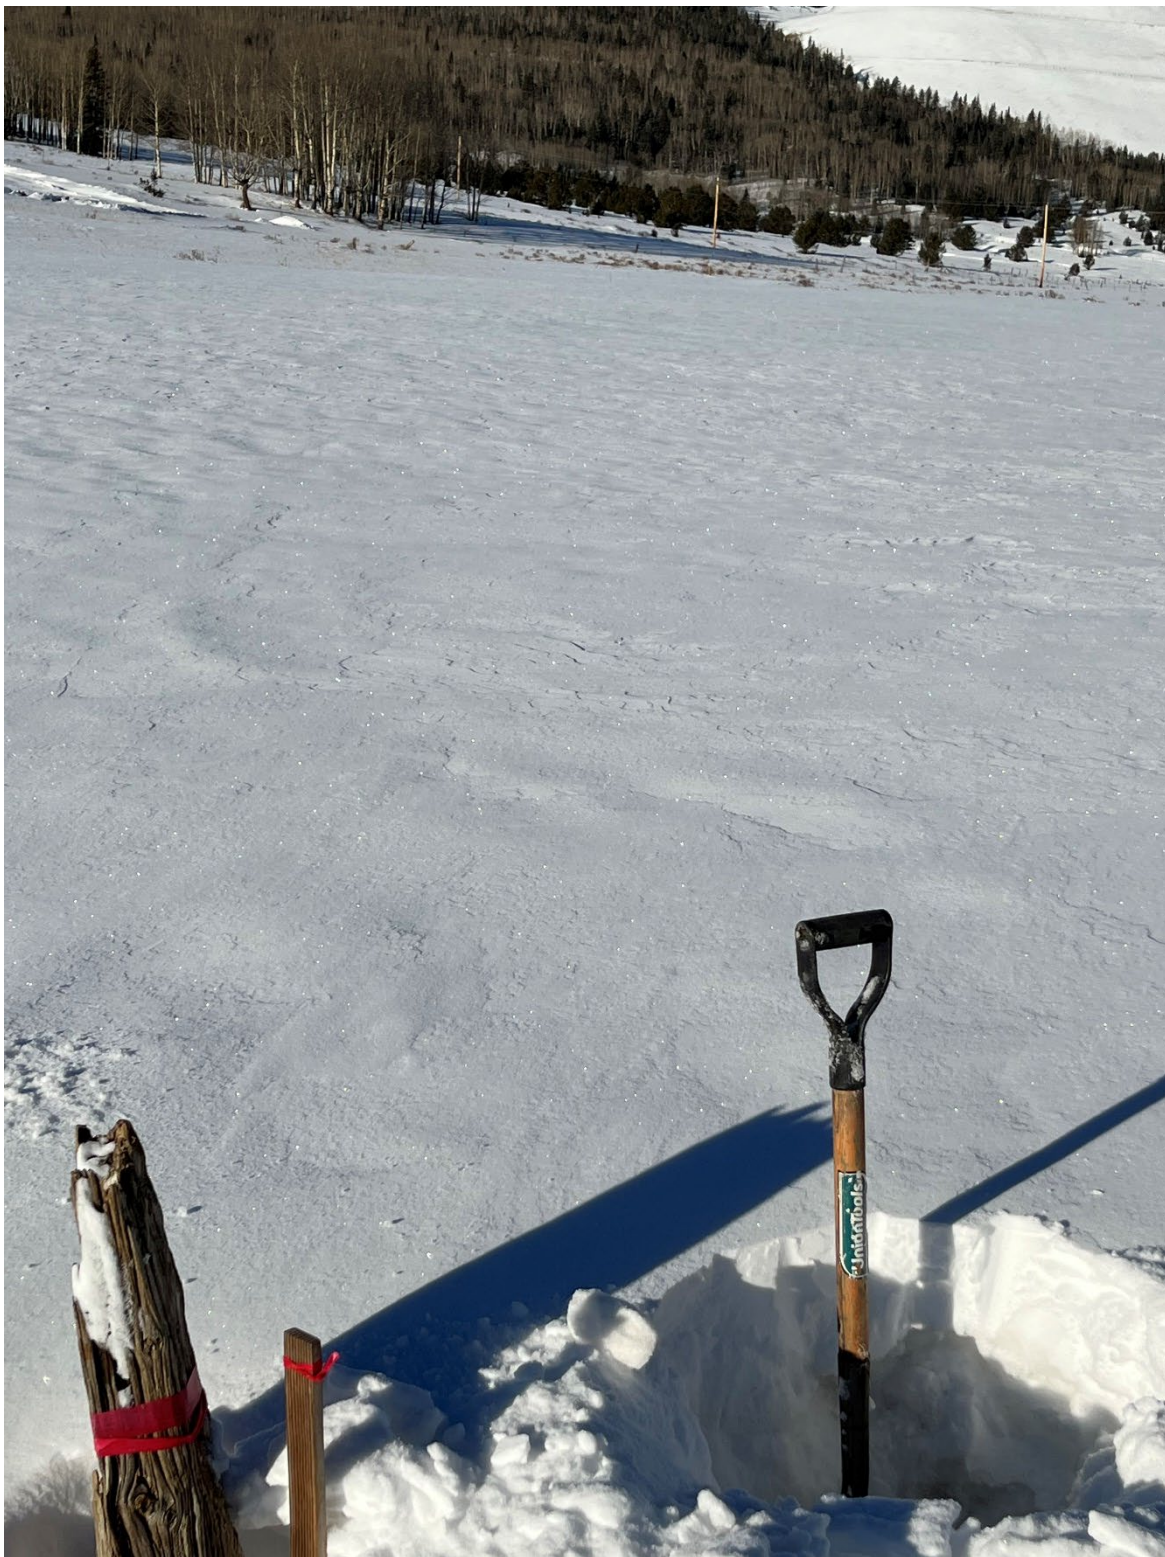
Photograph 1: View of the GV-06 surface water monitoring location, looking west. Photo taken 3/4/2024 at approximately 07:30 MST.

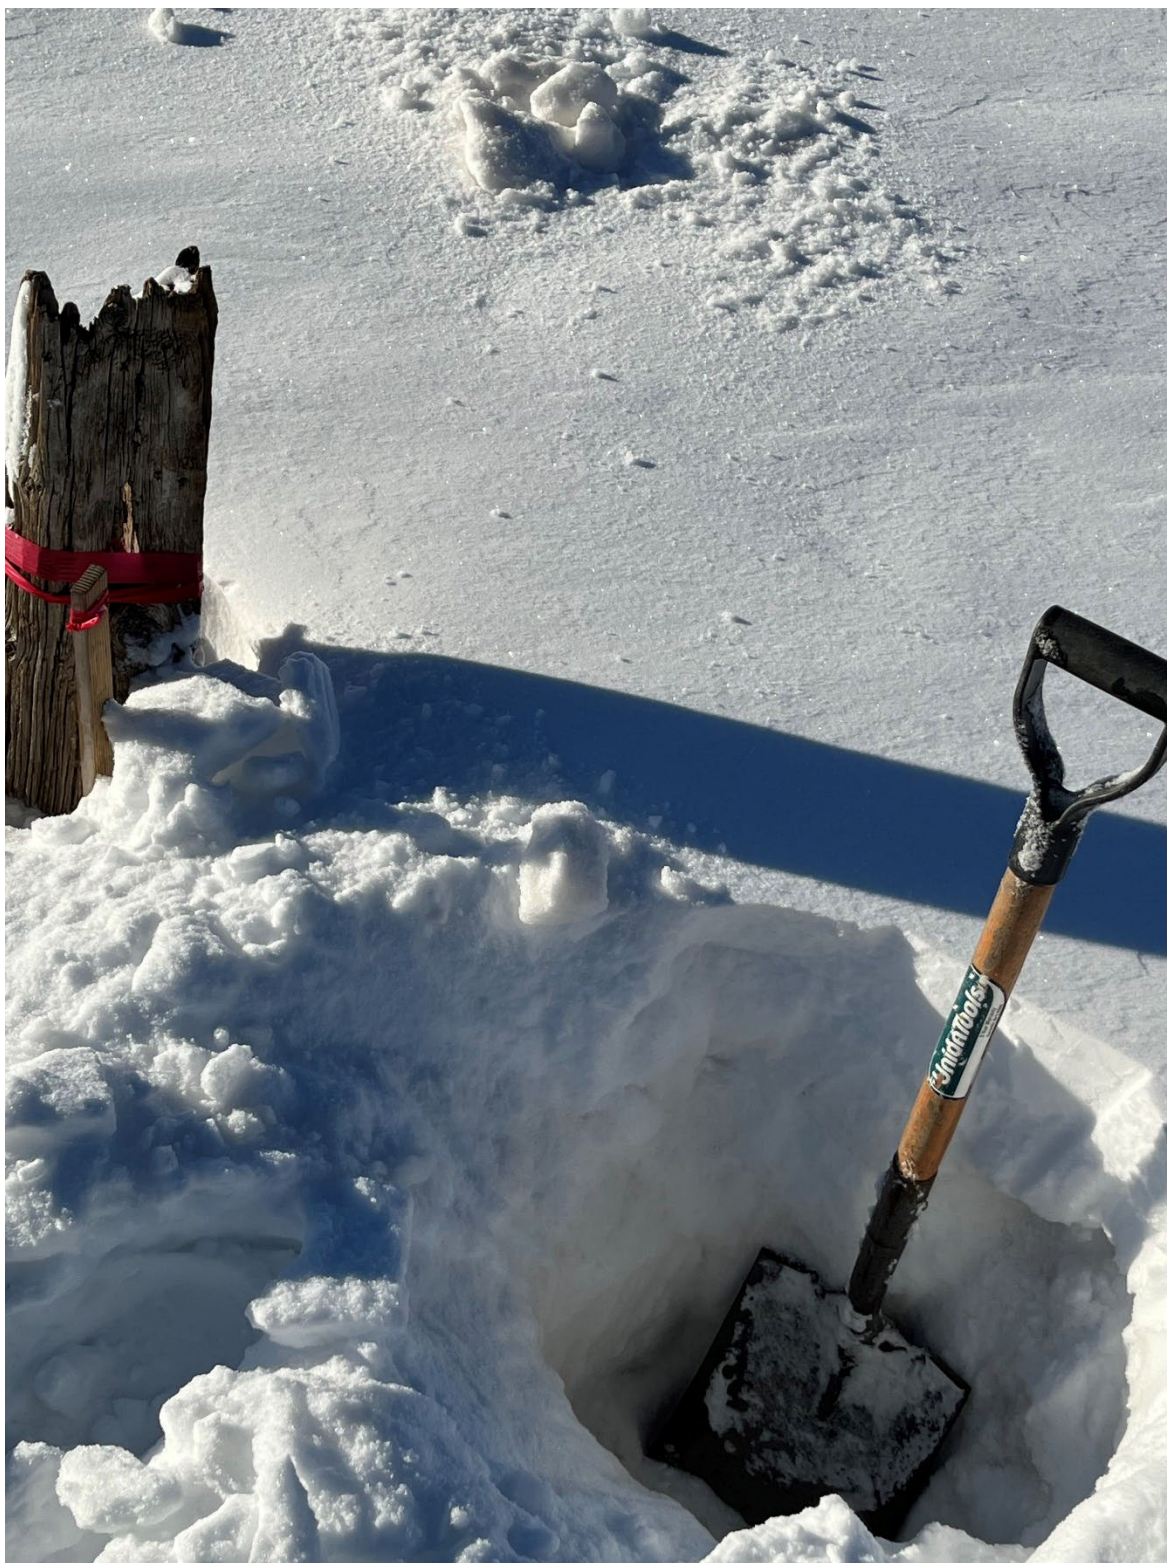
Photograph 2: View of the GV-06 surface water monitoring location, looking southeast. Photo taken 3/4/2024 at approximately 07:30 MST.

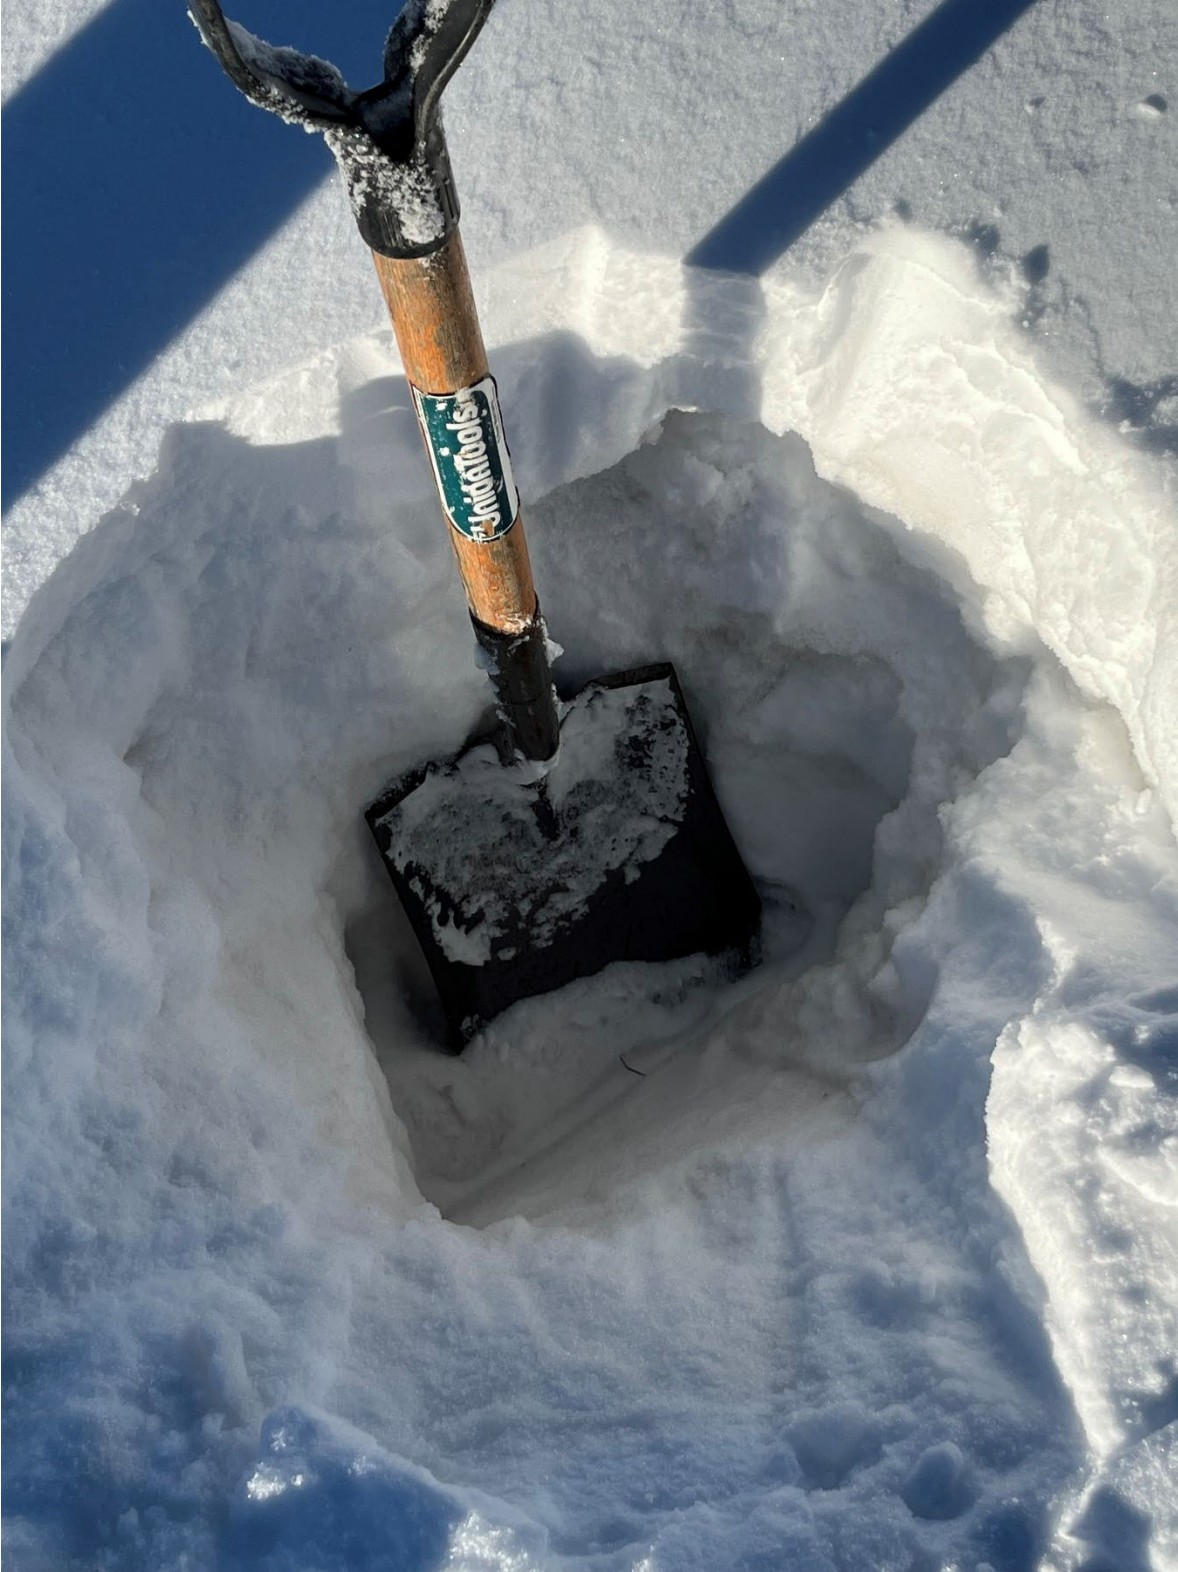
Photograph 3: View of the GV-06 surface water monitoring location after snow and ice was removed. No flowing water was observed at the location. Photo taken 3/4/2024 at approximately 07:30 MST.

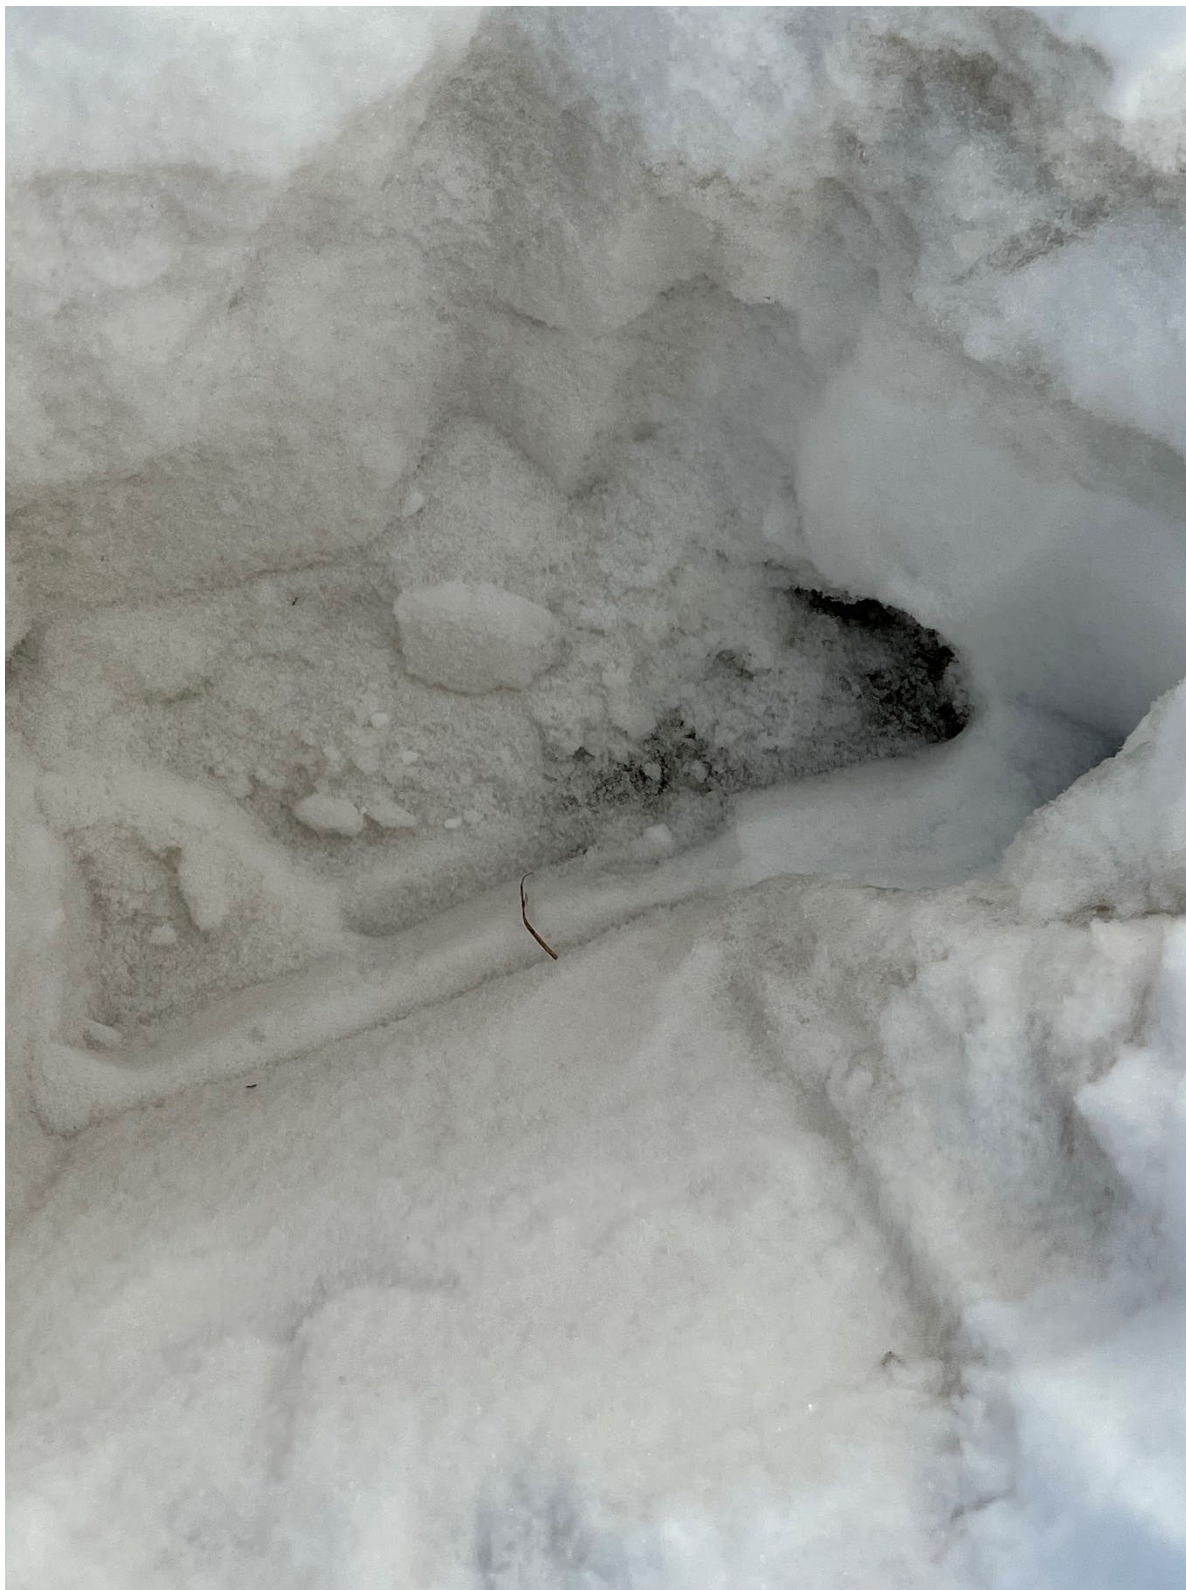
Photograph 4: View of the GV-06 surface water monitoring location after snow and ice was removed. No flowing water was observed at the location. Photo taken 3/4/2024 at approximately 07:30 MST.
