Inspection Report, February 15 2024 Cresson Project M-1980-244

MINERALS PROGRAM INSPECTION REPORT
PHONE: (303) 866-3567

MINE NAME: Cresson Project	MINE/PROSPECTING ID#: M-1980-244	MINERAL: Gold and silver	COUNTY: Teller
INSPECTION TYPE: Monitoring	WEATHER: Clear	INSP. DATE: February 15, 2024	INSP. TIME: 10:00
OPERATOR: Cripple Creek & Victor Gold Mining Company	OPERATOR REPRESENTATIVE: Katie Blake	TYPE OF OPERATION: 112d-3 - Designated Mining Operation	
REASON FOR INSPECTION: Priority – reported ore stacking issue In VLF 2 Phase III.	BOND CALCULATION TYPE: None	BOND AMOUNT: \$291,100,000.00	
DATE OF COMPLAINT: NA	POST INSP. CONTACTS: None	JOINT INSP. AGENCY: None	
INSPECTOR(S): Nikie Gagnon	INSPECTOR'S SIGNATURE:

On February 15, 2024, Nikie Gagnon with the Division of Reclamation, Mining and Safety (Division) conducted a priority inspection of Cells 5 & 6 in the VLF2 Phase 3A area. Katie Blake, Kathy Steele, and Brian Crawford representing the Operator, and Jay Janney-Moore representing Newfields, accompanied the Division for this inspection.

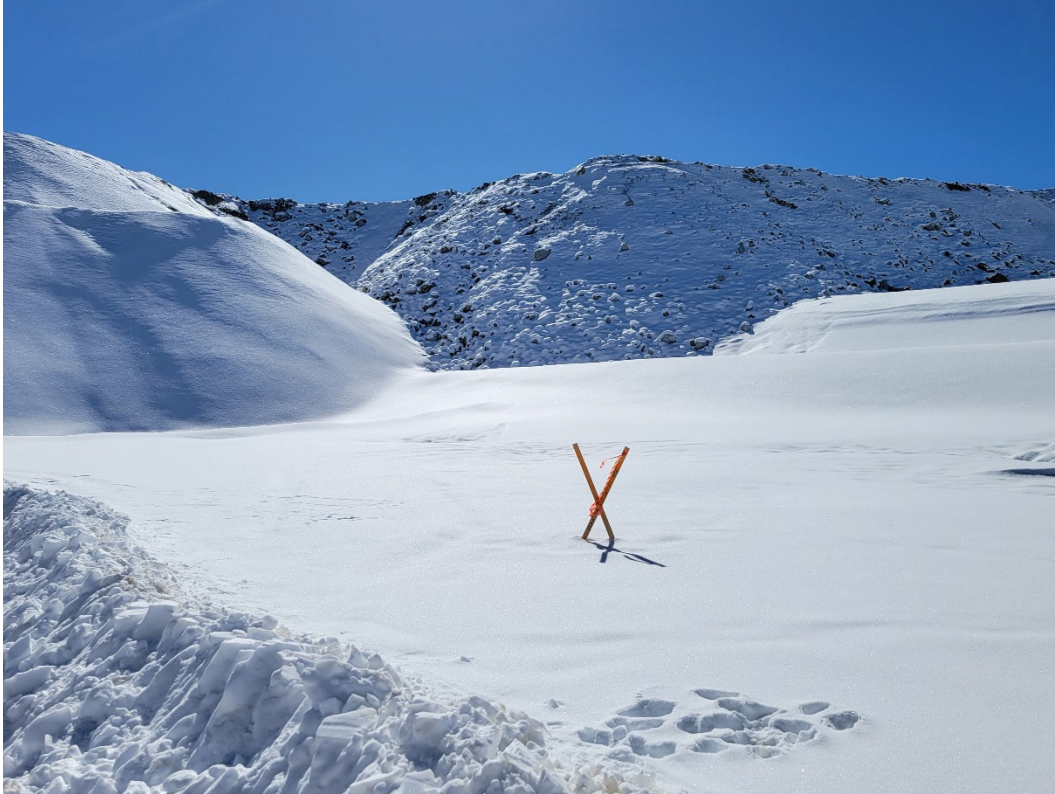
The Division observed the base and slope of a 50-foot lift in Cell 5 where the ROM ore was placed in a downhill direction (See Photos 1-4). Kathy Steele explained that ROM material was pushed with a dozer from the top and the ore flowed downhill into Cell 5. The Phase 3A area was covered in several inches of snow and therefore the Division was unable to inspect the base of the slope to determine if there was any movement of the DCF underlying the stacked ROM material. Cells 5 & 6 are adjacent and to the south of the PSSA in the Phase 3A area and the cells are underlain by 80 MIL geomembrane. The ROM material observed was primarily <3 feet in diameter. The largest rock observed by the Division at the bottom of the slope is shown in Photo 4.

Photo 1: Looking at the slope of downhill loaded ROM material from the base of Cell 5.

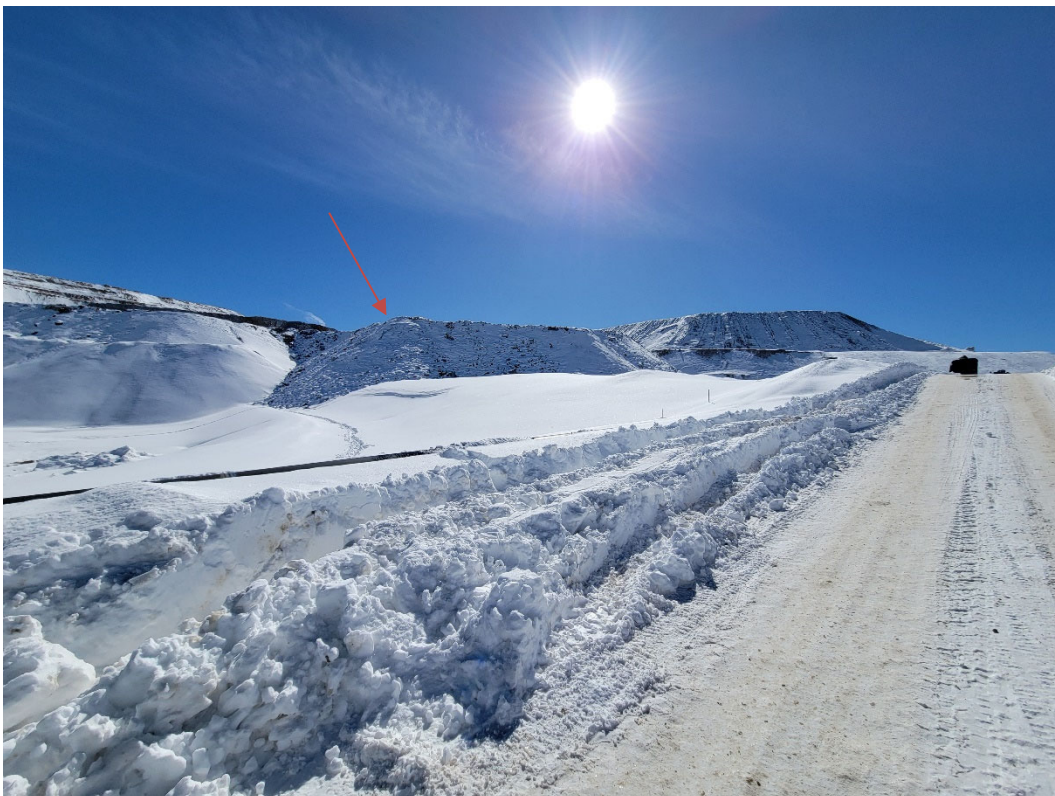
Photo 2: Looking at Cell 5 from the access road on the south side of the PSSA. Arrow points to the material placed downhill in Cell 5

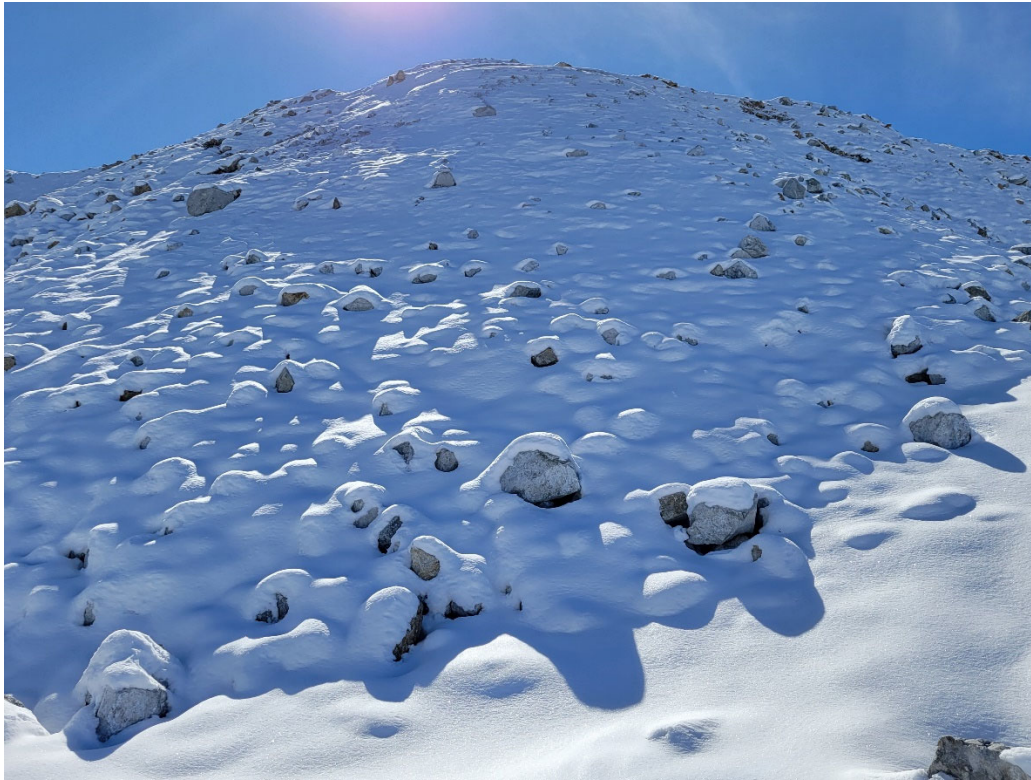
Photo 3: Closeup of the ROM material pushed down into Cell 5.

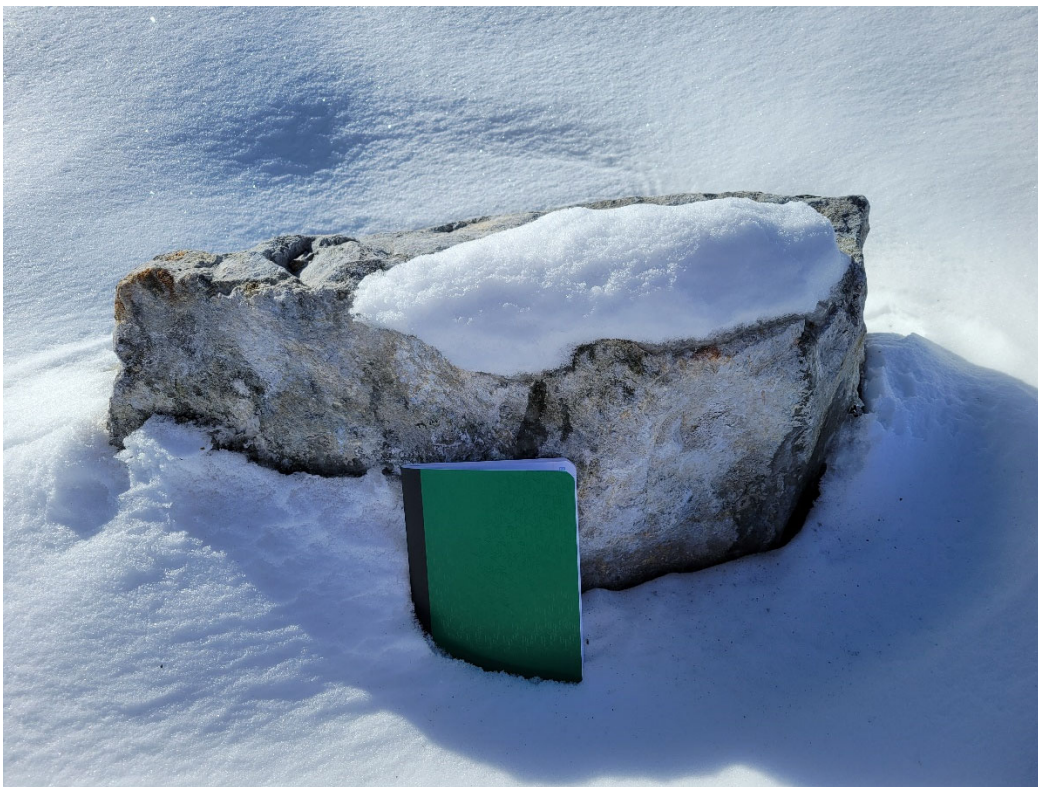
Photo 4: Rock observed at the bottom of the slope in Cell 5. Notebook is 8.5x11".

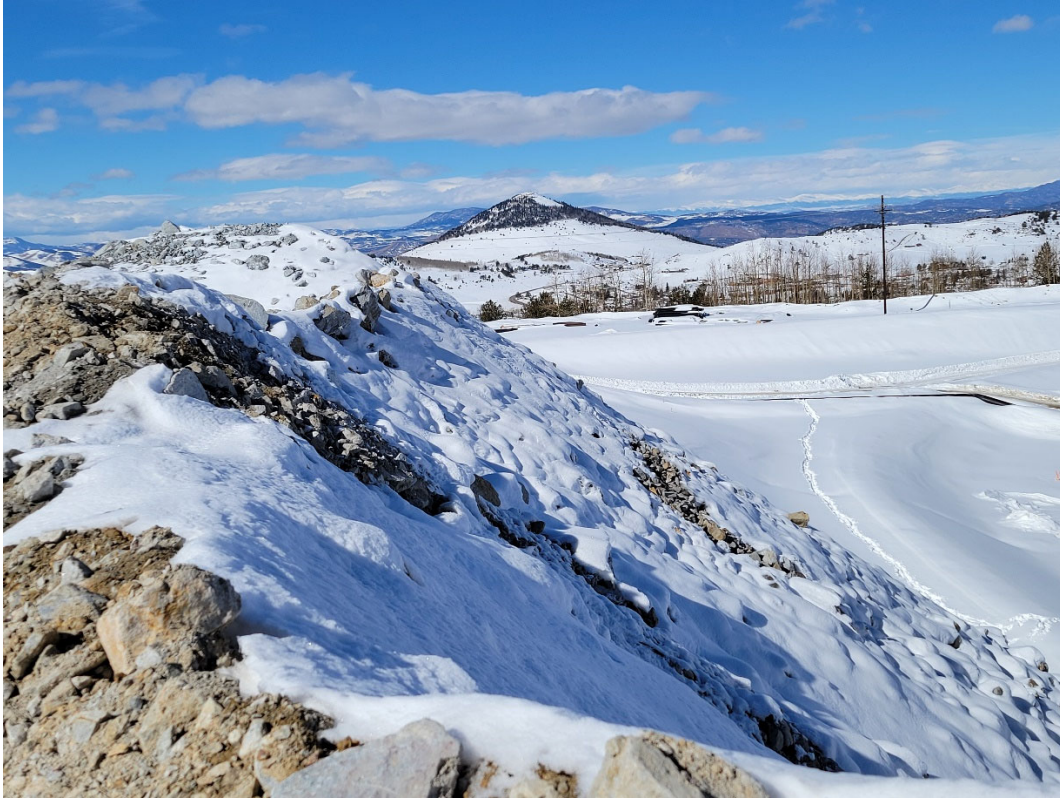
The Division observed Cells 5 and 6 from the top where the downhill ore stacking occurred on the 10,050 lift. (See Photos 5-8). The Operator stated that they were not stacking in the Phase 3A area on the day of this inspection and have not stacked additional material in Cells 5 or 6 since February 6. No evidence of further stacking or moving ore in Cell 6 was noted during this inspection. The area was blanketed in snow and no tracks were observed. The Division noted the entrance to Cells 5 & 6 have been blocked by a berm to ensure no additional stacking occurs in this area.

Photo 5: Looking down the slope from the top of Cell 5. Material was pushed downhill by a dozer.

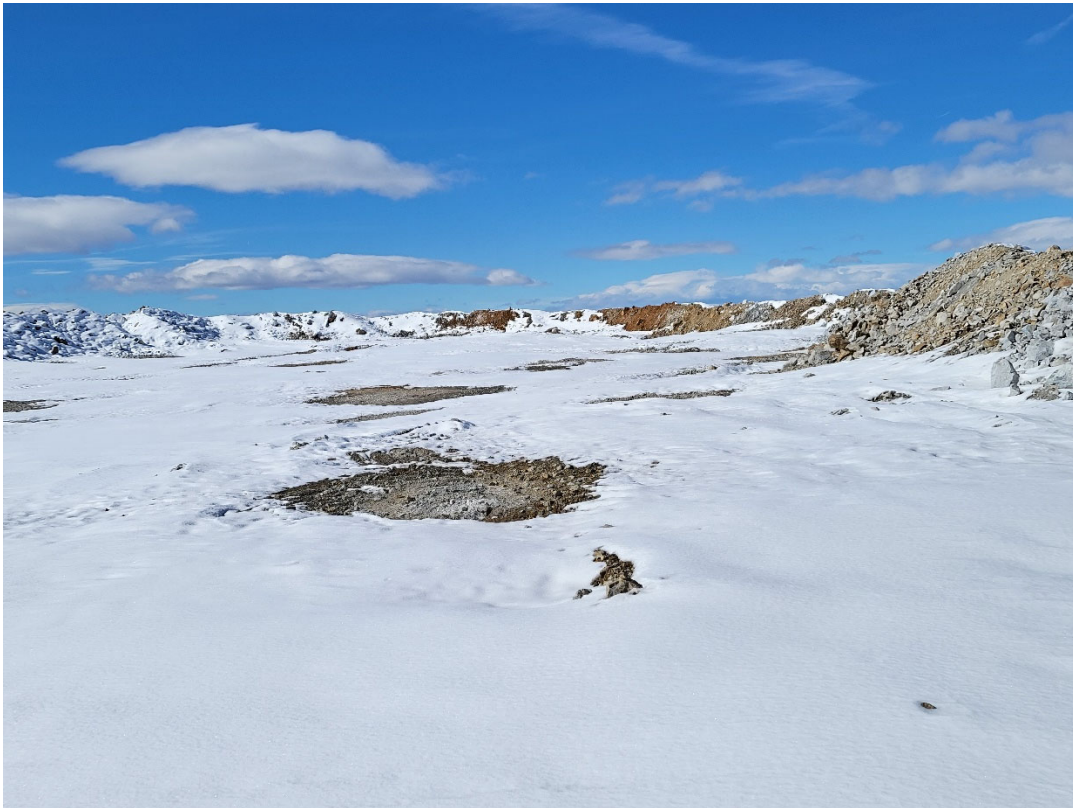
Photo 6: Looking across Cell 6 at the 10,050 level. Ore was stacked in this area on Sunday, February 4.

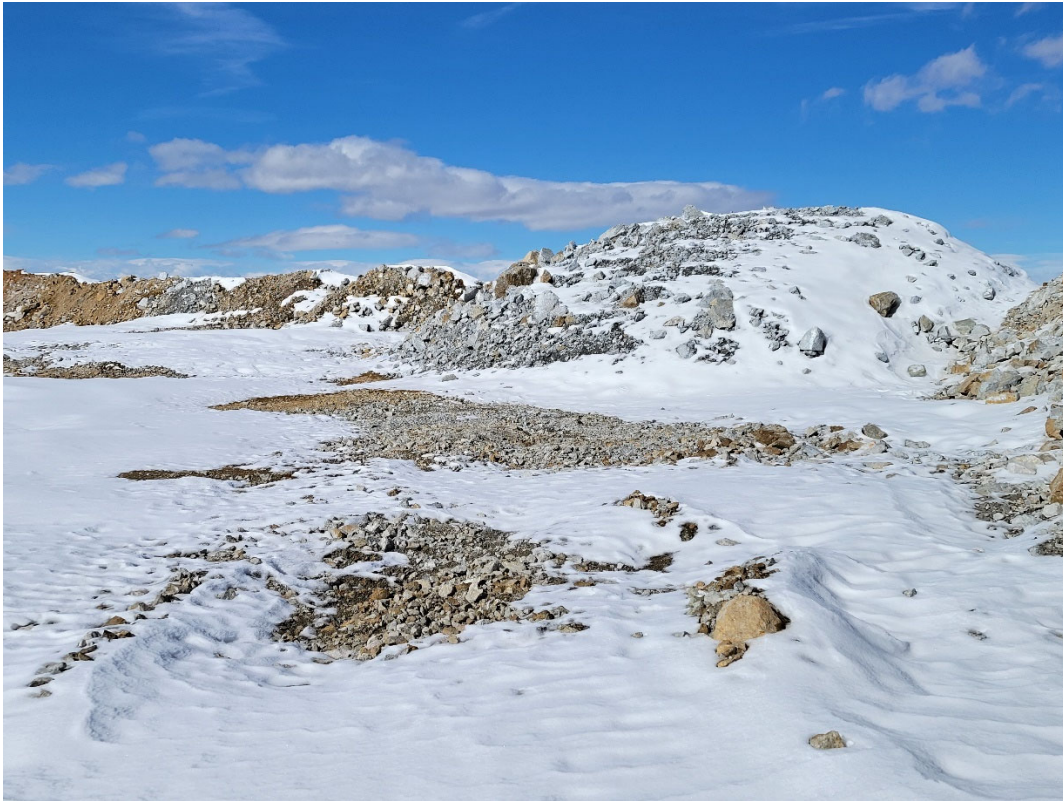
Photo 7: Standing on Cell 6 looking at area where ROM ore was pushed downhill in Cell 5.

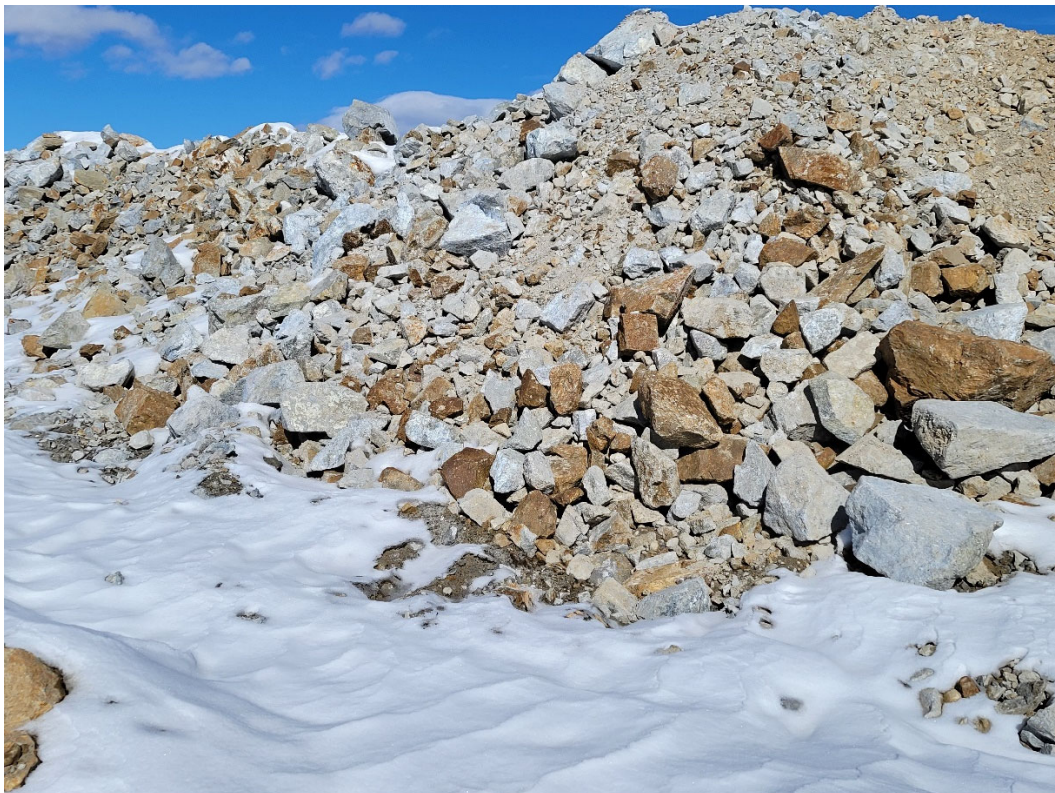
Photo 8: Close-up of ROM material in the 10,505 level.

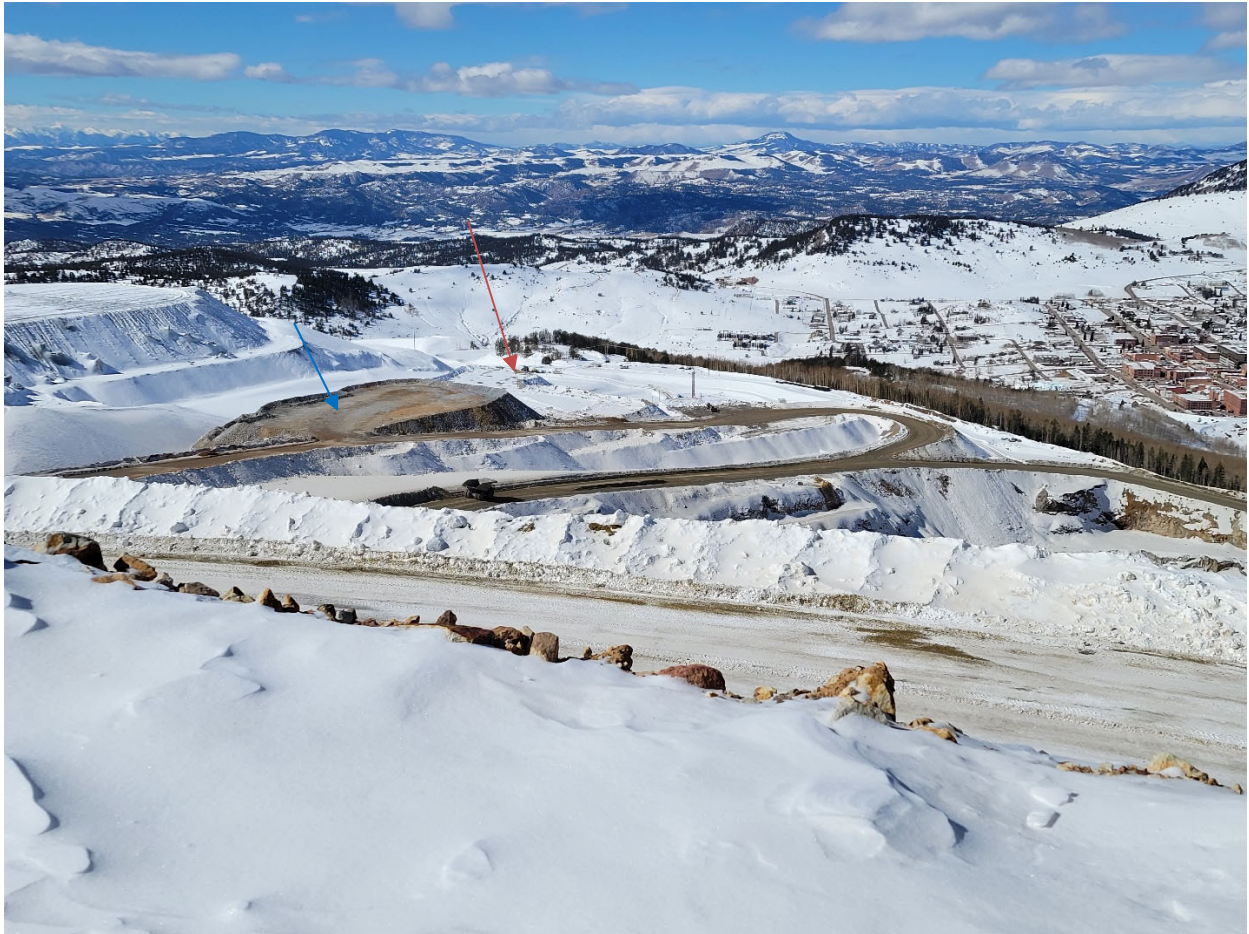
Photo 9: Overview photo showing the ore stacking within the Phase 3A area. Red arrow points to the location of the downhill stacking in Cell 5 at the 10,050 level. Blue arrow indicates ore stacking at the 10,100 ft. level.

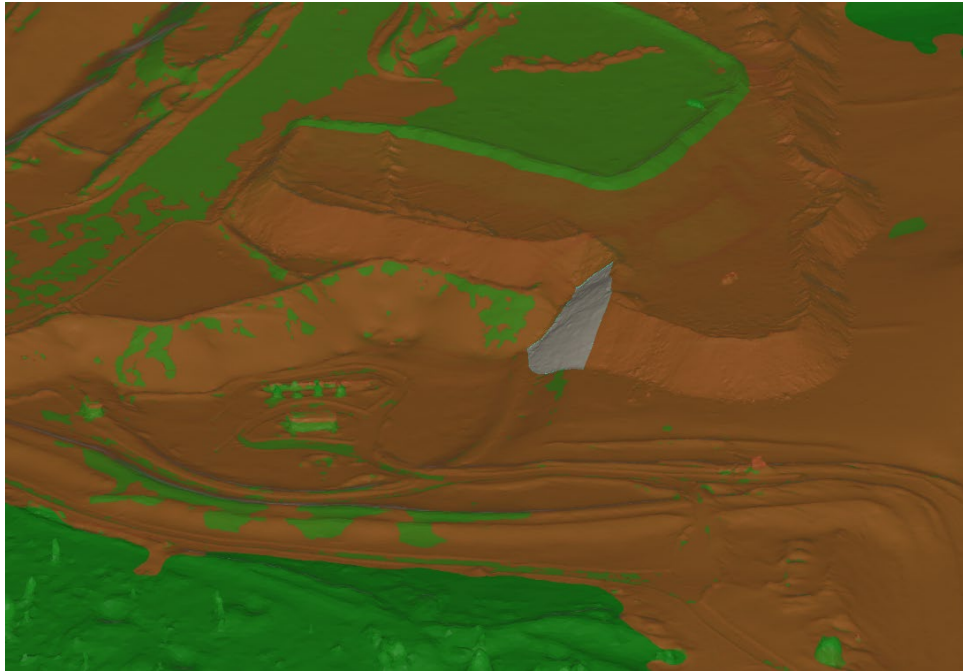
Cell 5 Overdump Tonnage: 5,232 tons

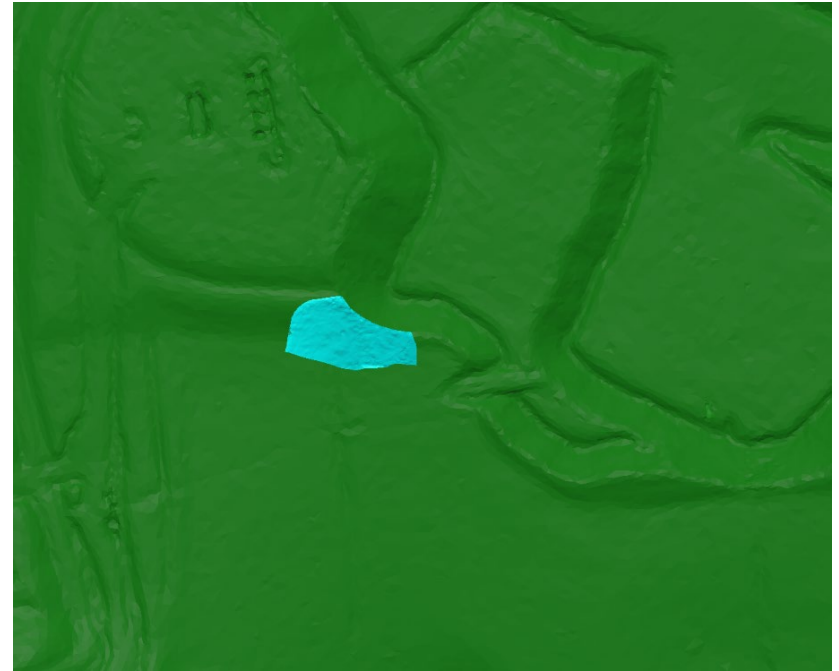
Cell 5 Overdump Surface Area: 5,144 ft²

Portion of Cell 5 dumped incorrectly on liner steeper than 25%
