### MINERALS PROGRAM INSPECTION REPORT

<b>MINE NAME:</b> Aldrich Gravel Pit	<b>MINE/PROSPECTING ID#:</b> M-1983-109	<b>MINERAL:</b> Sand and gravel	<b>COUNTY:</b> Kiowa
<b>INSPECTION TYPE:</b> Monitoring	<b>WEATHER:</b> Clear	<b>INSP. DATE:</b> January 30, 2024	<b>INSP. TIME:</b> 12:30
<b>OPERATOR:</b> Kiowa County	<b>OPERATOR REPRESENTATIVE:</b> Rick Spady	<b>TYPE OF OPERATION:</b> 110c - Construction Limited Impact

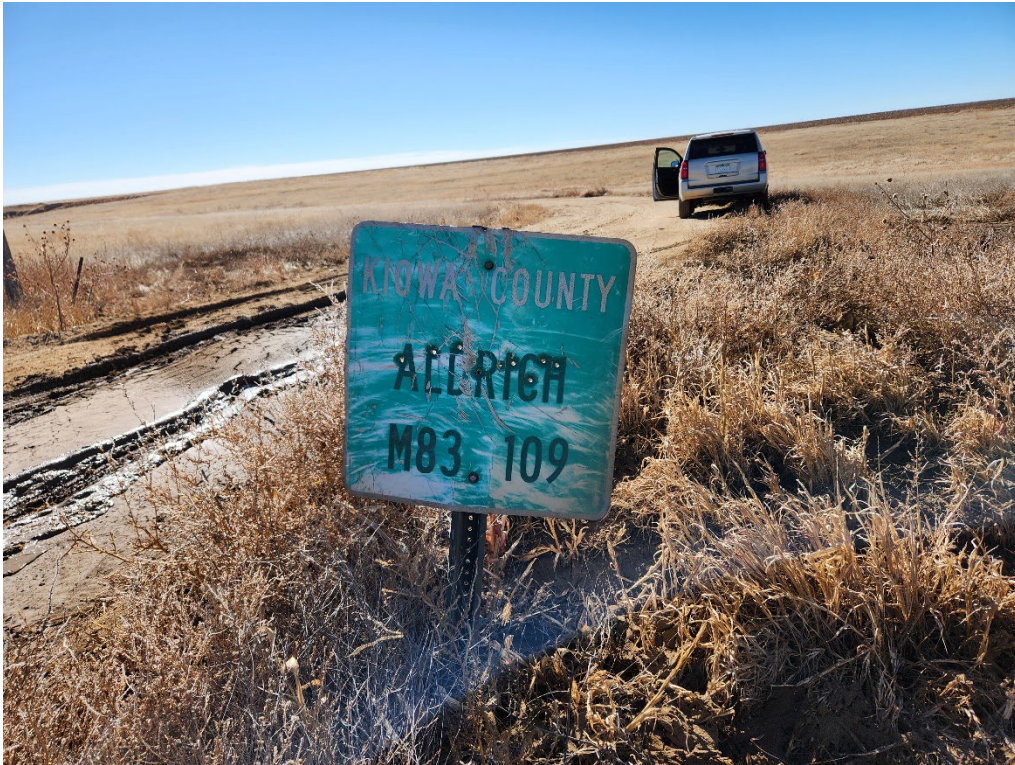
**PROBLEM/POSSIBLE VIOLATION:** Problem: The current mine identification sign posted at the entrance of the mine site is weathered and is no longer readable. The sign also does not include a statement that the reclamation permit for the operation has been issued by the Colorado Mined Land Reclamation Board (CMLRB). This is a problem for failure to meet all requirements of a mine identification sign per Rule 3.1.12(1).

The mine entrance sign is weathered away and difficult to read. There is also no statement on the mine entrance sign that a reclamation permit for the operation has been issued by the Colorado Mined Land Reclamation Board (CMLRB), therefore the sign does not include all information required by Rule 3.1.12(1). This is cited as a problem in the report (see page 1). The operator will need to submit photo documentation that a proper sign has been posted by the corrective action due date.

**Photo 1.** Mine entrance sign looking south.

**CORRECTIVE ACTIONS:** The operator shall, at the entrance of the mine site post a sign, which shall be clearly visible from the access road, with a minimum size equaling one hundred and eighty-seven (187) square inches, such as eleven (11) inches in height and seventeen (17) inches in width, with appropriate font size, with the following: the name of the operator, the operation name, a statement that a reclamation permit for the operation has been issued by the CMLRB, and the permit number. The operator shall submit photo documentation that a proper sign has been posted by the corrective action due date.

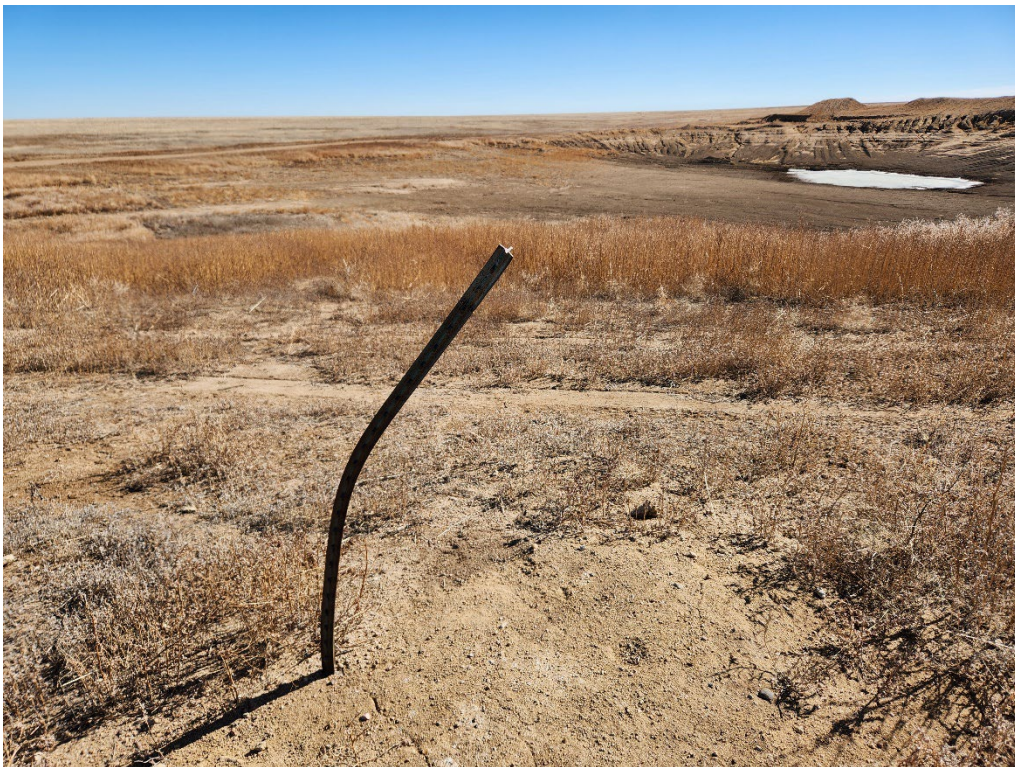
**Photo 2.** Permit boundary marker in the northwest corner of site looking south.

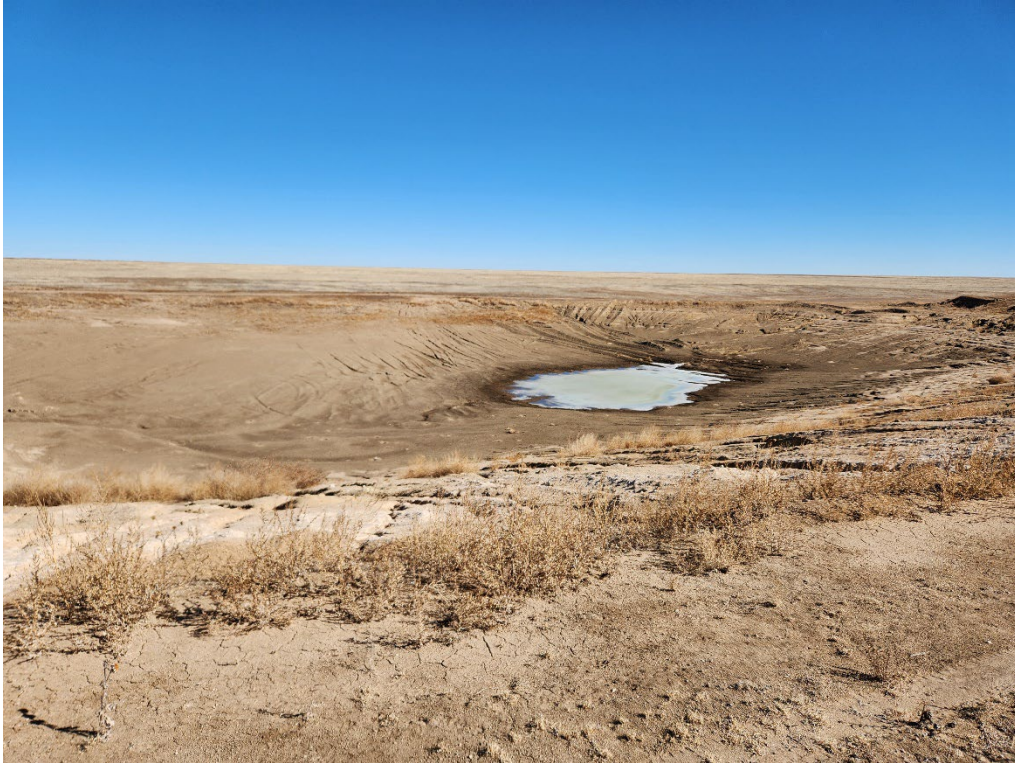
**Photo 3.** Mining pit looking south.

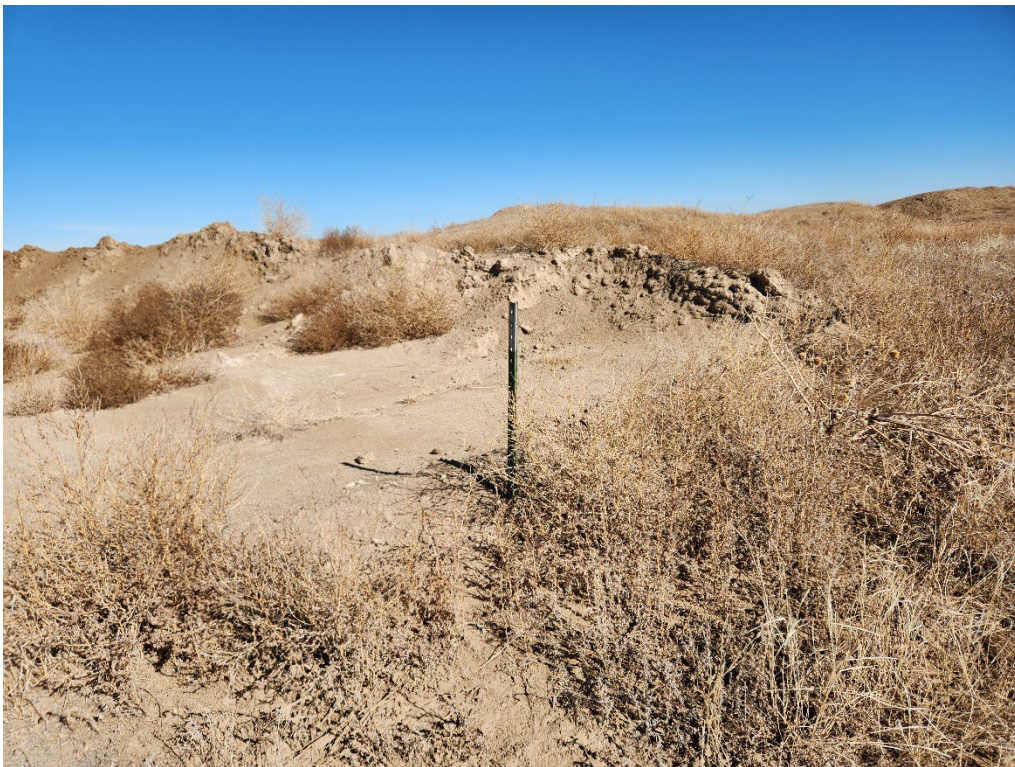
**Photo 4.** Permit boundary marker in the southwest corner of the site, looking east.

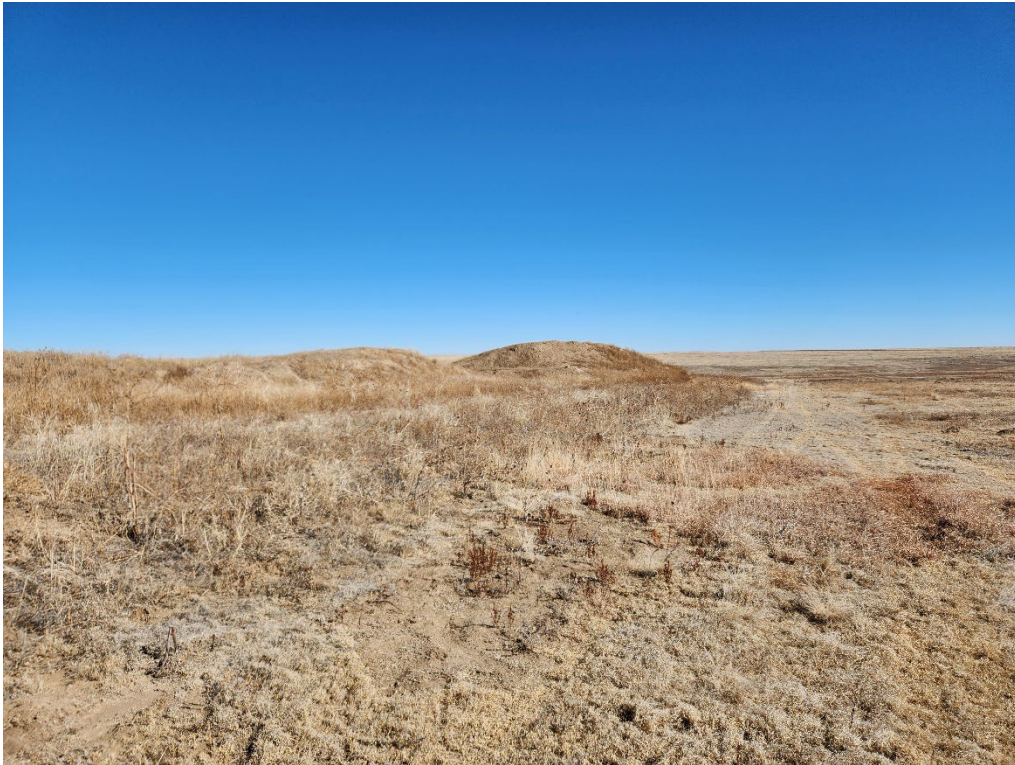
**Photo 5.** Topsoil stockpile along southern edge of permit boundary looking east.

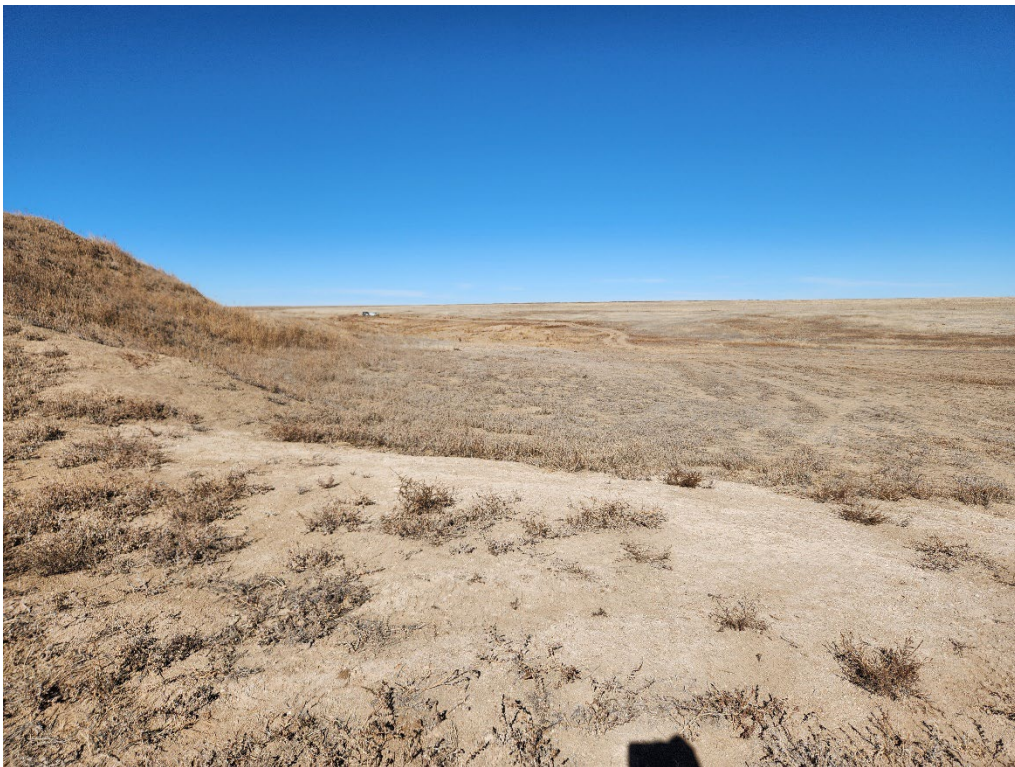
**Photo 6.** Eastern edge of the site looking north.

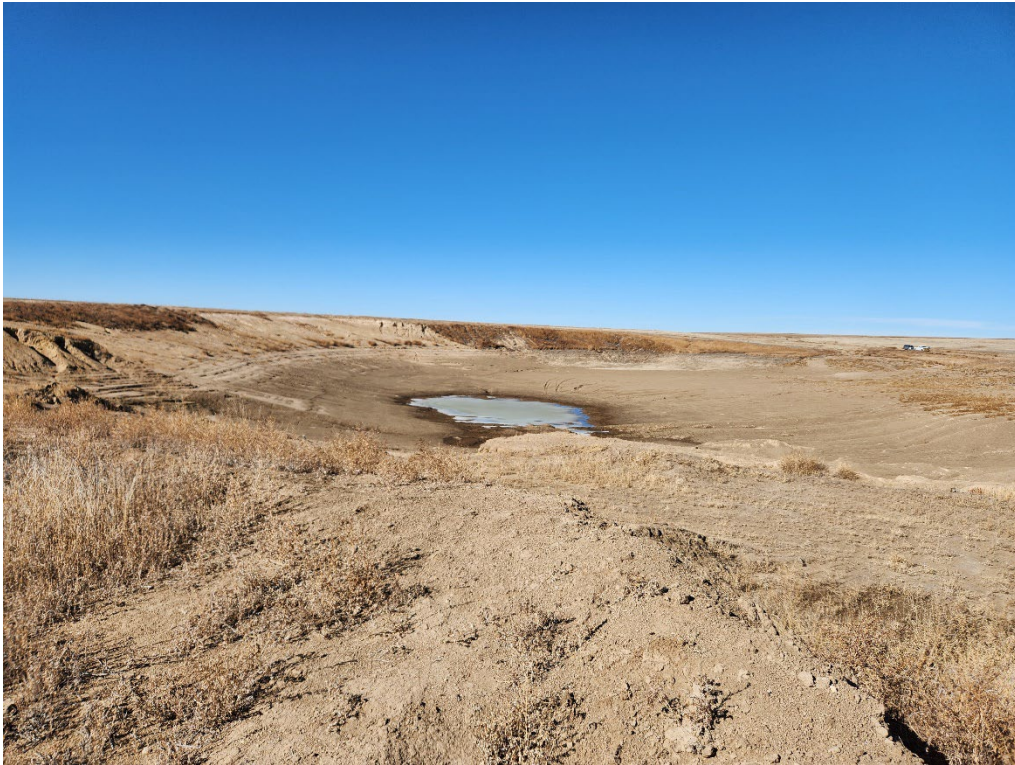
**Photo 7.** Mine pit from southern edge of the site looking north.

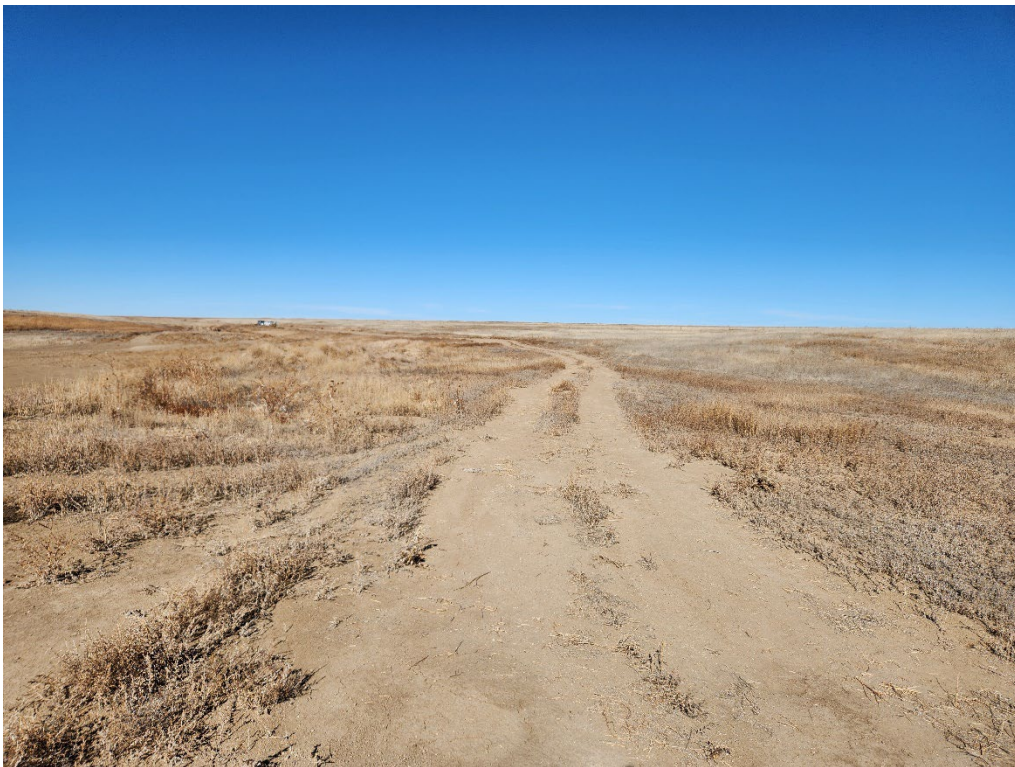
**Photo 8.** The access road into site looking north.
