Inspection Report for Bollish Pit M-2007-013

MINERALS PROGRAM INSPECTION REPORT
PHONE: (303) 866-3567

MINE NAME: Bollish Pit #2	MINE/PROSPECTING ID#: M-2007-013	MINERAL: Sand, gravel and borrow material	COUNTY: Logan
INSPECTION TYPE: Surety Release Inspection	WEATHER: Clear	INSP. DATE: February 13, 2024	INSP. TIME: 10:00
OPERATOR: McAtee Construction Company	OPERATOR REPRESENTATIVE: Jeff Harms	TYPE OF OPERATION: 112c - Construction Regular Operation	
REASON FOR INSPECTION: Full/Final Surety Release Requested SL1	BOND CALCULATION TYPE: None	BOND AMOUNT: \$34,450.00	
DATE OF COMPLAINT: NA	POST INSP. CONTACTS: None	JOINT INSP. AGENCY: None	
INSPECTOR(S): Nikie Gagnon	INSPECTOR'S SIGNATURE:

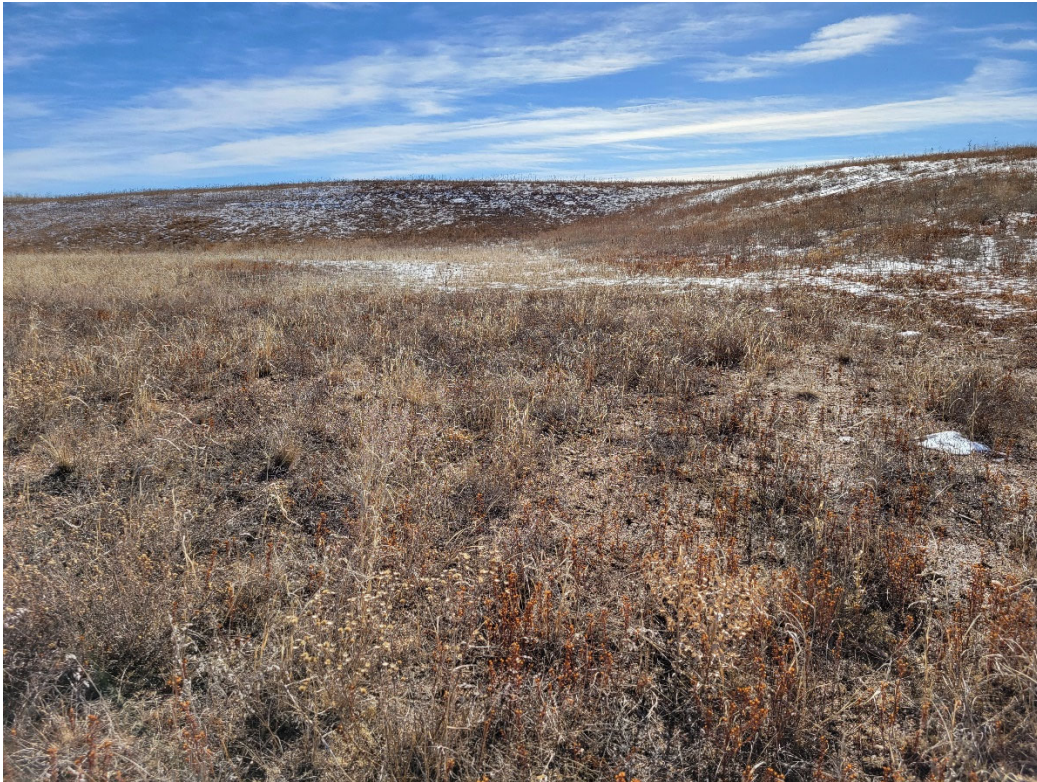
The mined area is a crescent shaped pit, approximately 15 acres in size. The permit was originally a 111 permit which was converted to a 112c in 2007. According to the operator the material was mined and trucked to a processing plant and the aggregate was used in the construction industry. The pit is graded flat, and the slopes are graded to 3H:1V or shallower. The reclamation plan calls for placing 6 inches of salvaged topsoil over the entire mined area for revegetation. According to the Operator, no additional topsoil was imported for reclamation. The disturbance area was drill seeded in the fall of 2021. Native grasses were observed established across the entire pit floor and on the slopes. The soil on site is a quick draining gravelly loam. Based on observations of the density of vegetation on the adjacent agricultural land, the density of vegetation in the former pit is consistent with an arid environment and capable of self-regeneration. The Division noted western wheatgrass, switchgrass, and little bluestem in the pit area.

Photo 1: Looking southeast across the reclaimed pit. Slopes are graded and vegetated.

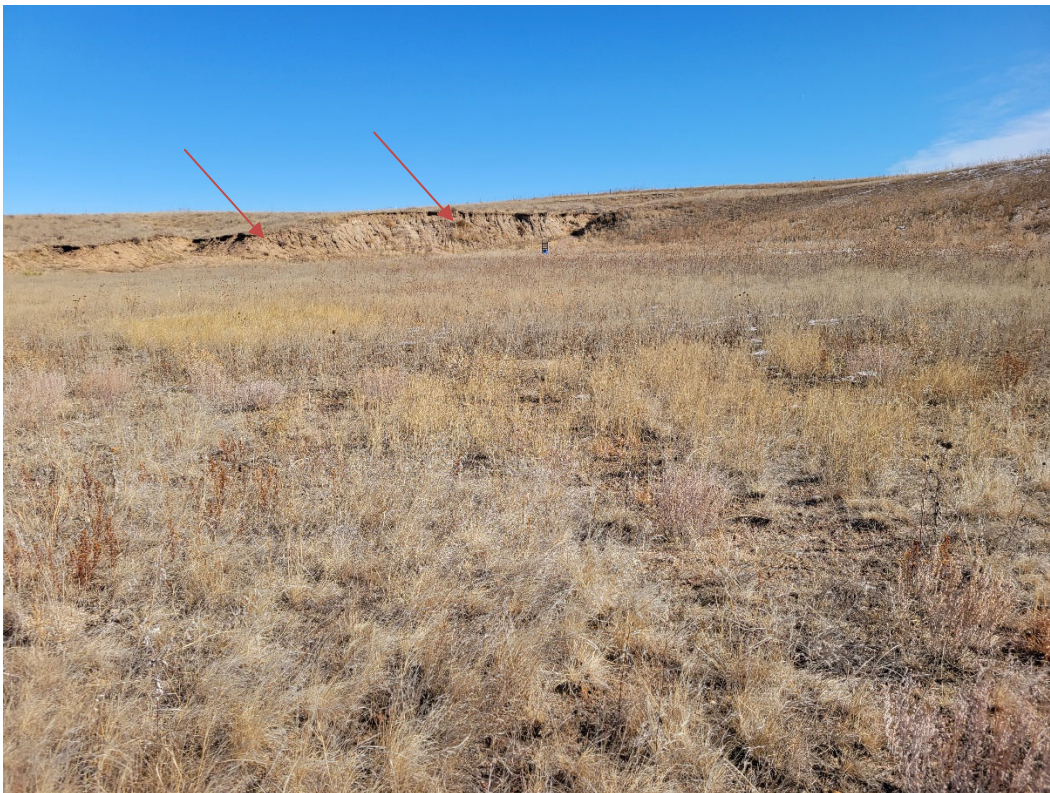
During this inspection, the Division observed a small borrow area in the northeast corner of the reclaimed pit. This borrow area was approved in Technical Revision 2 for use by the landowner. The Division also observed a small storage area, approximately 10'x10', near the entrance to the pit. The Operator indicated the landowner was storing borrow material here to use on the property.

Photo 2: Looking northeast across the pit. Arrow indicates the borrow pit for use by the landowner approved in Technical Revision 2 in 2018.

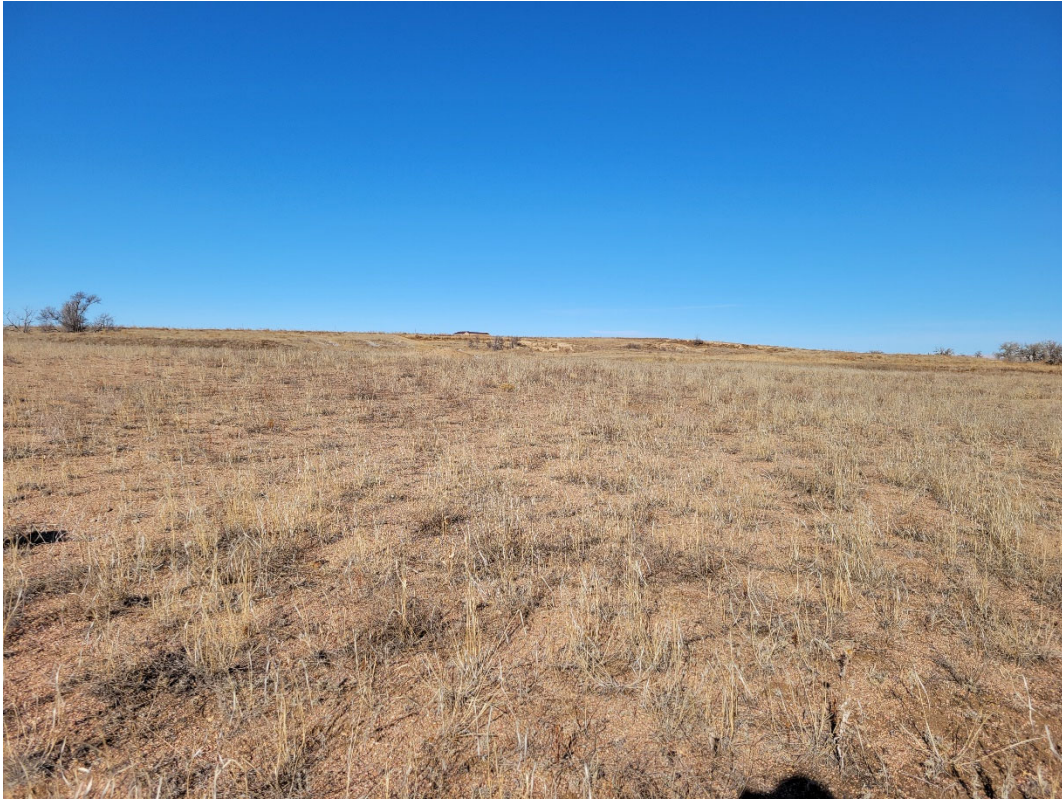
Photo 3: Looking west towards the entrance to the pit.

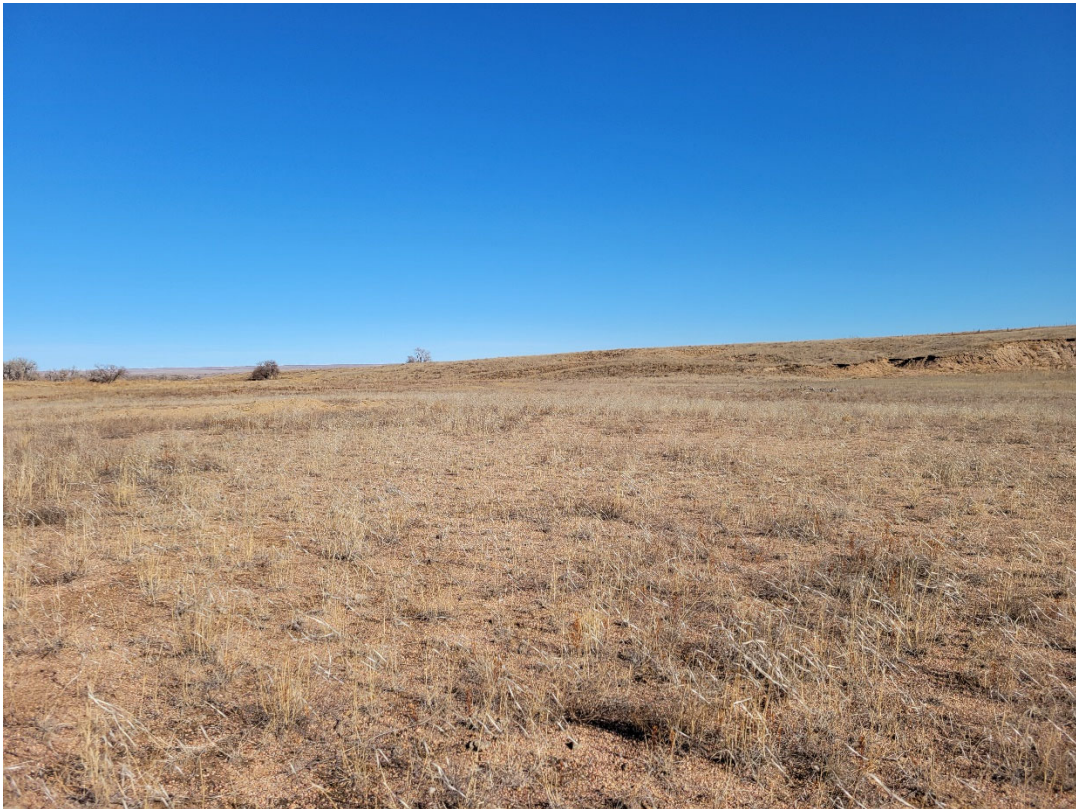
Photo 4: Looking north across the revegetated pit area.

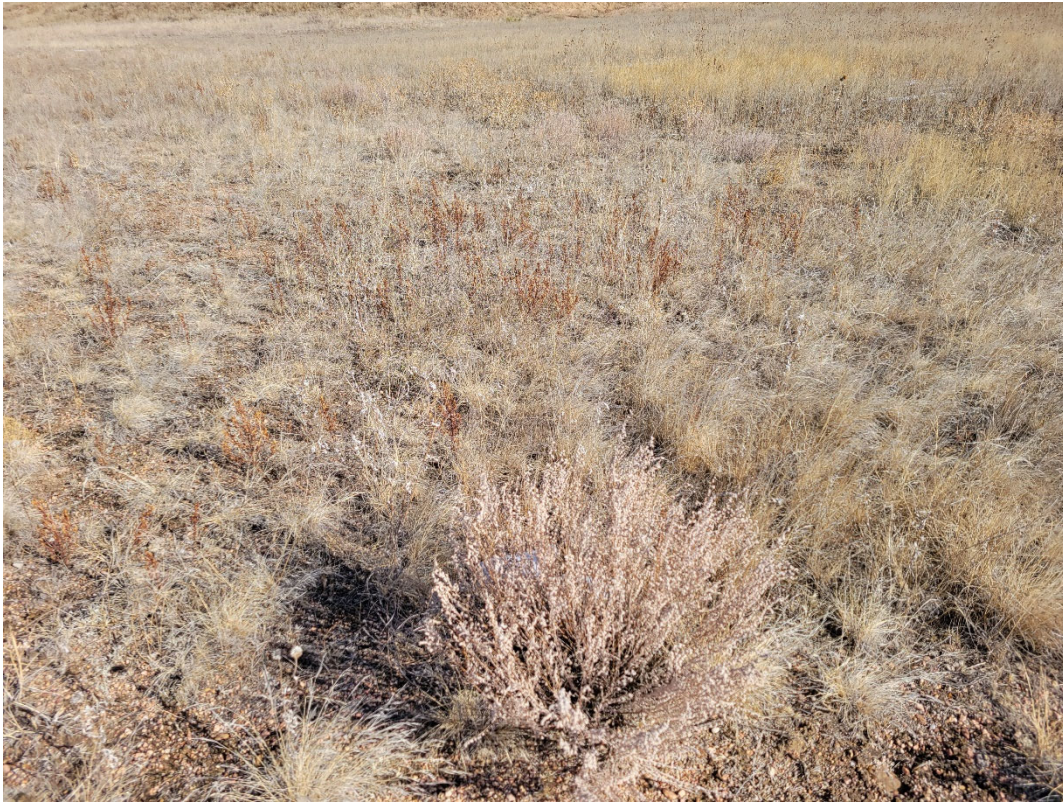
Photo 5: Close-up view of the vegetation on the pit floor.

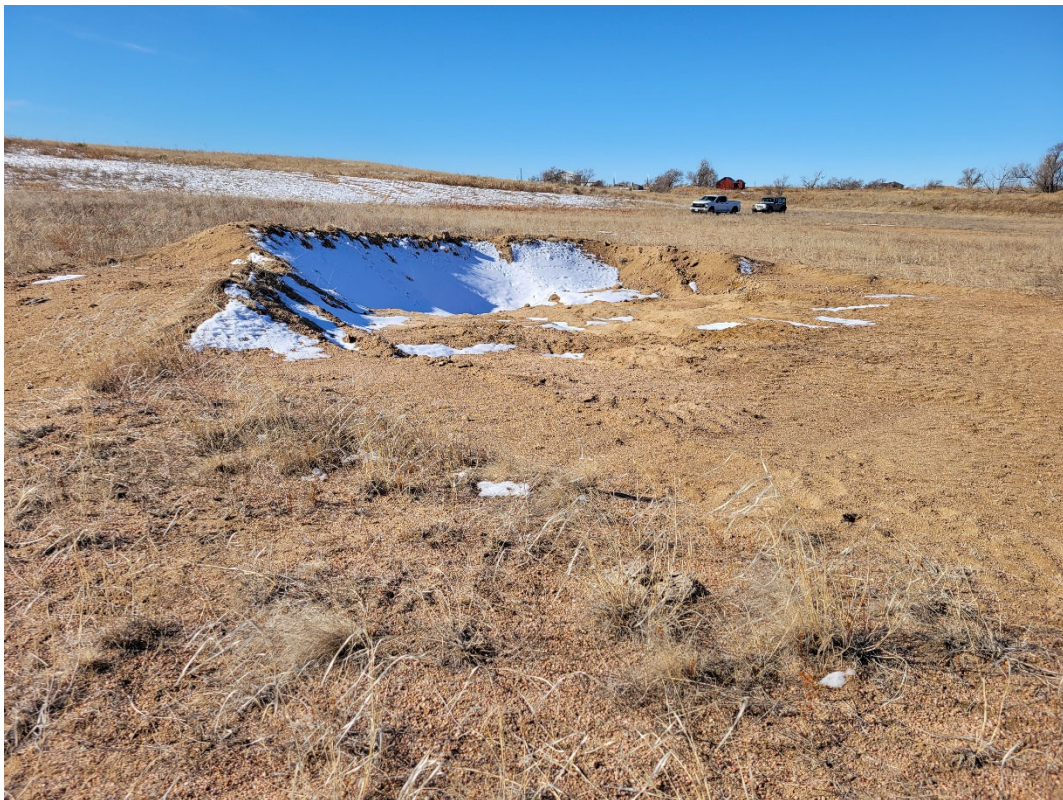
Photo 6: Recent earthwork/tracks observed near the entrance during this inspection. The Operator indicated the landowner was storing material from the approved borrow area here for easy access.

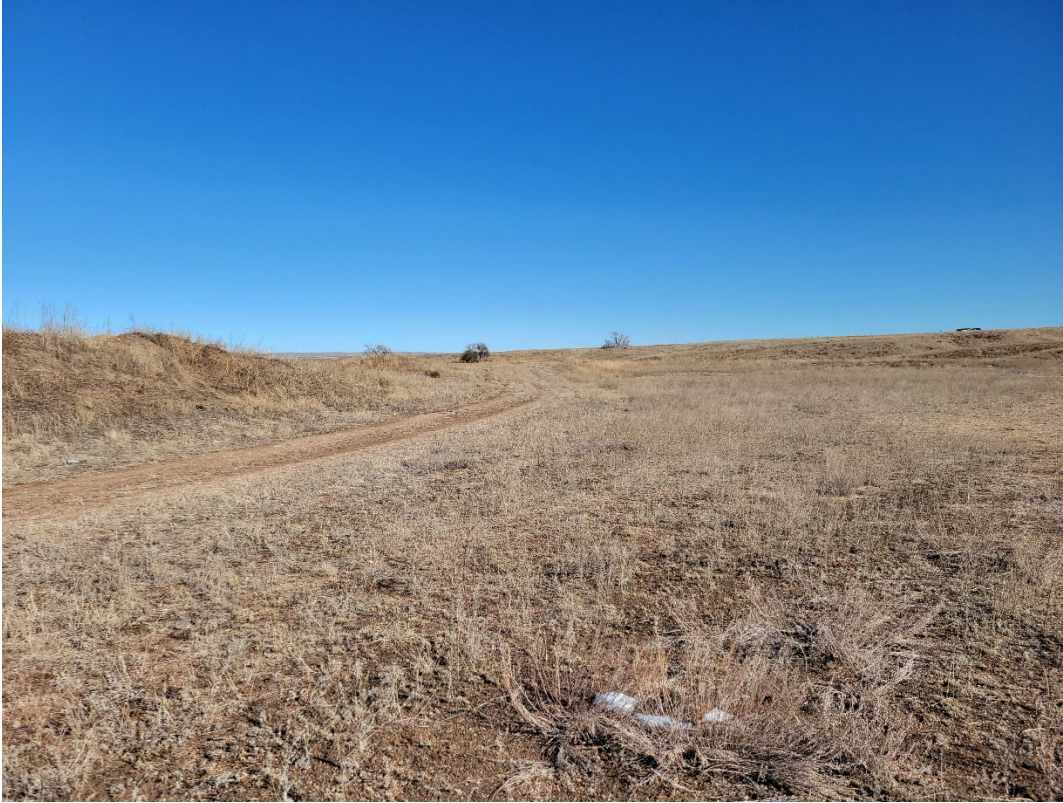
A dirt access road runs along the western boundary of the disturbance area. This road is approved to remain after reclamation.

Photo 7: Access road approved to remain after reclamation on the west side of the disturbance area.
