## March 2024 Trapper Mine Inspection Report

**6 March 2024**

Permit Number: C1981010 Mine Name: Trapper Mine Operator: Trapper Mining, Inc. Operator Address:  Mr. Graham Roberts P.O. Box 187 Craig, CO 81626	County: Moffat Operation Type: Surface Permit Status: Active Ownership: Federal
	Operator Representative Present: Graham Roberts
This report was issued electronically from the Divisions' Denver Office.

Inspection Start Date: <b>6 March 2024</b> Inspection Start Time: 8:45 a.m. Inspection End Date: <b>6 March 2024</b> Inspection End Time: 3:30 p.m.	Inspection Type: <b>Coal Partial Inspection</b> Inspection Reason: Normal I&E Program Weather: Partly Cloudy
Joint Inspection Agency:	Joint Inspection Contacts:
Post Inspection Agency: None	Post Inspection Contacts:
Inspector(s): Robin A. Reilley, M.S. GISP	Inspector's Signature:   Signature Date: <b>7 March 2024</b>

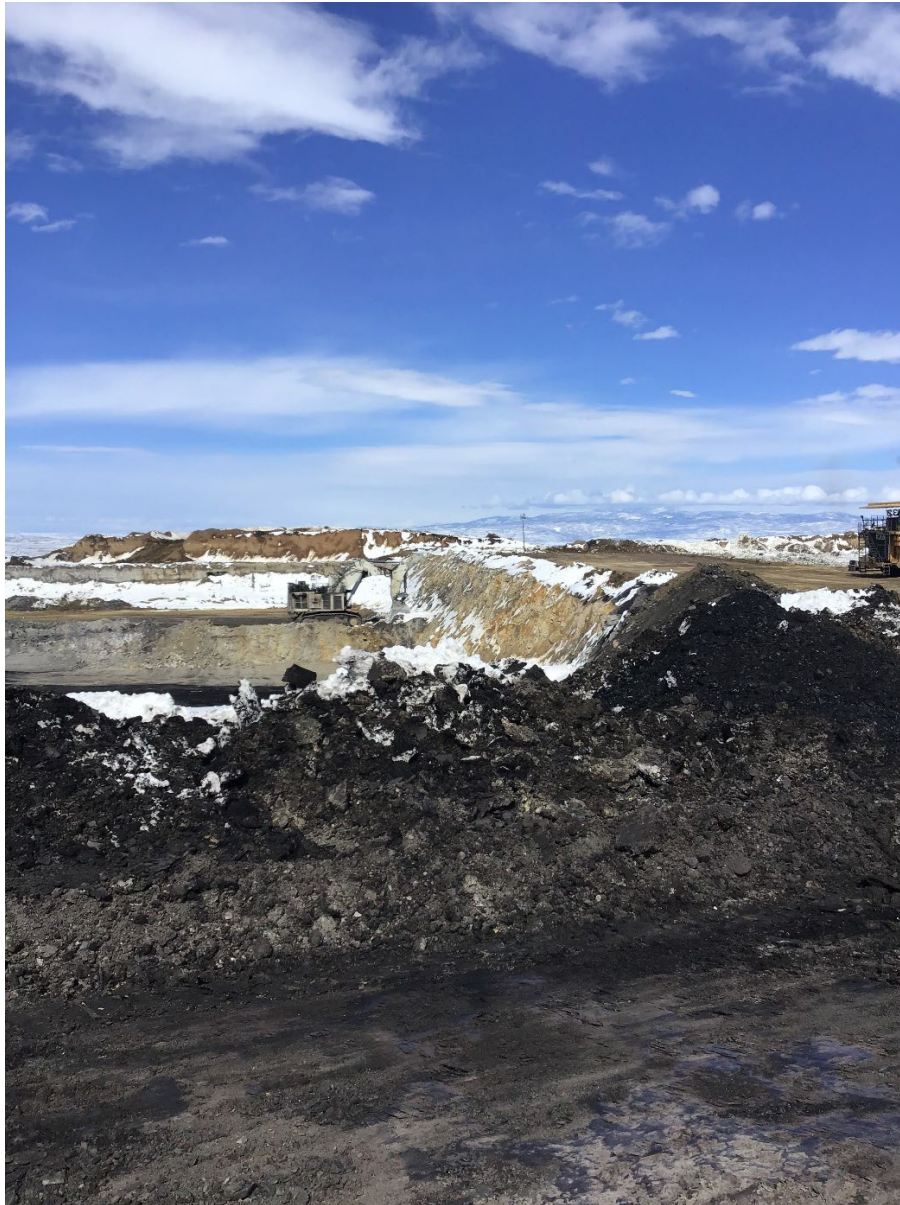
*Photo 1: Activities in L Pit, looking north.*

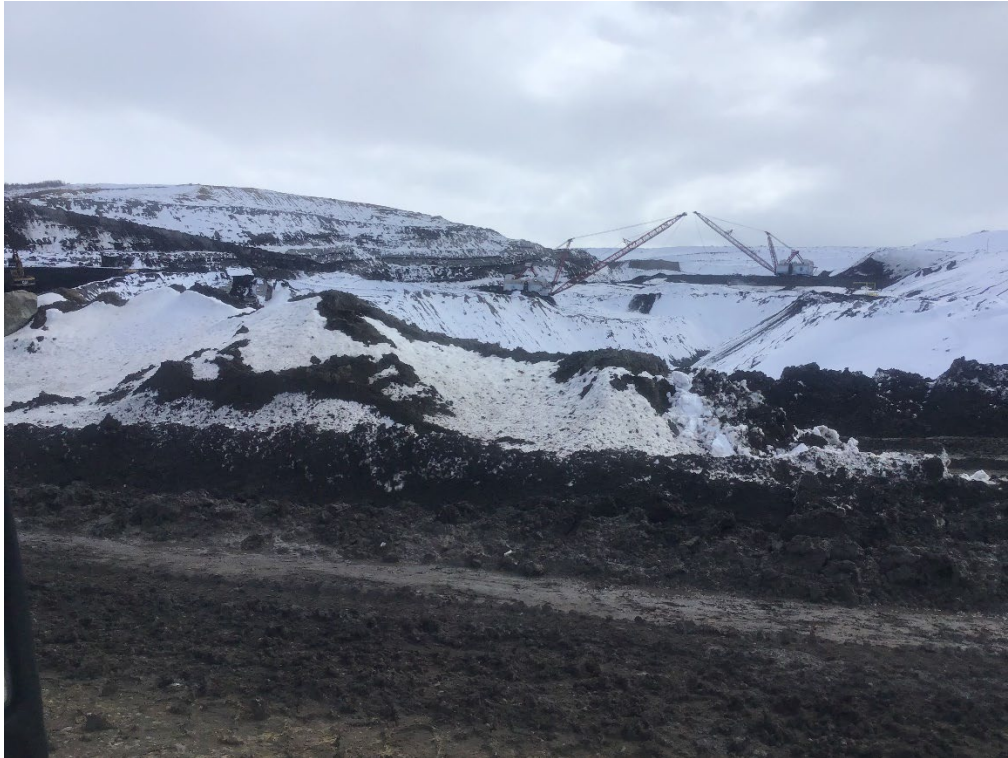
The inspection began in L Pit, where neither the Molly Braun, nor the Baby Doe drag lines were working. Overburden was being moved in preparation for a blast. Coal was being loaded and hauled. A blast was being set up at east end of the N Pit to remove overburden. No other activities were occurring in the pit at the time of inspection. The Queen Ann dragline was working at the east end of the J Pit.

*Photo 2: Drag lines stationed in the L pit, looking south.*

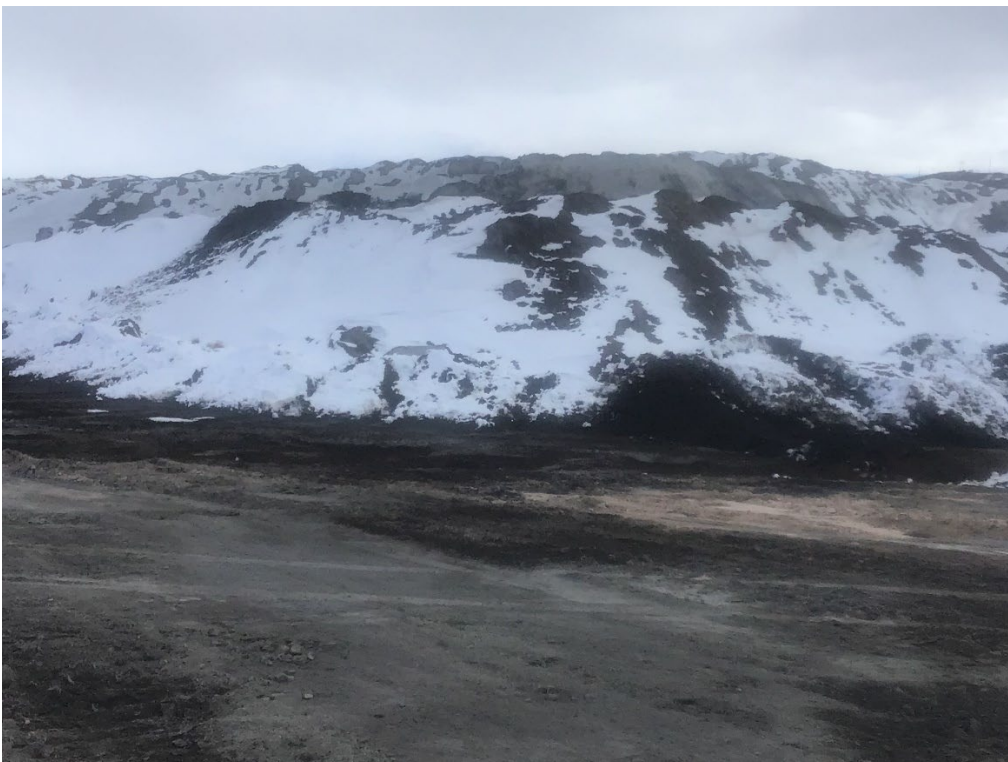
*Photo 3: N Pit looking east.*
