Additional Information Required, 4Q2023 GW/SW Monitoring Report, Cresson Project, M1980-244

Photographic Log - GV06 031124.pdf

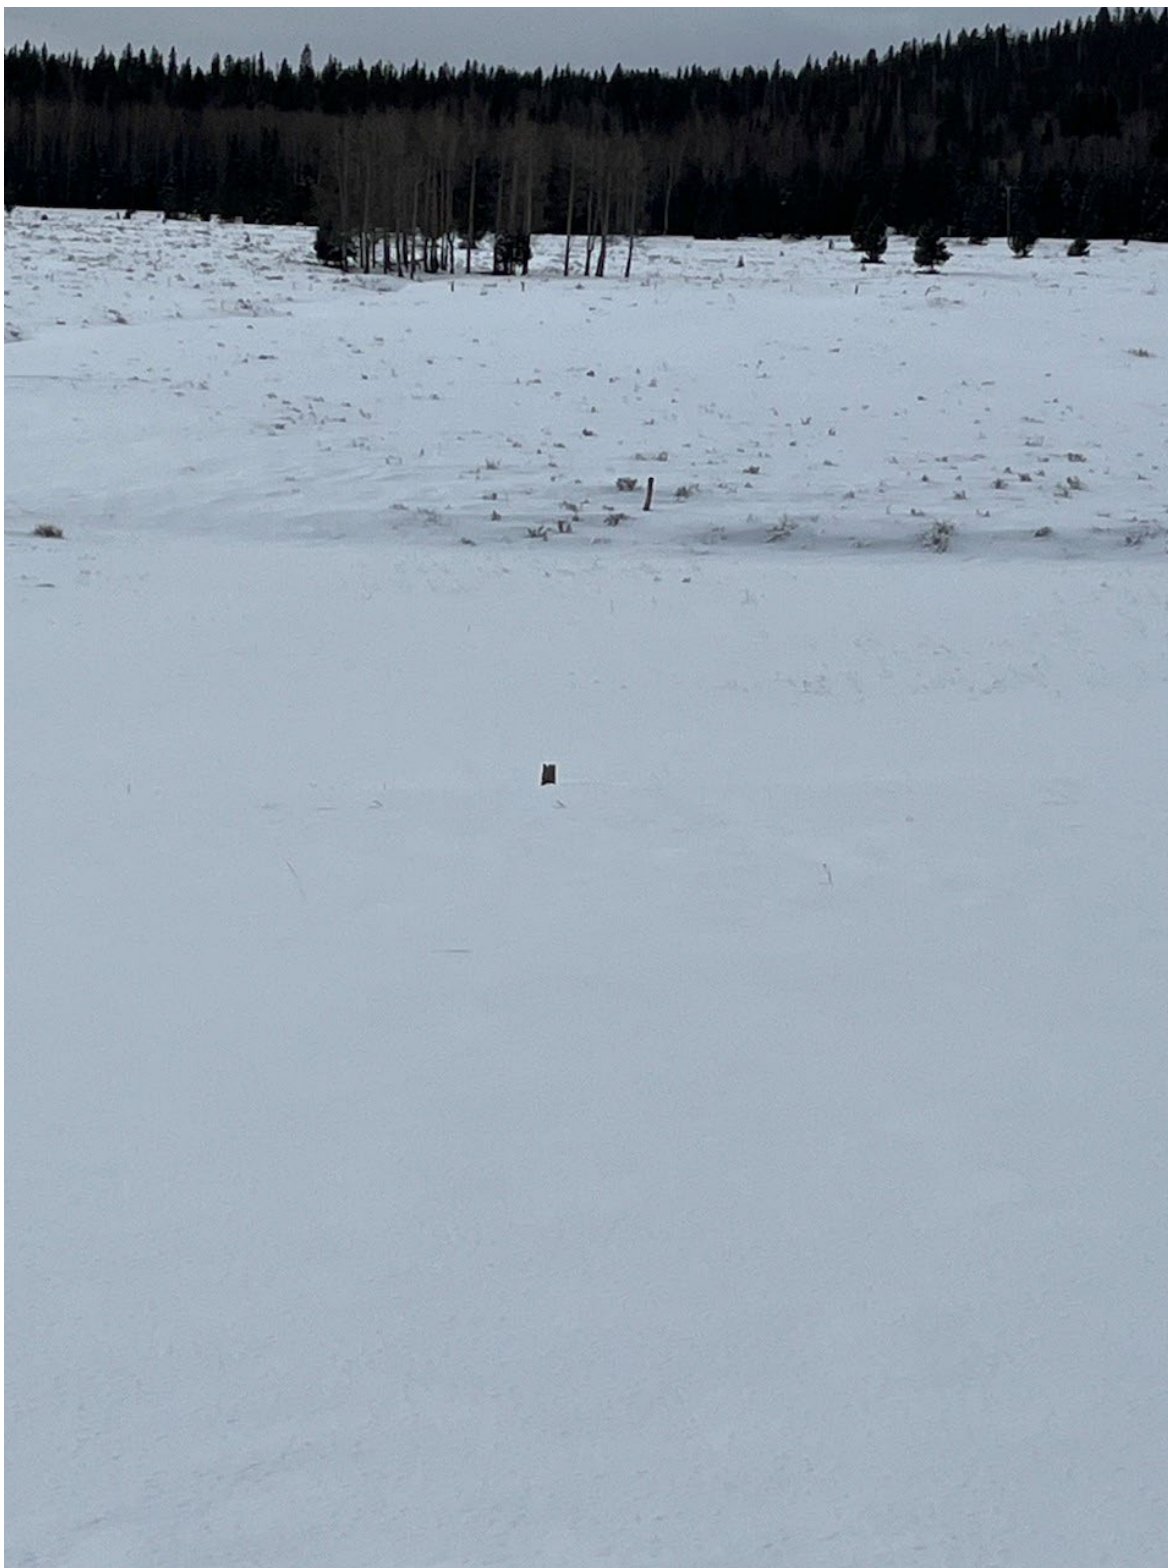
Photograph 1: View of the GV-06 surface water monitoring location, looking south. Photo taken 3/11/2024 at approximately 09:30 MDT.

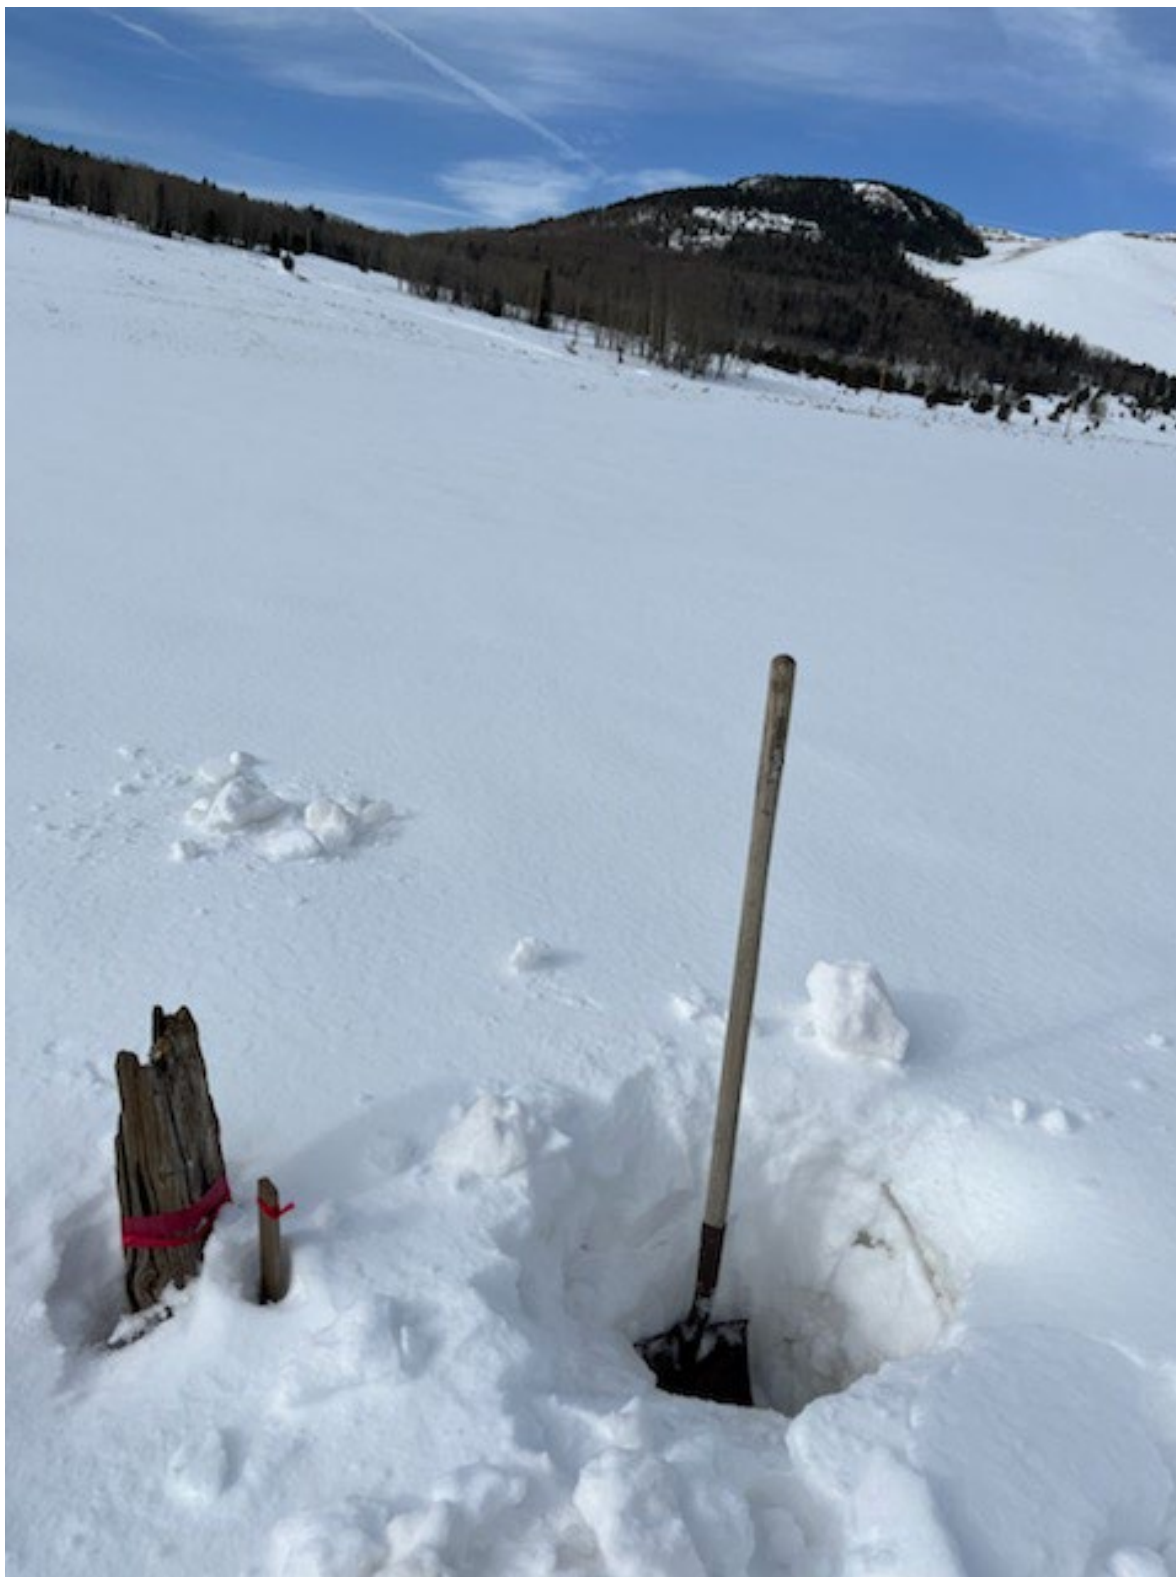
Photograph 2: View of the GV-06 surface water monitoring location, looking southeast. Photo taken 3/11/2024 at approximately 09:30 MDT.

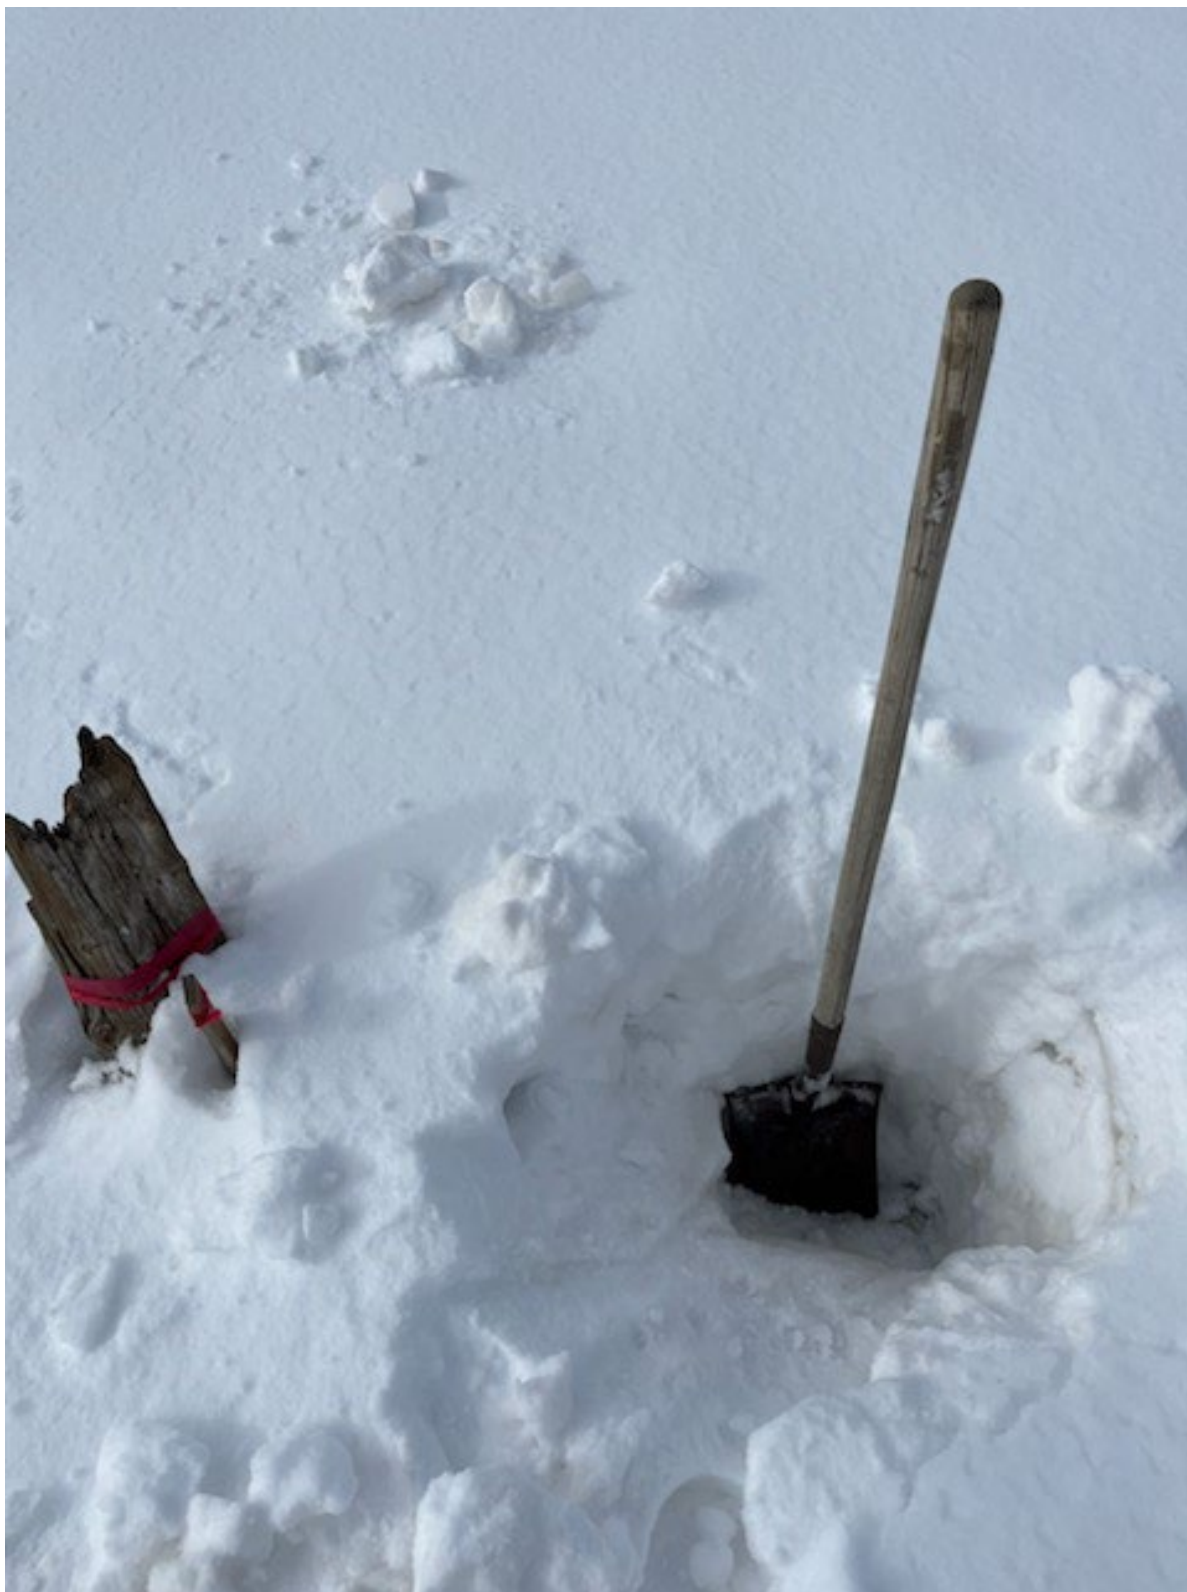
Photograph 3: View of the GV-06 surface water monitoring location after snow and ice was removed. No flowing water was observed at the location. Photo taken 3/11/2024 at approximately 09:30 MDT.

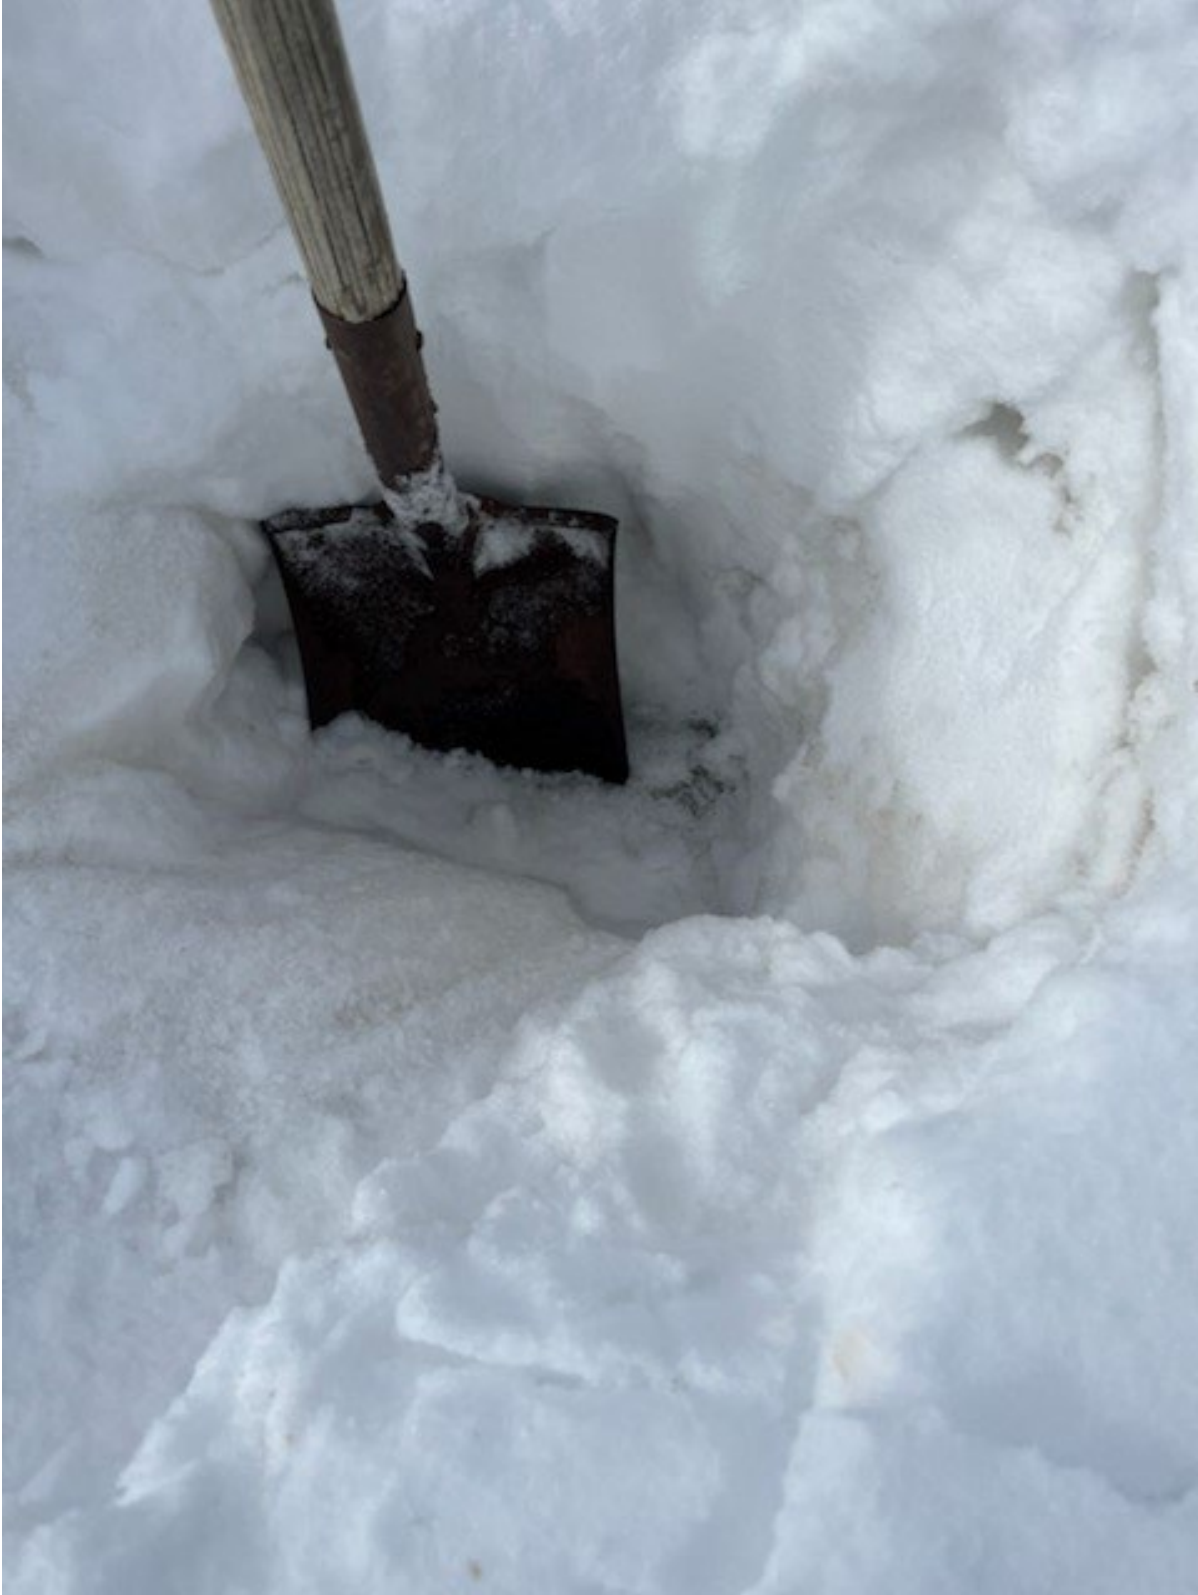
Photograph 4: View of the GV-06 surface water monitoring location after snow and ice was removed. No flowing water was observed at the location. Photo taken 3/11/2024 at approximately 09:30 MDT.
