MINERALS PROGRAM INSPECTION REPORT
PHONE: (303) 866-3567

MINE NAME: Sand Creek Mine	MINE/PROSPECTING ID#: M-1992-038	MINERAL: Sand	COUNTY: Adams
INSPECTION TYPE: Surety-Related Inspection	WEATHER: Clear	INSP. DATE: January 23, 2024	INSP. TIME: 10:00
OPERATOR: 4K Equipment, LLC	OPERATOR REPRESENTATIVE: Calvin Kelly	TYPE OF OPERATION: 112c - Construction Regular Operation	
REASON FOR INSPECTION: Surety Related – SO2	BOND CALCULATION TYPE: Complete Bond	BOND AMOUNT: \$7,210.00	
DATE OF COMPLAINT: NA	POST INSP. CONTACTS: None	JOINT INSP. AGENCY: None	
INSPECTOR(S): Nikie Gagnon	INSPECTOR'S SIGNATURE:

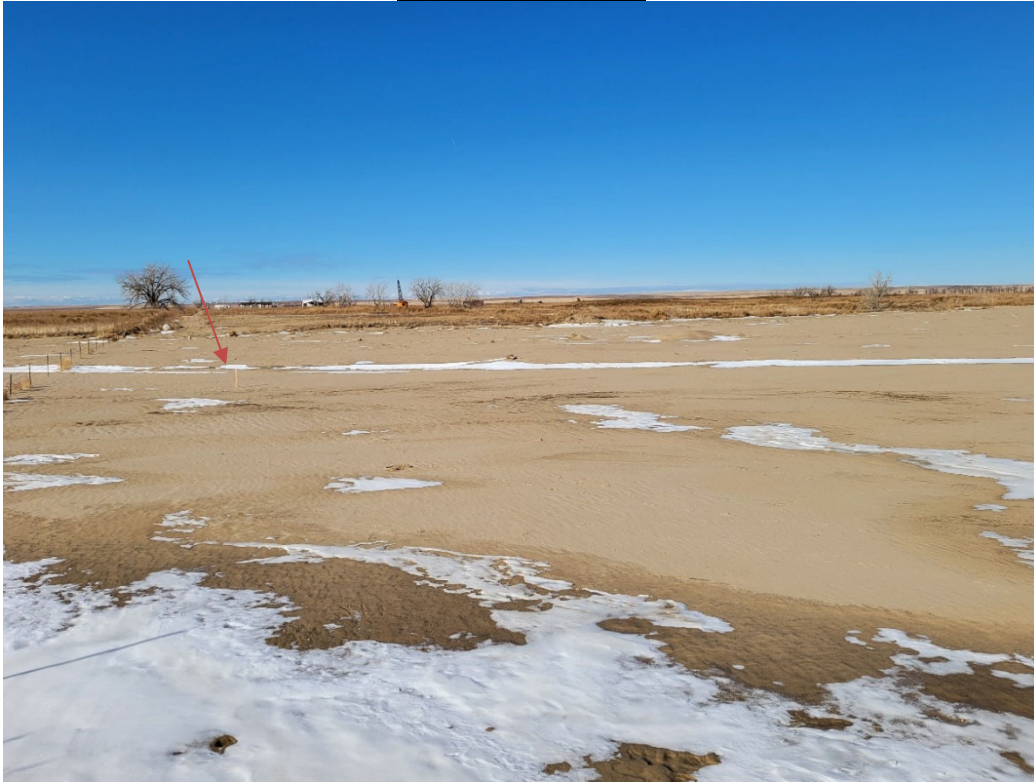
Wood stakes with flags were observed marking the permit boundary. The Division is concerned that the boundary markers will be washed away during another high spring runoff since the eastern permit boundary now runs down the center of the streambed. The Operator should be aware that per C.R.S. 34-32.5-116(4)(i), failure to protect areas outside of the affected land will be a violation of the mining permit.

Photo 1: Looking west along the southern boundary of the permit area. The southeastern corner permit boundary marker is noted by red arrow in the middle of West Bijou creek.

During the inspection, the Operator stated they do not intend to mine this site right away but will likely start up operations in the summer or fall of 2024. The Division would like the Operator to inform us when mining operations resume at this site. At that time, the Division will conduct another inspection and observe how the Operator marks the eastern boundary of the permit area to ensure the mining operation does not enter the adjacent parcel.

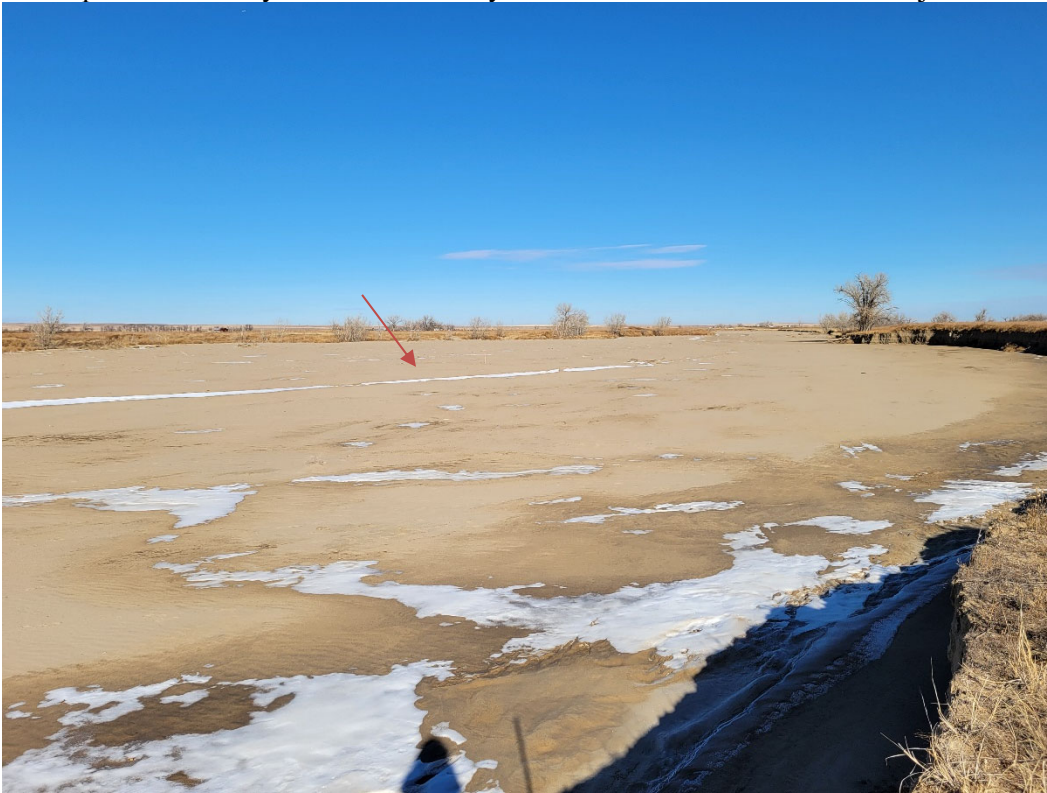
West Bijou creek is typically dry, however, this region experienced higher than average precipitation in 2023. High water levels altered the course of the river and eroded the banks within the permit area and the channel follows a wider path into the parcel east of the permit area. The eastern permit boundary now runs down the middle of the creek bed. The active mining area within the creek bed and an older pit on the west side of the creek were observed to be refilled with sand.

Photo 2: Looking north down West Bijou creek. The permit boundary is marked with posts in the center of the creek bed (red arrow). The mining area was observed to be refilled with sand.

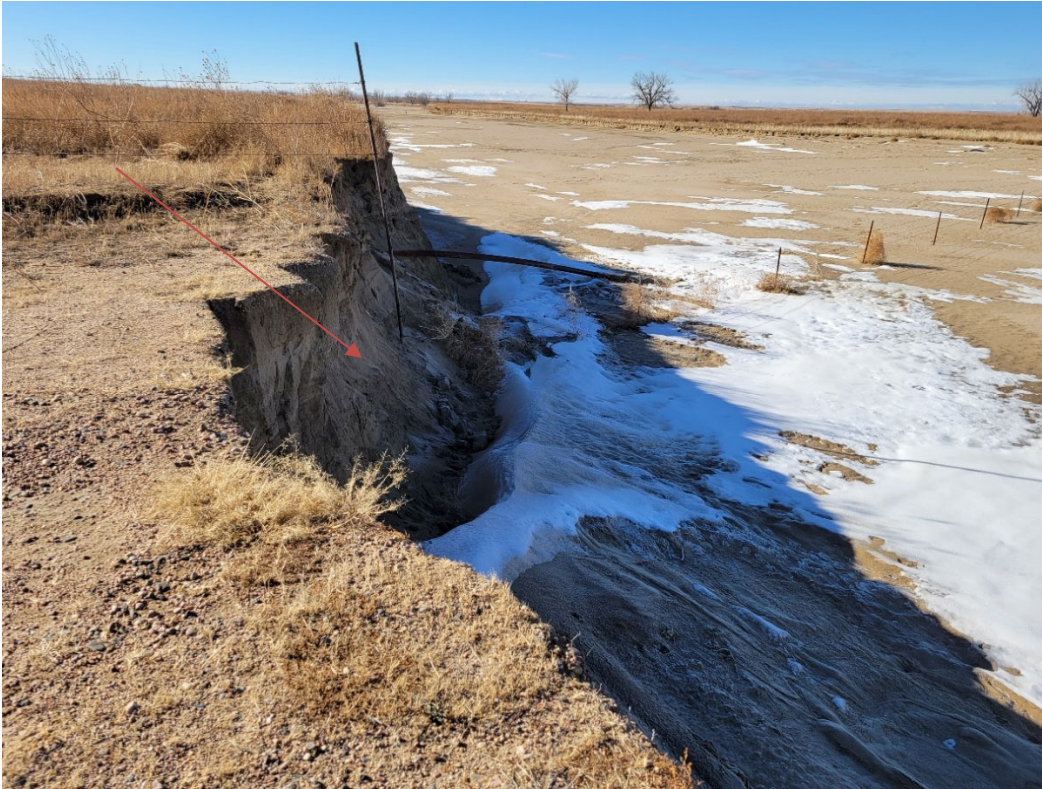
A gravel access road ran parallel the southern side of the permit area. However, the high water flows in 2023 washed out the road where it meets the river and left a 9-foot cut where the road enters the eastern side of the permit area. The access road is outside of the permit boundary, however, once mining resumes at this site, the road will need to be rebuilt across the streambed to allow access and support truck traffic.

Photo 3: Access road washed out across the creek. Access road runs parallel to the southern permit area and is outside the permit boundary. Arrow points to a 9' foot high erosion cut where the road entered the permit area.

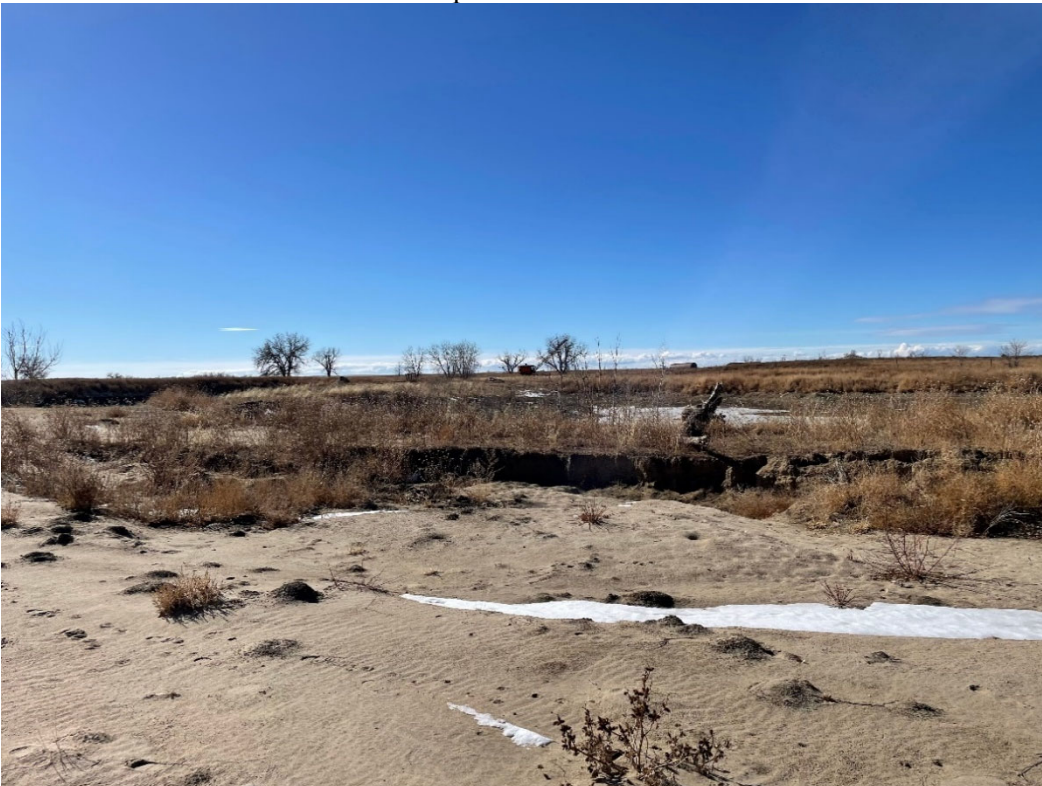
Photo 4: Area that has been refilled with sediment on the west side of the creek.

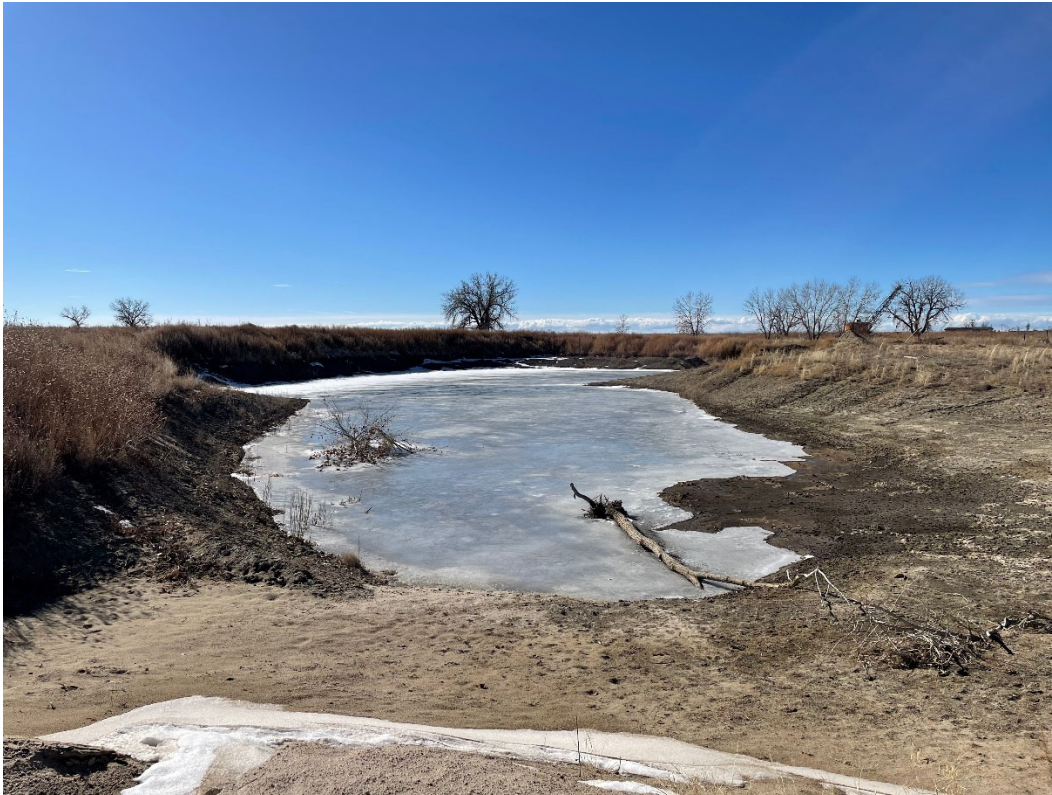
In 2019, the former operator was approved under TR1 to backfill the pit slopes on the west side using inert structural fill generated at processing facility owned by Jones Fine Sand. If the new Operator (4K Equipment) intends to import inert structural fill, a Technical Revision and inert fill application will need to be submitted to the Division prior to importing fill.

Photo 5: Looking at former pit area on the west side of the permit area. Former operator was using inert fill to backfill and grade the slopes in this pit to 4H:1V.

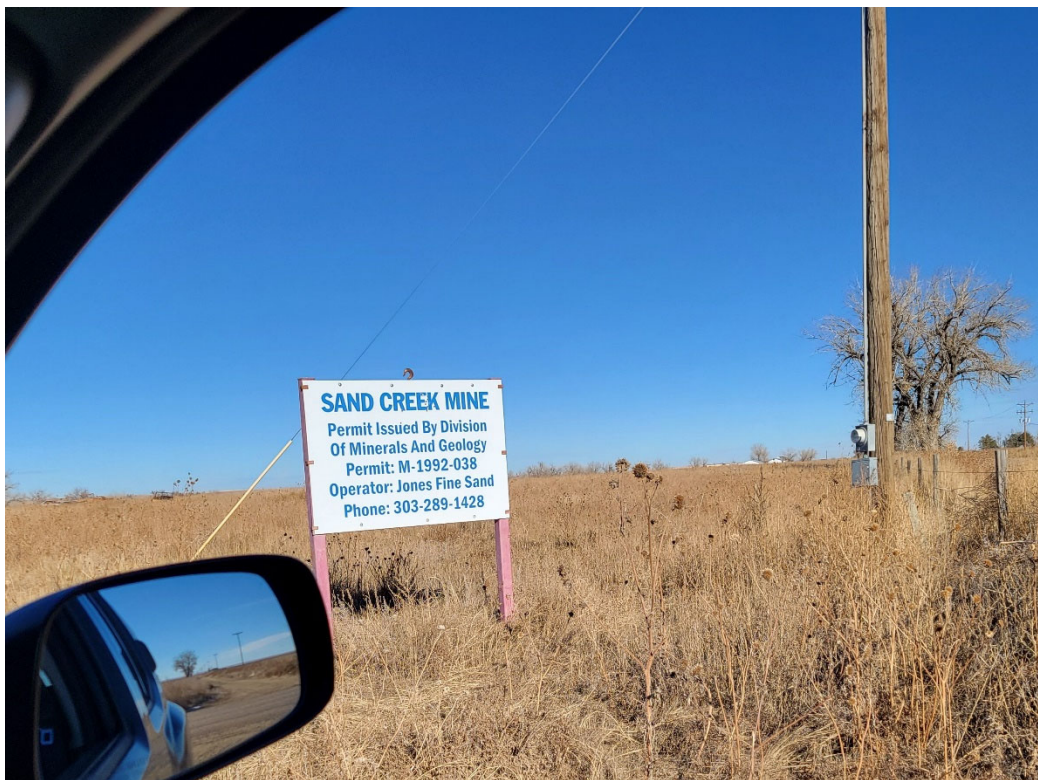
A permit identification sign was in place at the entrance to the site, however Jones Fine Sand is listed as the permittee. Per Rule 3.1.12, the Operator must post a sign that includes the following:

Photo 6: Mine sign posted at the entrance to the site shows Operator as Jones Fine Sand.

Within 30 days of this inspection report, please send the Division proof of a new sign posted at the entrance to the site with the current Operator's name. Proof can be in the form of a photo emailed to the Division.

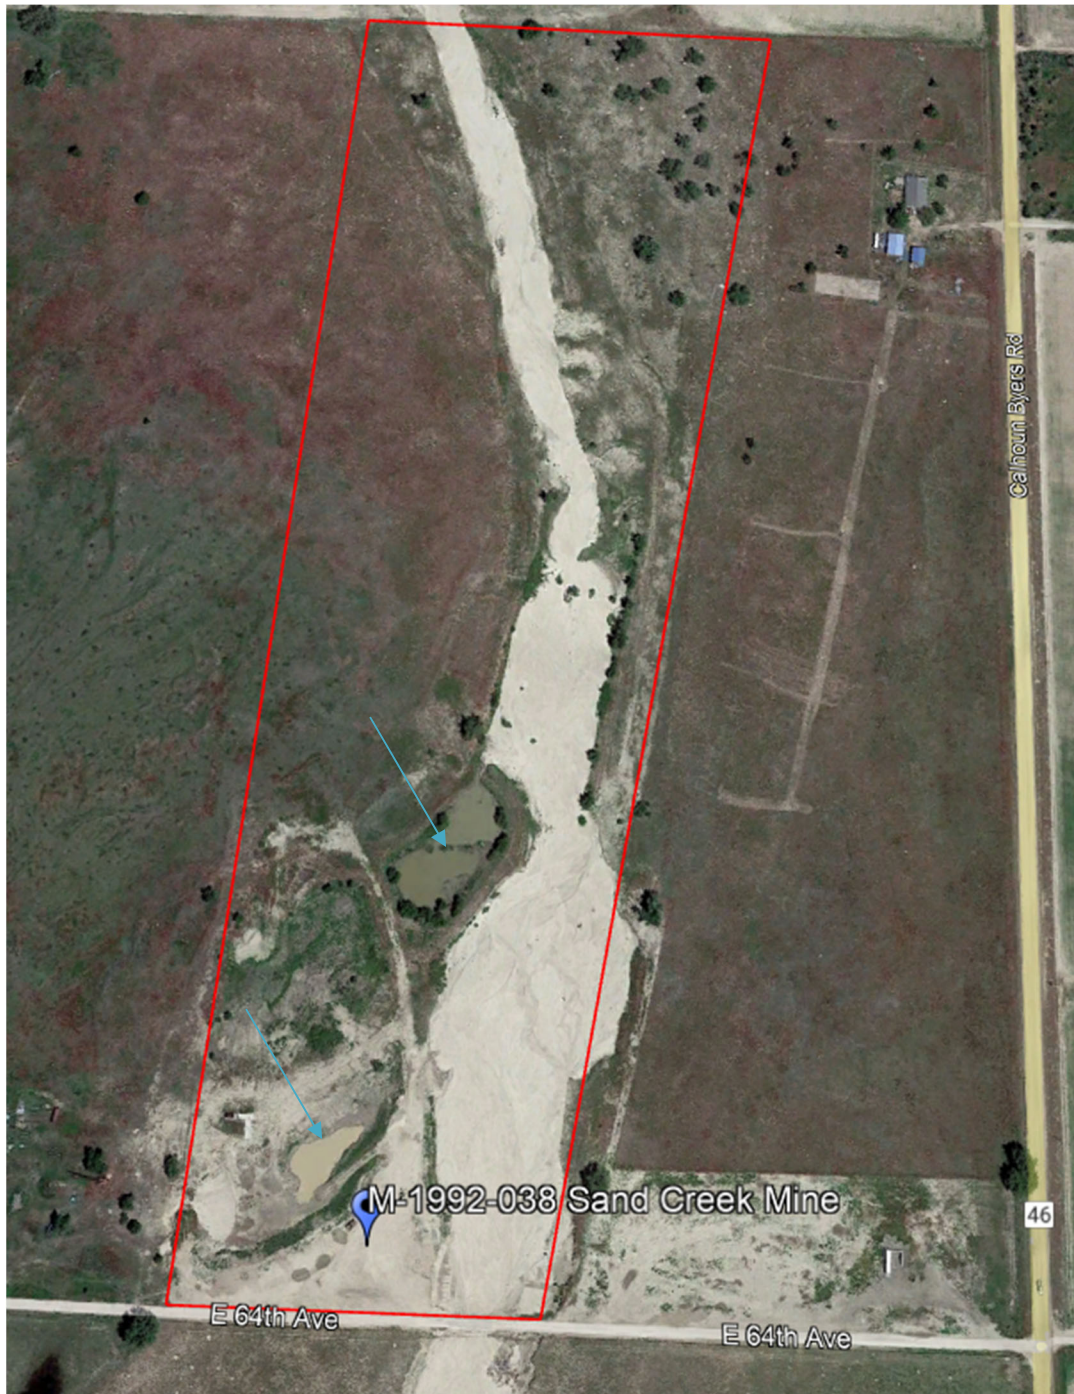
Figure 1: Google image dated 3/5/2020. Permit boundary in red and the two pits on the west side of the creek noted by blue arrows. This image does not reflect the current streambed of the river which now tracks wider into the parcel east of the permit boundary. North pit has filled with sediment. South pit will require some grading to achieve the 4H:1V slopes.
