## M1973007SG Daniels Quarterly Report

March 13, 2024  
Project No.: 19125

Regarding: Daniels Sand Pit 2, Permit No. M-1973-007-SG  
Slope Stability Monthly Monitoring Report

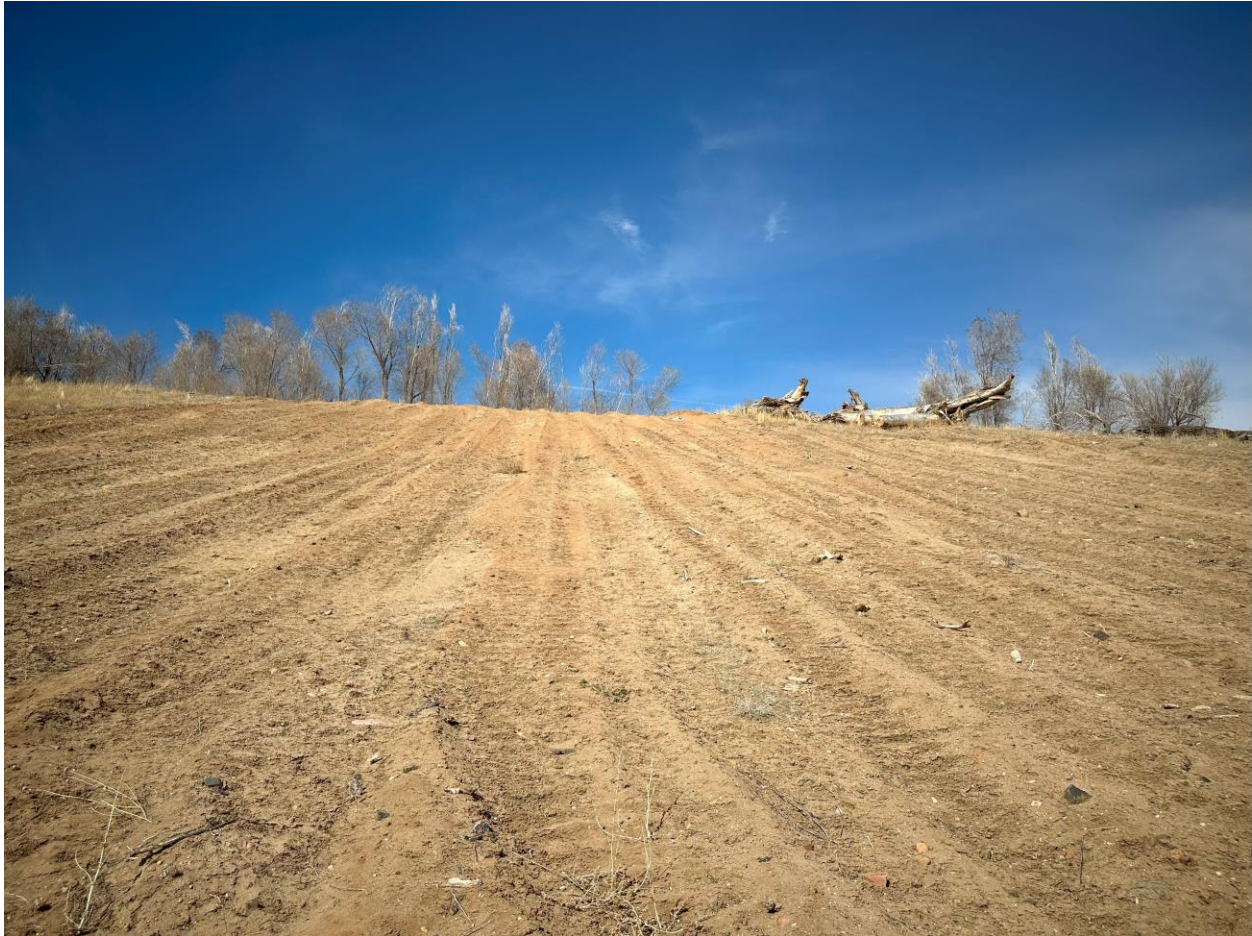
Photo 1. Recent repair

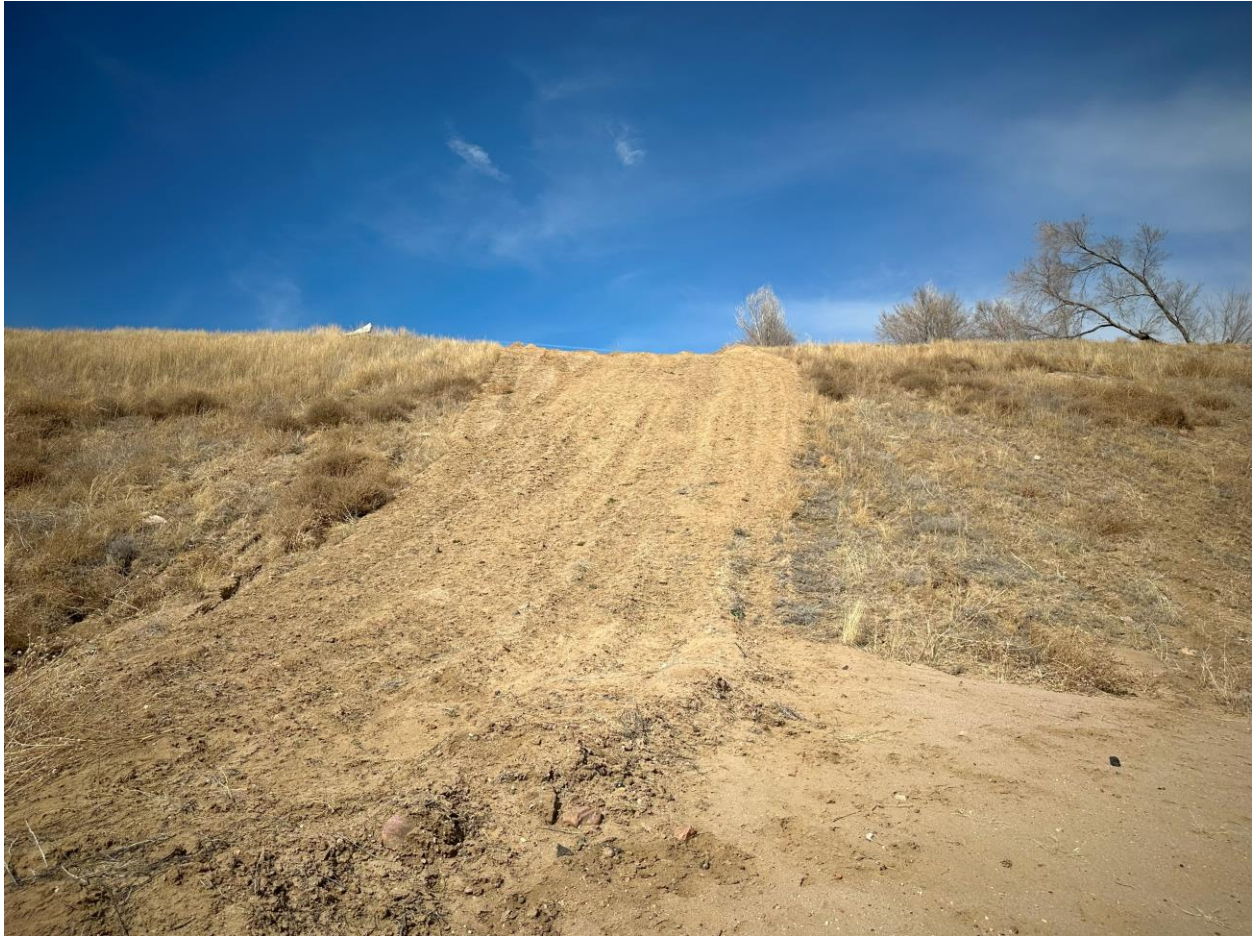
Photo 2. Recent repair

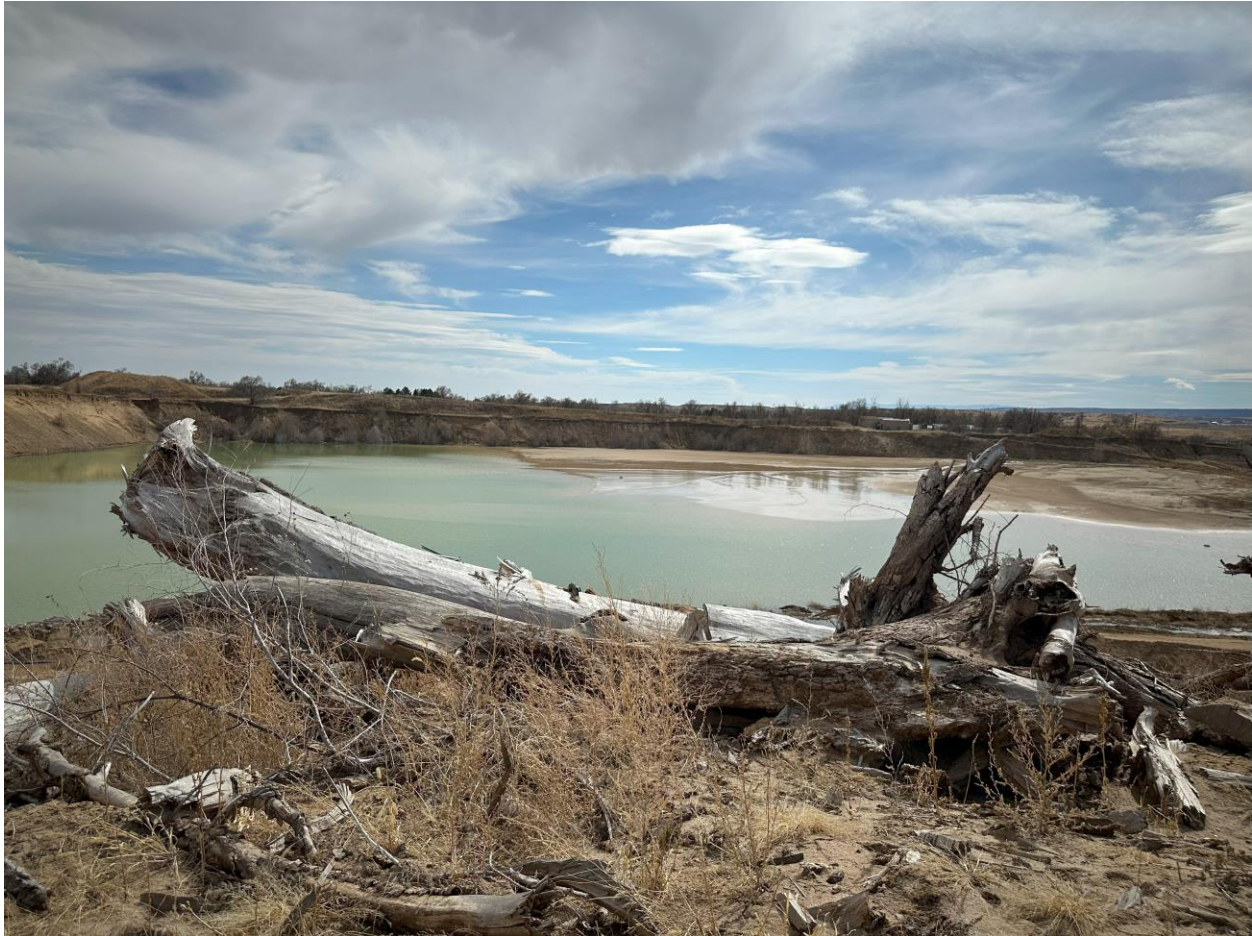
- d) Several broken trees exist on the slope/buttress crest near the ditch access road.

Photo 3. Tree south of access road and on crest of buttress slope

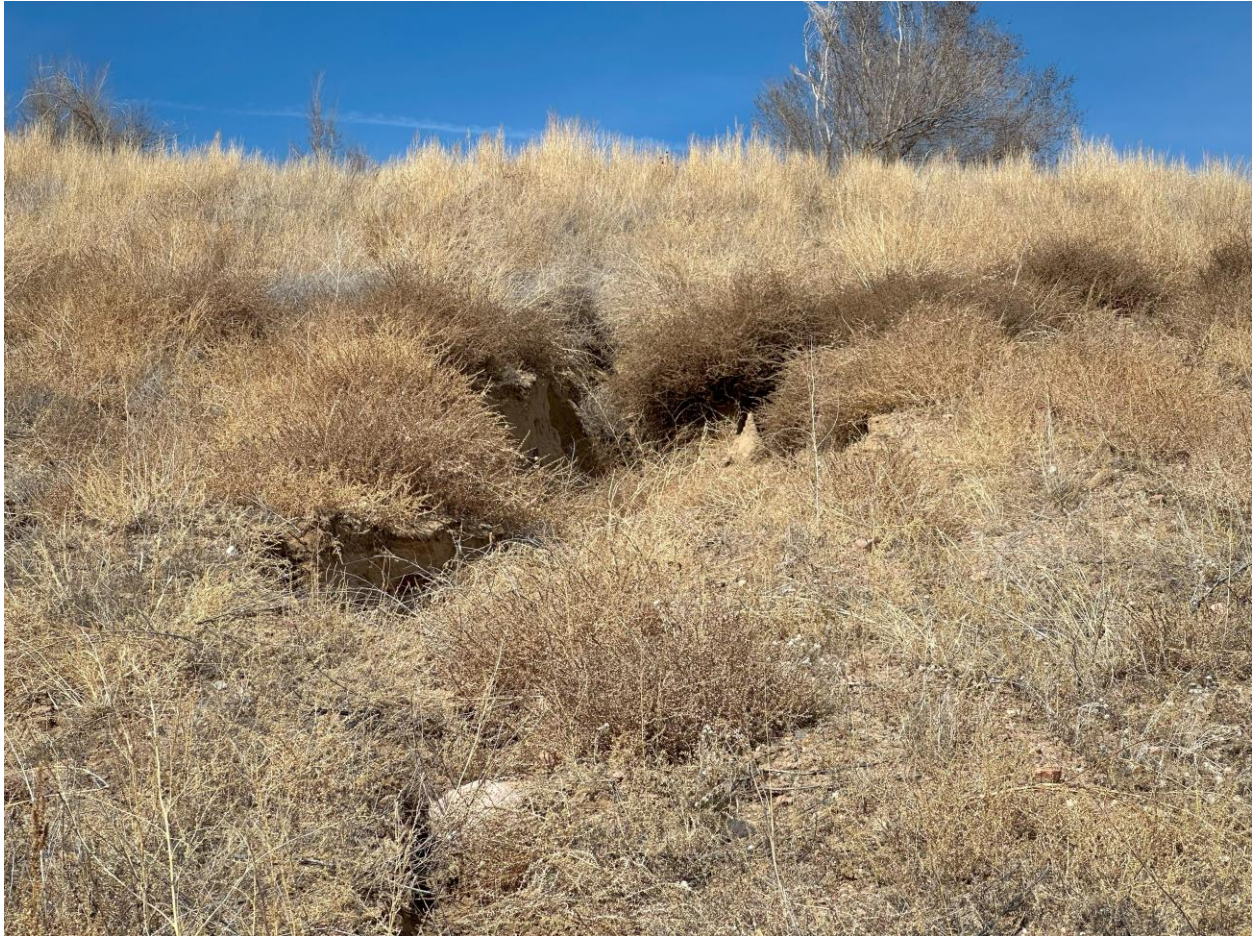
- a) The buttress slope varies from 3H:1V to 4H:1V.
  - b) Vegetation (mainly weeds) are growing in some locations on the buttress.
  - c) Several locations show visible evidence of surface water runoff and expanding erosion gullies throughout the buttress.

Photo 4. Erosion gully in eastern portion of buttress

- 1) Some erosion gullies have been repaired. However, several erosion gullies still exist within the embankment slope. We recommend those areas be reconstructed ASAP and that the areas be seeded per the reclamation plan.

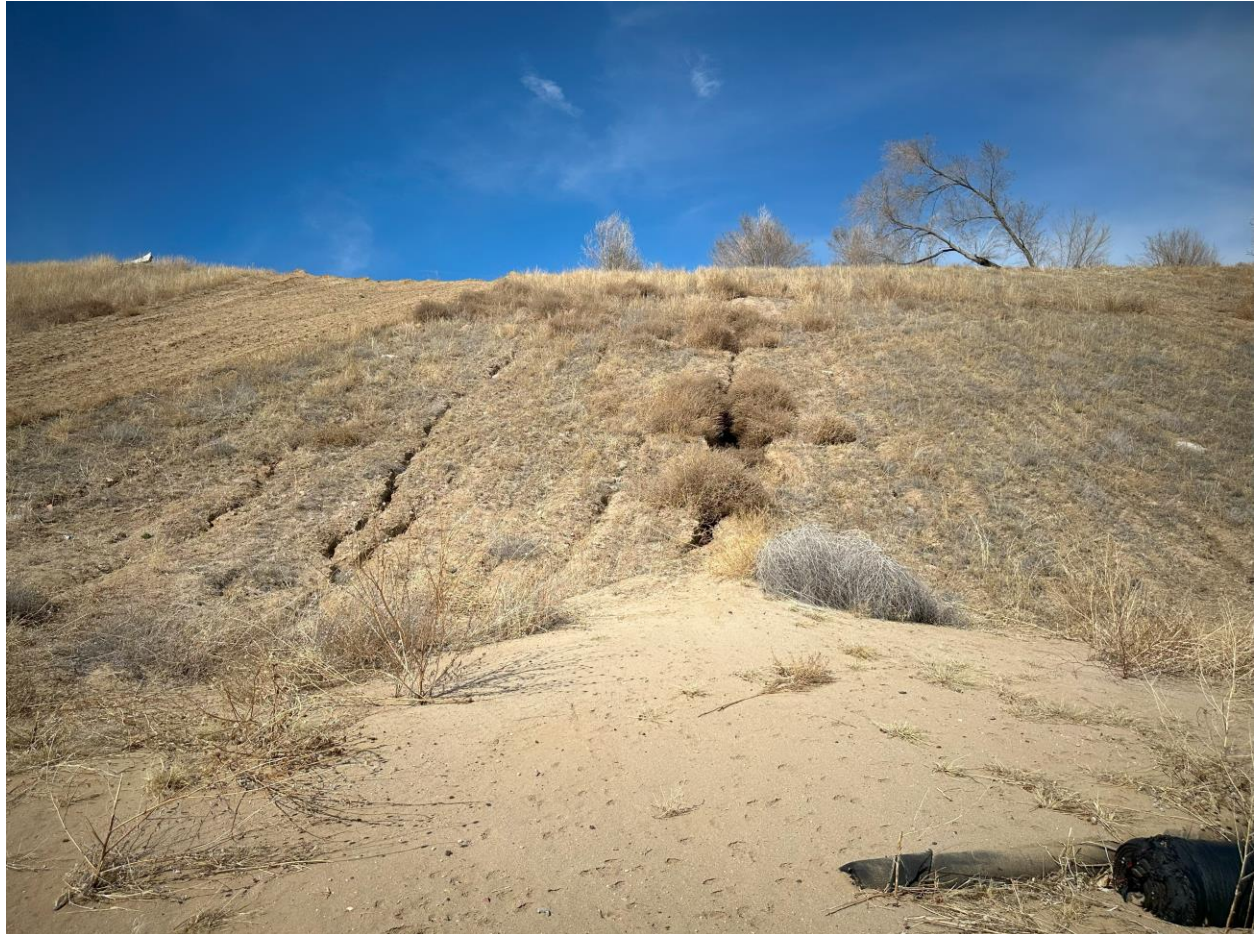
Photo 5. Erosion gullies in central area of buttress, note sand at toe of slope

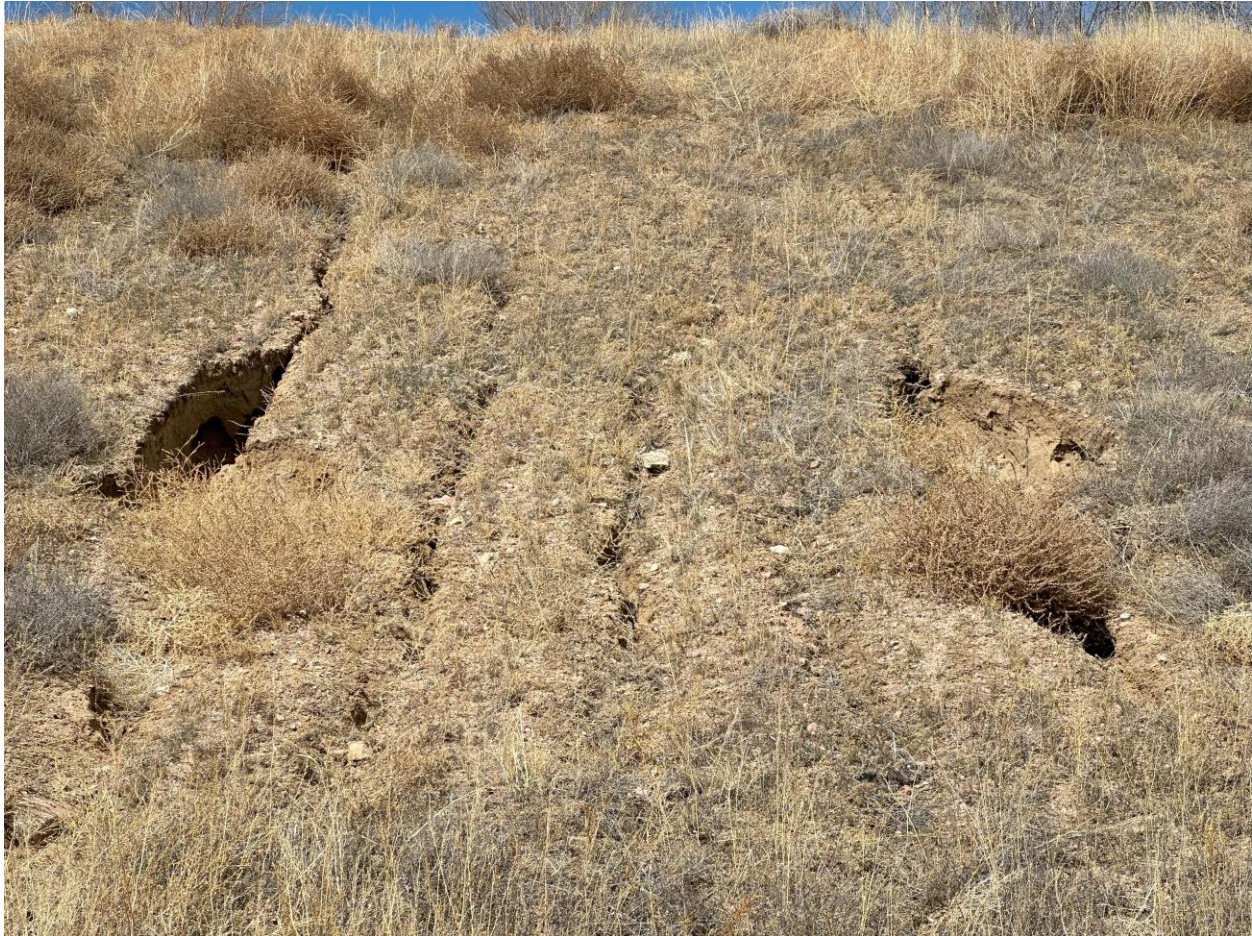
Photo 6. Erosion gullies in central area of buttress

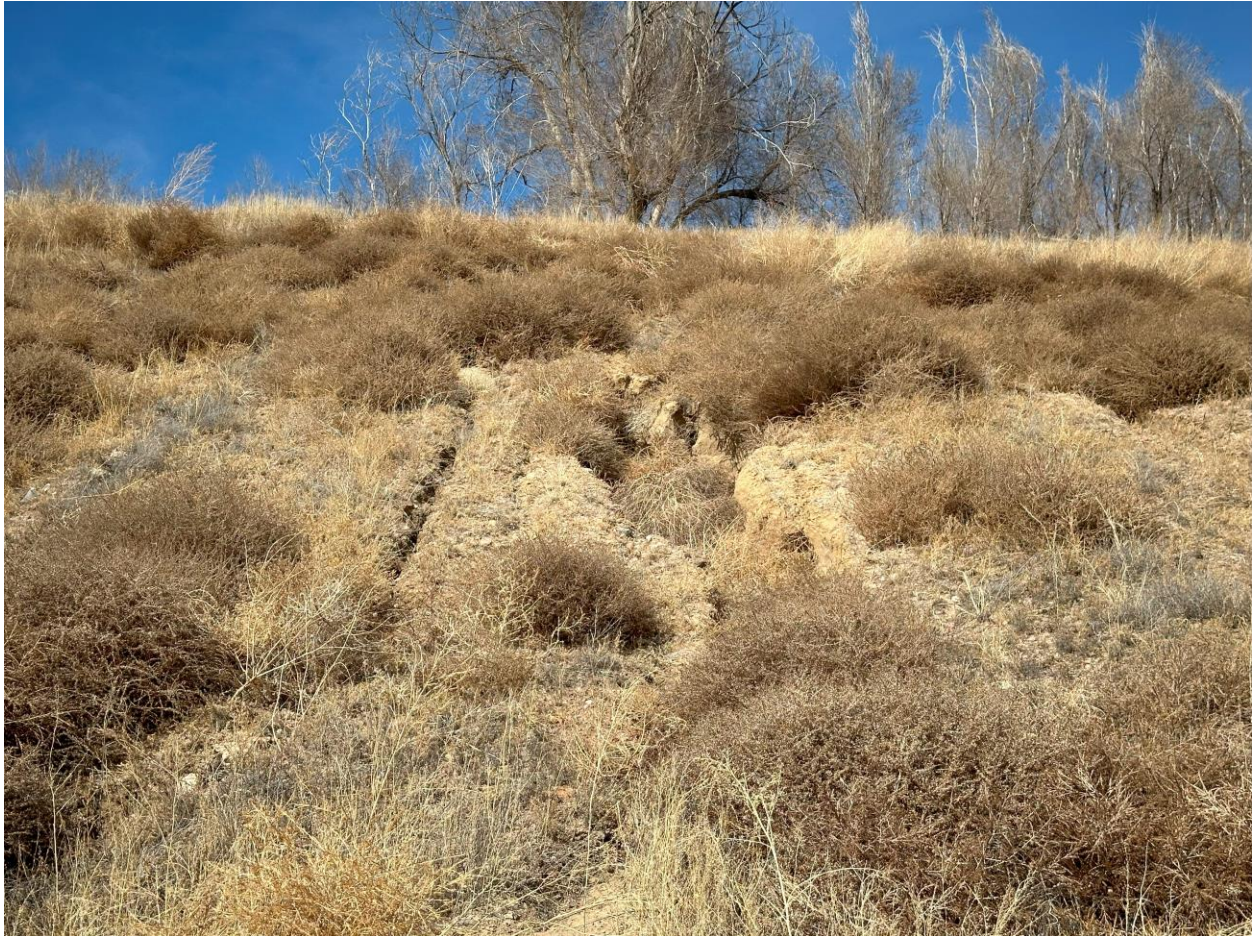
Photo 7. Erosion gullies

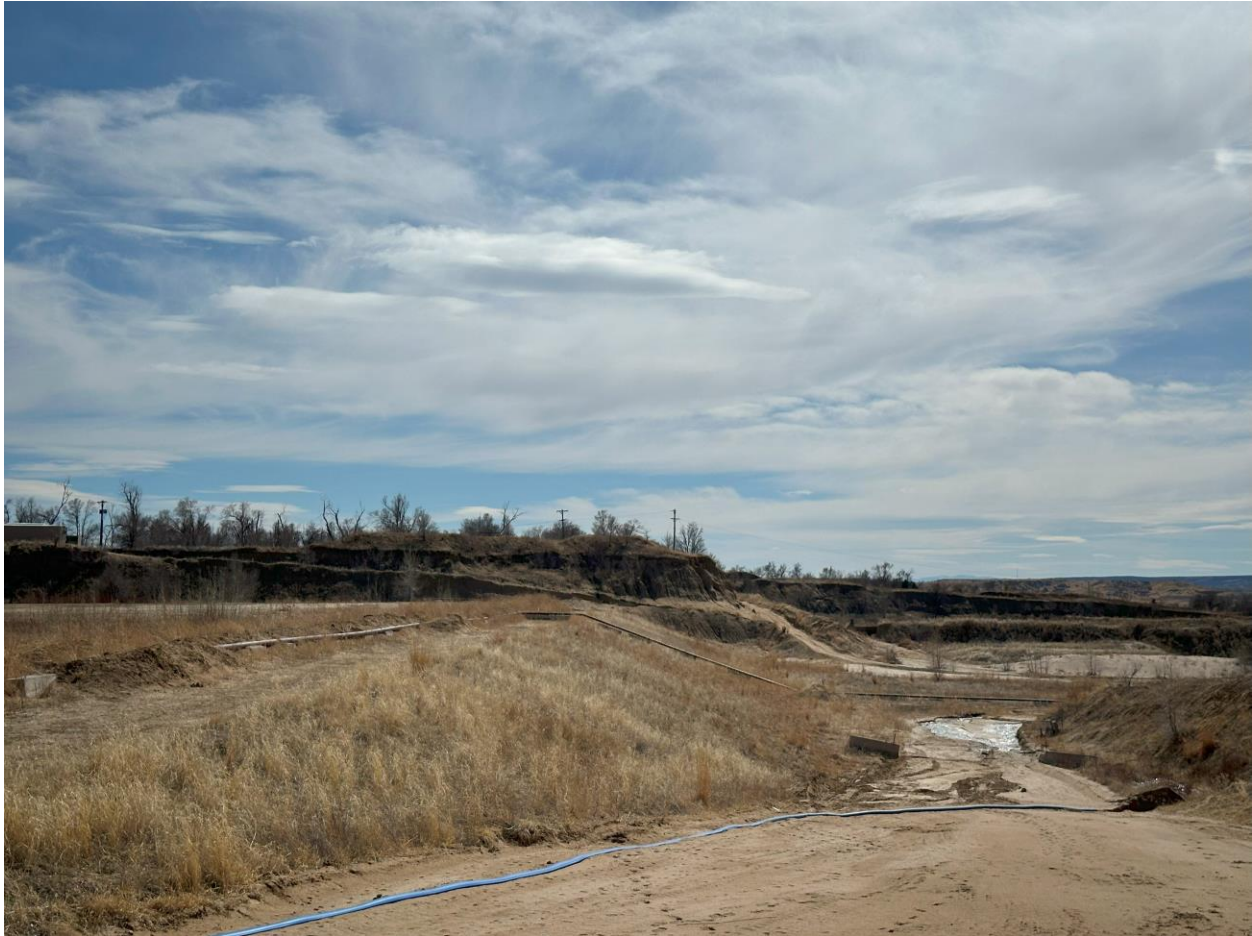
Photo 8. Pumping operations near toe of impoundment pond embankment

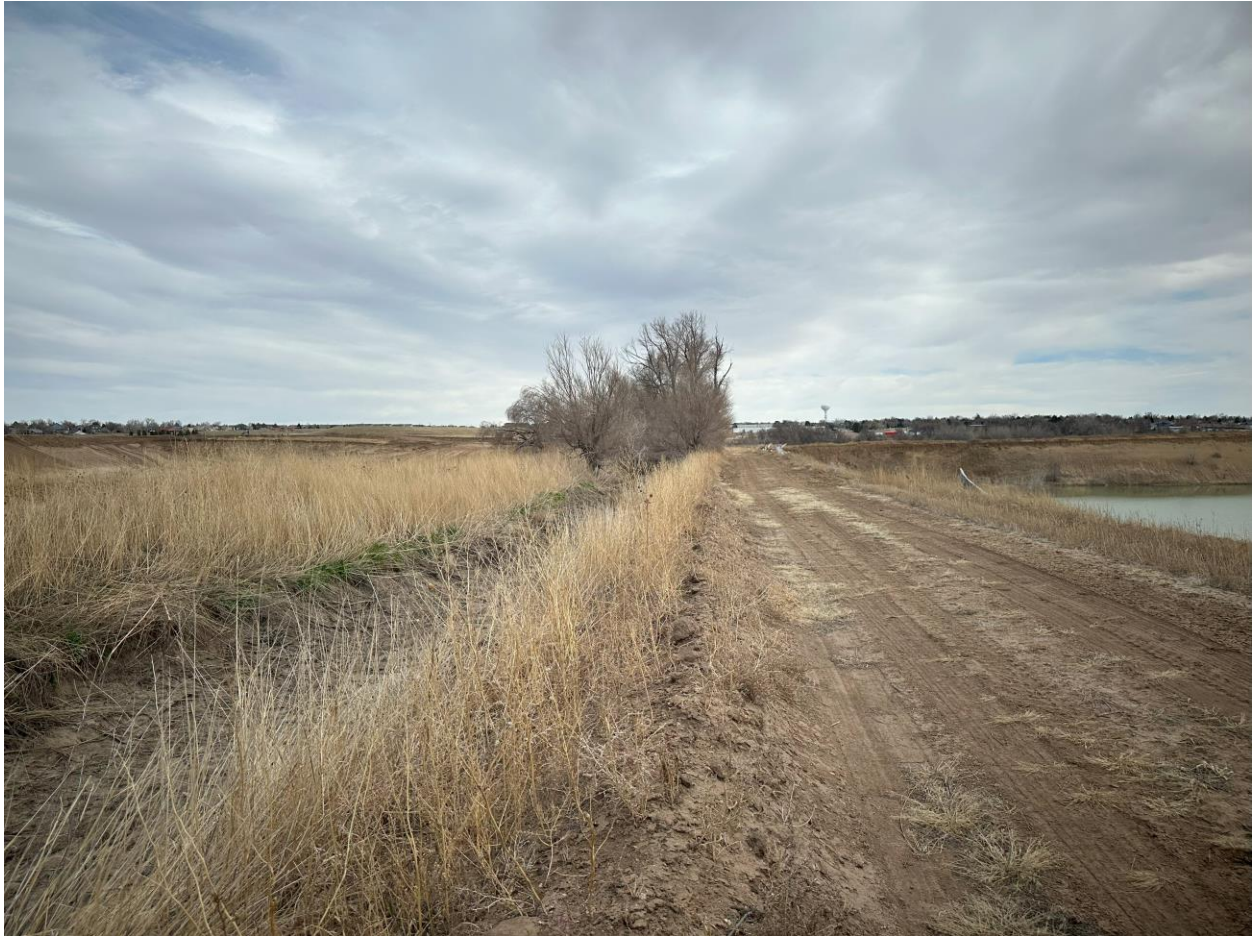
Photo 9. Ditch and access road looking east

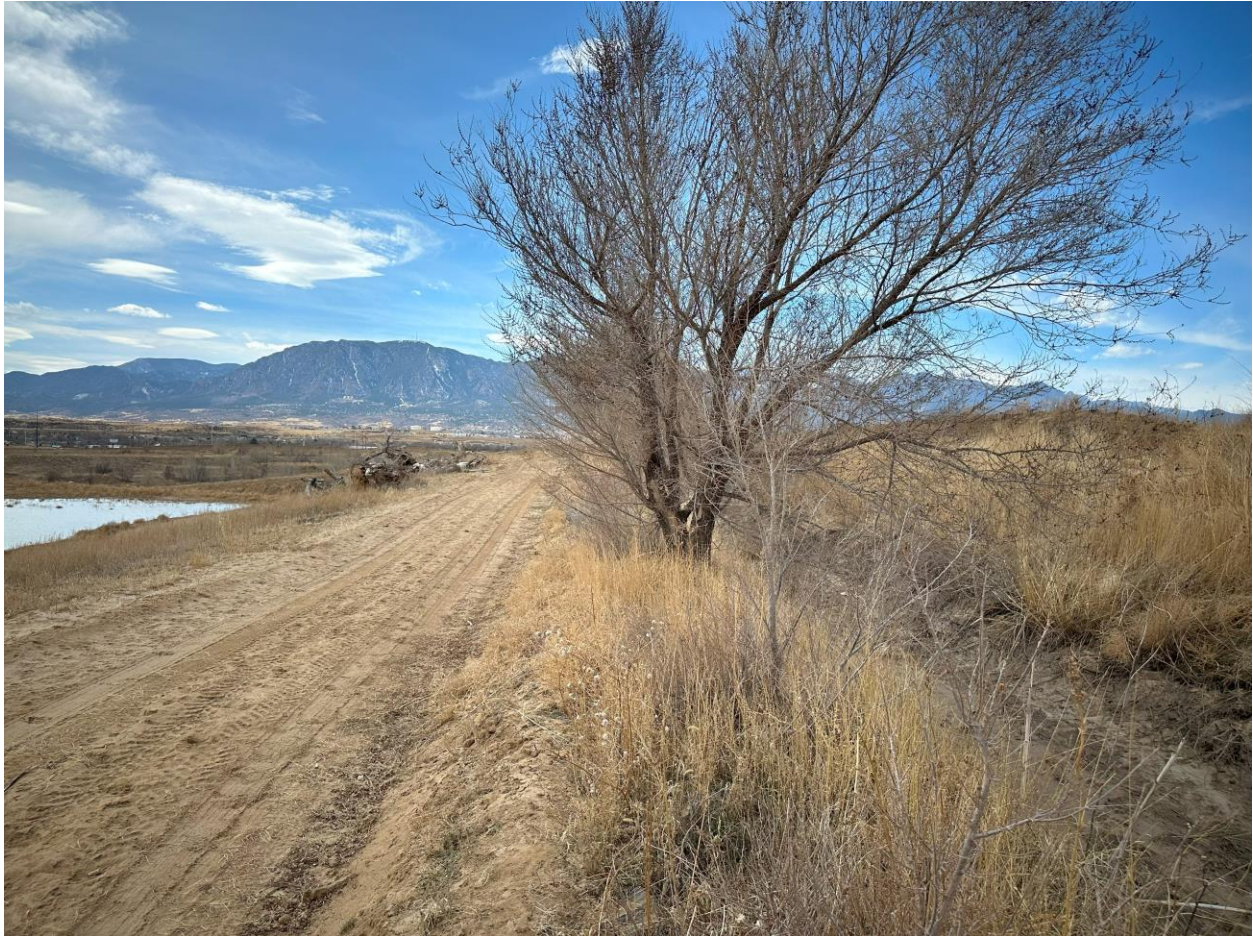
Photo 10. Ditch and access road looking west

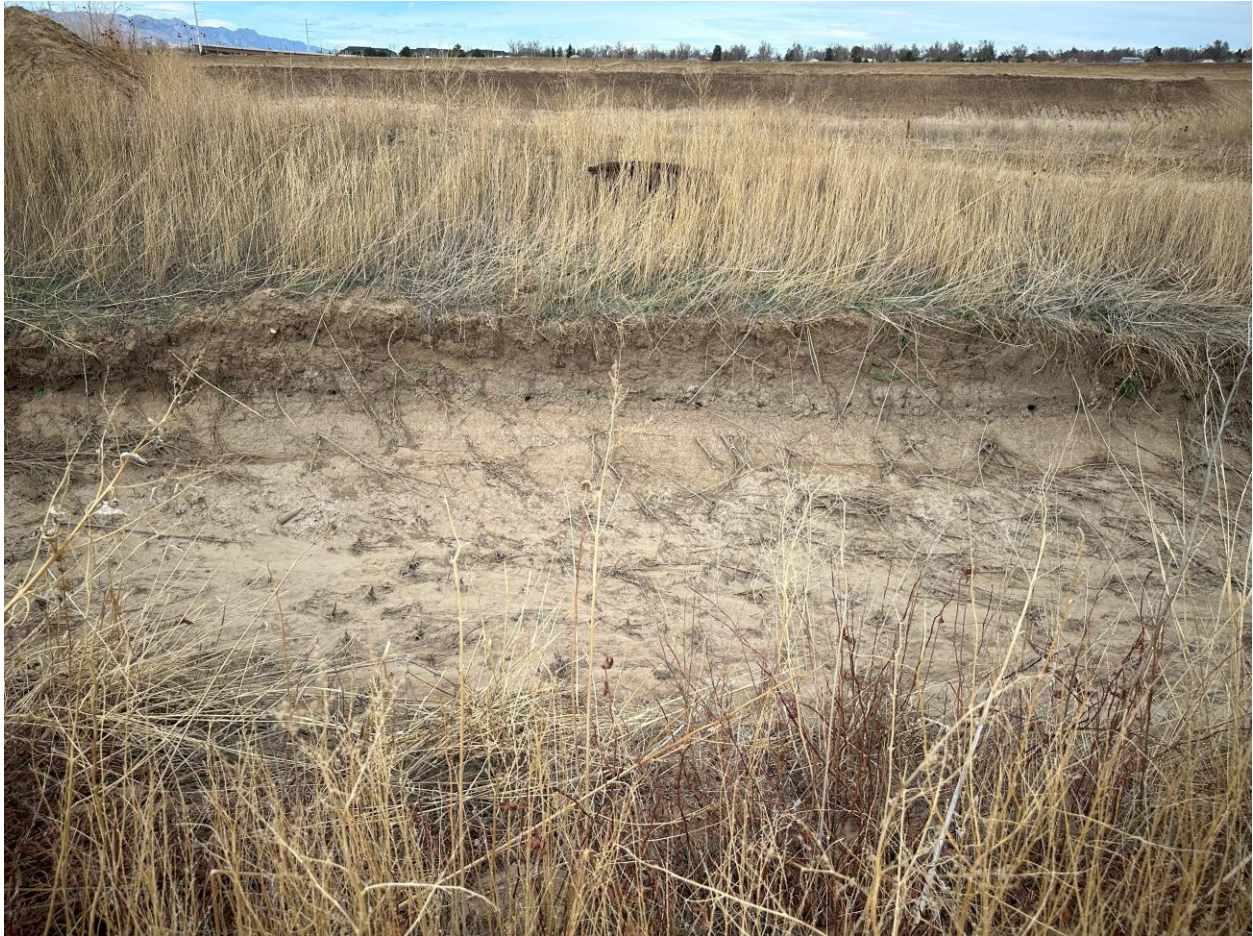
Photo 11. Ditch looking north
