U.S. DEPT. OF THE INTERIOR
OFFICE OF SURFACE MINING
Mine Site Evaluation
State Program

**Denver Field Branch
Mine Site Evaluation Narrative**

Permittee:	New Elk Coal Company, LLC
Operator:	New Elk Coal Company, LLC
Site:	New Elk Mine
Permit No:	C-1981-012
Date of Inspection:	February 15, 2024
Inspection Type:	Partial Oversight
Weather:	Warm and Sunny
Operator Representatives:	John Terry
State Official:	Amber Gibson and Jared Ebert
OSMRE Officials:	Jim Stark #591

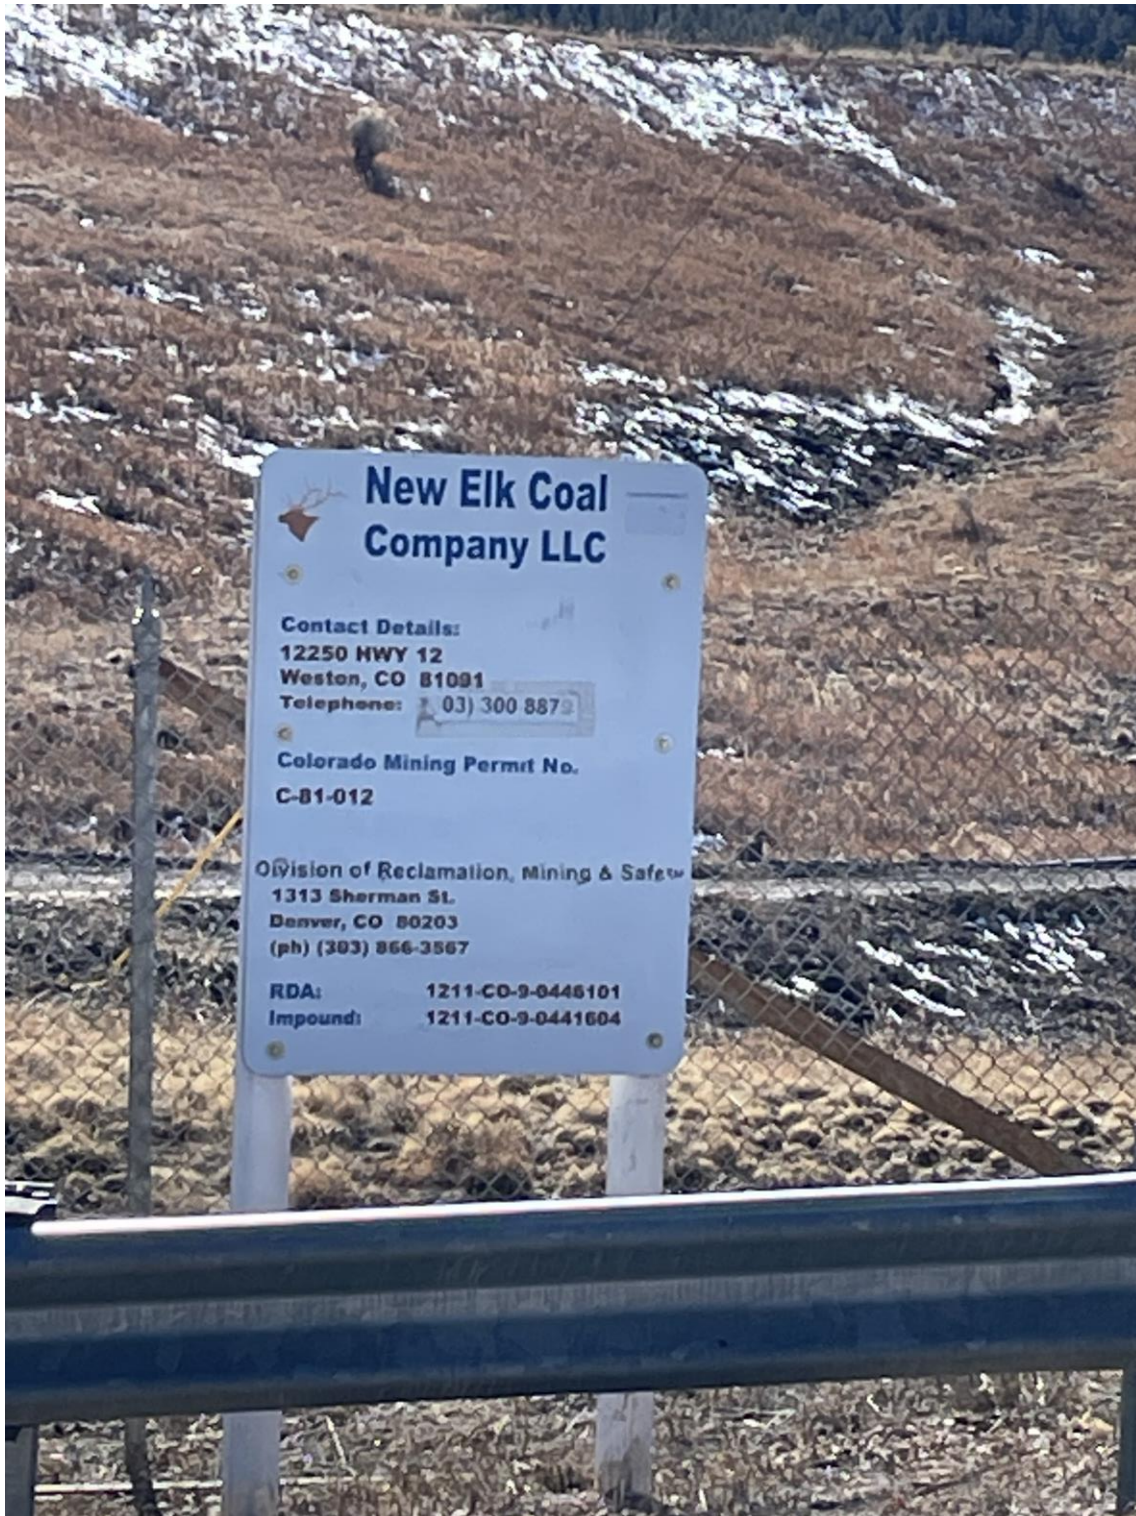
The mine ID sign was in place at the entrance to the site off of CO Hwy 12. The sign contained all of the information required by Rule. (Picture 01).

Picture 01 – Mine ID sign

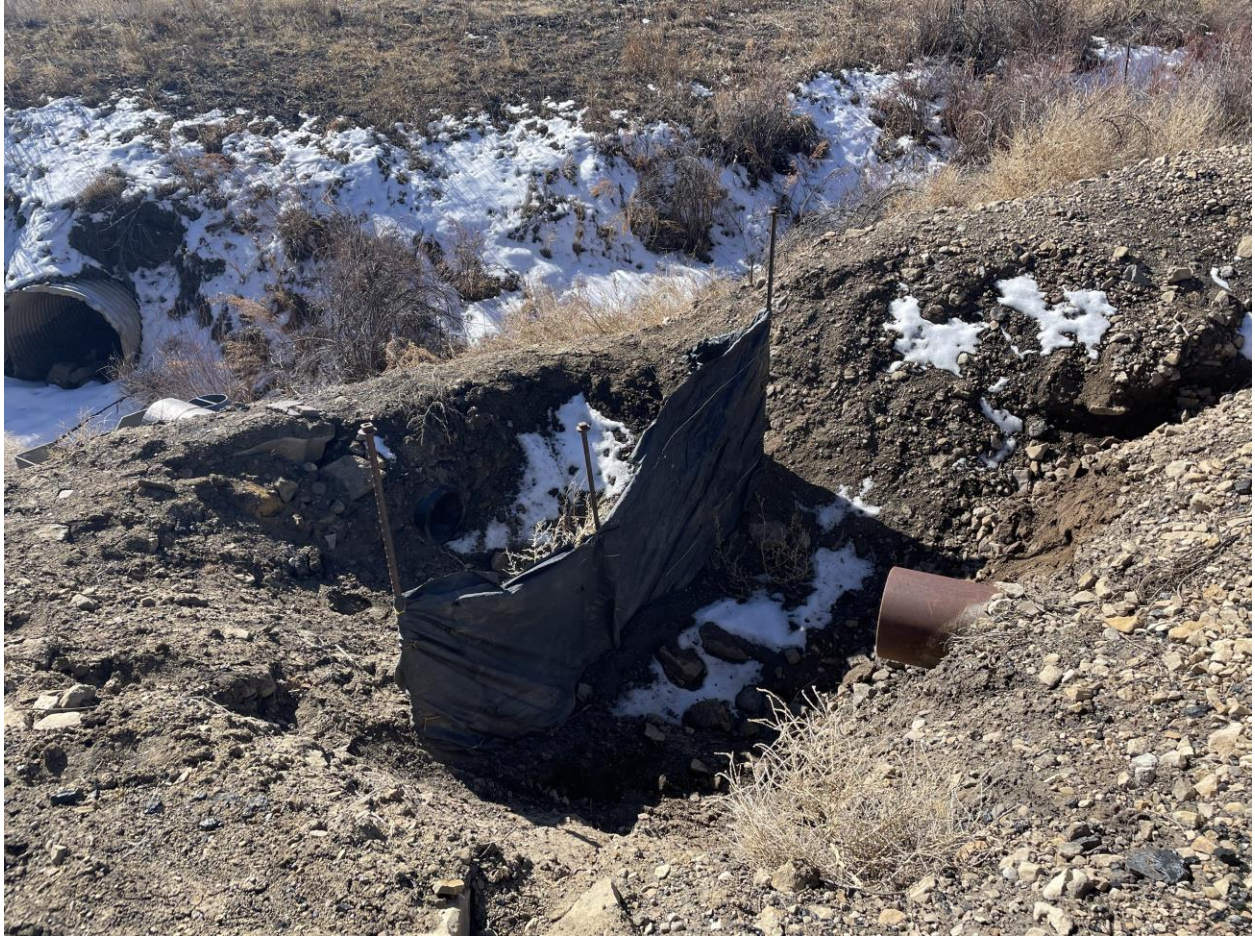
Culvert Number	Dimensions (Inches)	Comments	Picture
86	12	Clean, discharges into SAE (sump with silt fence)	02
20	36	Clean, flows into Pond 7	
32	36	Minor sediment at inlet, inlet damaged but not impeding flow	03
		Ditch flowing to culvert are clean, stable and dry	
46	24	Flows to C-32, culvert clean	
48	24	Flows to C-32, culvert clean	
17	35	Concrete culvert at coal stockpile area, sediment at inlet	04
		Needs to be cleaned	
12A	36	Flows to ditch to Pond 7, water flowing into culvert	05
		Starting to side-cut	
61	12	Culvert is backing up and this area needs to be mucked out	06
16D	20	Clean, water flowing, slight undercutting	07
16	36	Clean, water flowing	
73	24	Clean, some water in sump at inlet	08
72	24	Clean	
8	21	Clean	
19	36	Clean, this culvert is a duplicate on Map 13 - DRMS will investigate	
5	60	Clean, clear water diversion to Purgatoire River	09
9A	10	Clean, erosion into ditch	10
7	18.5	Clean

Picture 02 – C-86 and silt fence/SAE

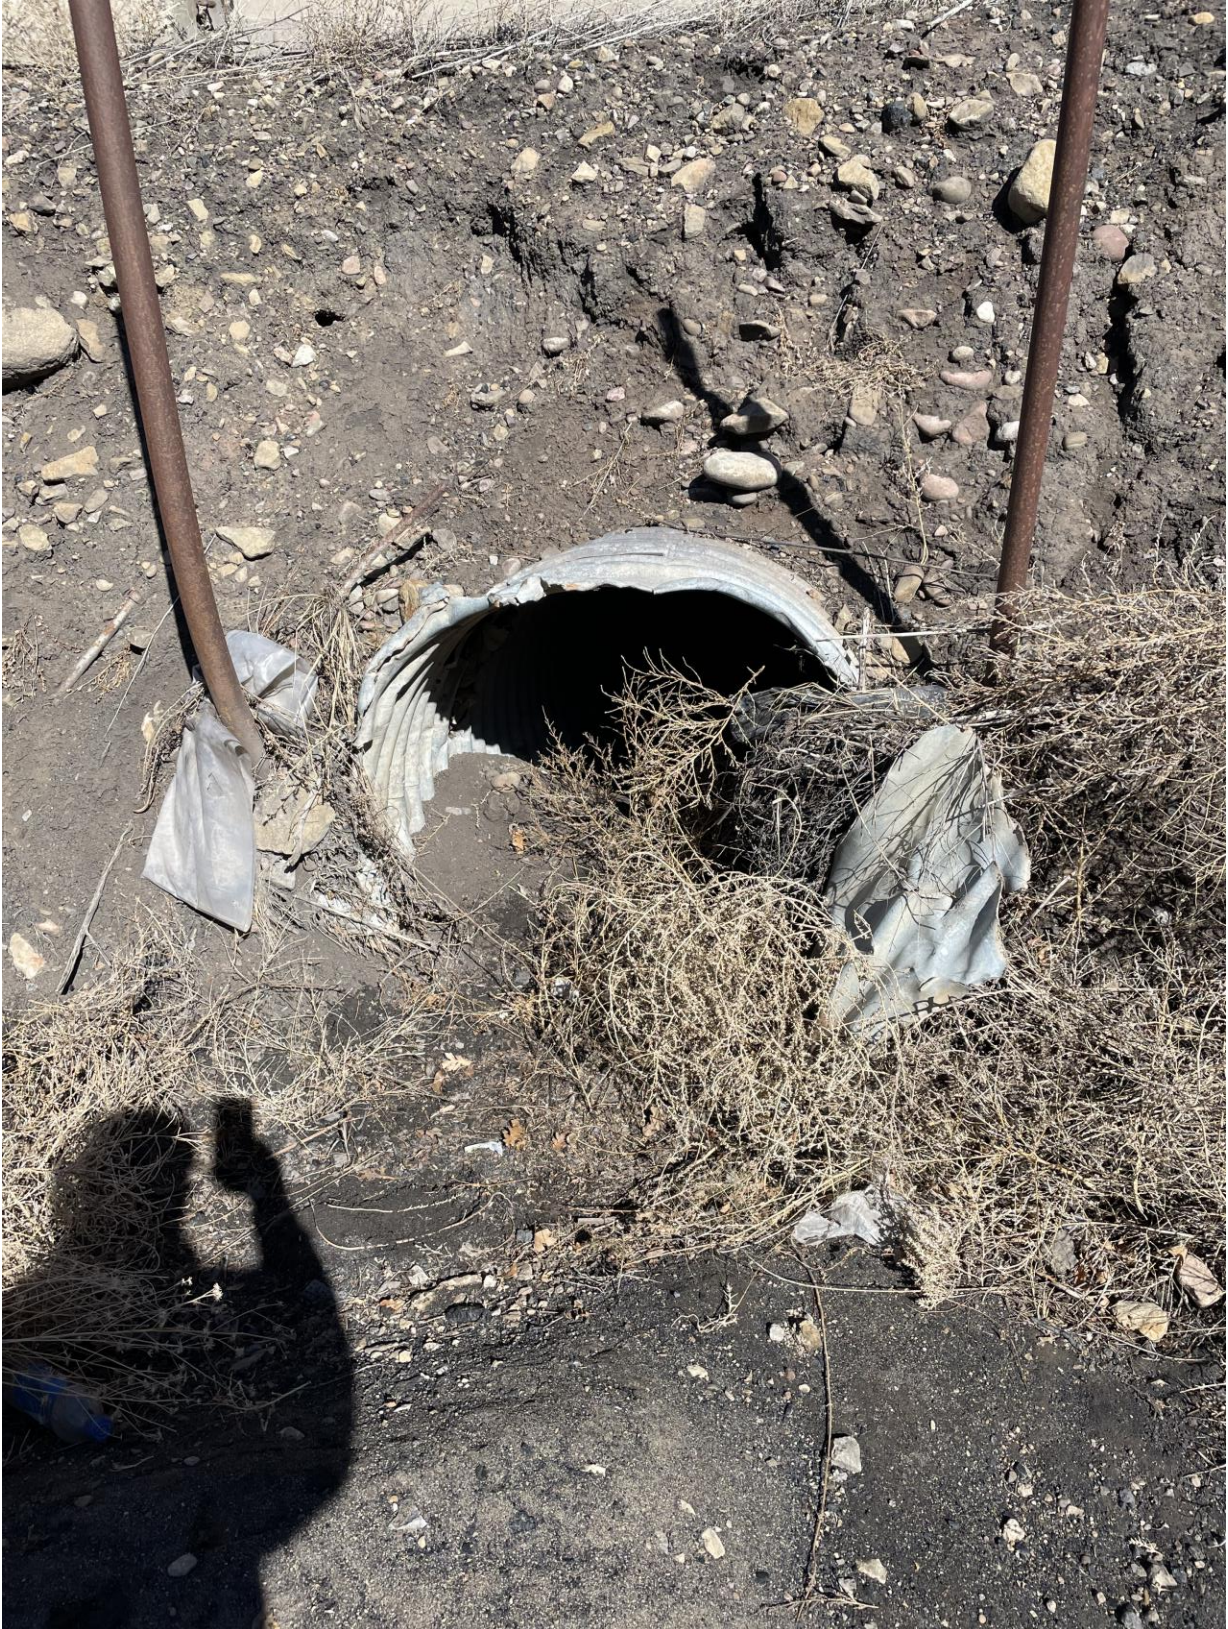
Picture 03 – C-32 with damaged inlet

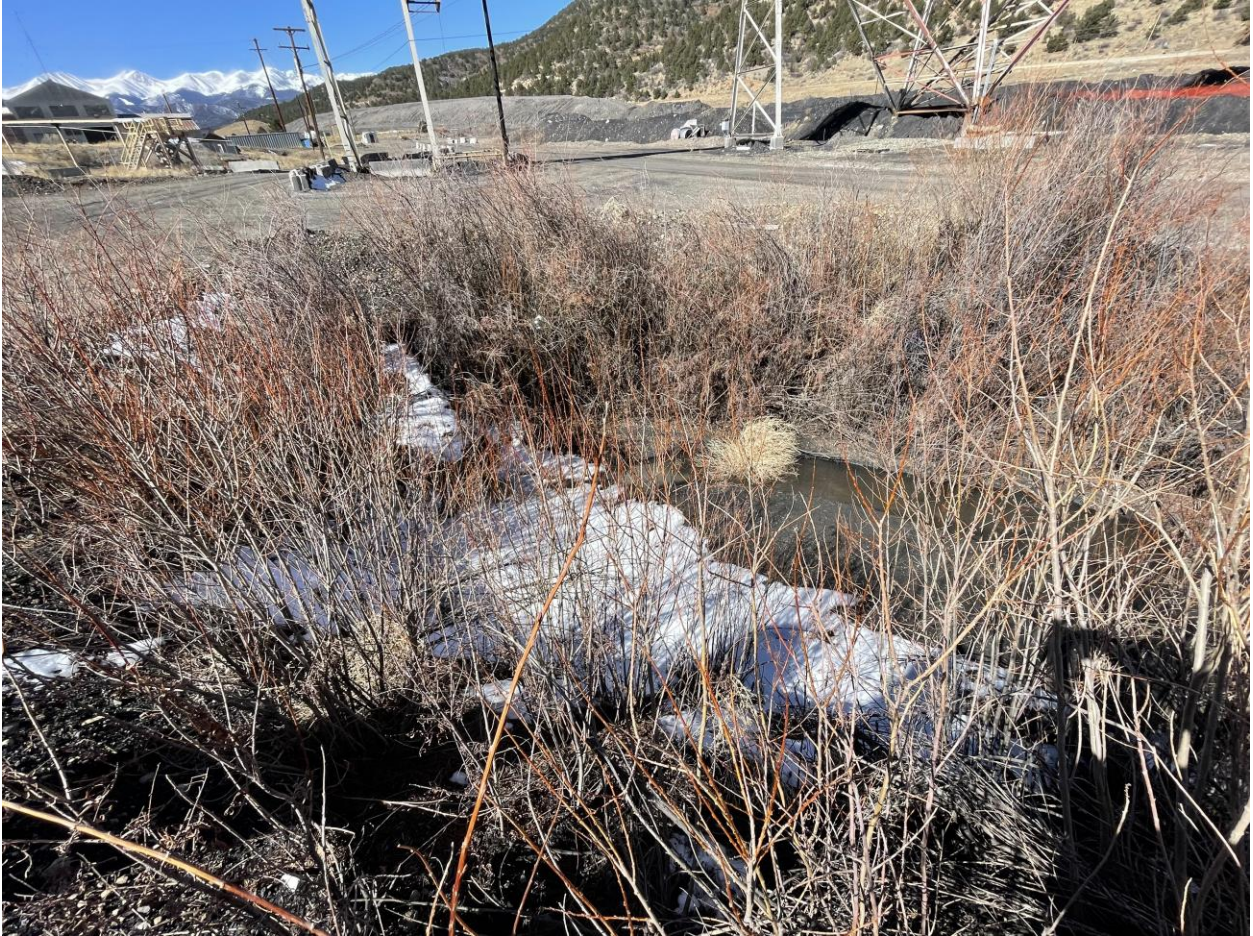
Picture 06 – C-61 and area that needs to be mucked out

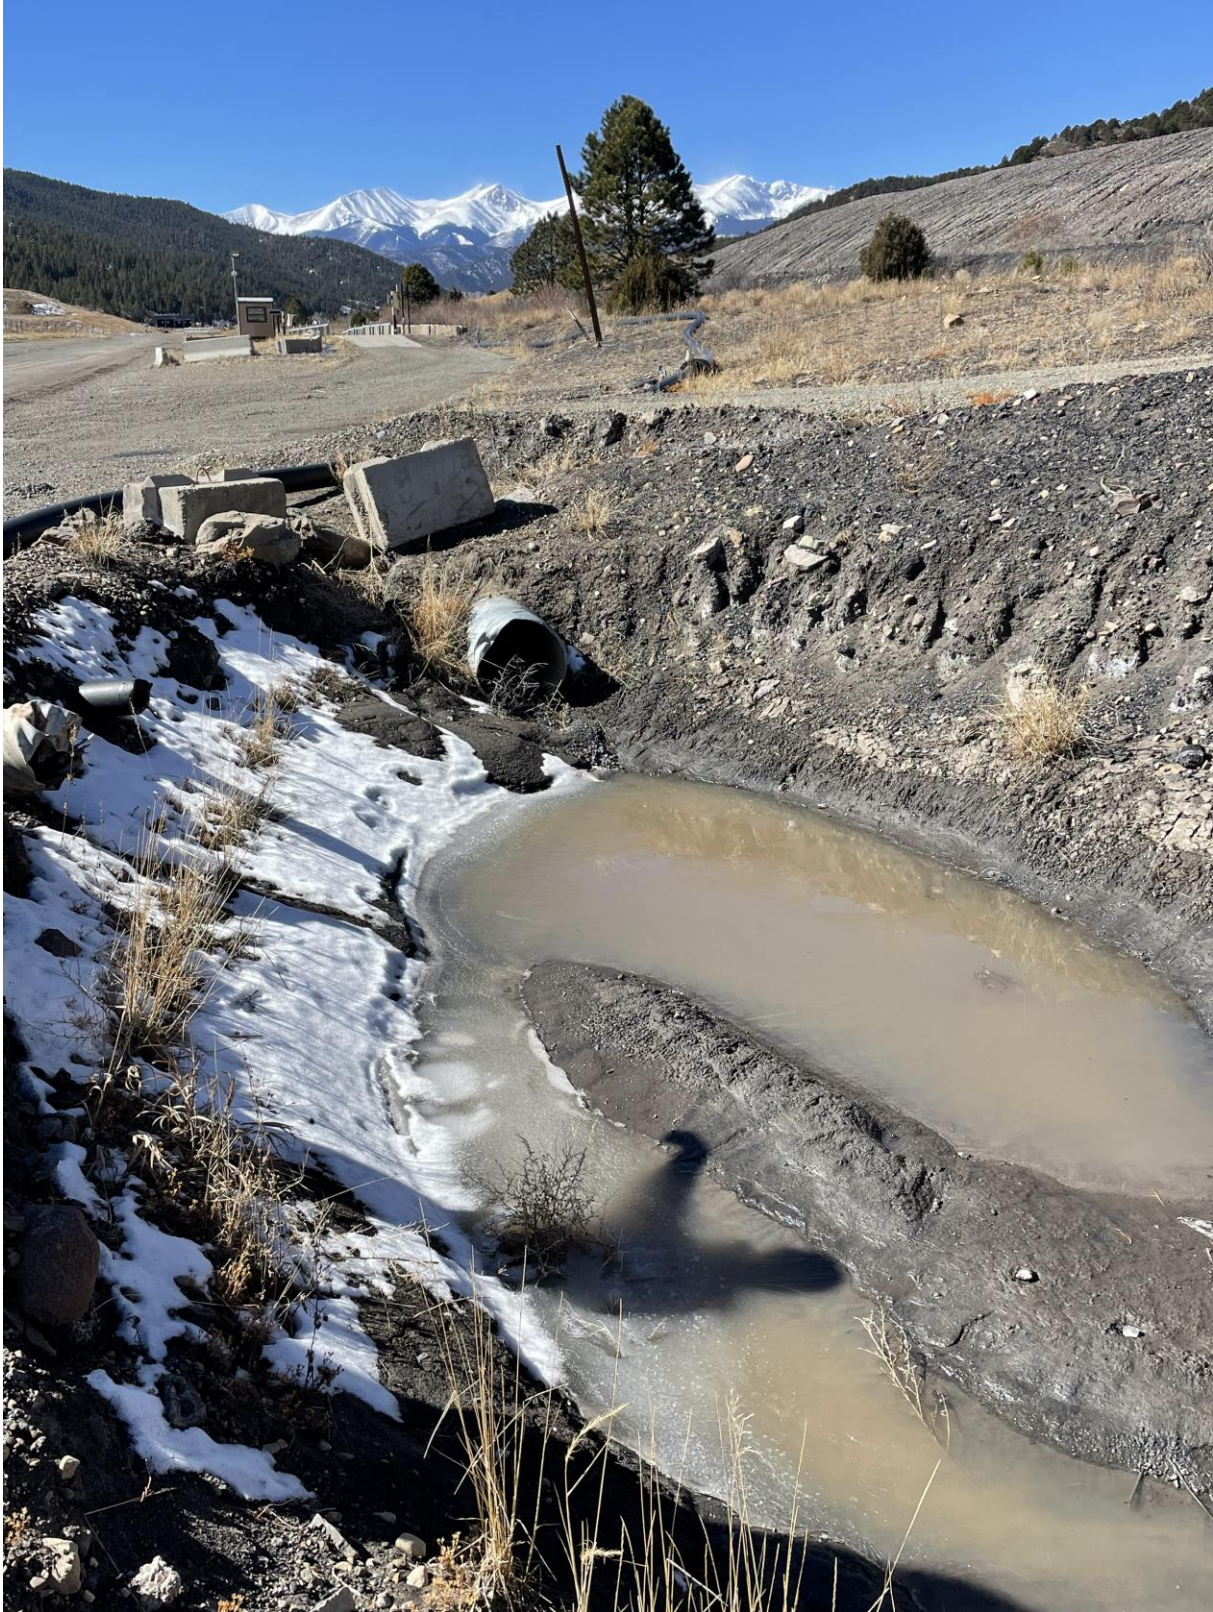
Picture 08 – C-73 and sump

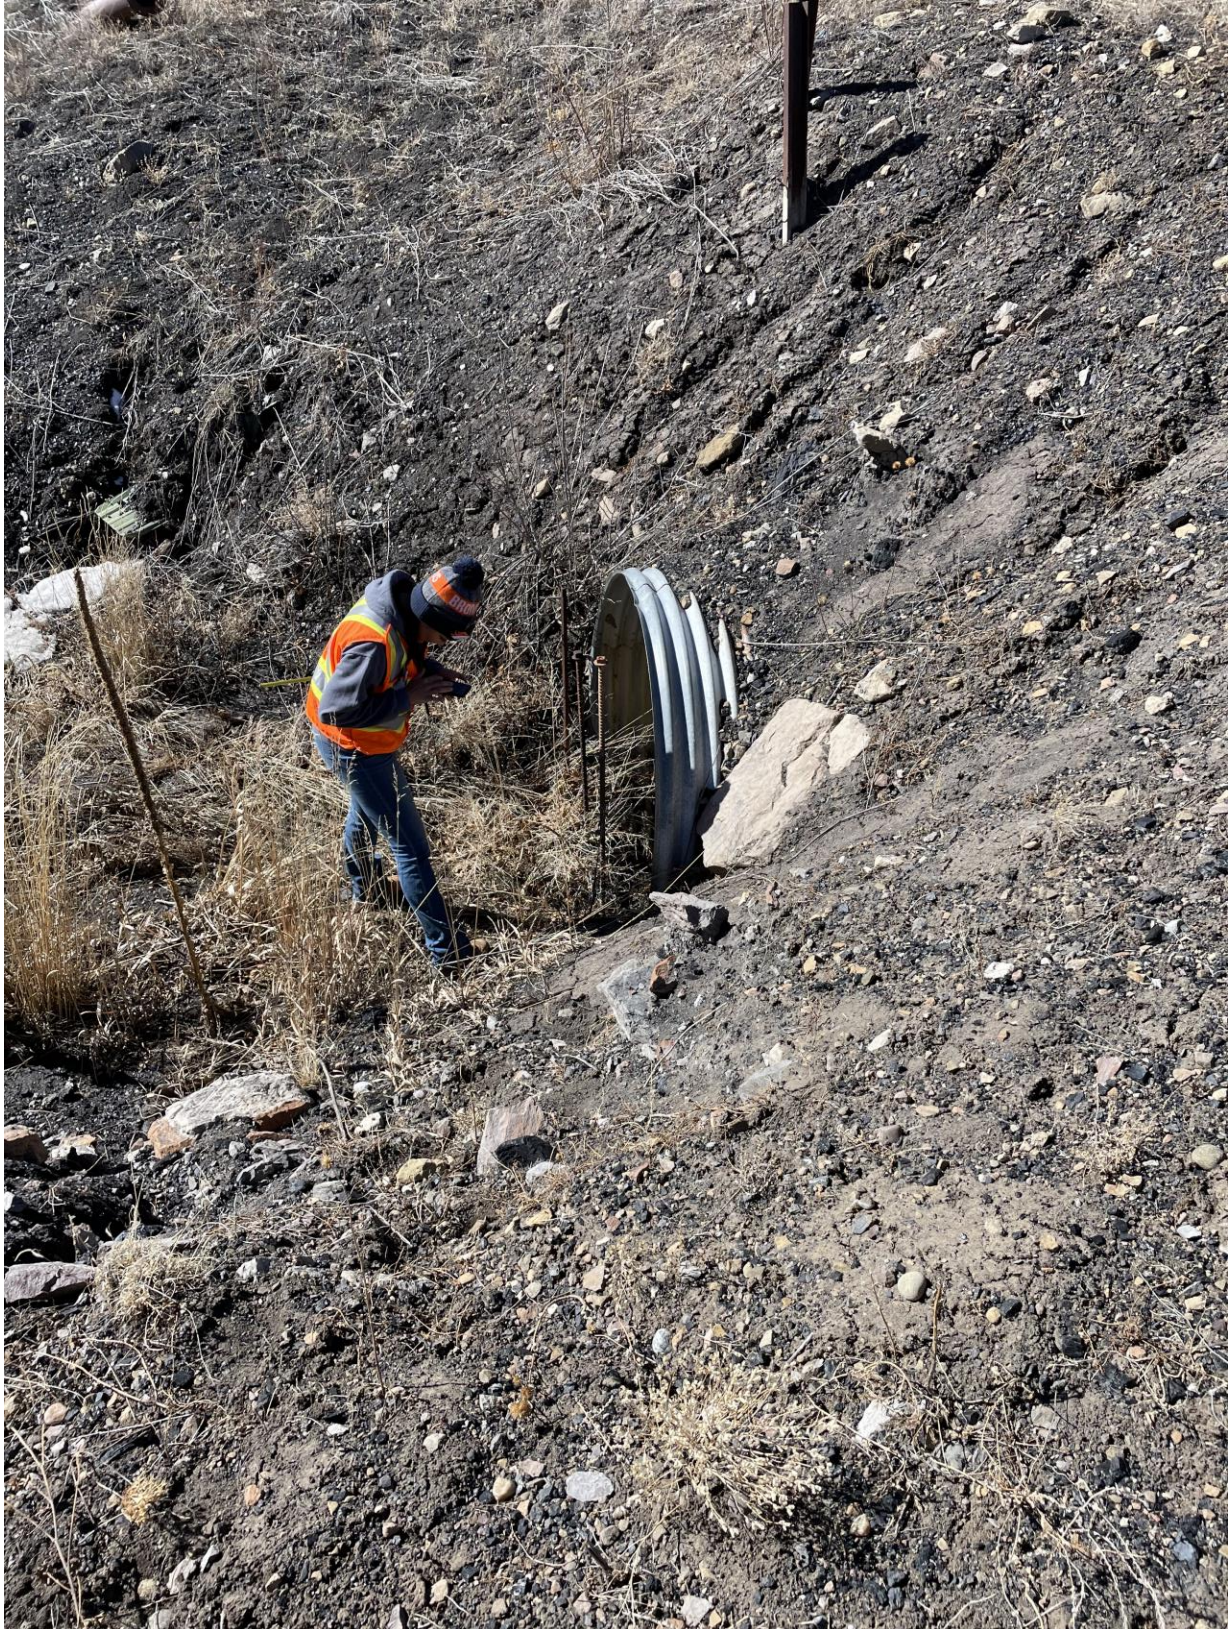
Picture 09 – C-5

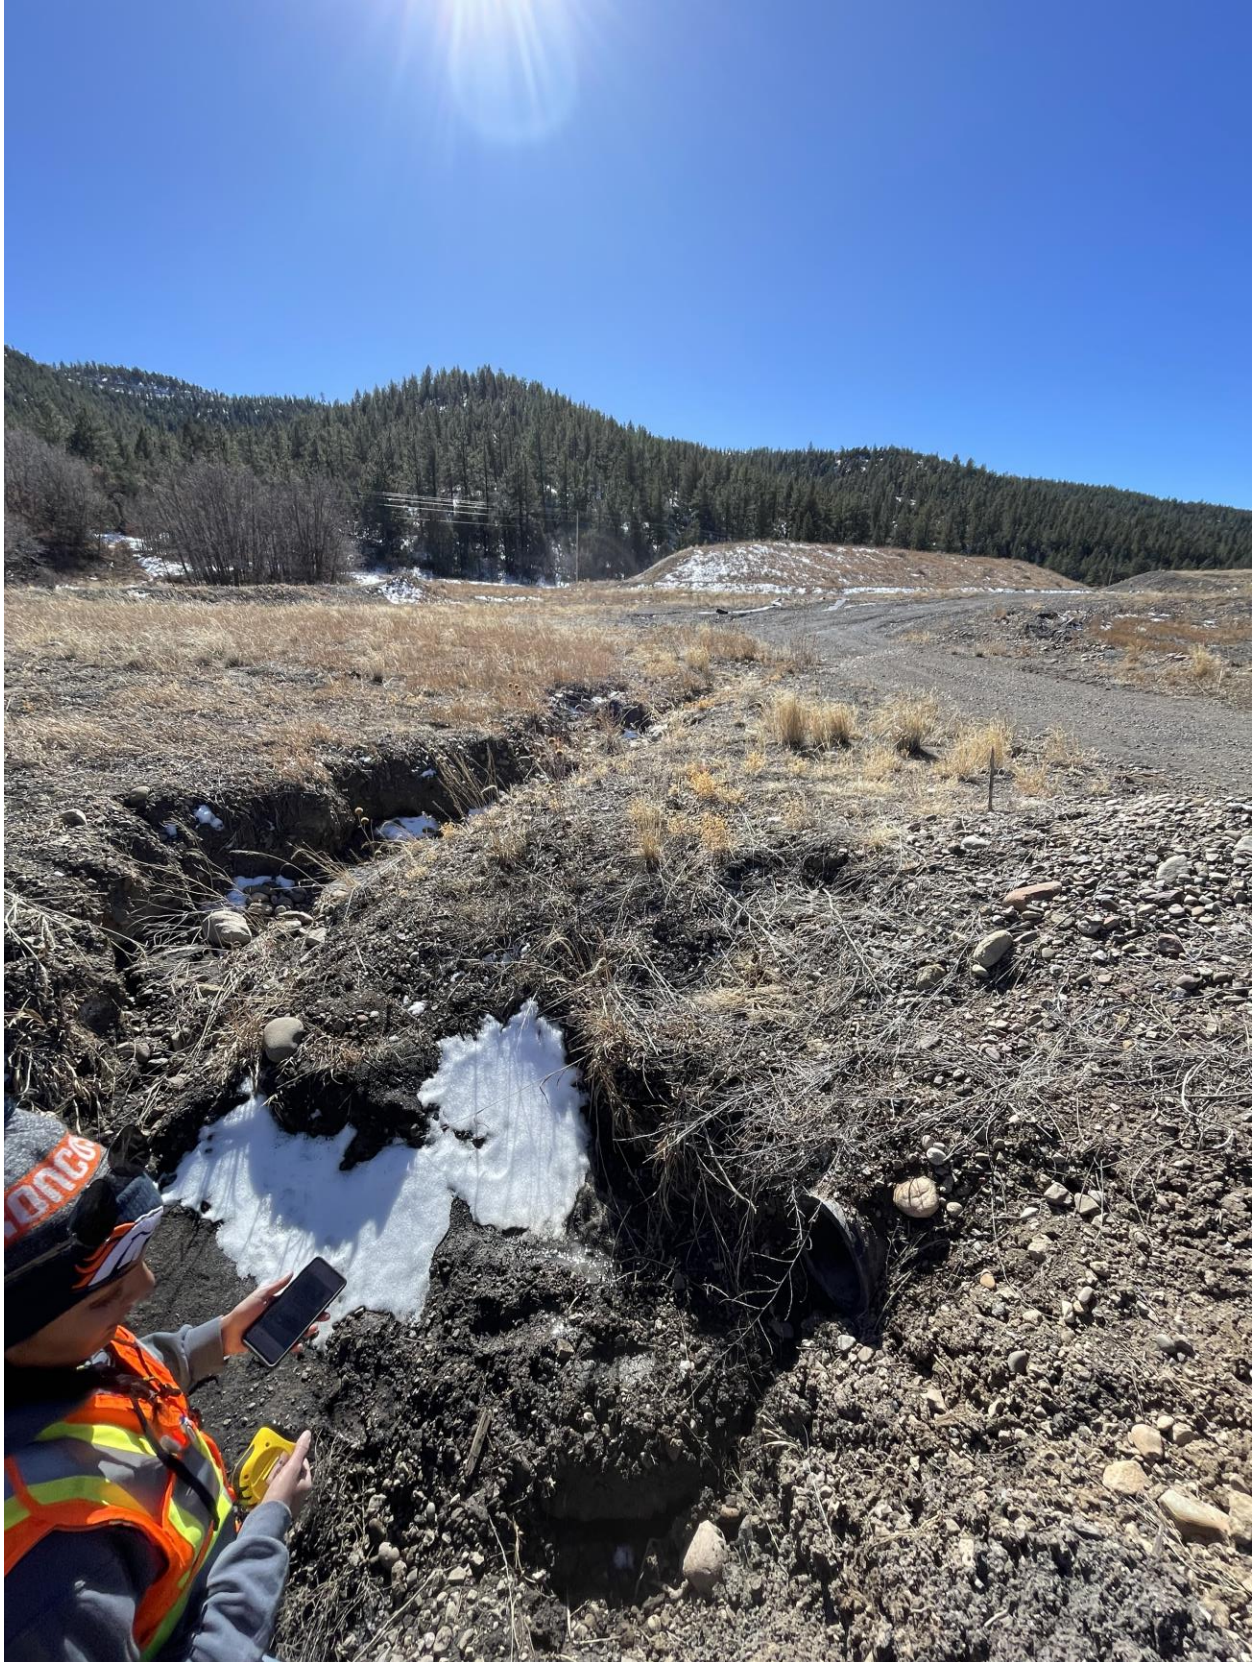
Picture 10 – C-9A

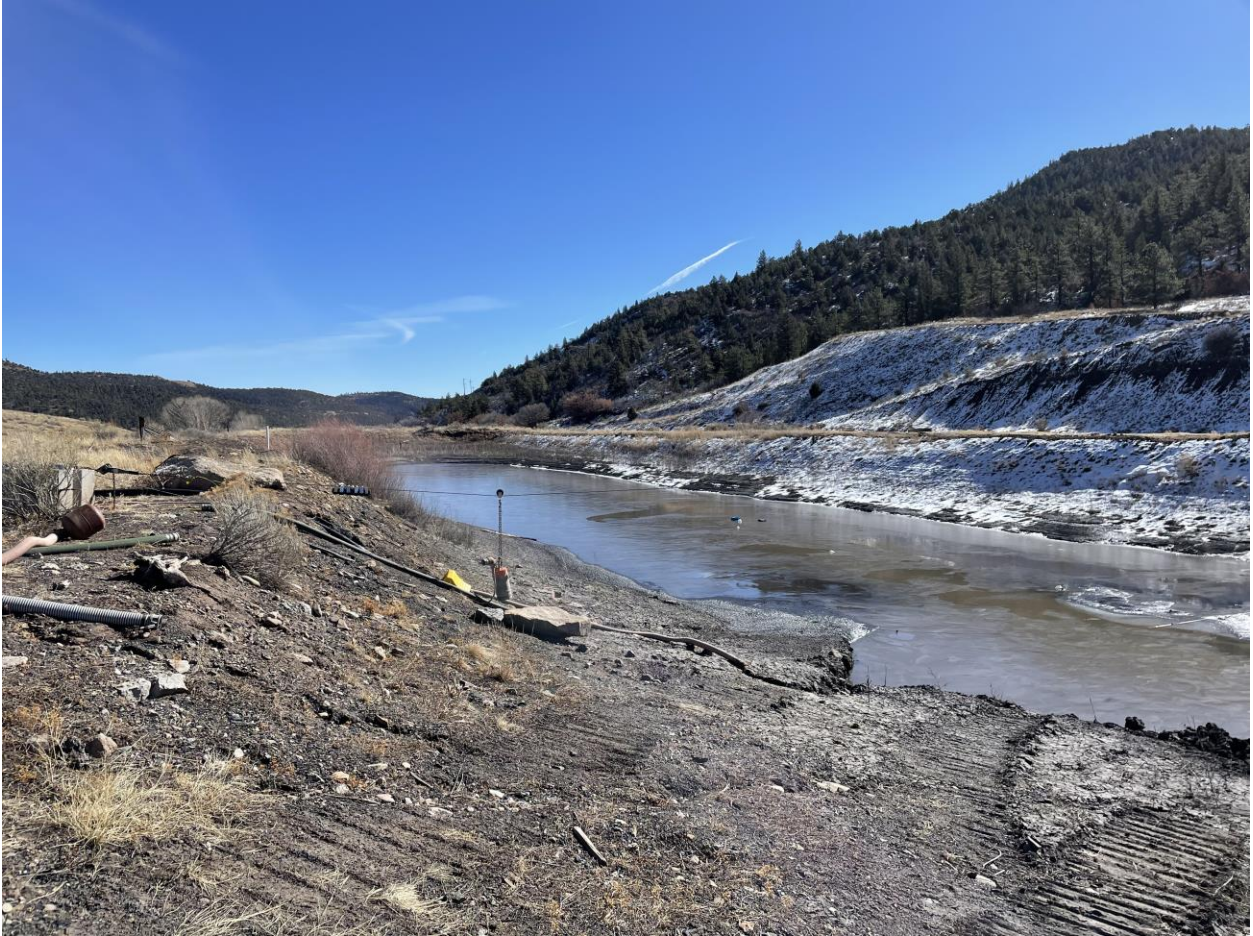
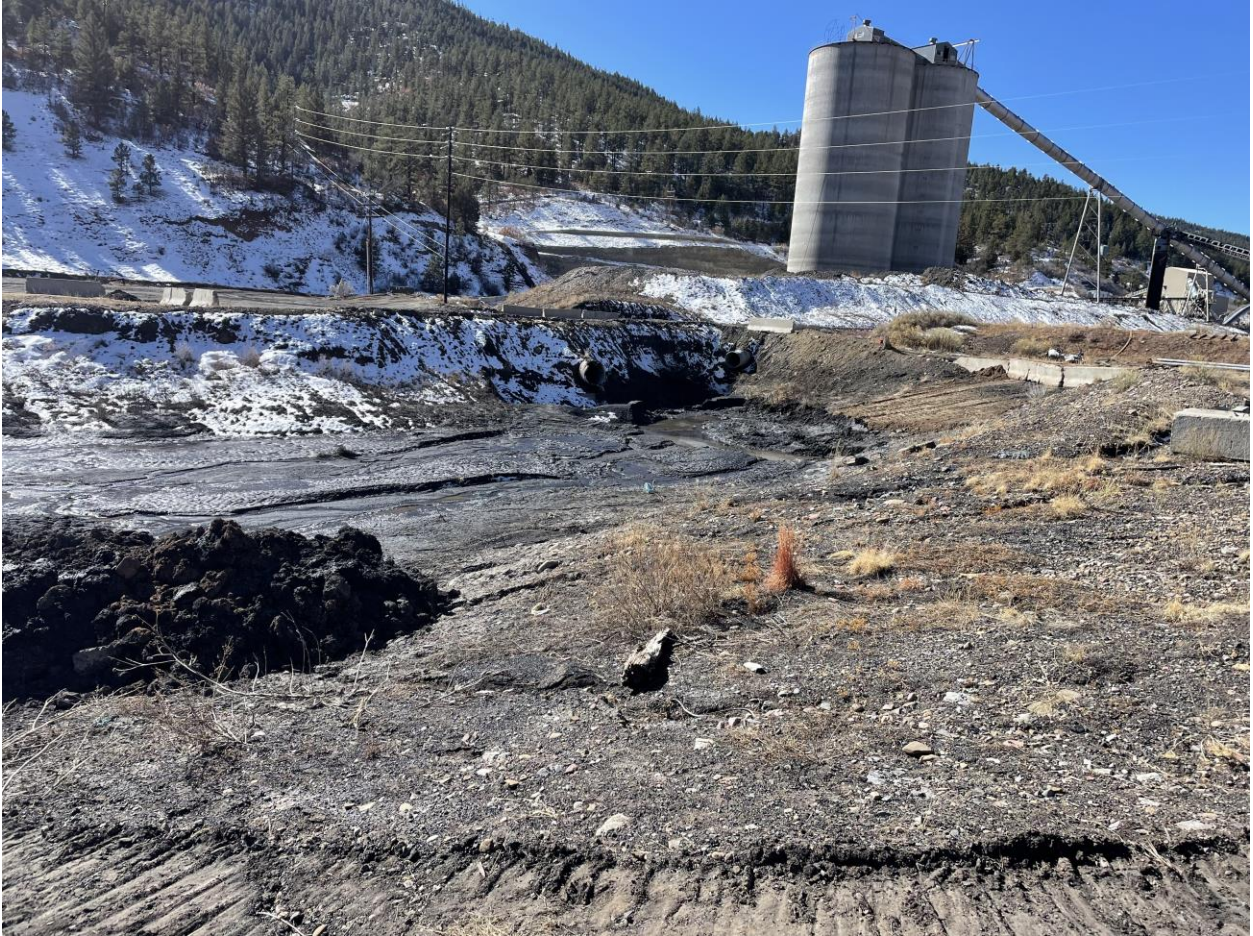
Pond 7 contained water but was not discharging at the time of the inspection. There was some sediment at the inlet but it does not appear to be a problem at this time. The pond embankment appeared to be stable and no erosional problems were noted. (Pictures 11 and 12)

Picture 11 – Pond 7

Picture 12 – Sediment at inlet of Pond 7

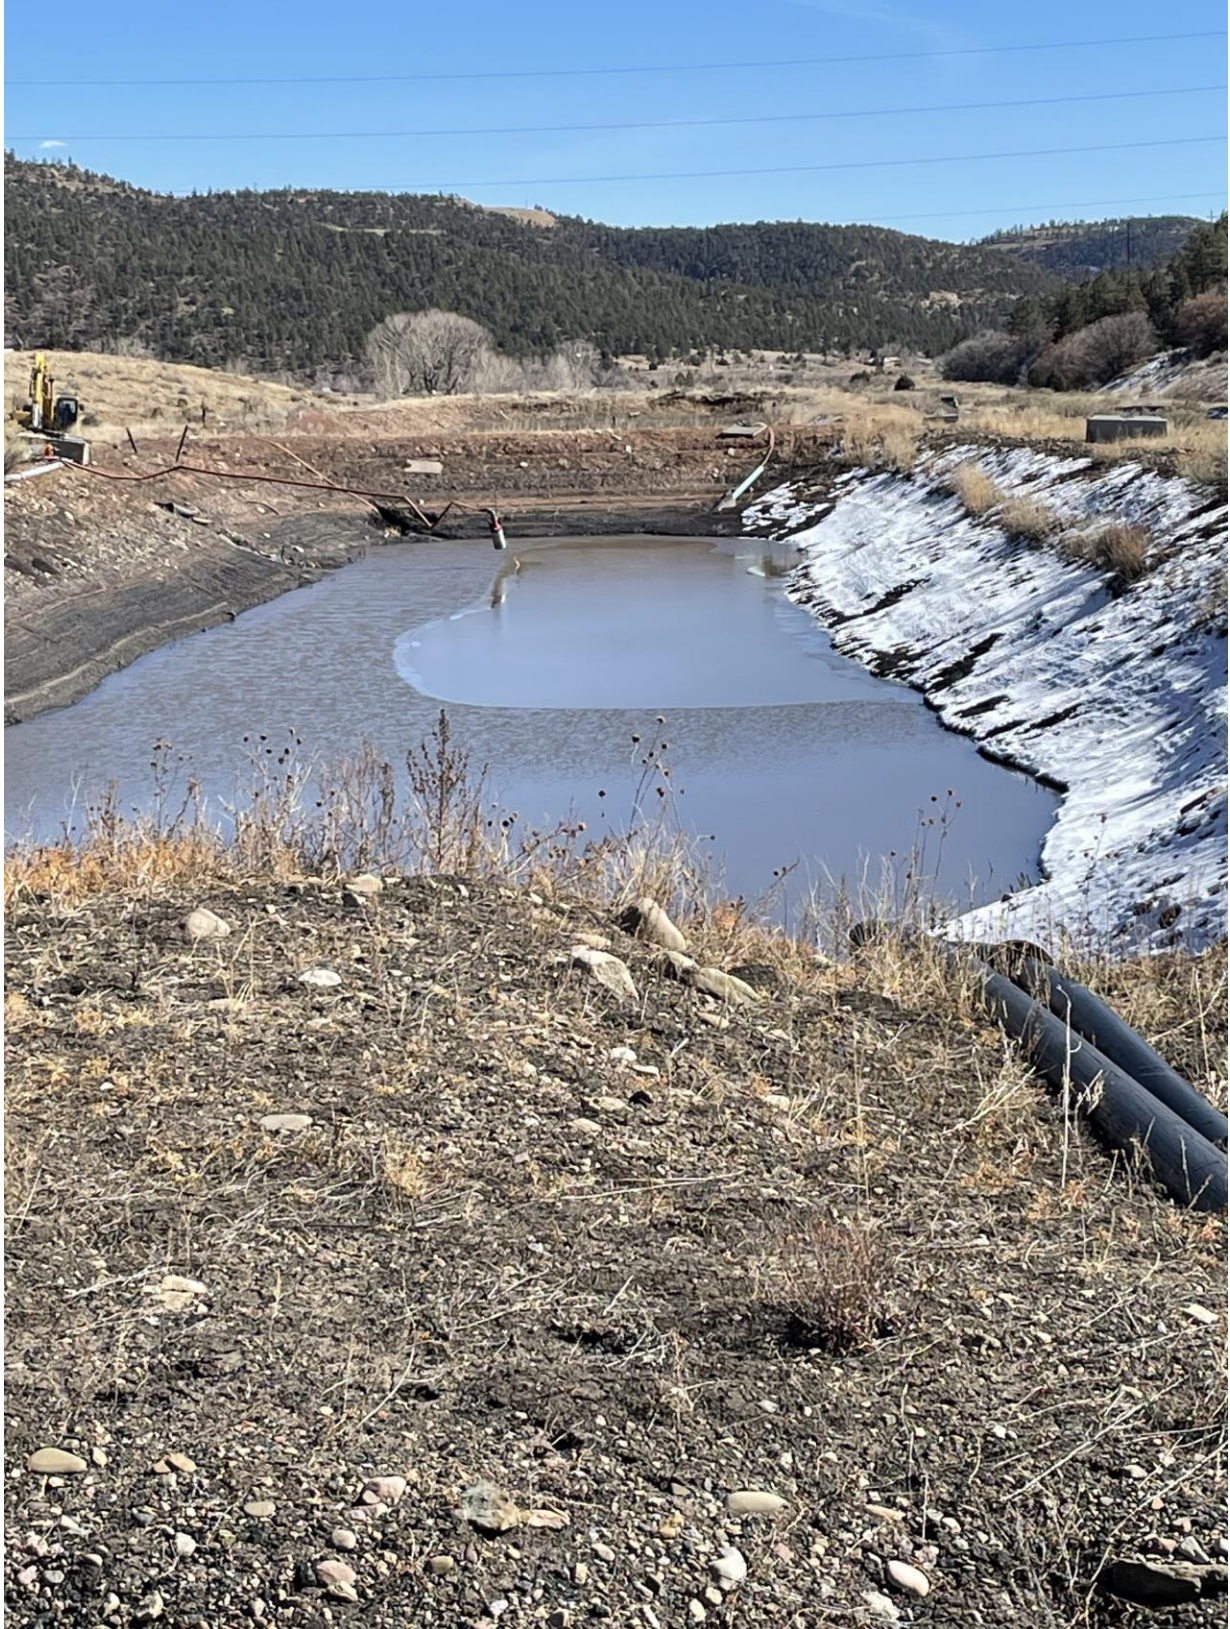
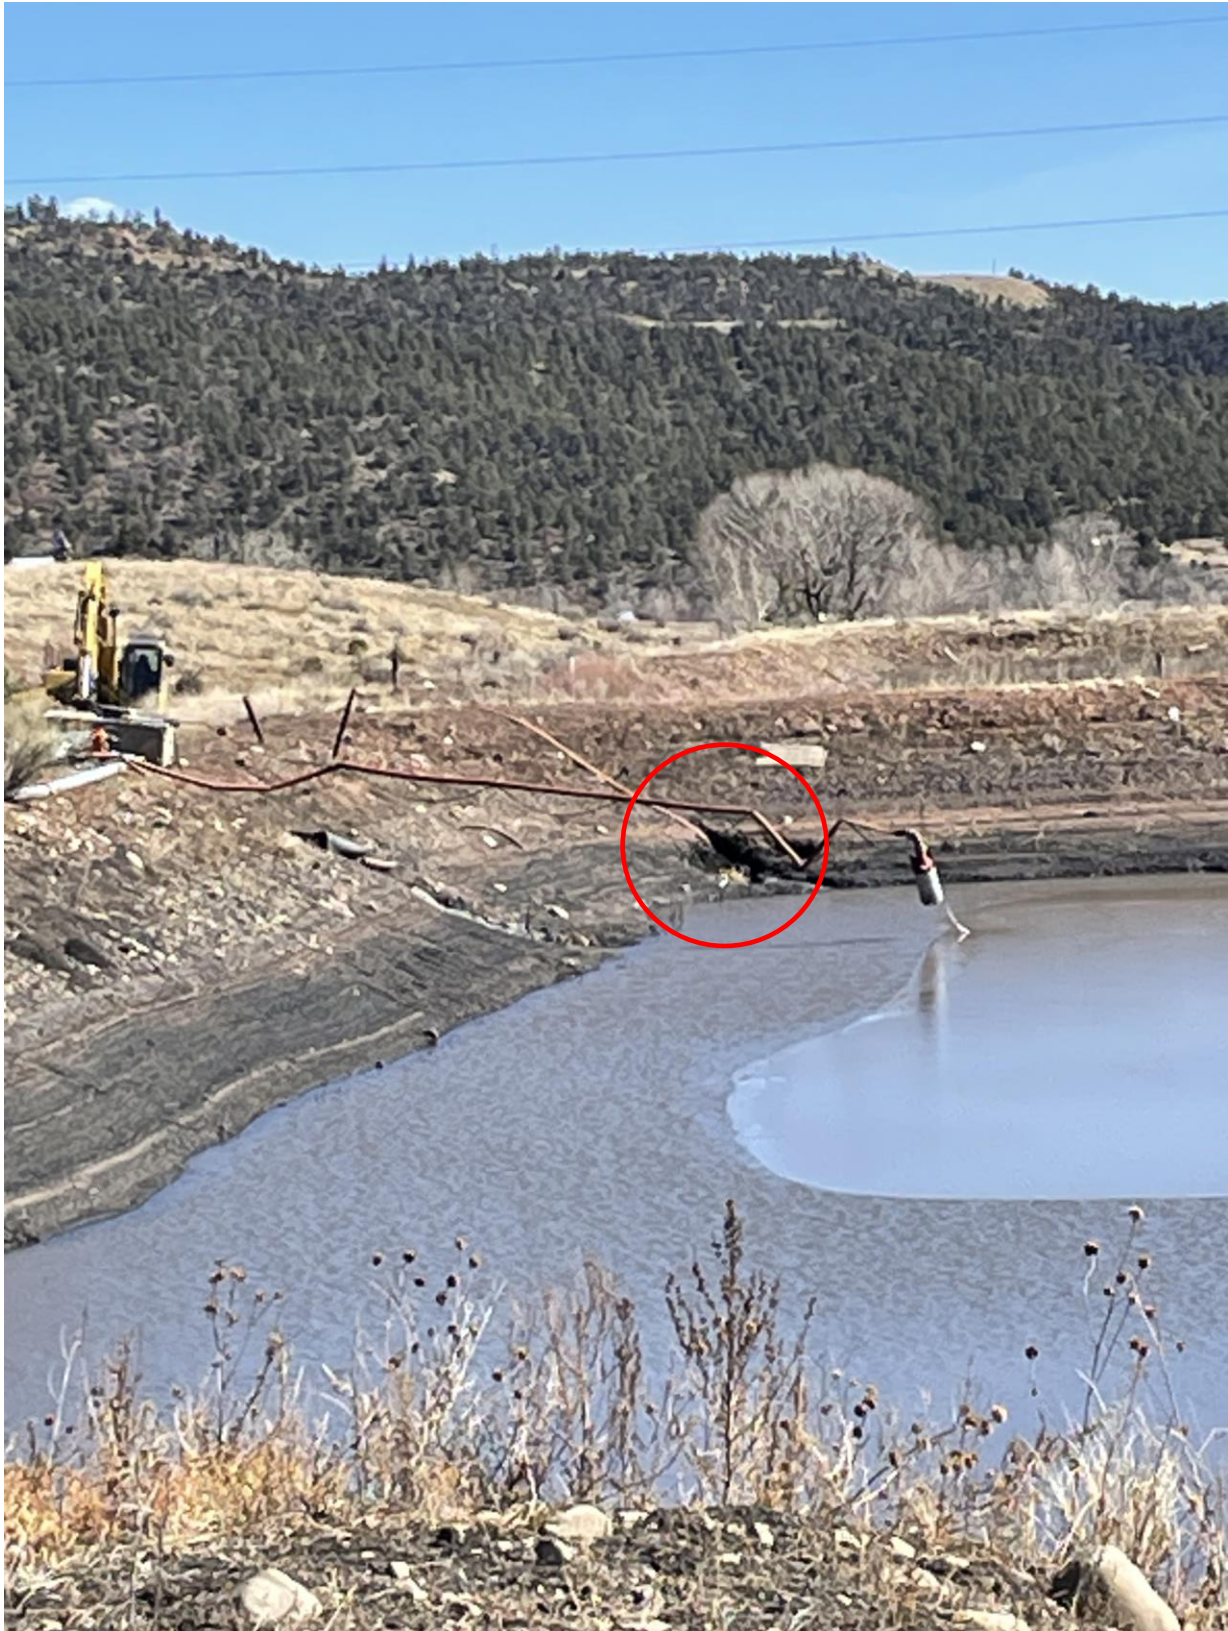
Pond 6 contained water but was not discharging at the time of the inspection. The pond embankment was generally stable at the time of the inspection. There was some erosion on the inslope of the embankment from pumping water into the pond. This area should be repaired before it becomes a problem. (Pictures 13 and 14)

Picture 13 – Pond 6

Picture 14 – Erosion on inslope of Pond 6 embankment

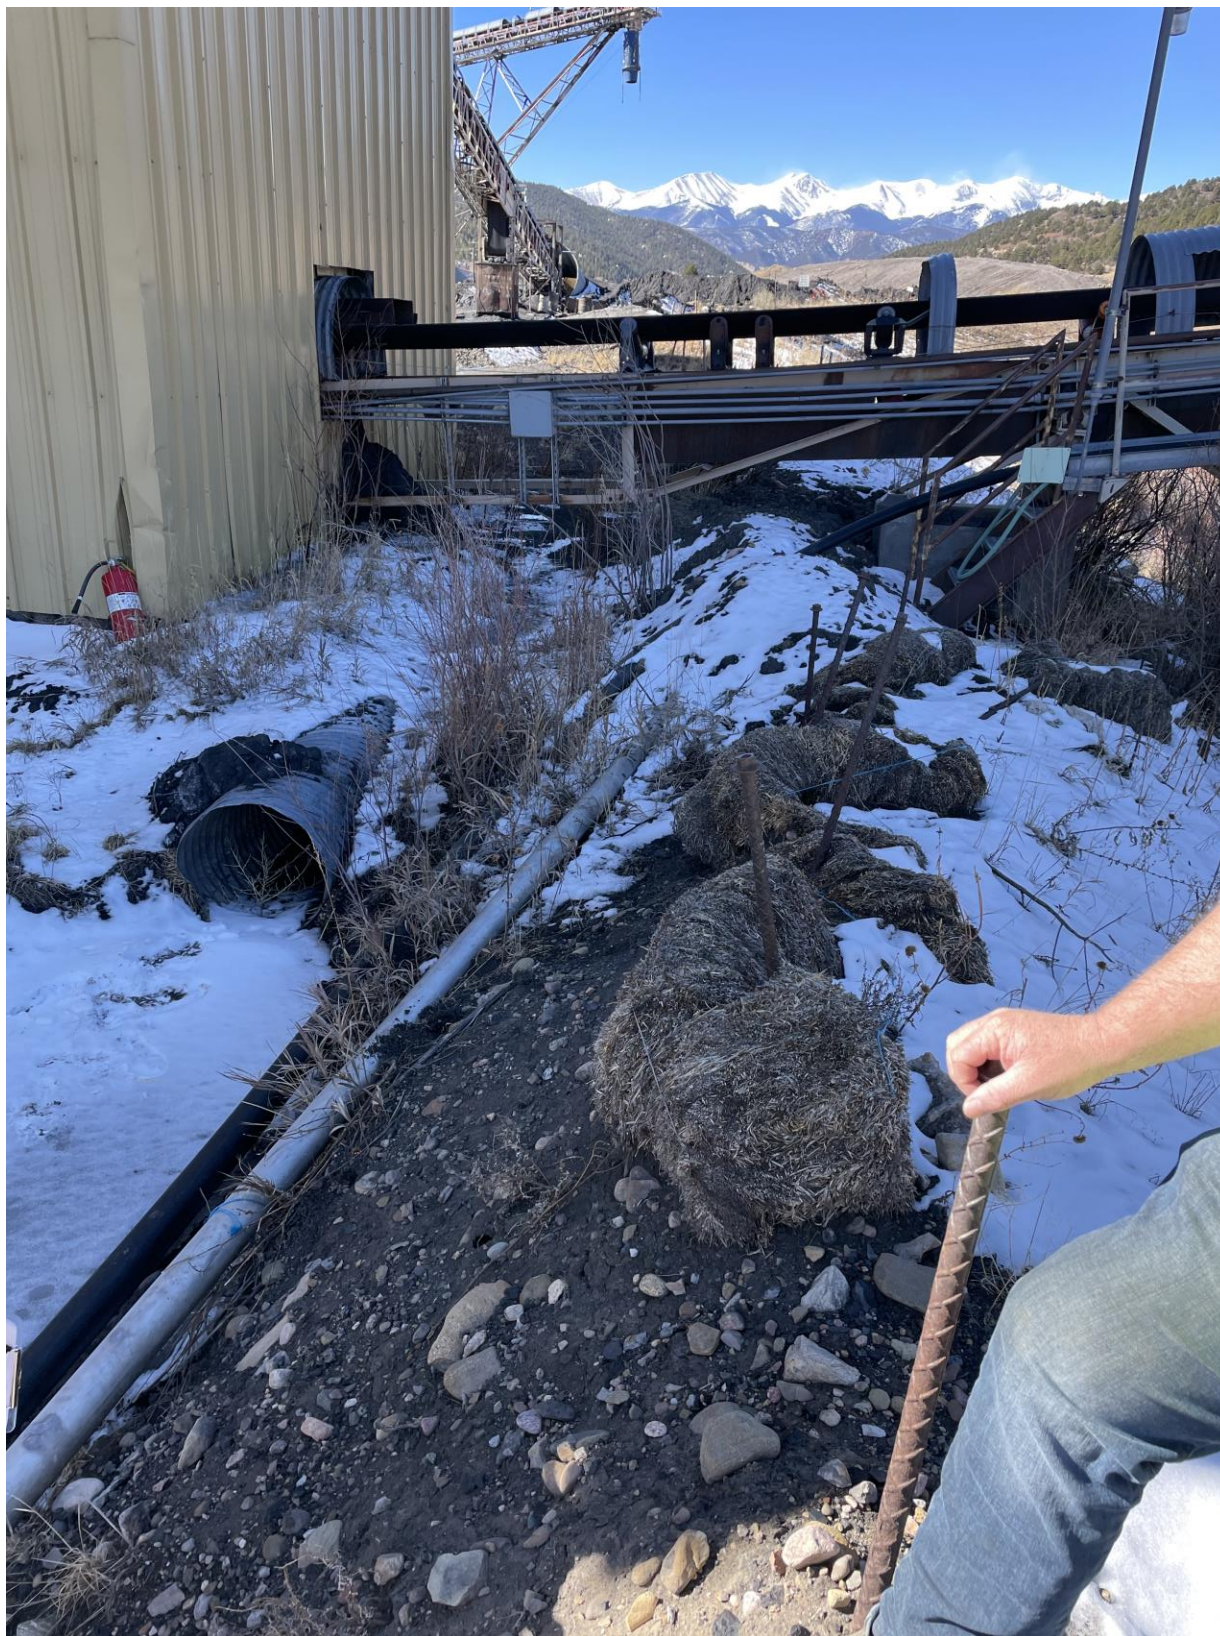
There is an area by the wash plant that is a variance to the stream buffer zone Rule 4.05.18. There are some straw bales in this area that need some maintenance. (Picture 15)

Picture 15 – Stream buffer zone variance area by wash plant

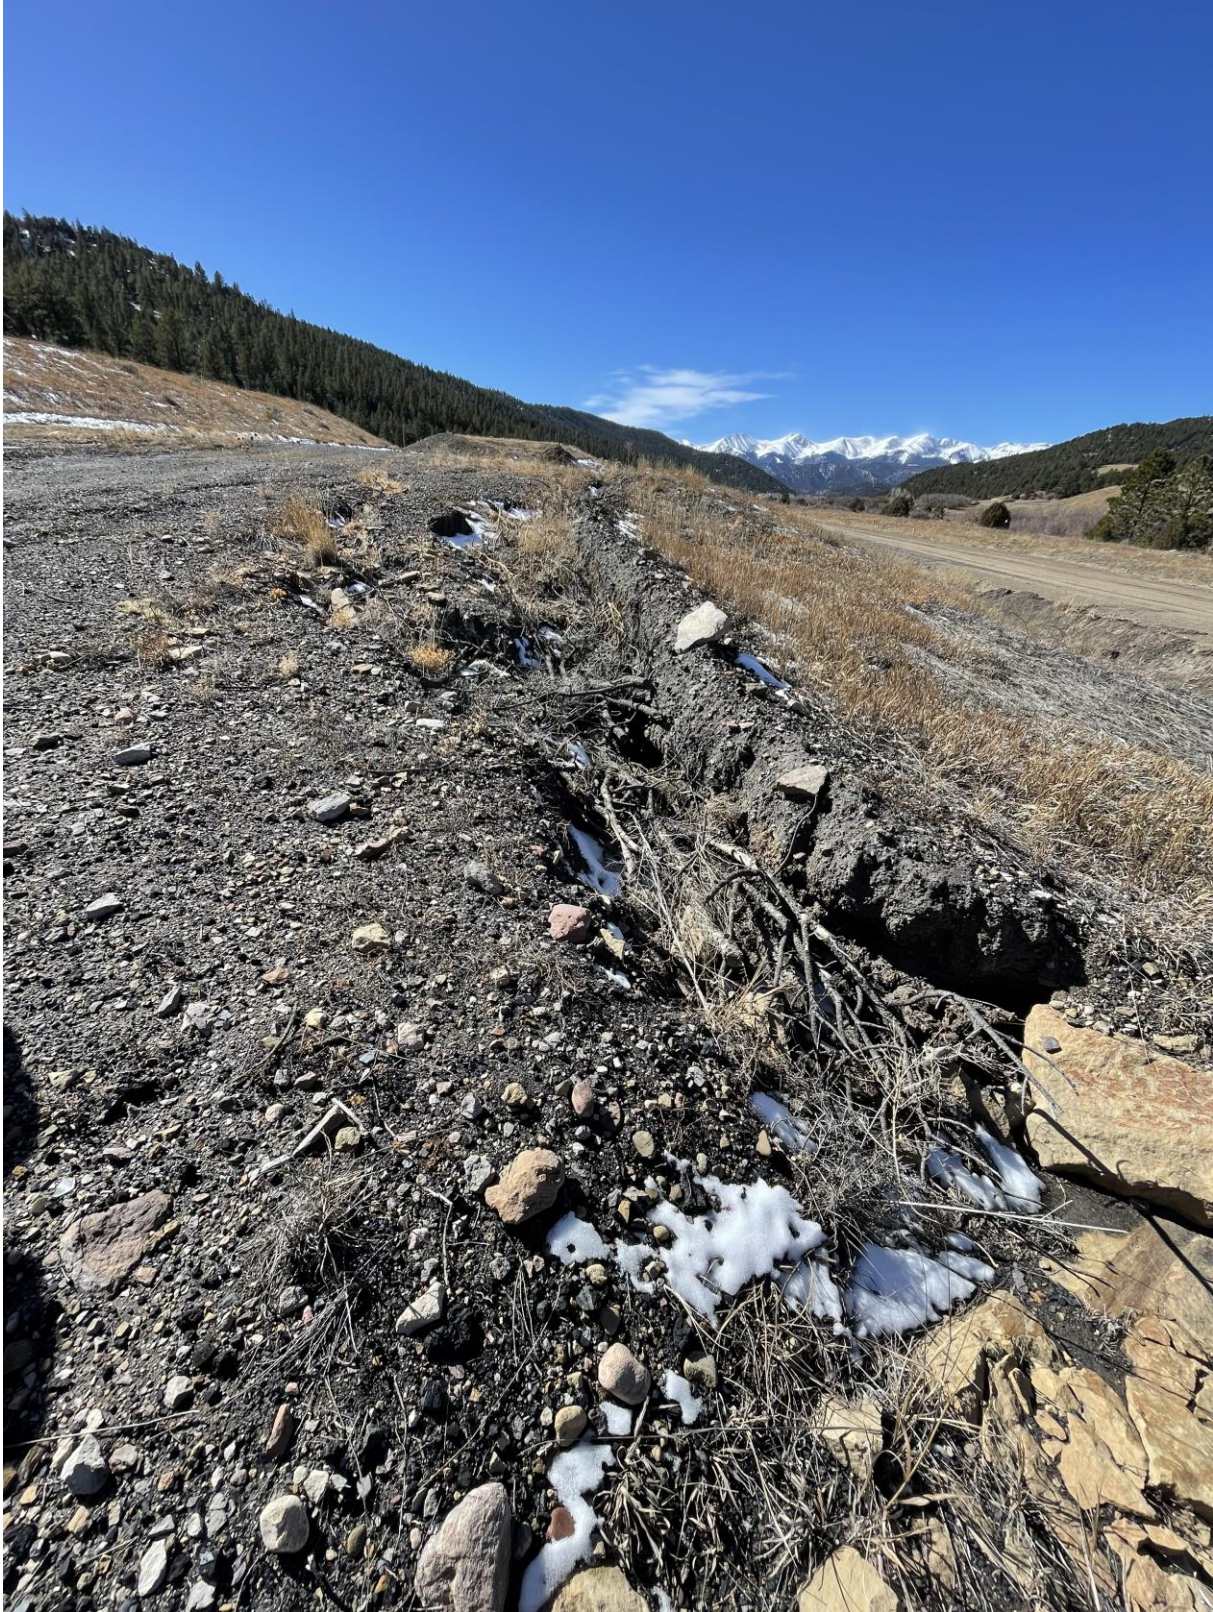
All of the roads around the site were well maintained and stable. There was some erosion on the sides of the road leading to the topsoil and subsoil piles that needs to be repaired. (Picture 16)

Picture 16 – Erosion by road to topsoil pile
