U.S. DEPT. OF THE INTERIOR
OFFICE OF SURFACE MINING
Mine Site Evaluation
State Program

**Denver Field Branch
Mine Site Evaluation Narrative**

Permittee:	New Elk Coal Company, LLC
Operator:	New Elk Coal Company, LLC
Site:	New Elk Mine
Permit No:	C-1981-012
Date of Inspection:	February 15, 2024
Inspection Type:	Partial Oversight
Weather:	Warm and Sunny
Operator Representatives:	John Terry
State Official:	Amber Gibson and Jared Ebert
OSMRE Officials:	Jim Stark #591

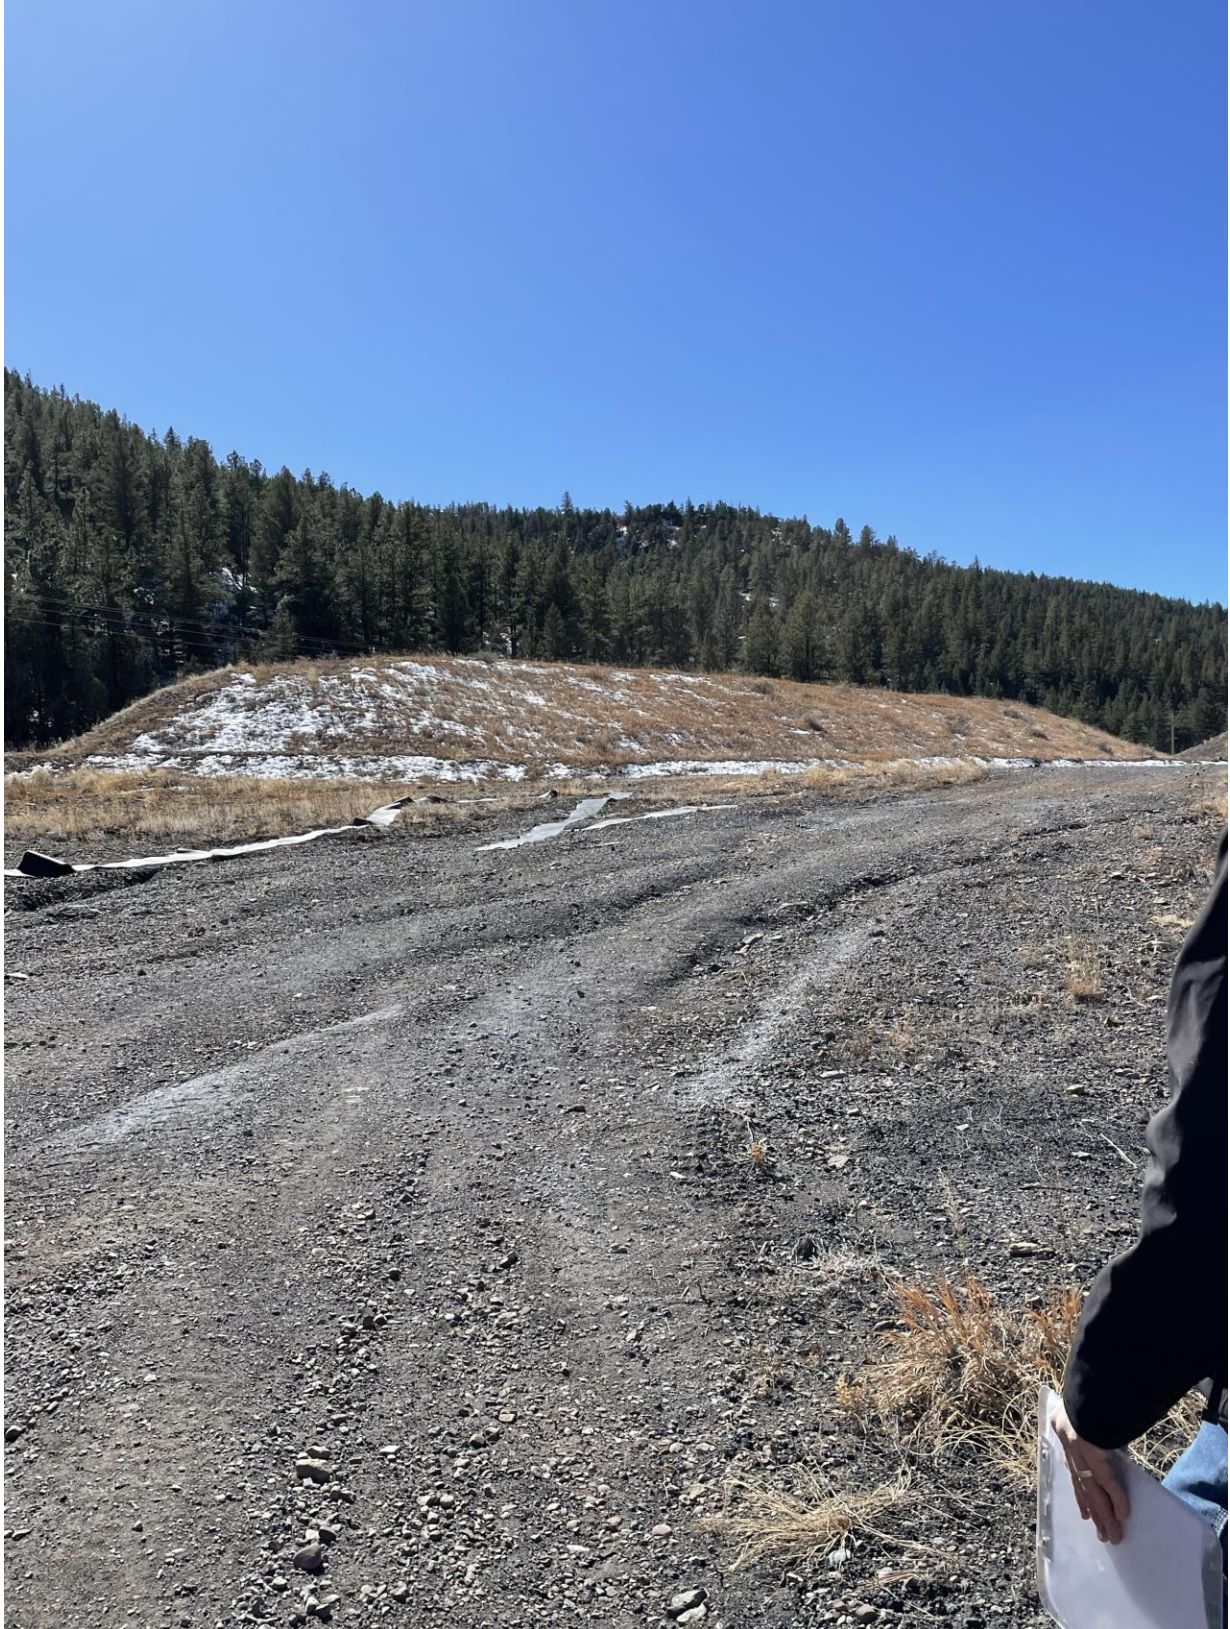
The topsoil pile was well vegetated and stable and no erosional problems were noted at the time of the inspection. (Picture 17)

Picture 17 – Topsoil pile

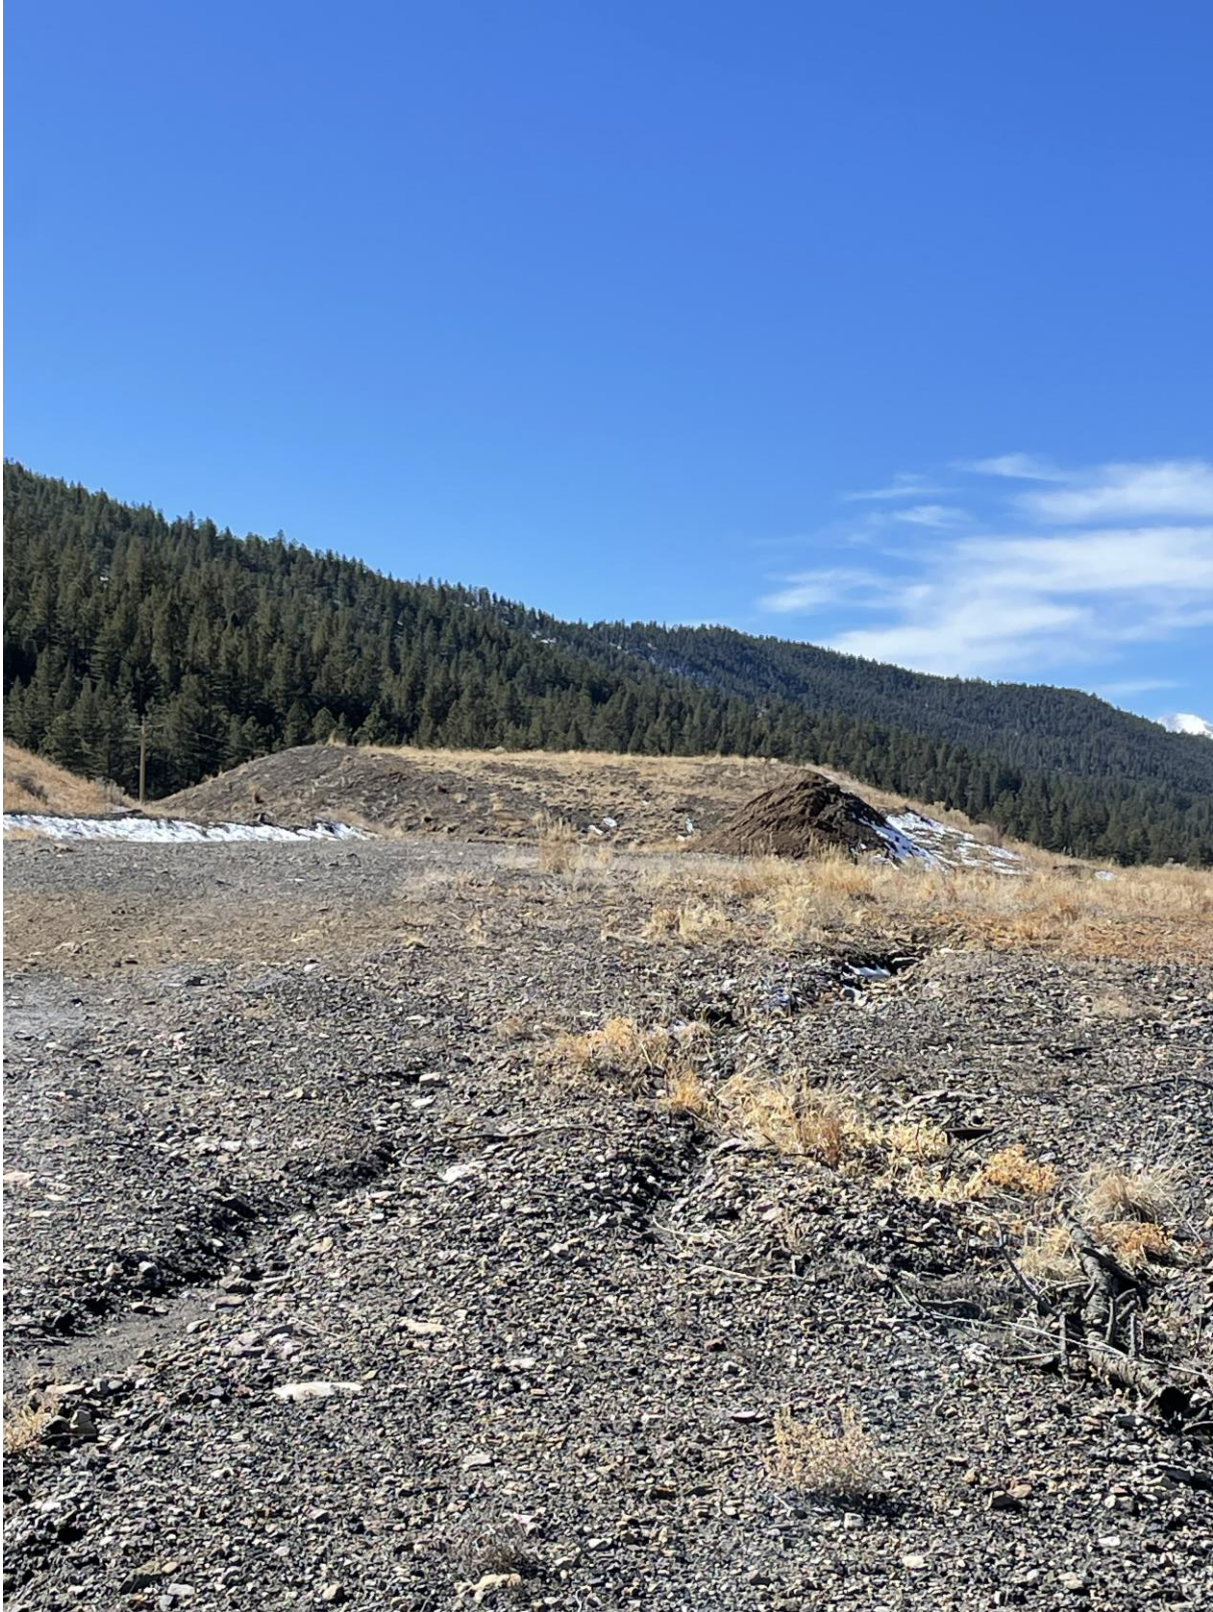
The subsoil pile was well vegetated and stable and no erosional problems were noted at the time of the inspection (Picture 18)

Picture 18 – Subsoil pile (background) and new topsoil pile (foreground)

There is a new topsoil pile by the subsoil pile. This pile will either need to be combined with the current topsoil pile and seeded or, if it is left in place, will need to be seeded and have a berm placed around it to protect the resource (Picture 18)

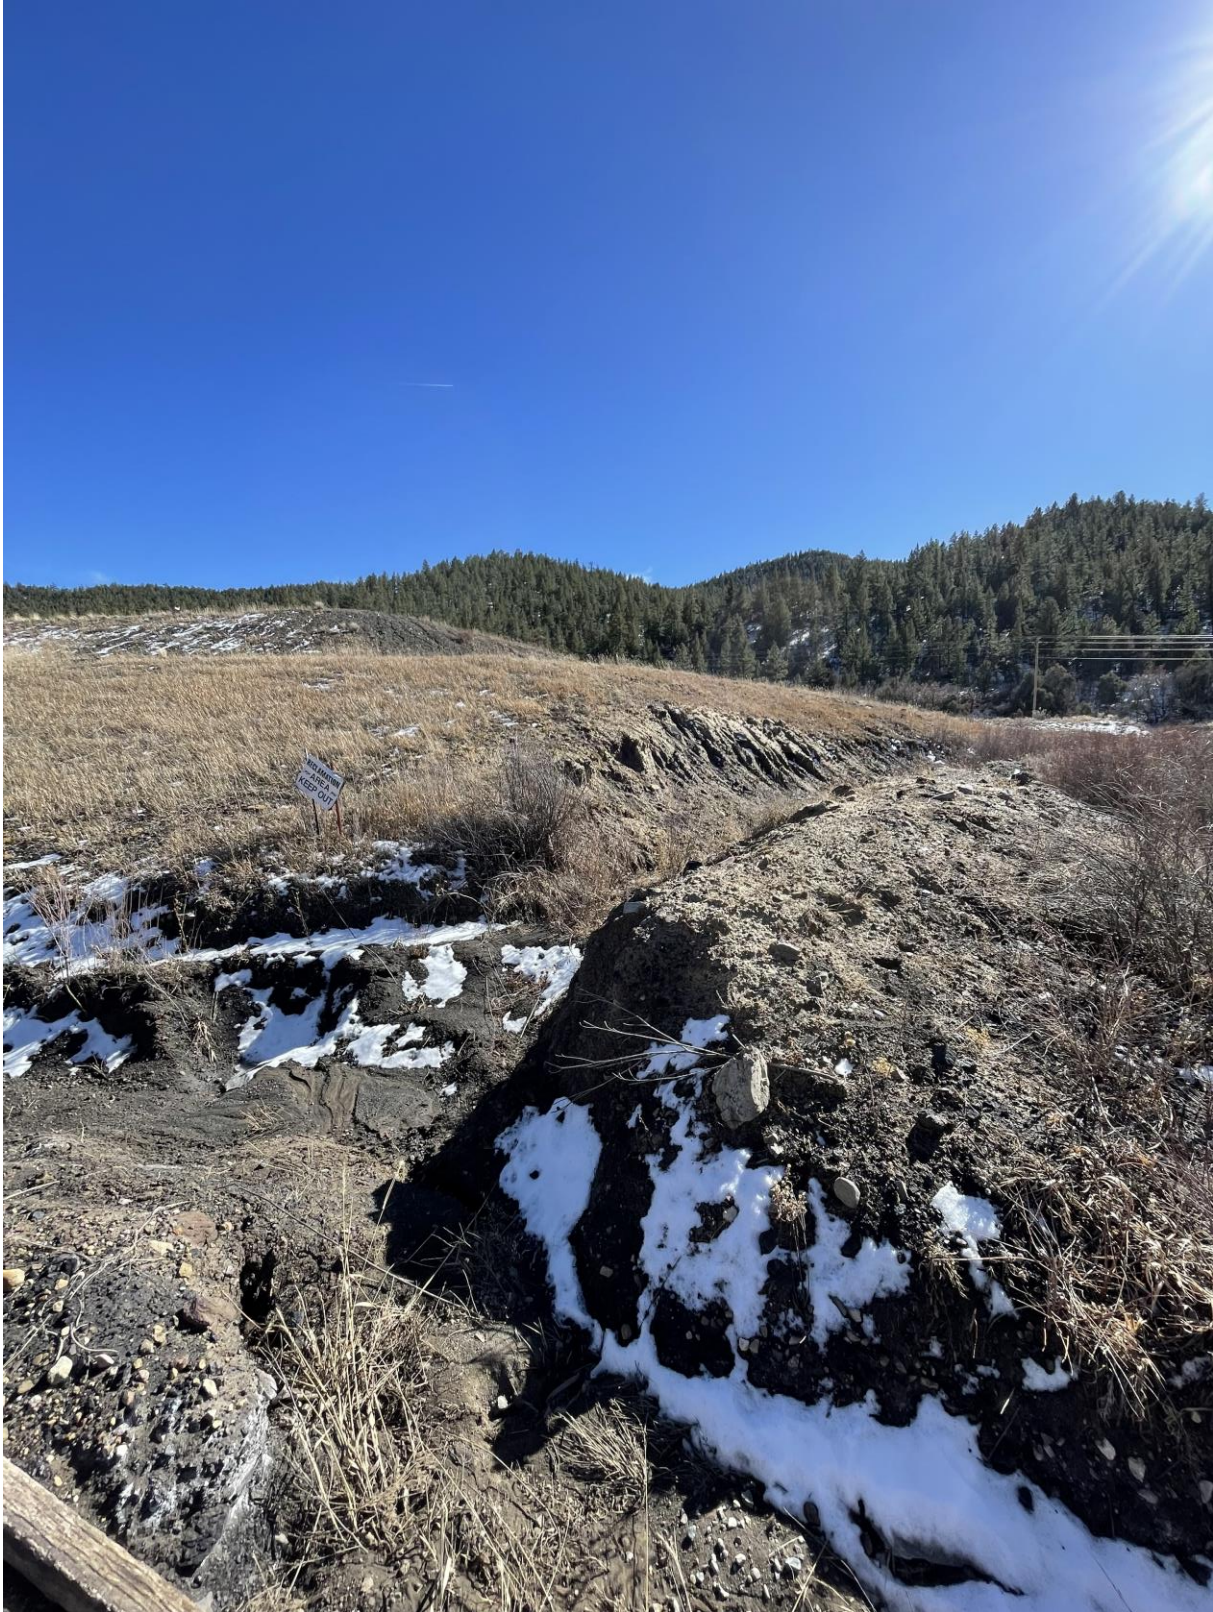
There was an area just below the subsoil pile that was noted in previous inspection reports as having some erosional problems. This area was repaired and hydroseeded and is currently being monitored. (Picture 19)

Picture 19 – Repair and hydroseed area
